PROPERTY CONDITION REPORT OUTLINE

May 2, 2007

The Palms

Prepared for:
No. 1 LTC Operator, Anytown, USA

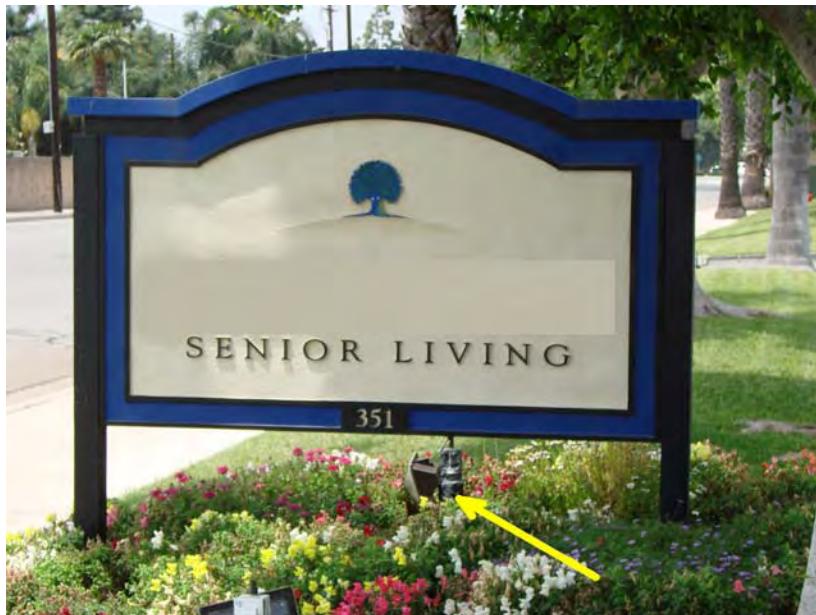
Signage: See photos. Attractive monument sign with landscaping and sign lighting. Note sign lighting is broken.

002 P_E: Facility identification sign. Note broken sign lighting.

2. Update identification sign to reflect change in ownership.
3. Repair broken lighting at identification sign, enhance landscaping around sign.
4. Minor asphalt maintenance, reseal & restripe.
5. Replace & repaint all exterior wood trim & fascia.
6. Pressure wash buildings, minor exterior wall repairs where paint has “bubbled” and peeled.
7. Consider investigating adding an emergency generator.
8. Emergency reserve for replacing/repairing older central HVAC equipment.

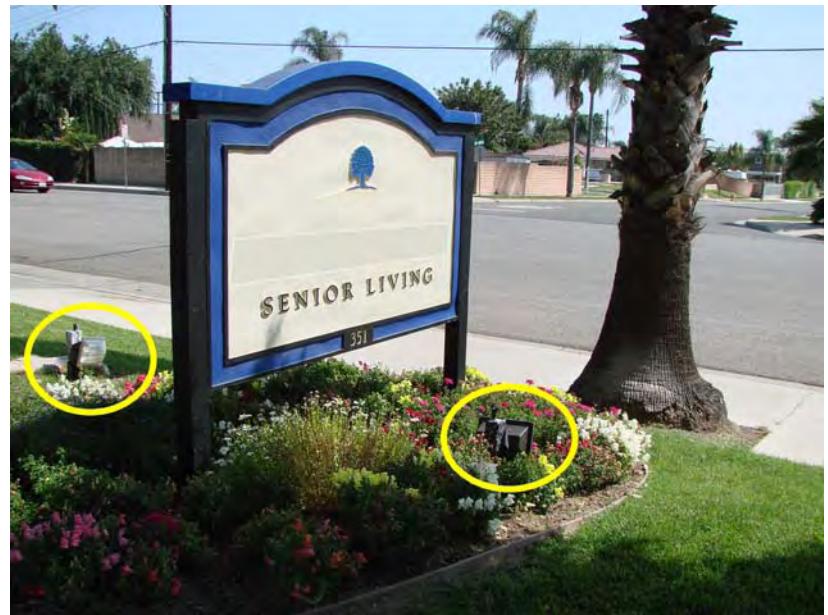
003 P_E: Facility identification sign. Note broken sign lighting.

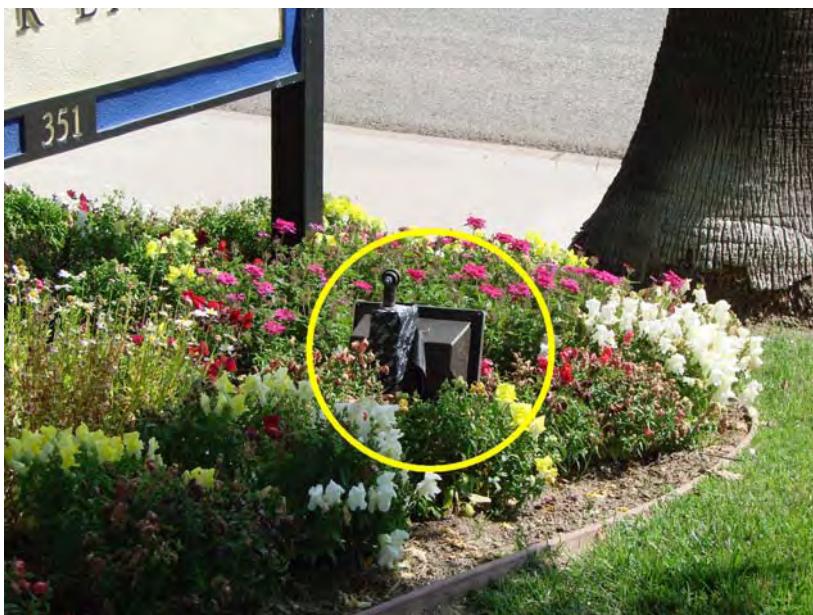
004 P_E: Broken light detail.

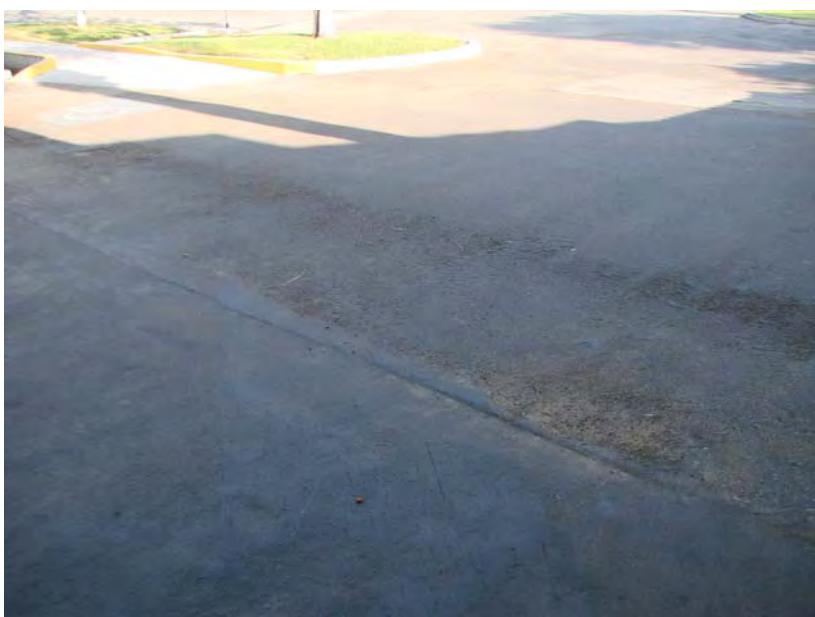
Paving & Striping: Asphalt paving, generally good condition with isolated areas of deterioration. Striping is in generally adequate condition. Paving will need some attention in near future.

016 P_E: Asphalt paving detail - minor surface damage.

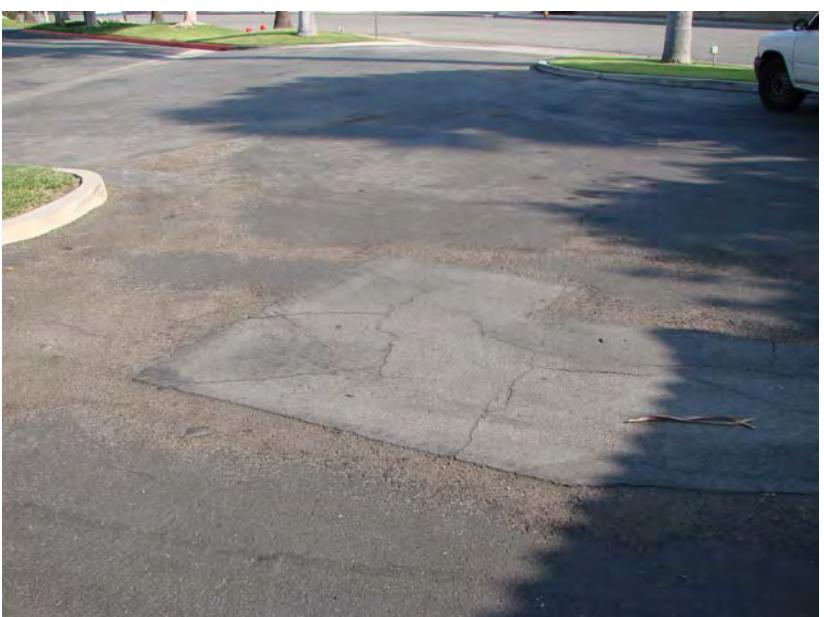
017 P_E: Asphalt paving detail at Palm West - prior asphalt patch.

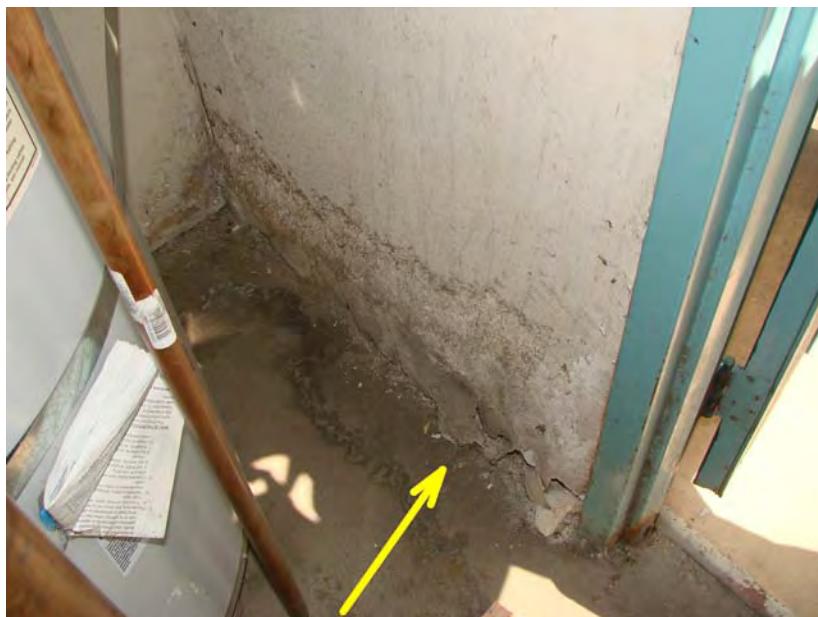
030 P_E: Water damage in water heater closet.

19. Repair water damage to wall in water heater closet.
20. Miscellaneous repairs.
 - a. Ceiling repair in dry storage (fire sprinkler pipe leak)
 - b. Courtyard doors need repainting

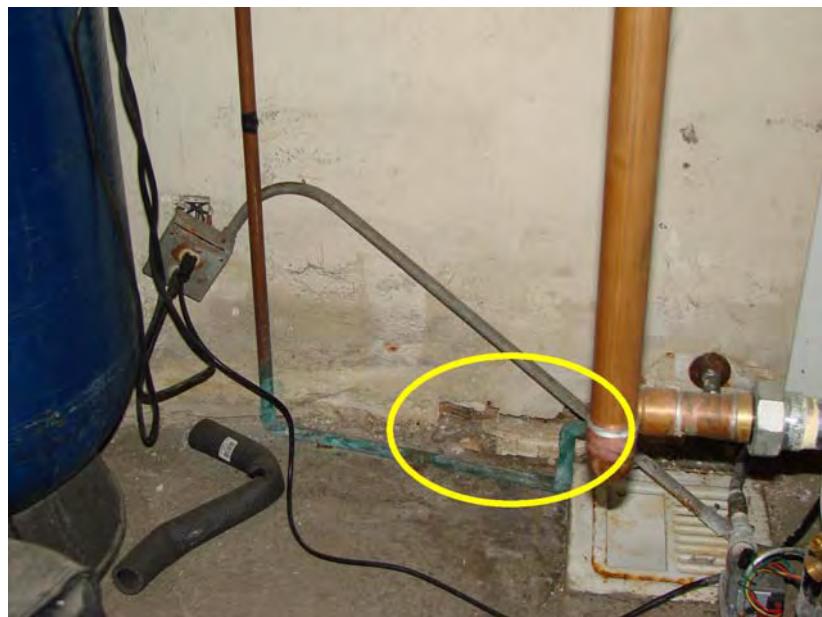
031 P_E: Water damage in water heater closet.

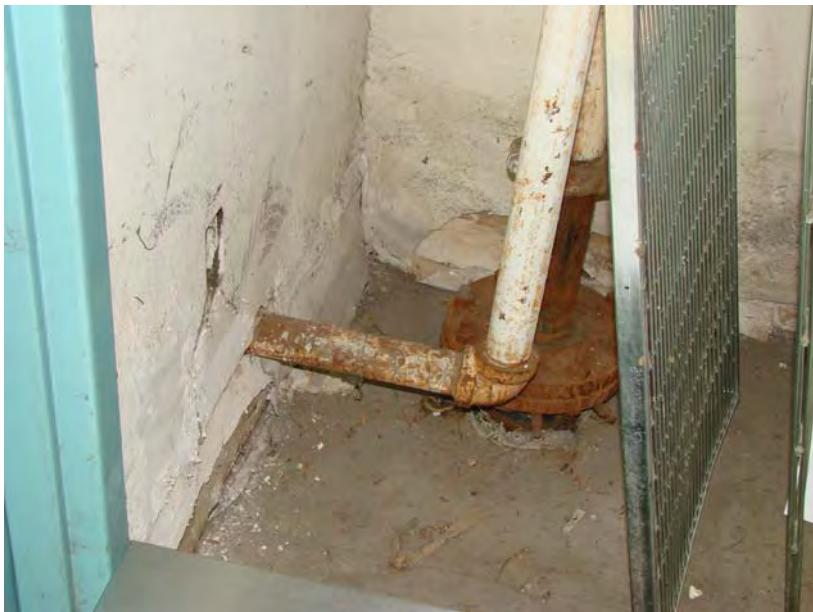
032 P_E: Water damage in water heater closet.

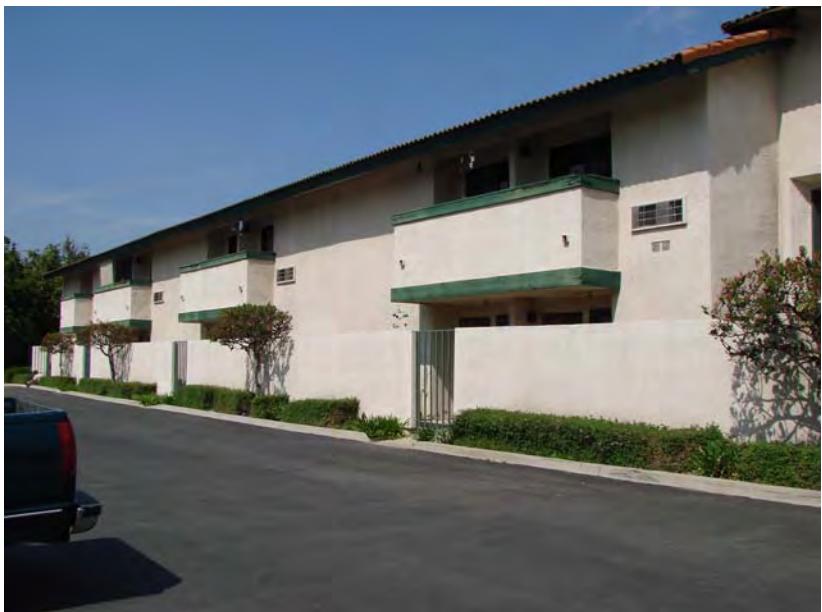
Condition: All wood trim is rotten and needs to be replaced.

033 P_E: Palm East - west elevation. note rotten wood trim on 2nd floor balconies.

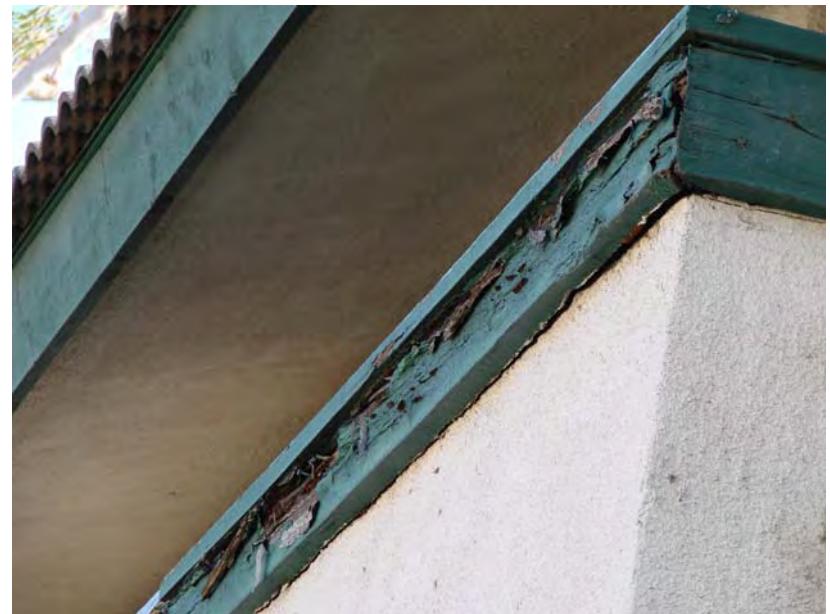
043 P_E: Detail - rotten trim on 2nd floor balcony.

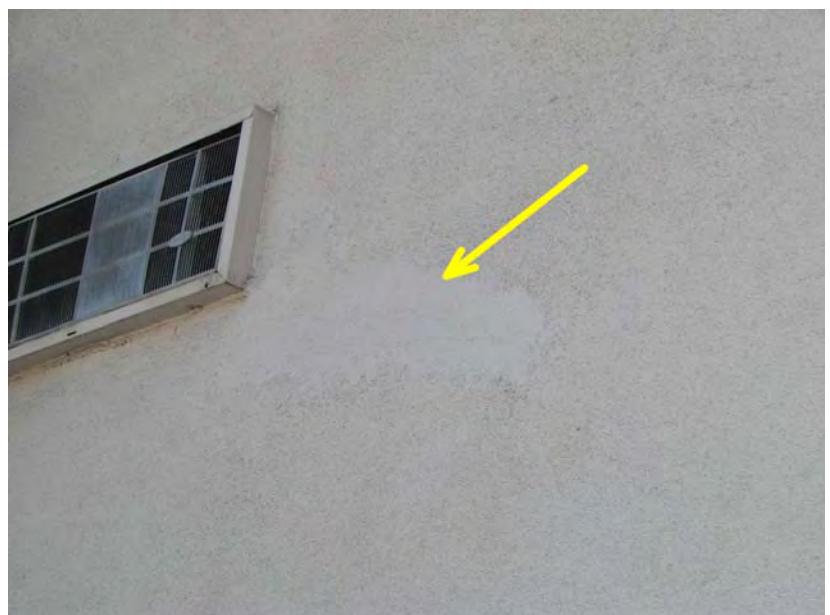
045 P_E: Wall patch on east elevation at PTAC unit.

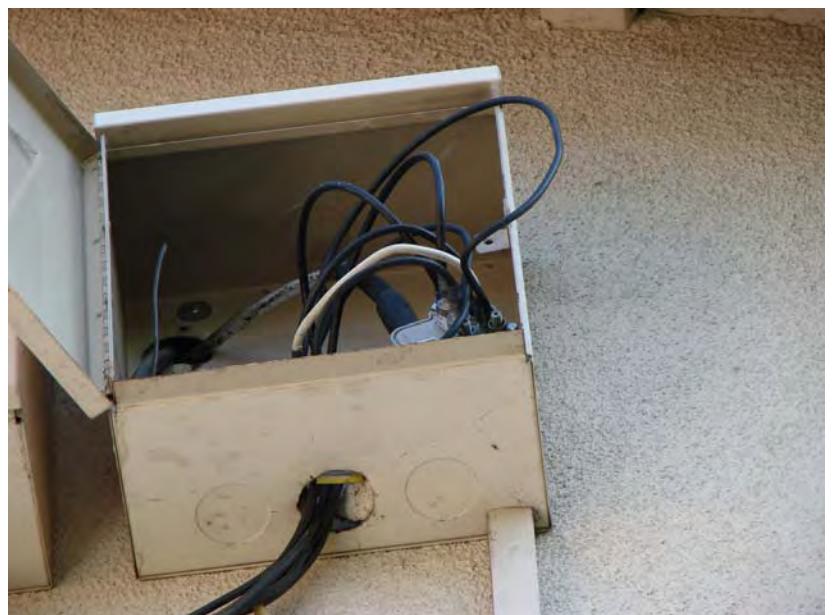
049 P_E: Open CATV junction box.

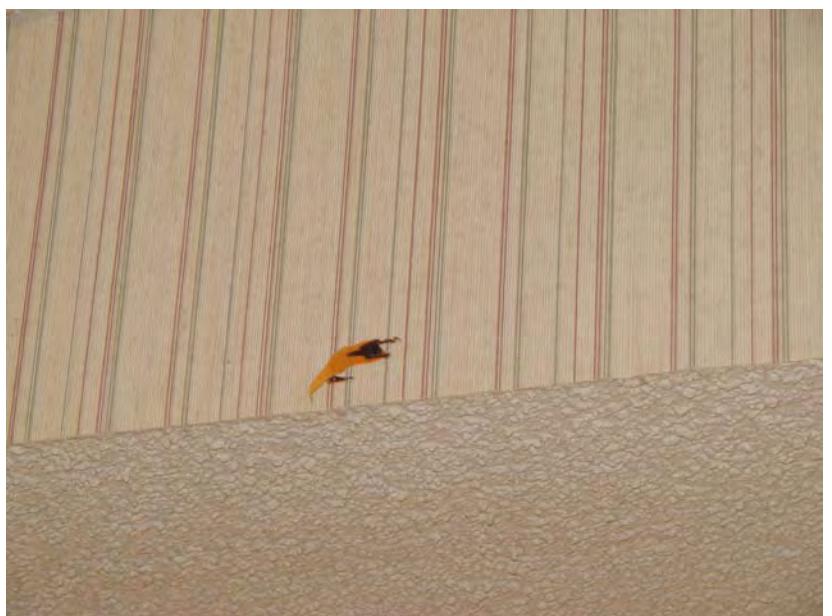
069 P_E: Staples and old decoration streamers in Dining room.

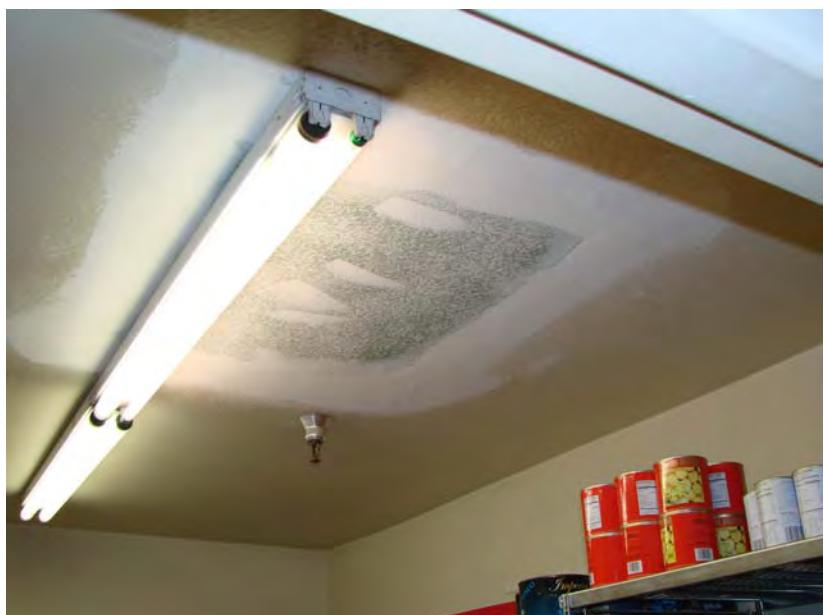
077 P_E: Kitchen - ceiling repair in dry storage (fire sprinkler pipe leak).

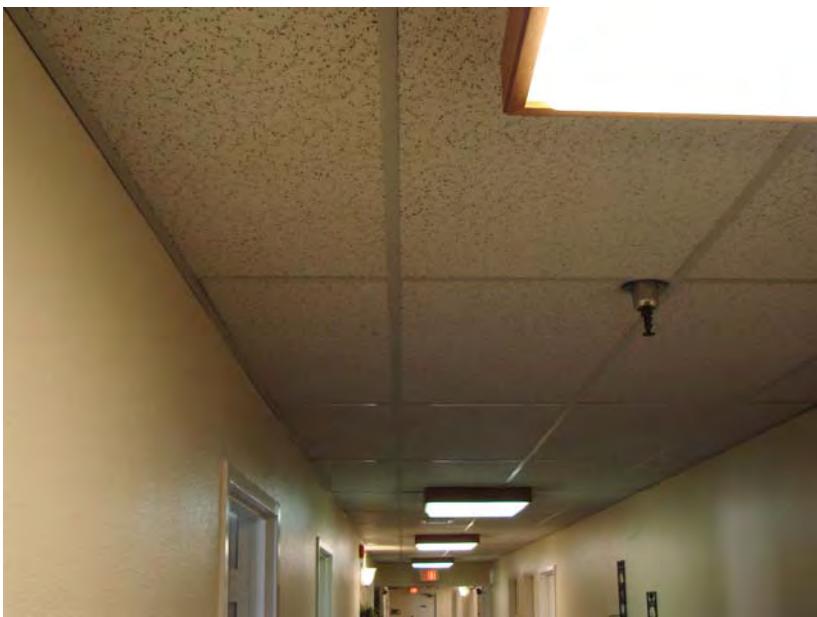
123 P_E: Acoustic lay-in ceiling tile - consider repainting ceiling grid. Replace or paint tile.

13. Repaint acoustic ceiling grid & tile in corridors.
14. Consider adding handrails in corridors.
15. Replace Rauland emergency call system – age.
16. Replace kitchen equipment/appliances in future years – age.

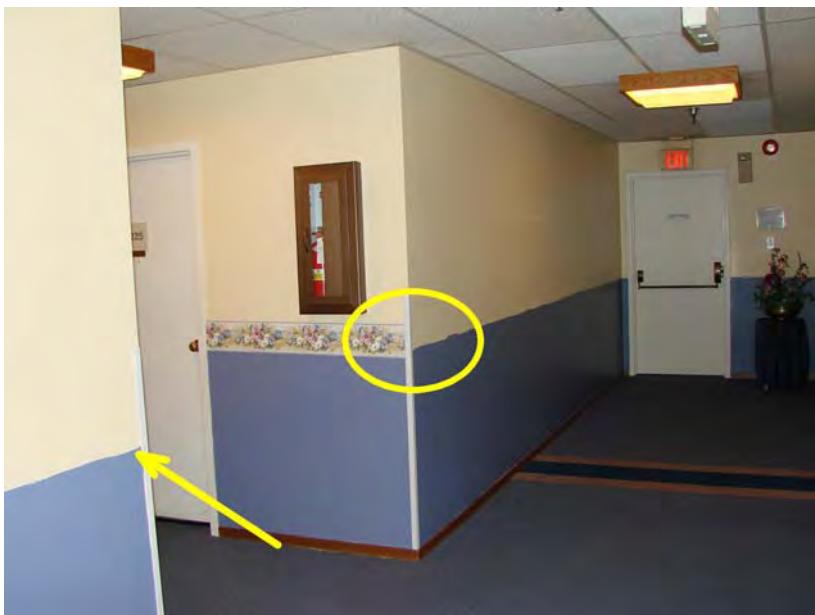
124 P_E: 2nd floor east hall @ north end. Note missing wallpaper border - staff is in the process of installing border after painting corridor walls.

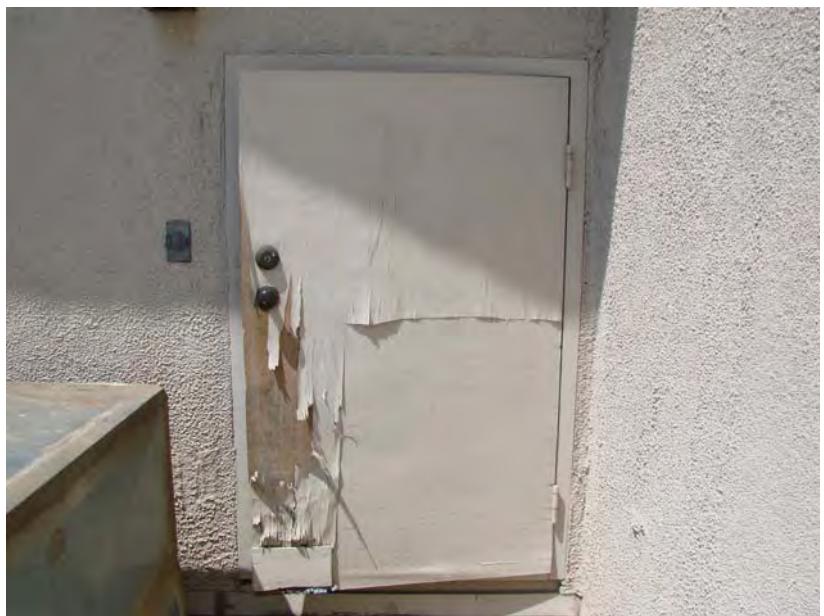
143 P_E: Roof well access door needs to be replaced.

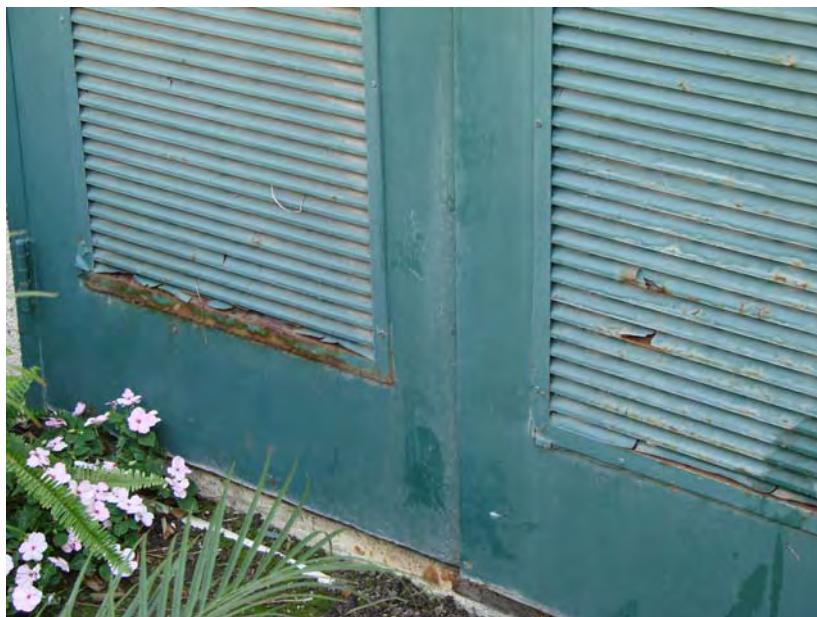
168 P_E: Detail of elevator equipment room doors - doors will need to be replaced in future years.

- c. Replace elevator equipment room doors in future years.
 - d. Water damage outside private dining room (possibly from sprinklers?)
 - e. Laundry dryer vents - consider adding a wire cage lint trap

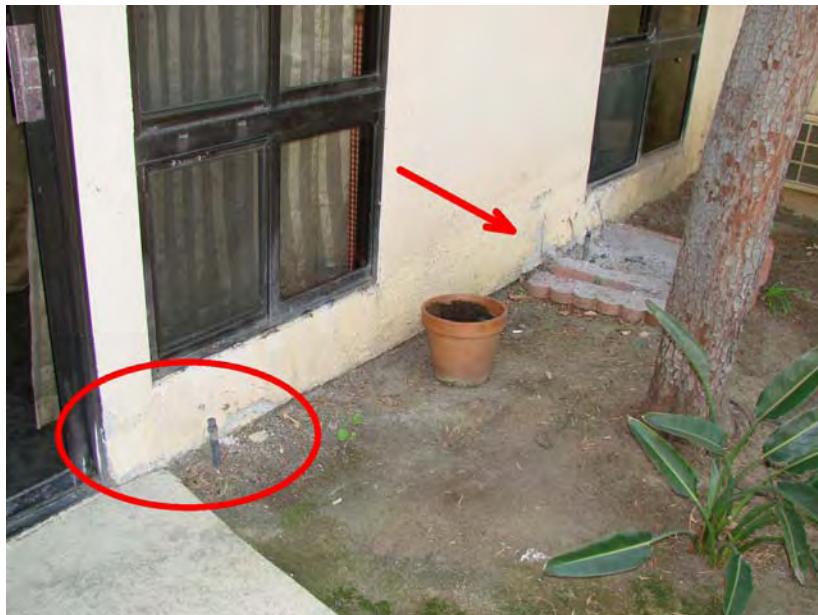
170 P_E: Courtyard detail - water damage outside private dining room (possibly from sprinklers-).

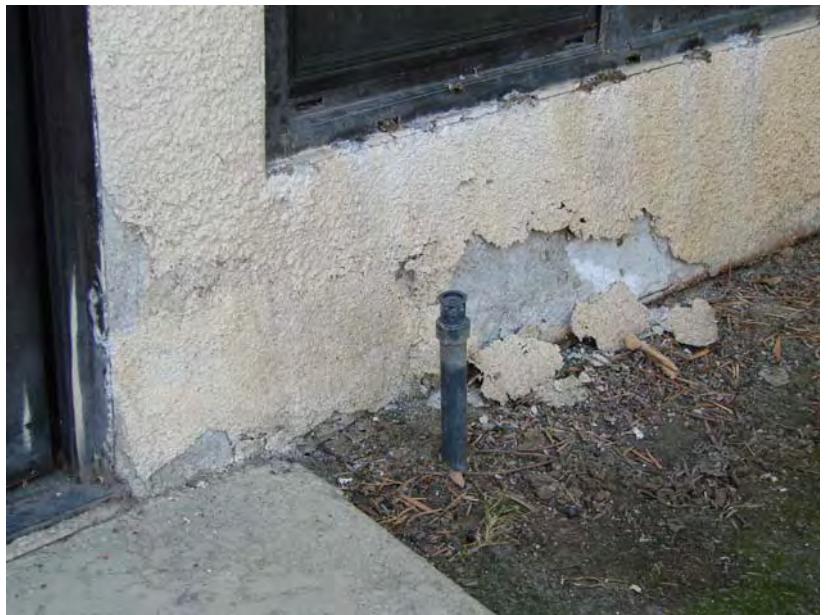
171 P_E: Water damage detail.

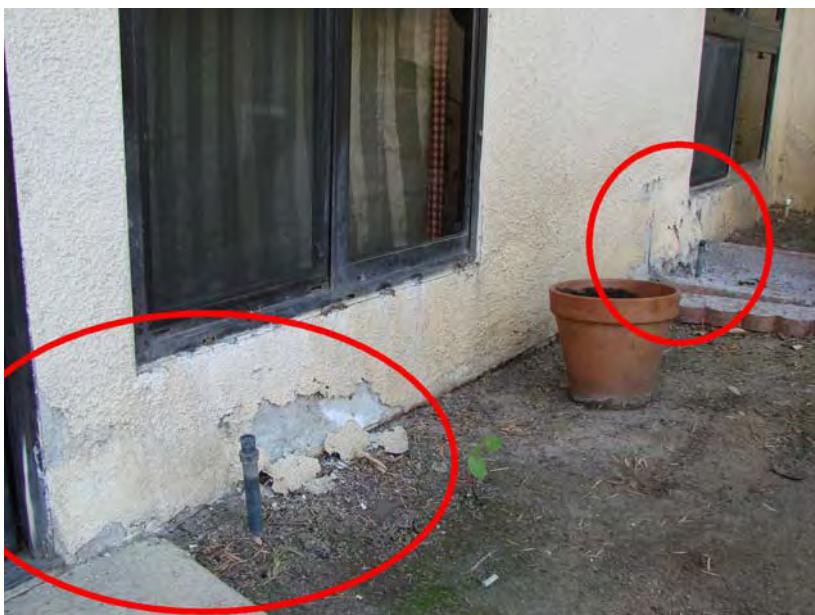
172 P_E: Courtyard detail - water damage outside private dining room (possibly from sprinklers-).

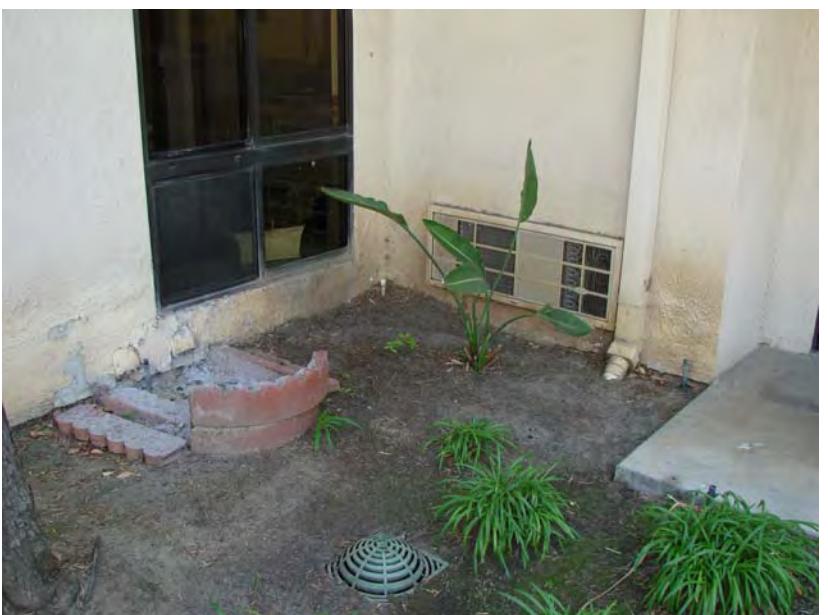
173 P_E: Laundry dryer vents - consider adding a wire cage lint trap.

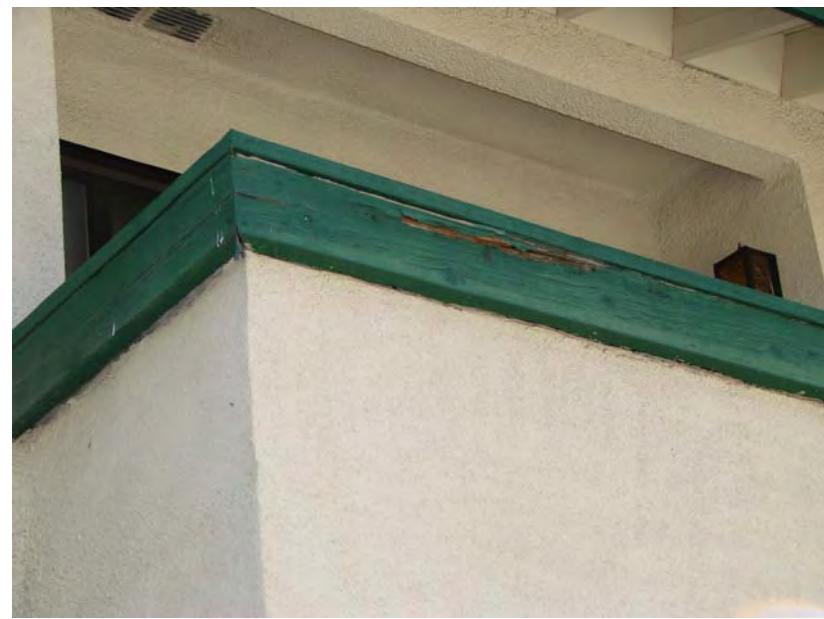
183 P_E: Detail - rotten wood trim on 2nd floor balconies.

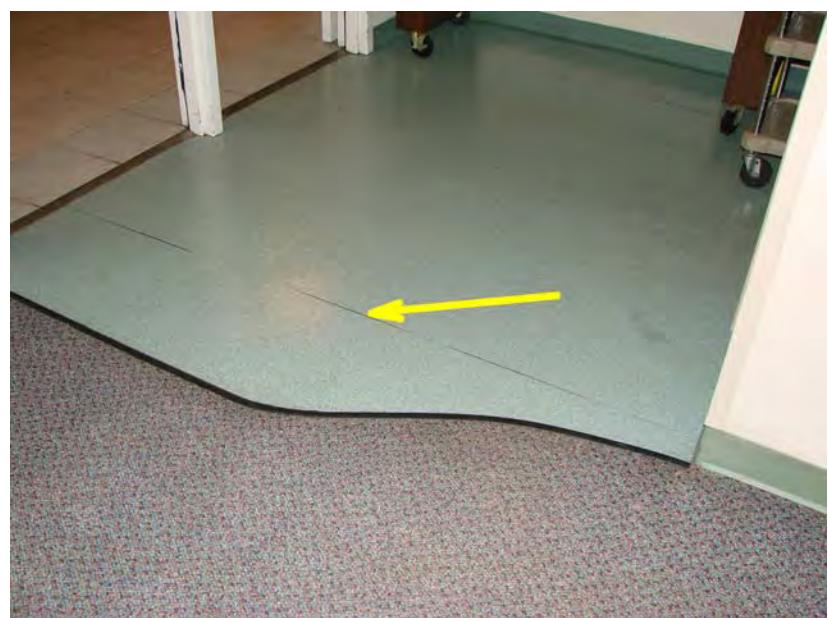
013 P_W: Dining room floor detail - note separated seam in sheet vinyl.

13. Replace dining room floor vinyl (All common area finishes and furnishings need to be upgraded.)
14. Replace Mirtone emergency call system – age.
15. Replace steam table in kitchen.

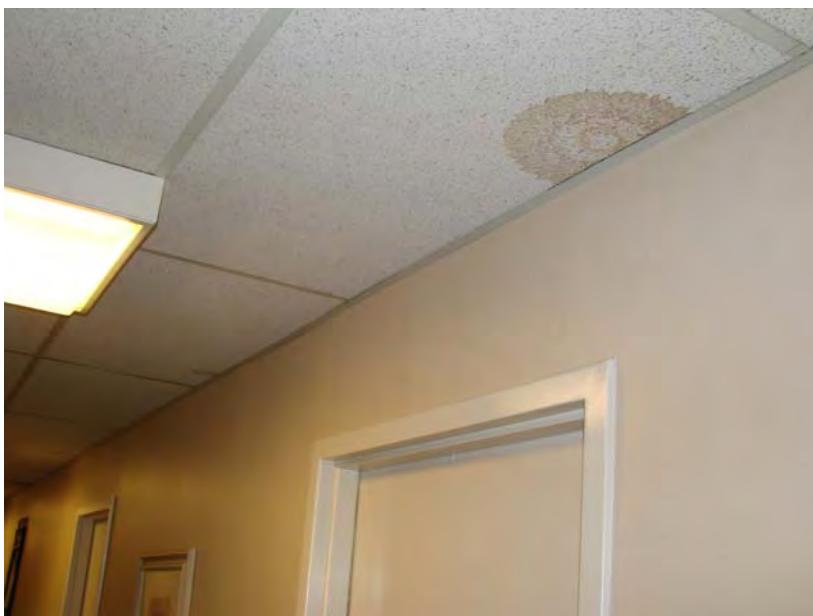
036 P_W: Water stain in 1st floor corridor. Likely from pipe condensation.

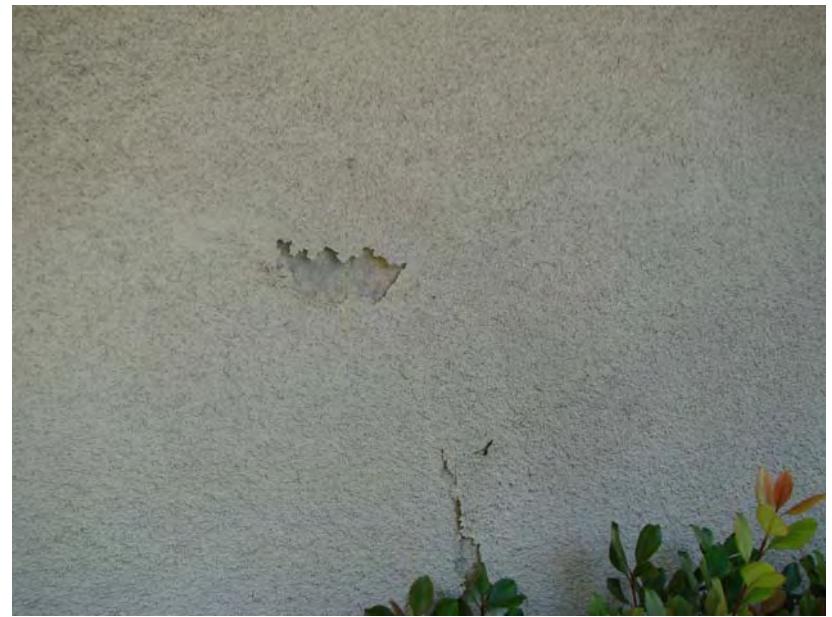
067 P_W: Exterior finish coming off building.

2. Deferred/age related maintenance to porch outside 2nd floor activity room.
3. Repair rotten wood trim on building exterior.
4. Pressure wash buildings, minor exterior wall repairs where paint has “bubbled” and peeled.
5. Consider investigating adding an emergency generator.

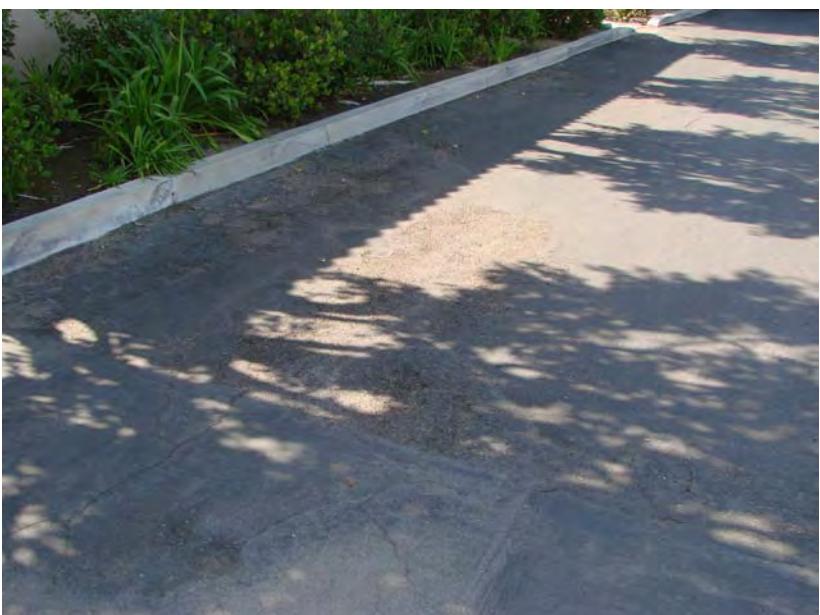
073 P_W: Paving detail - minor surface damage.

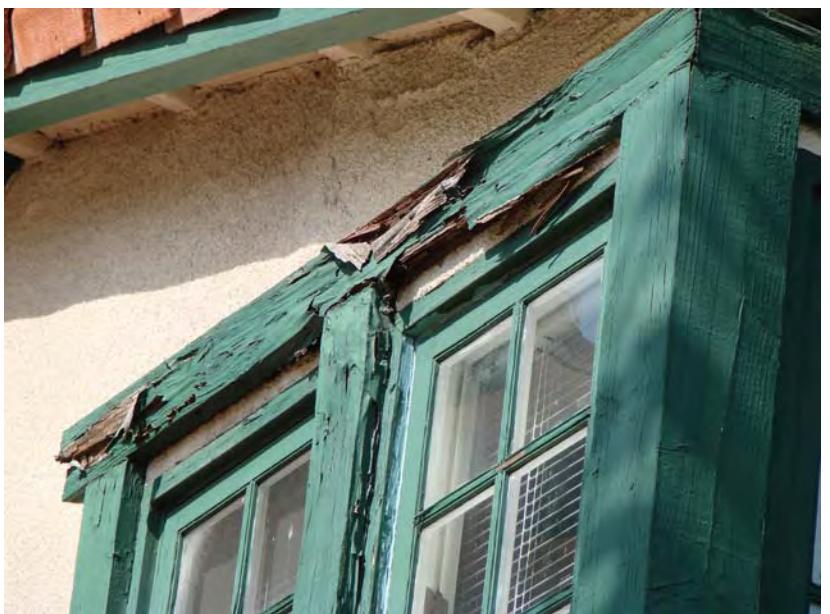
089 P_W: Rotten wood trim on windows.

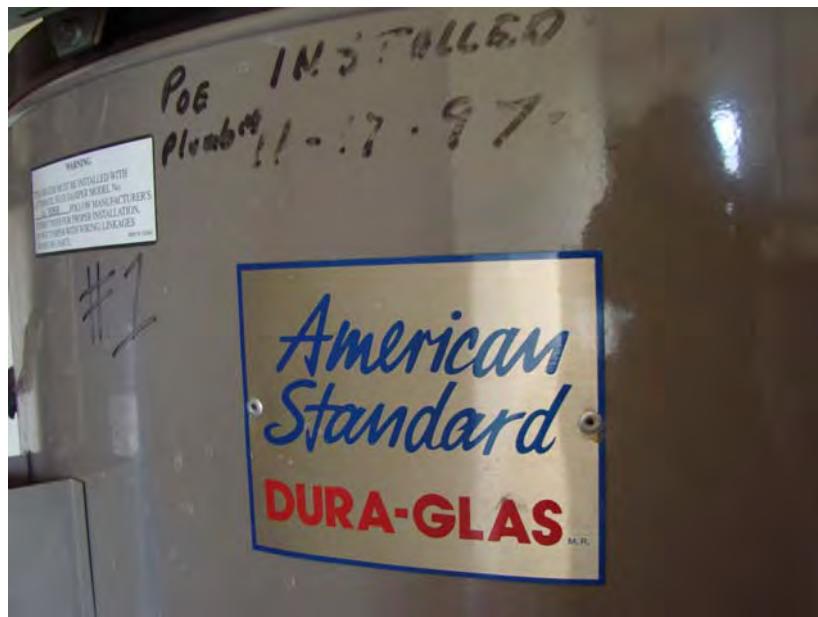
095 P_W: American standard water heater (#1), 100-gal, 250,000 BTUH. Installed in 1997, needs to be replaced soon.

18. Replace 2nd water heater in future years.
19. Replace 1997 water heater.
20. Emergency reserve for replacing/repairing older central HVAC equipment.
21. Misc. PTAC replacement as needed.

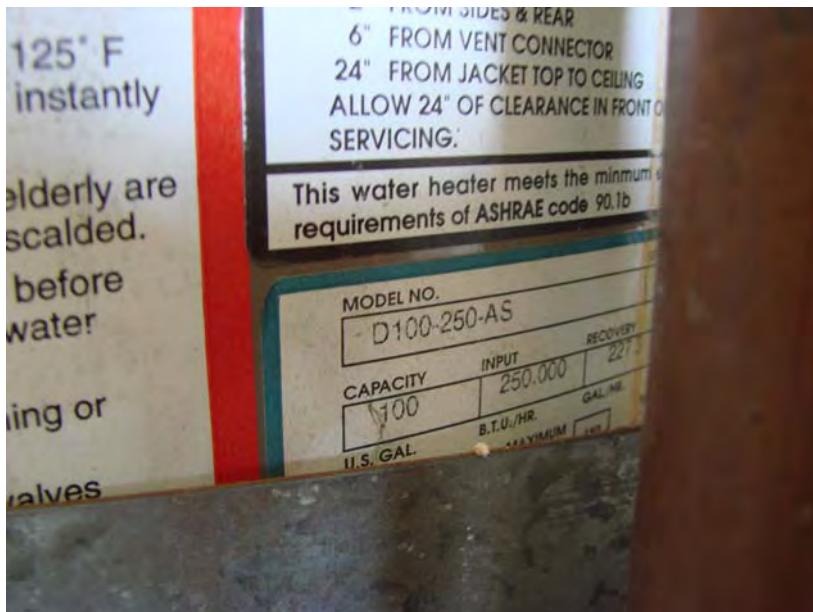
096 P_W: American standard water heater (#1), 100-gal, 250,000 BTUH. Installed in 1997, needs to be replaced soon.

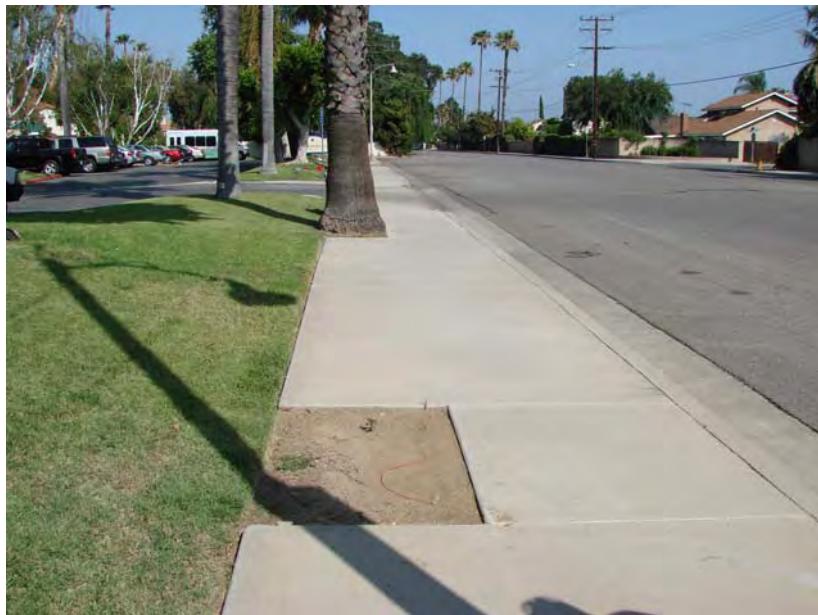
099 P_W: Removed palm tree in public right of way - consider petitioning City to replace tree or fill in with concrete.
