# The Palms: Before ~ After Photos

351 East Palm Drive, Anytown, USA 01995

Anytown, USA; July 31, 2009

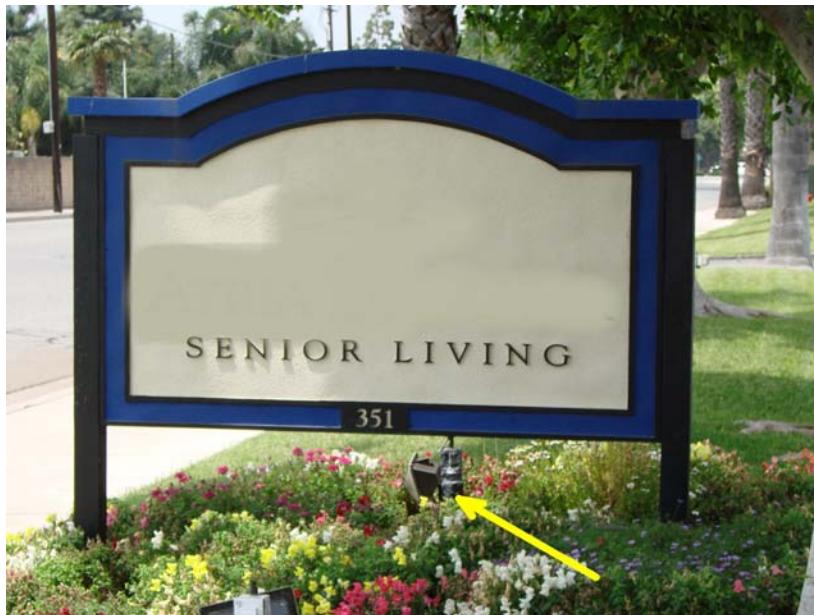
01-2007-05-02\_002 P\_E: Before - Facility identification sign. Note broken sign lighting.

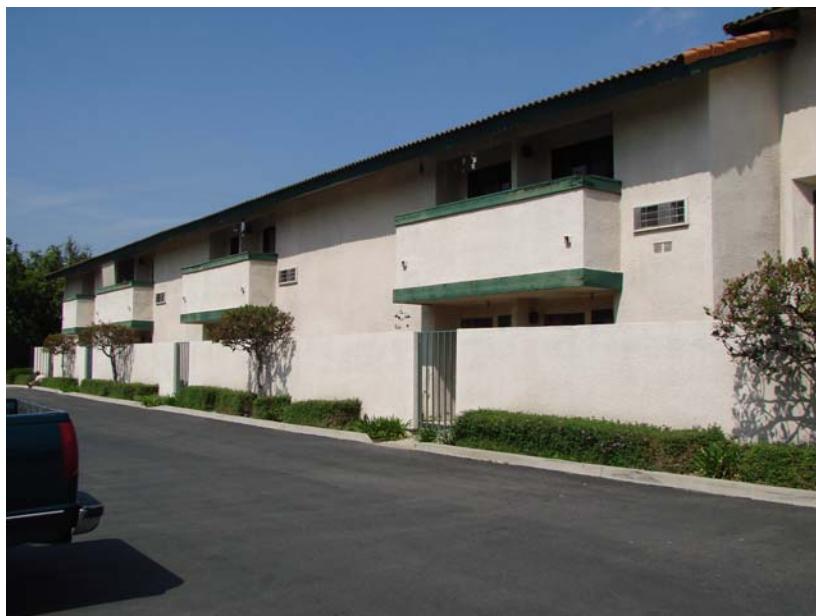
09-2007-05-02\_033 P\_E: Before - Palm East - west elevation. note rotten wood trim on 2nd floor balconies.

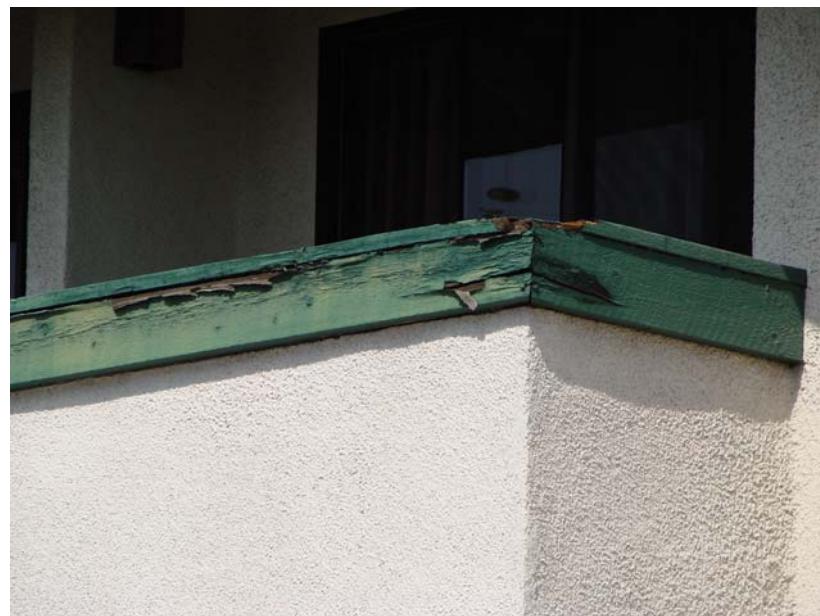
10-2007-05-02\_034 P\_E: Before - Detail - rotten wood trim on 2nd floor balconies.

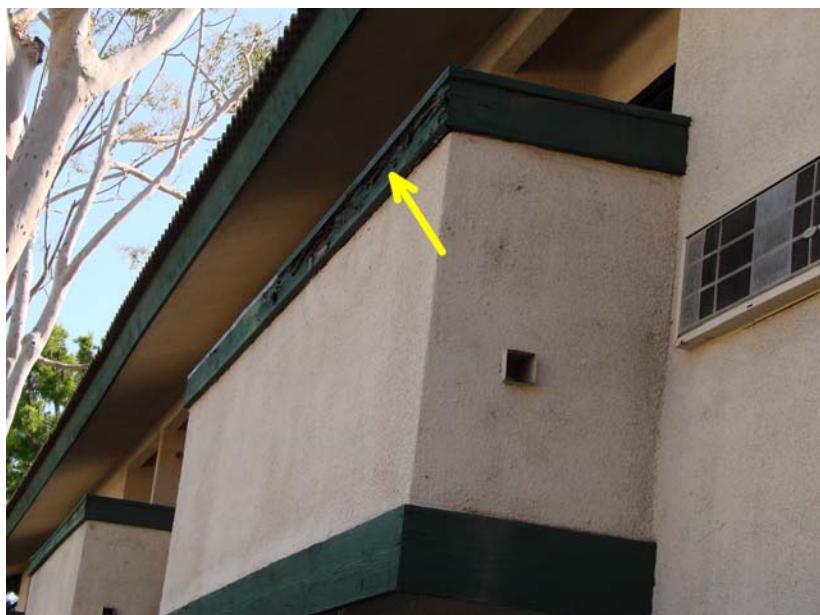
12-2007-05-02\_042 P\_E: Before - Detail - rotten trim on 2nd floor balcony.

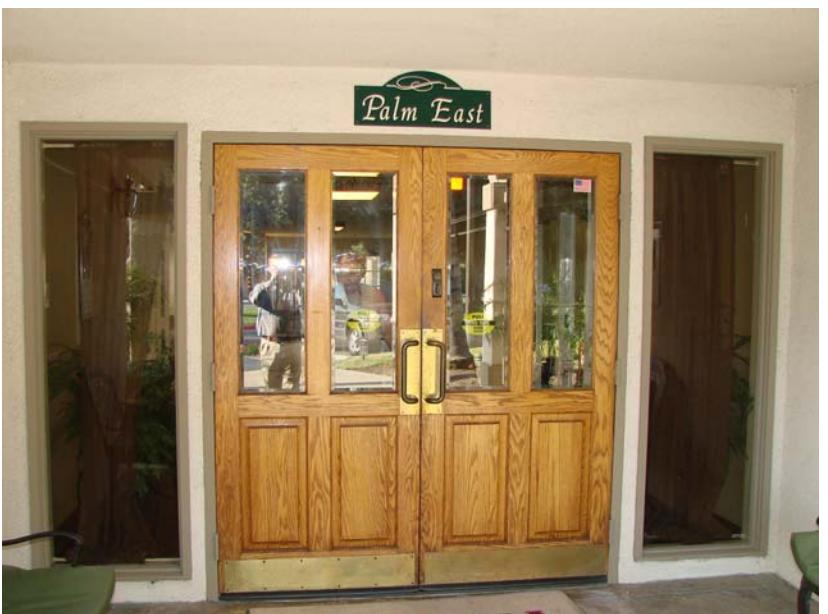
16-2009-04-23\_DSC09436: Before - Front entrance doors need to be re-finished.

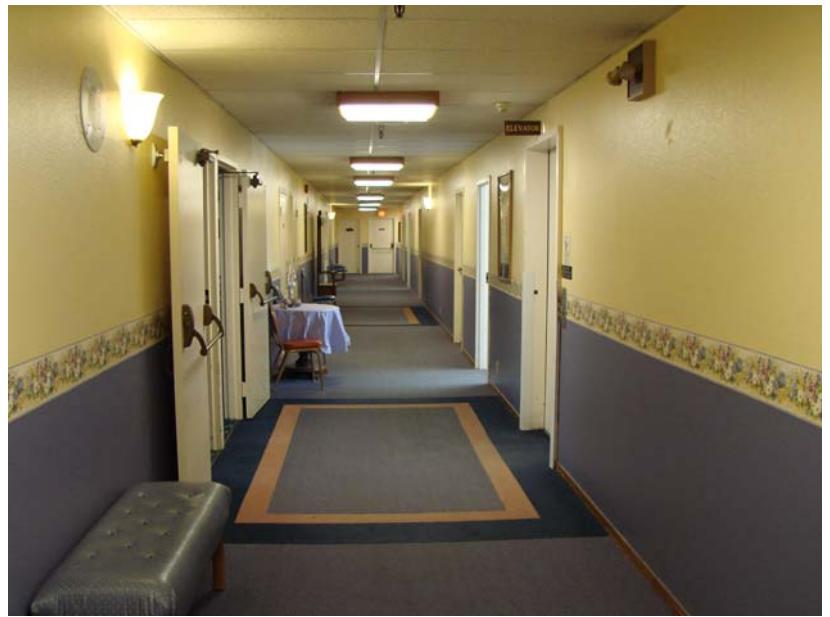
22-2007-05-02\_093 P\_E: Before - Palm East - typical 2nd floor corridor. Wood base, painted walls, no handrails, wallpaper border transition. Paint and border are

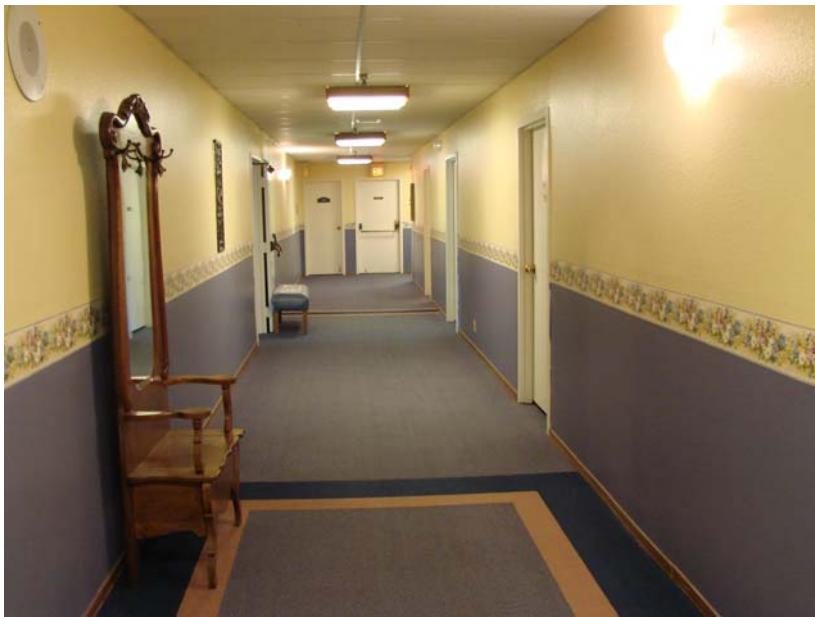
23-2008-05-19\_DSC08586: Before - Palm East - typical 2nd floor corridor. Wood base, painted walls, no handrails, wallpaper border transition. Paint and

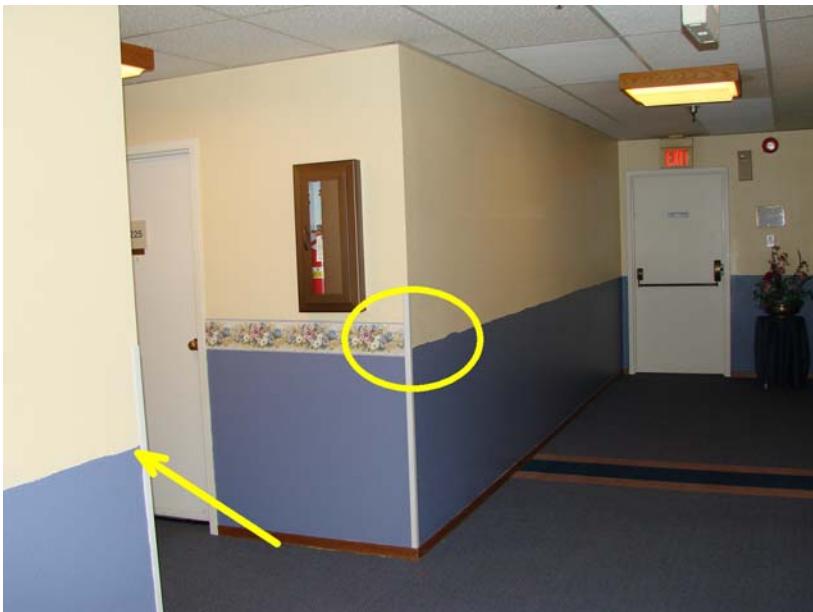
25-2007-05-02\_124 P\_E: Before - 2nd floor east hall @ north end. Note missing wallpaper border - staff is in the process of installing border after painting

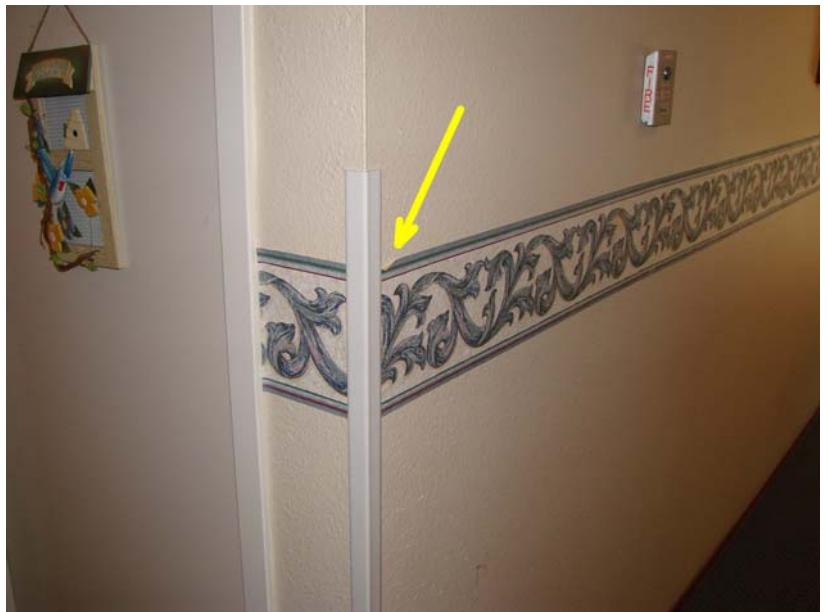
26-2007-05-02\_087 P\_E: Before - Detail - wallpaper border peeling at wall corner. (Note - staff has not yet begun 1st floor painting improvements.
