The Palms - PALM EAST
351 East Palm Drive, Anytown, USA 01995
PH 987-654-3210 * FAX 987-654-3211

The Palms - PALM EAST

Anytown, USA; May 2, 2007

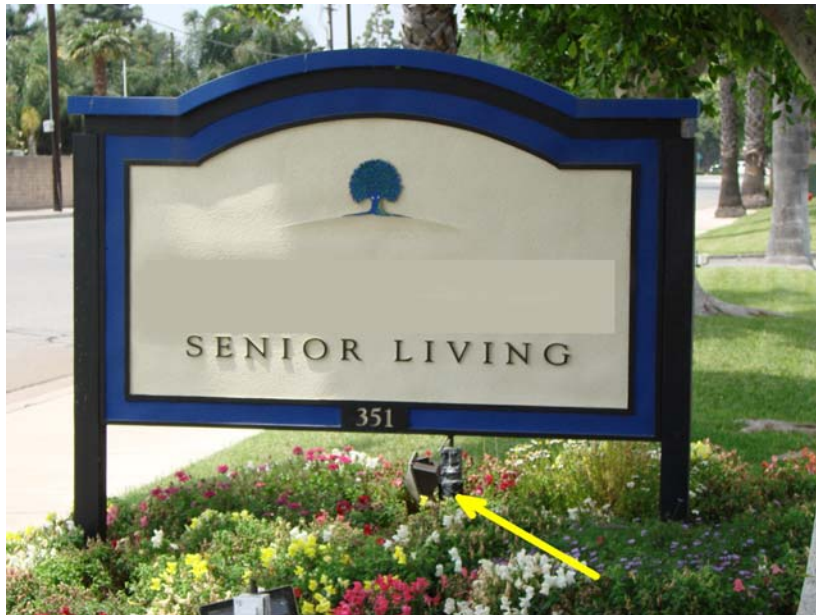
002 P_E: Facility identification sign. Note broken sign lighting.

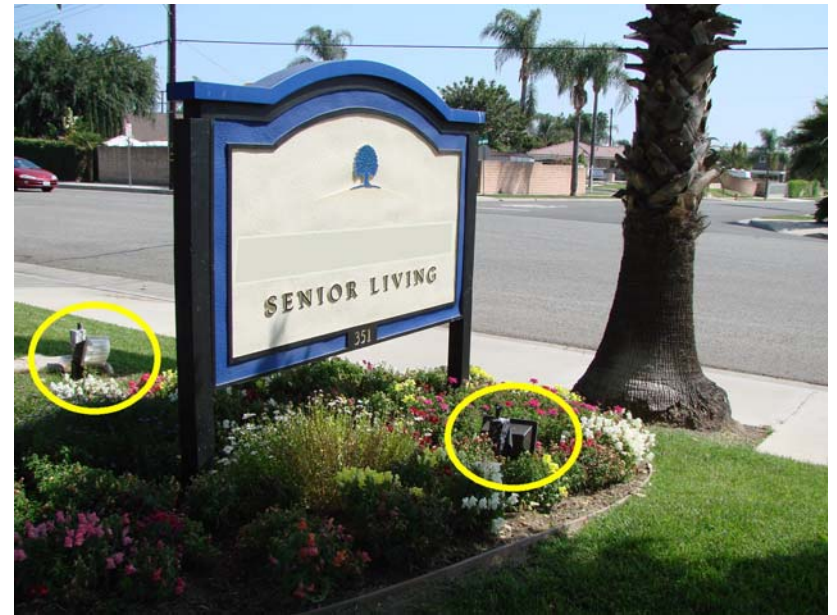
003 P_E: Facility identification sign. Note broken sign lighting.

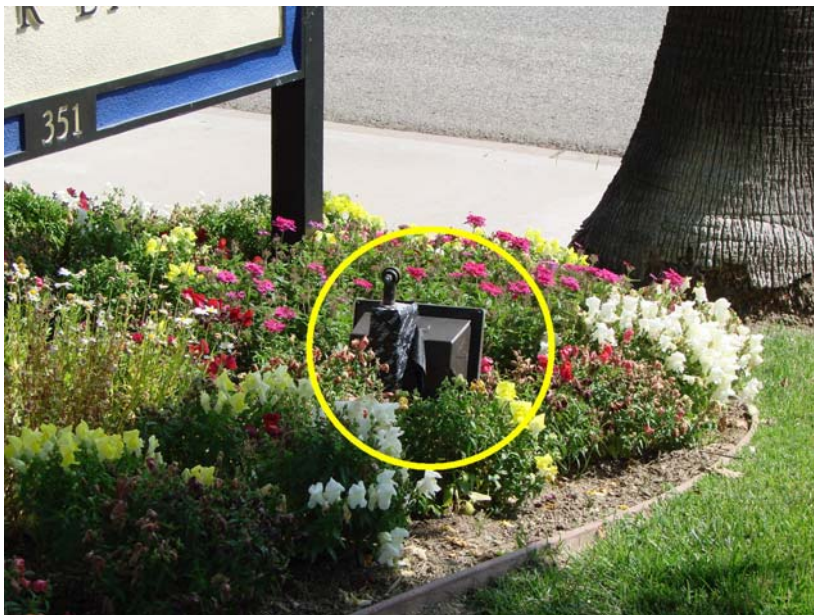
004 P_E: Broken light detail.

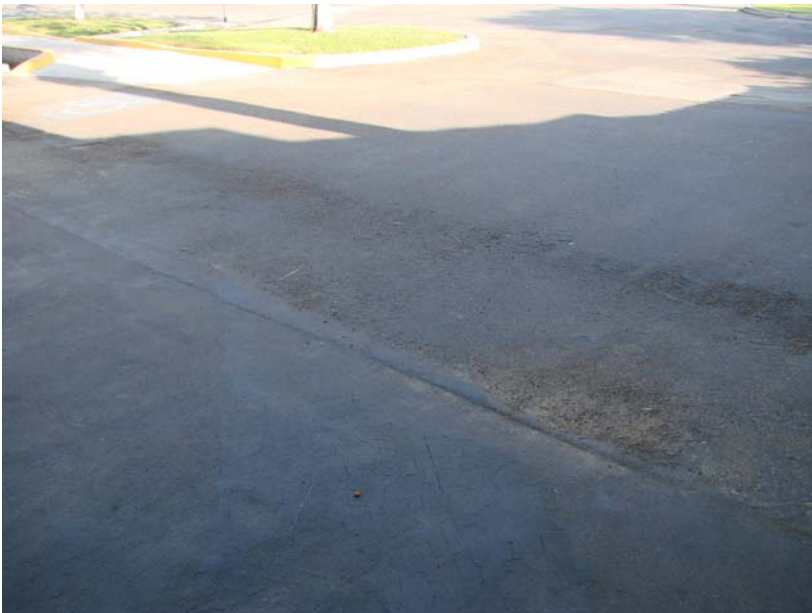
016 P_E: Asphalt paving detail - minor surface damage.

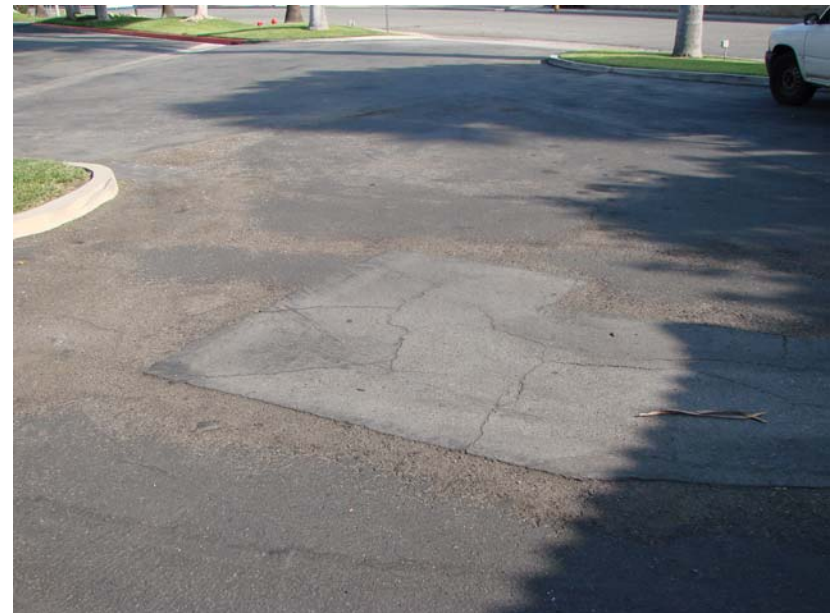
017 P_E: Asphalt paving detail at Palm West - prior asphalt patch.

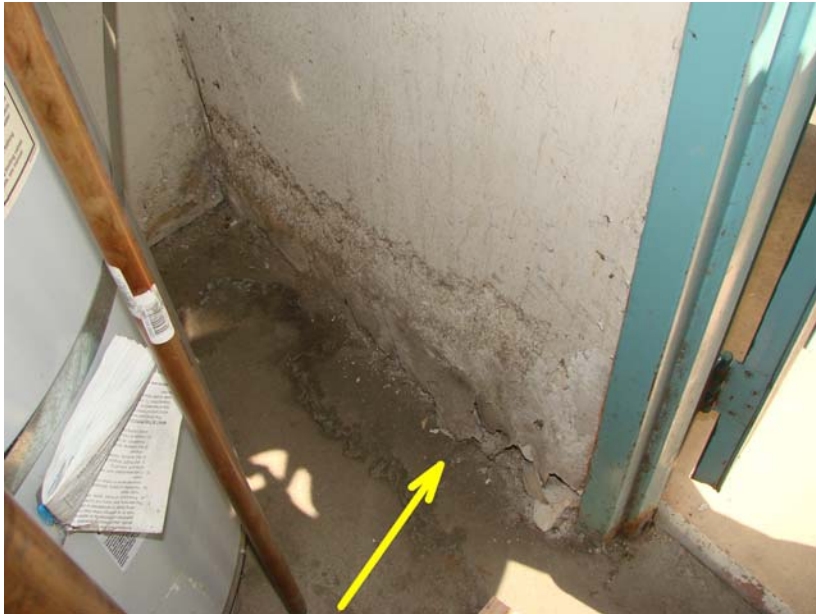
030 P_E: Water damage in water heater closet.

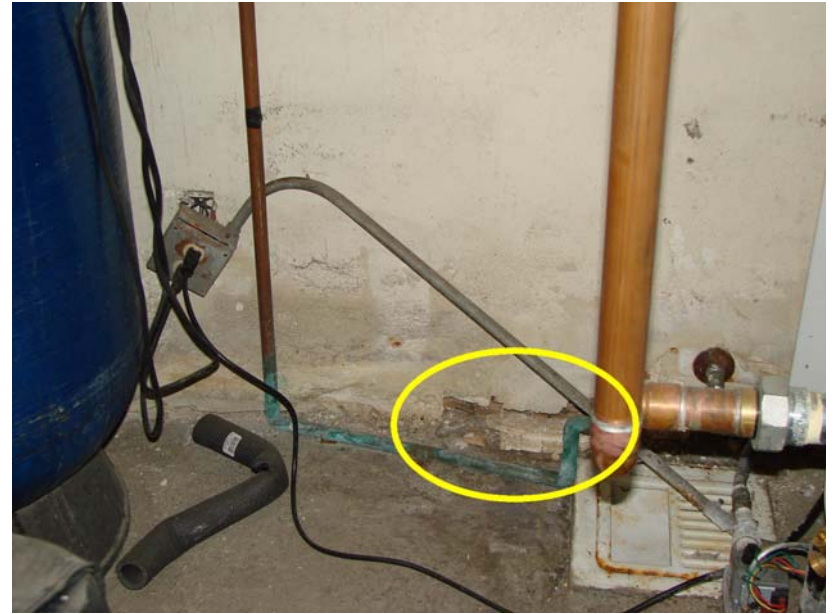
031 P_E: Water damage in water heater closet.

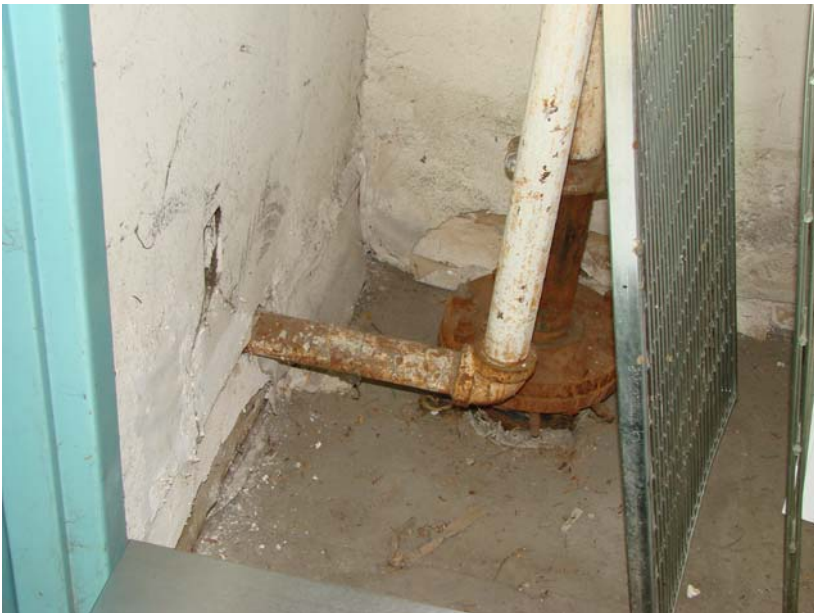
032 P_E: Water damage in water heater closet.

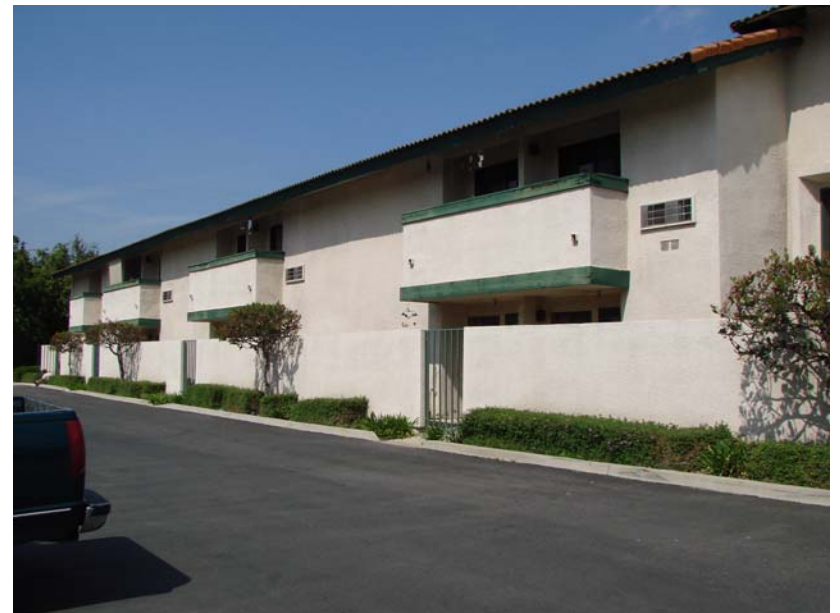
033 P_E: Palm East - west elevation. note rotten wood trim on 2nd floor balconies.

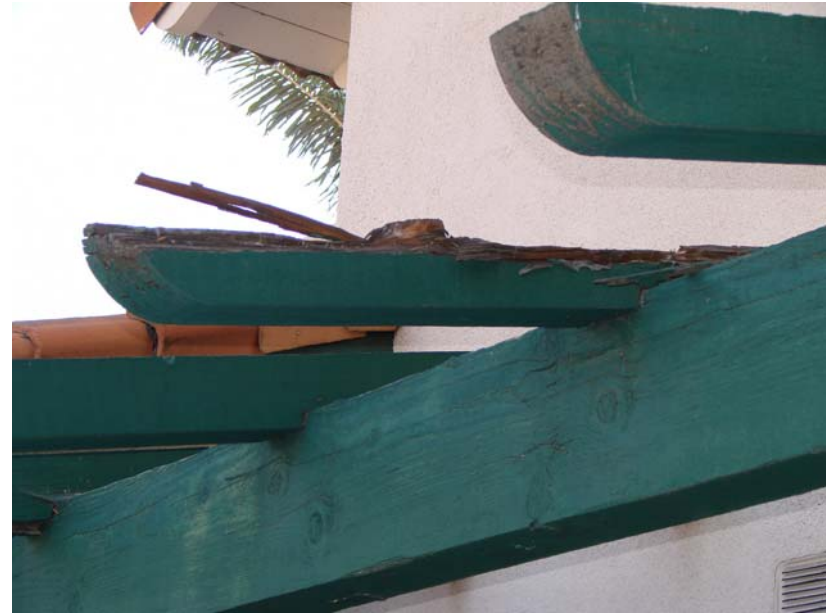
039 P_E: Detail - rotten beam.

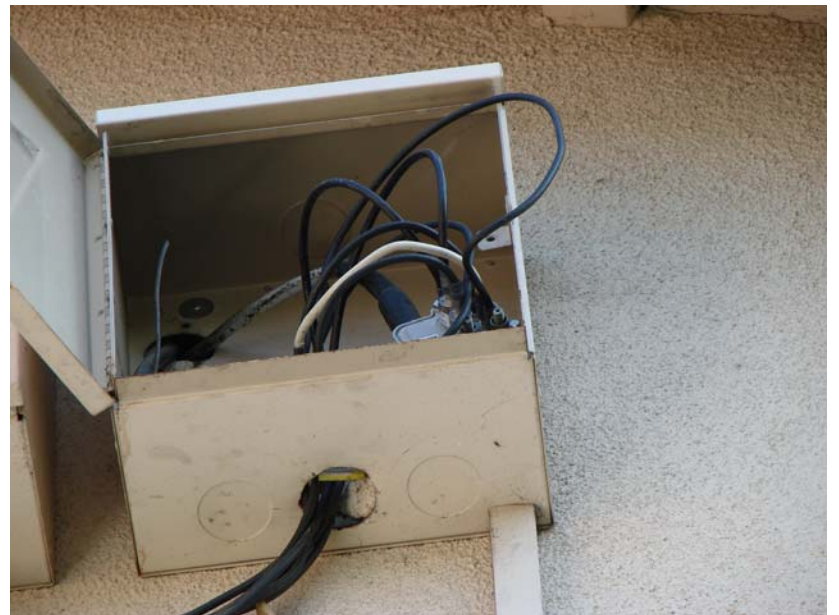
049 P_E: Open CATV junction box.

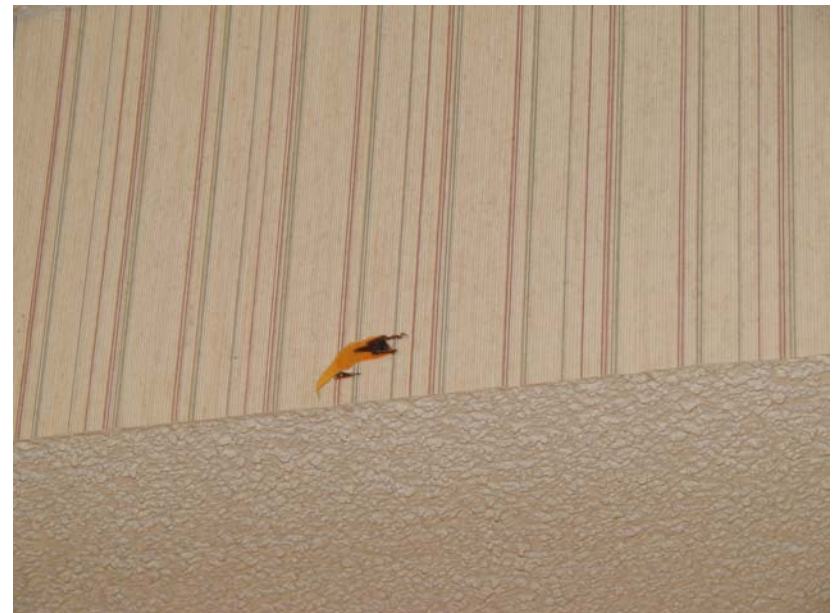
069 P_E: Staples and old decoration streamers in Dining room.

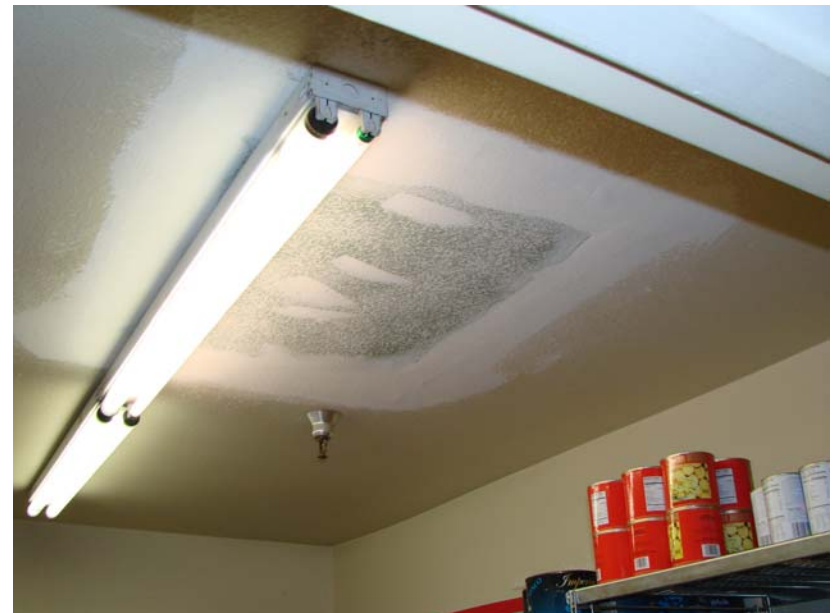
077 P_E: Kitchen - ceiling repair in dry storage (fire sprinkler pipe leak).

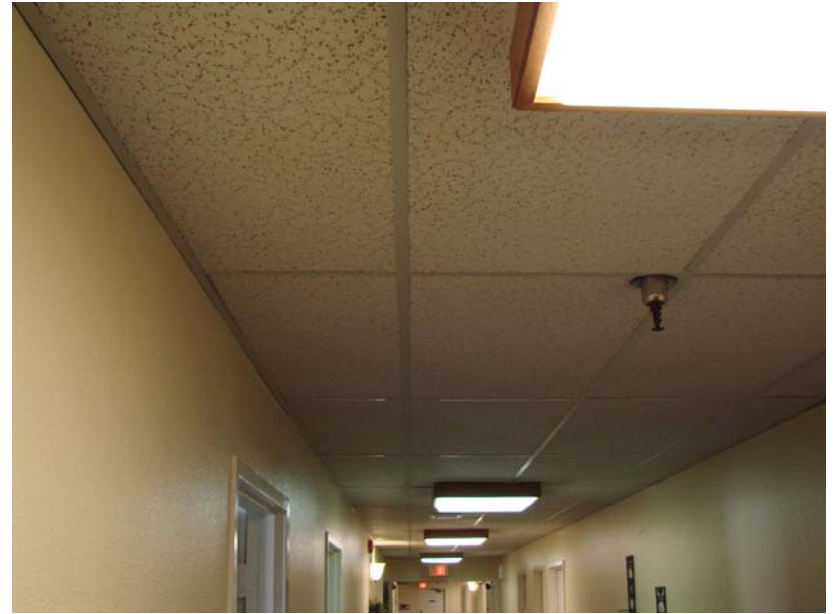
123 P_E: Acoustic lay-in ceiling tile - consider repainting ceiling grid. Replace or paint tile.

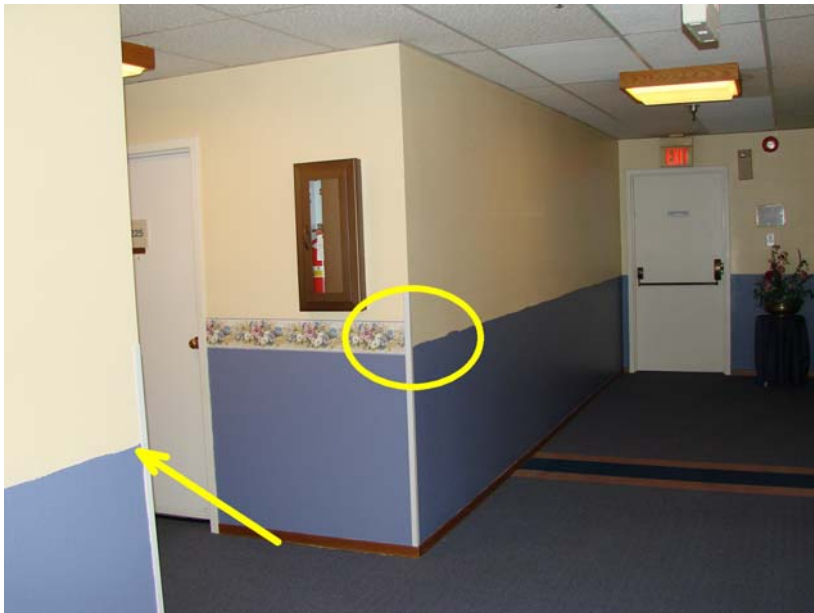
124 P_E: 2nd floor east hall @ north end. Note missing wallpaper border - staff in the process of installing border after painting corridor walls.

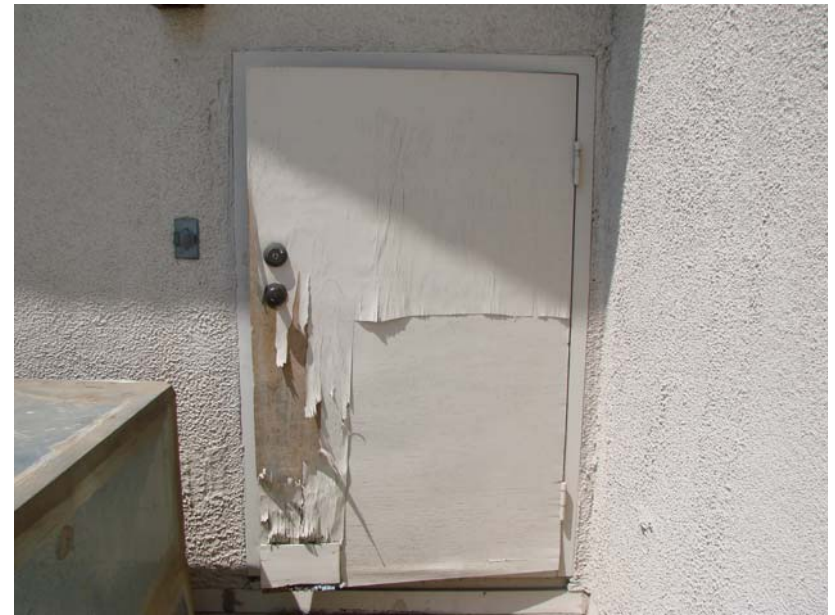
143 P_E: Roof well access door needs to be replaced.

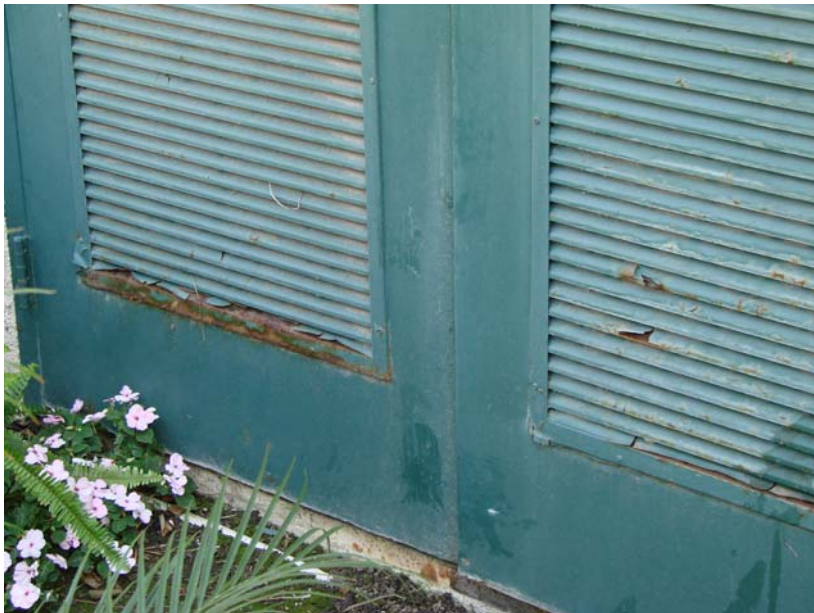
168 P_E: Detail of elevator equipment room doors - doors will need to be replaced in future years.

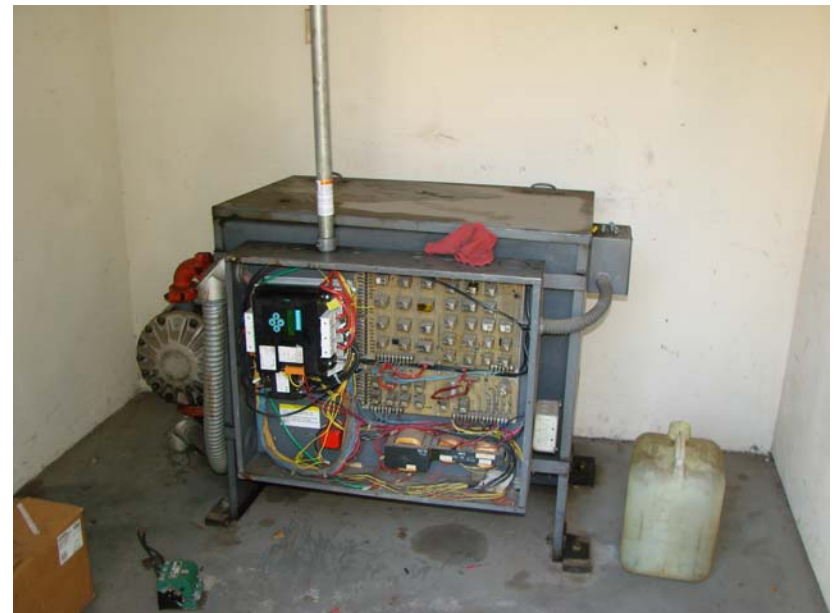
169 P_E: Hydraulic elevator equipment - recent repairs-maintenance.

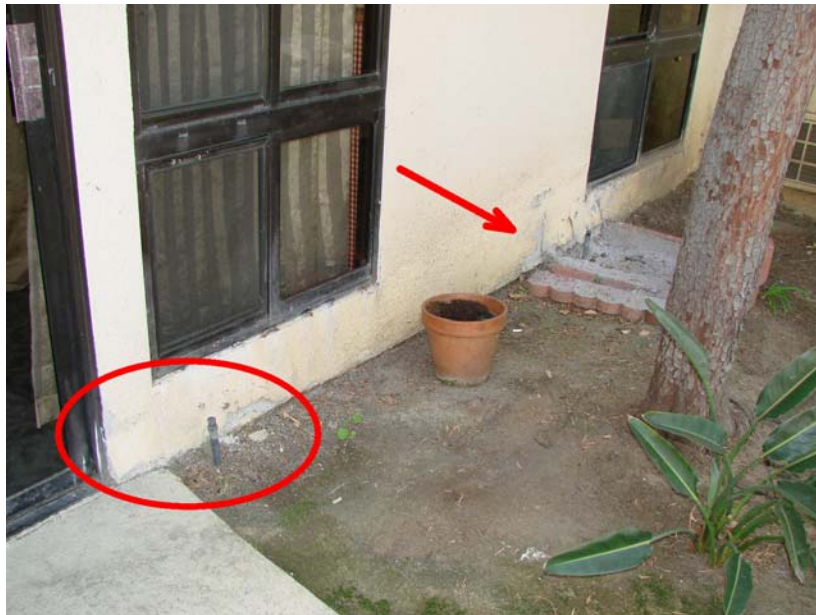
170 P_E: Courtyard detail - water damage outside private dining room (possibly from sprinklers-).

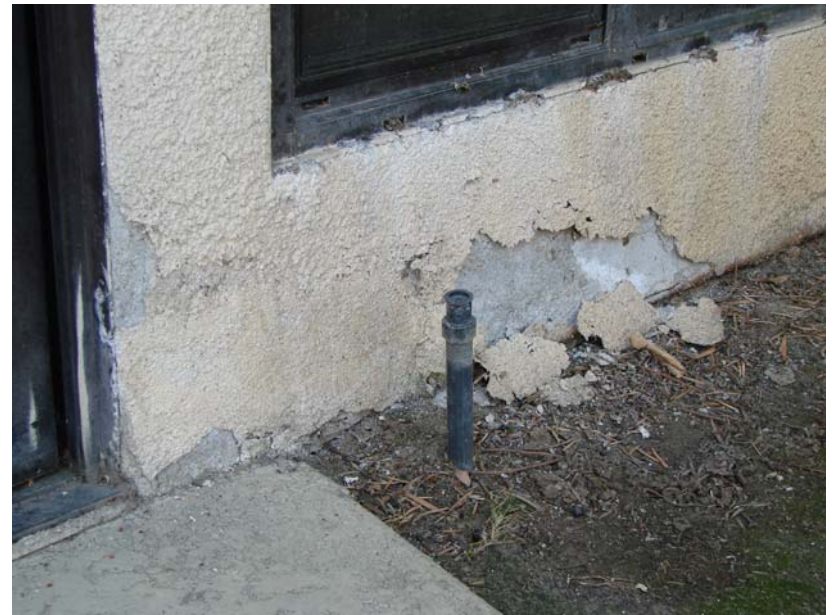
171 P_E: Water damage detail.

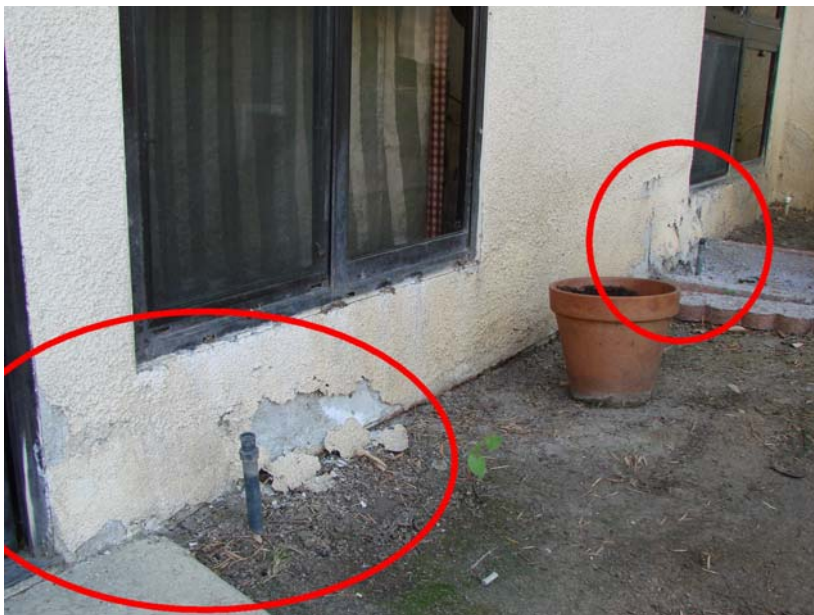
172 P_E: Courtyard detail - water damage outside private dining room (possibly from sprinklers-).

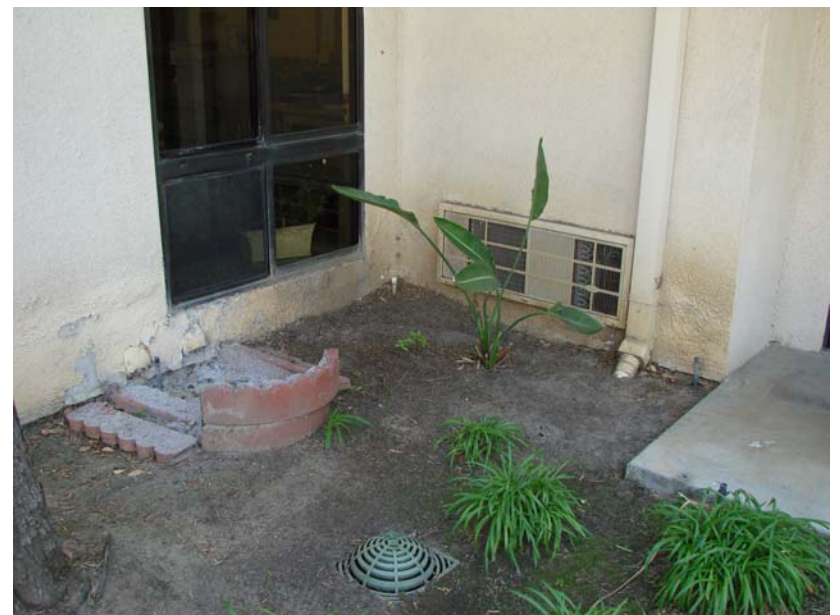
173 P_E: Laundry dryer vents - consider adding a wire cage lint trap.

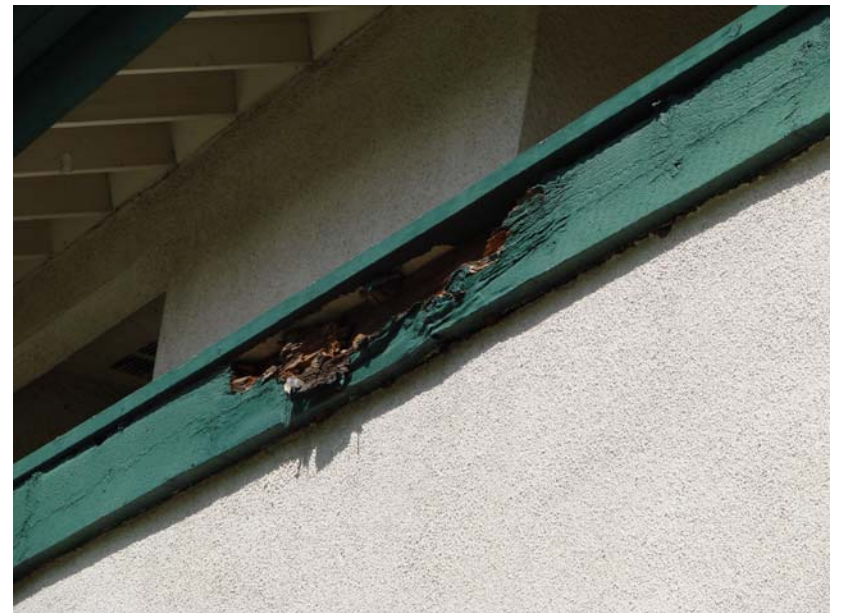
185 P_E: Detail - rotten wood trim on 2nd floor balconies.

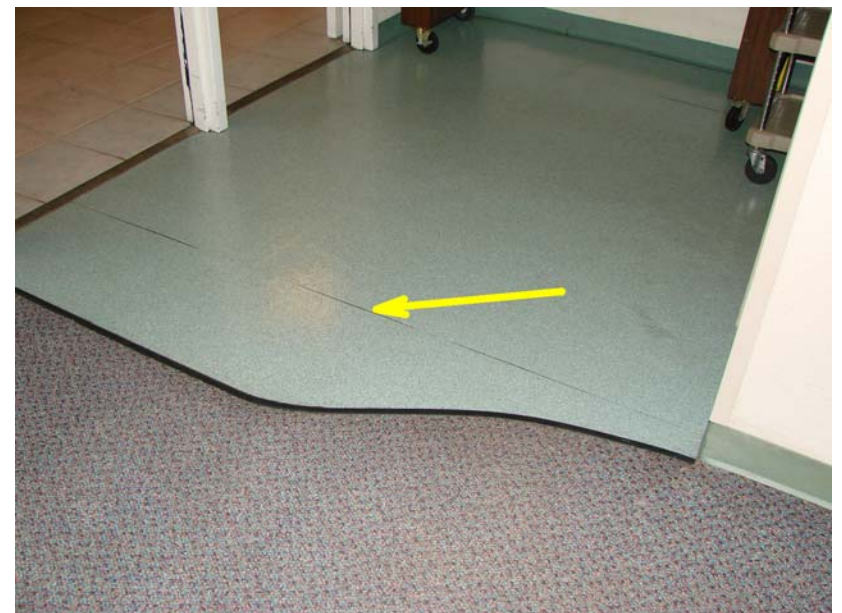
013 P_W: Dining room floor detail - note separated seam in sheet vinyl.

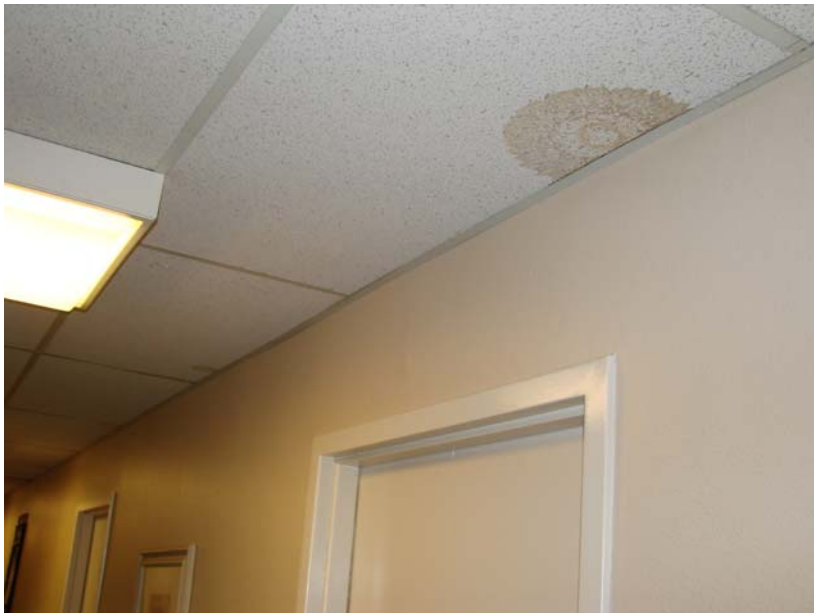
036 P_W: Water stain in 1st floor corridor. Likely from pipe condensation.

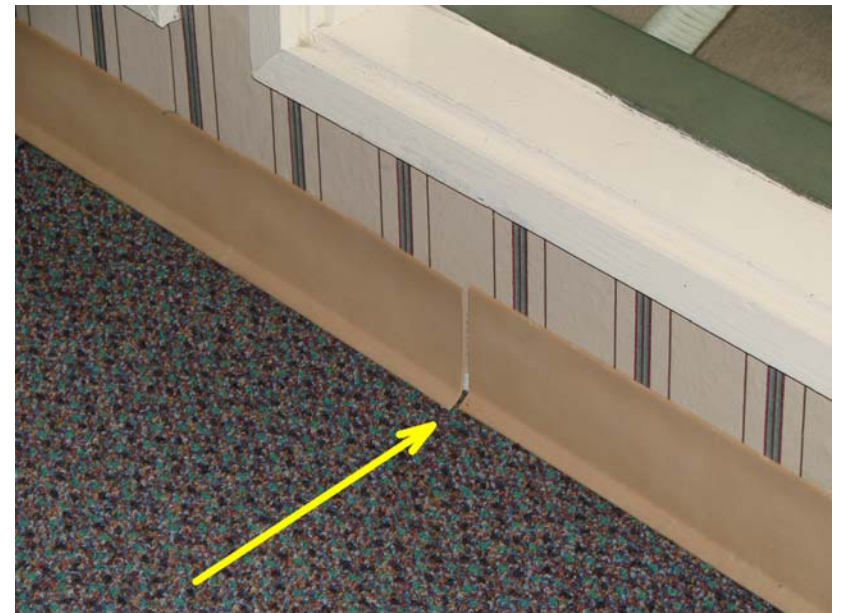
049 P_W: Detail - poor floor base installation.

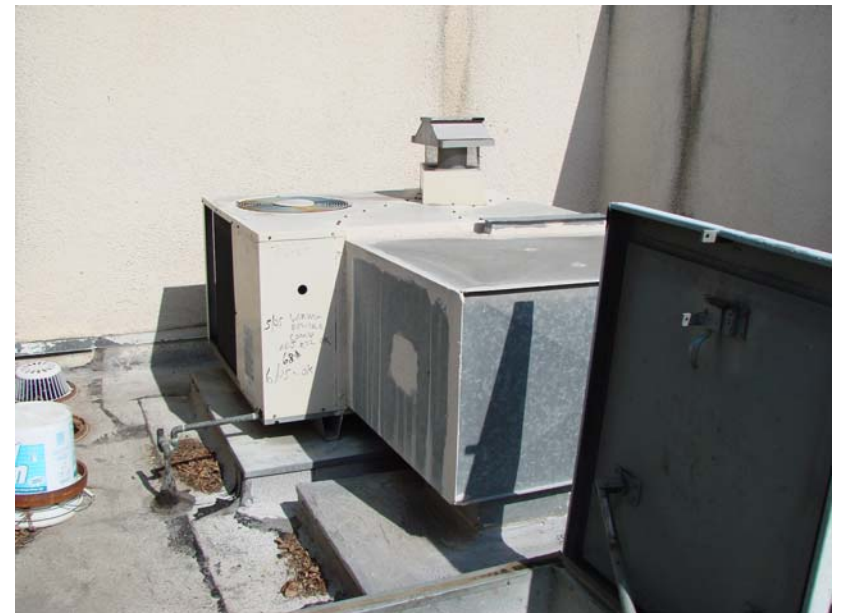
057 P_W: Day & Night HVAC unit in roof well - AC & gas heat.

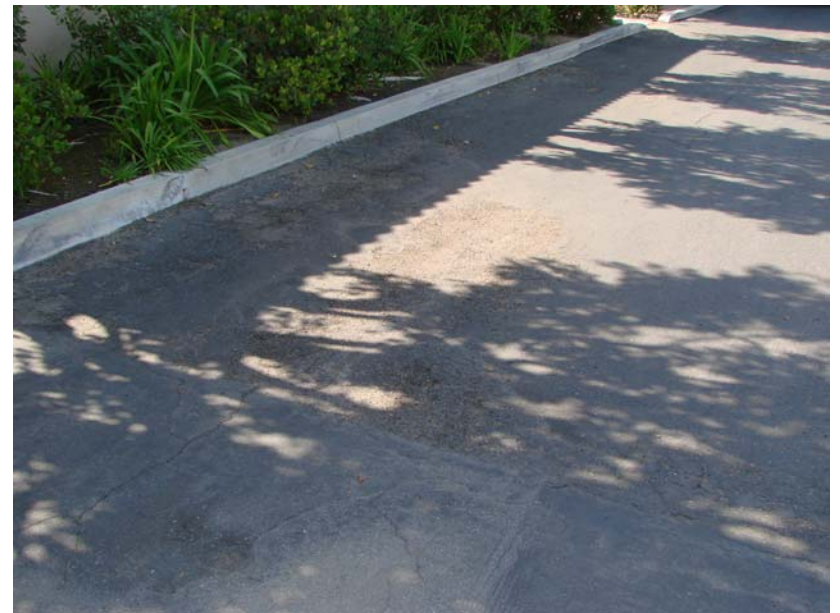
073 P_W: Paving detail - minor surface damage.

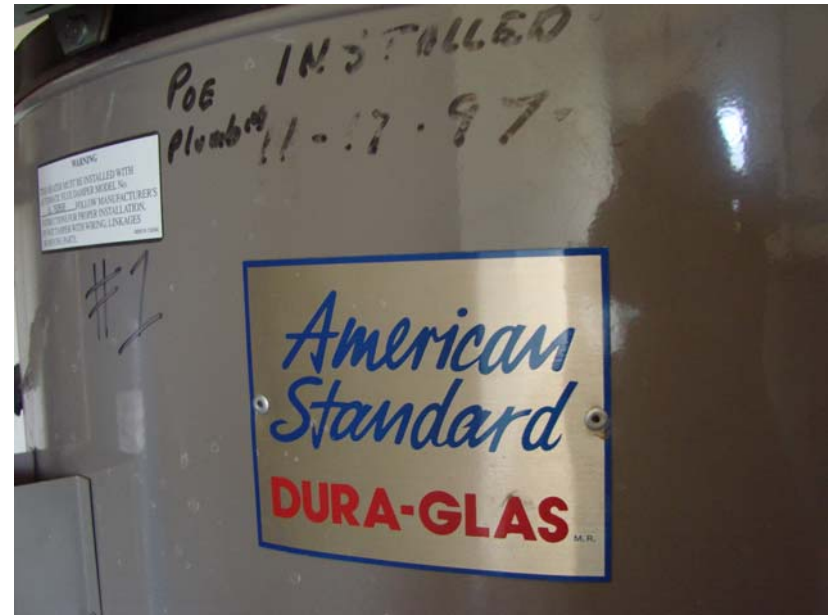
095 P_W: American standard water heater (#1), 100-gal, 250,000 BTUH. Installed in 1997, needs to be replaced soon.

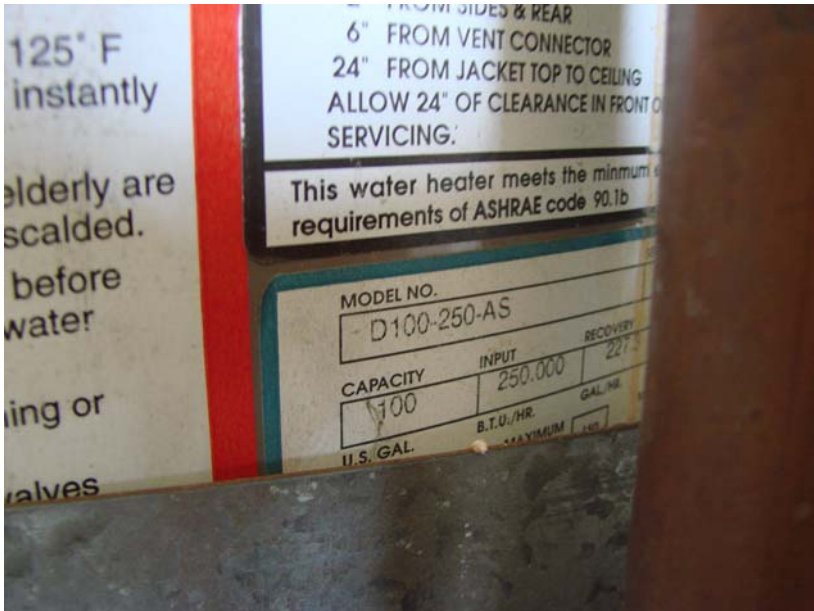
096 P_W: American standard water heater (#1), 100-gal, 250,000 BTUH. Installed in 1997, needs to be replaced soon.

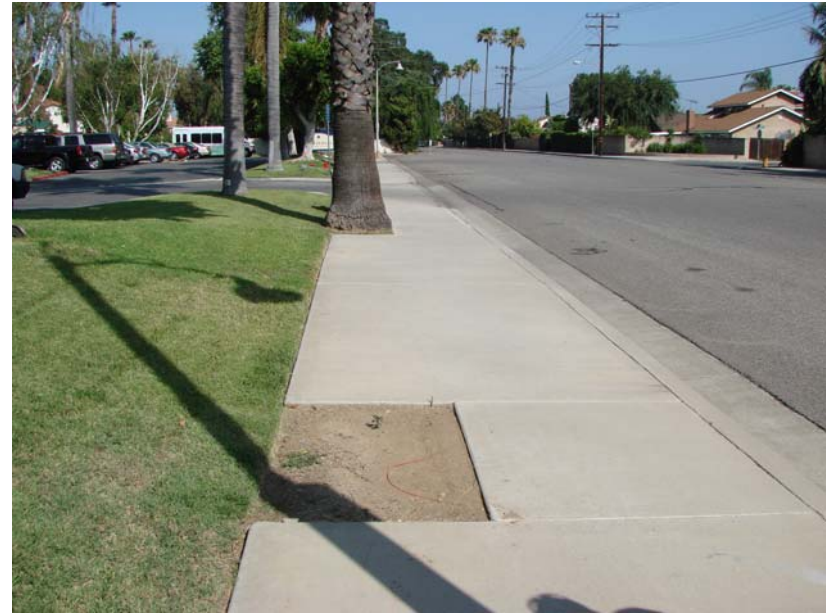
099 P_W: Removed palm tree in public right of way - consider petitioning City to replace tree or fill in with concrete.
