## The Willows @ Anytown

Anytown, USA; Oct 4, 2006

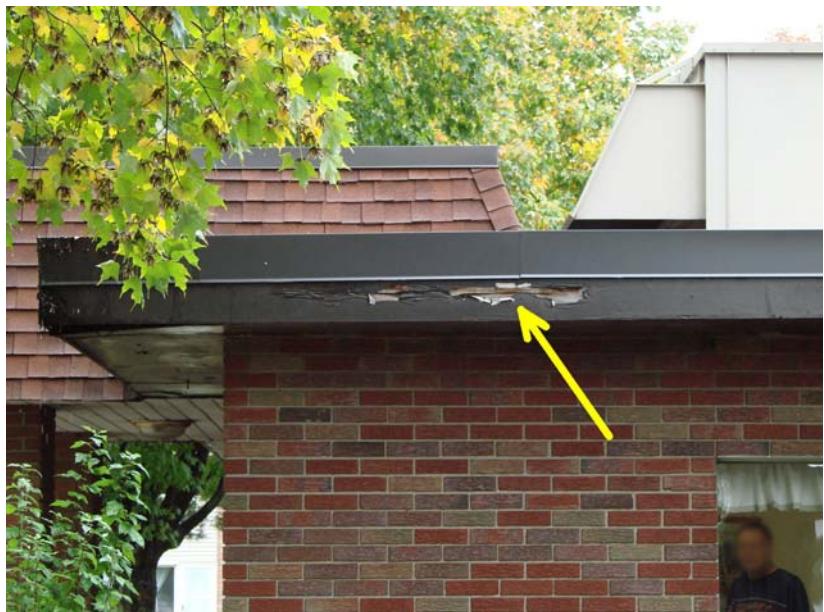
004\_MI\_1: Fascia detail - fascia needs repairs.

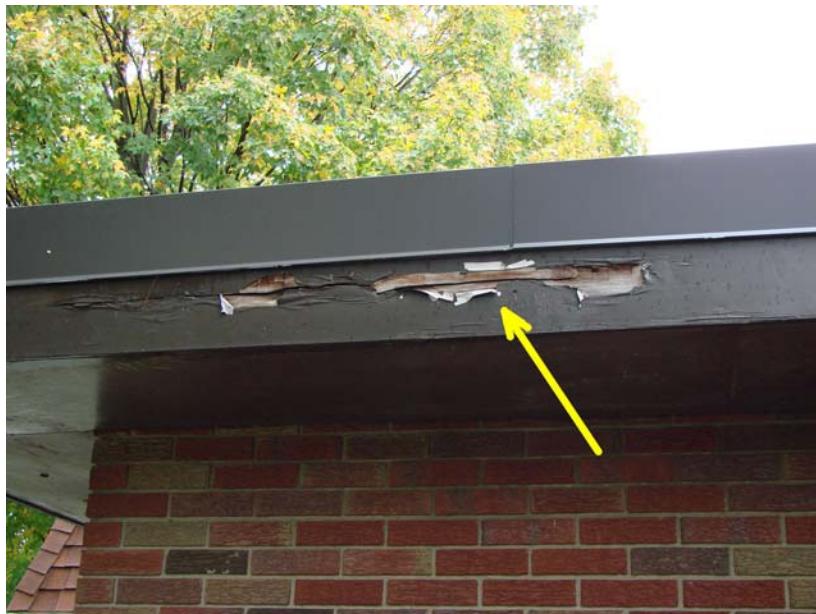
005\_MI\_1: Fascia detail - fascia needs repairs.

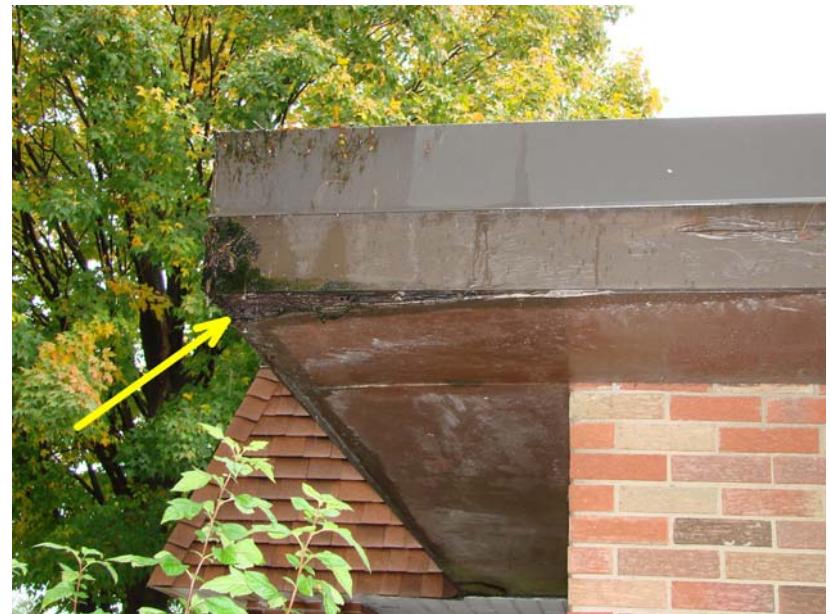
006\_MI\_1: Fascia detail - fascia needs repairs.

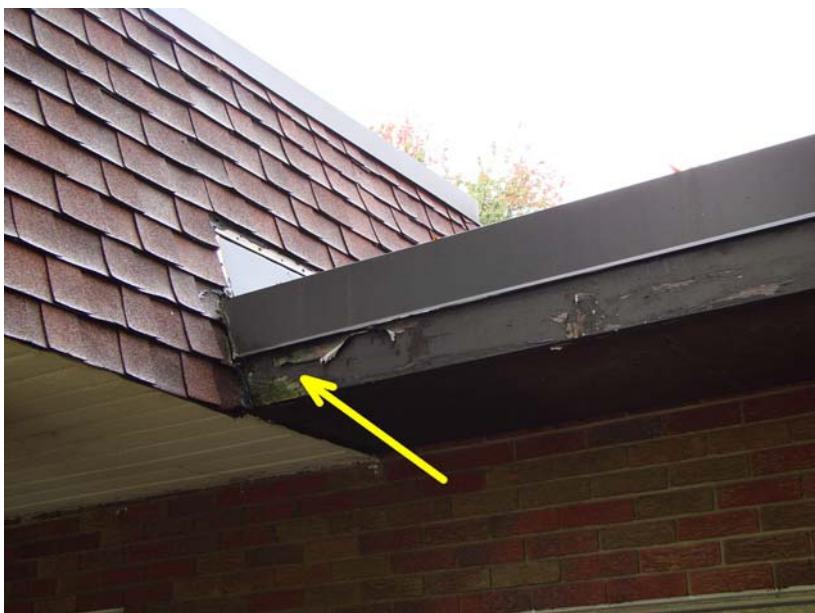
007\_MI\_1: Fascia detail - fascia needs repairs.

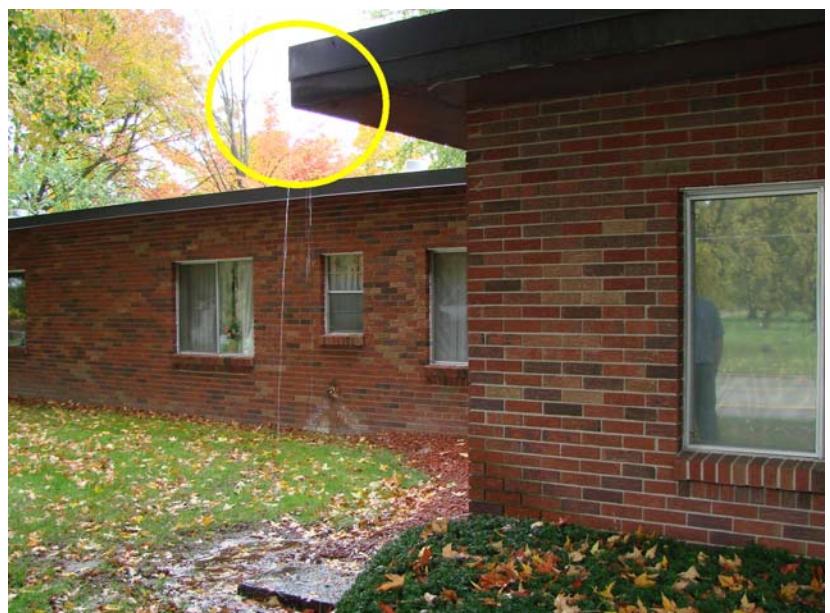
008\_MI\_1: Water running off edge of roof due to poor roof drainage.

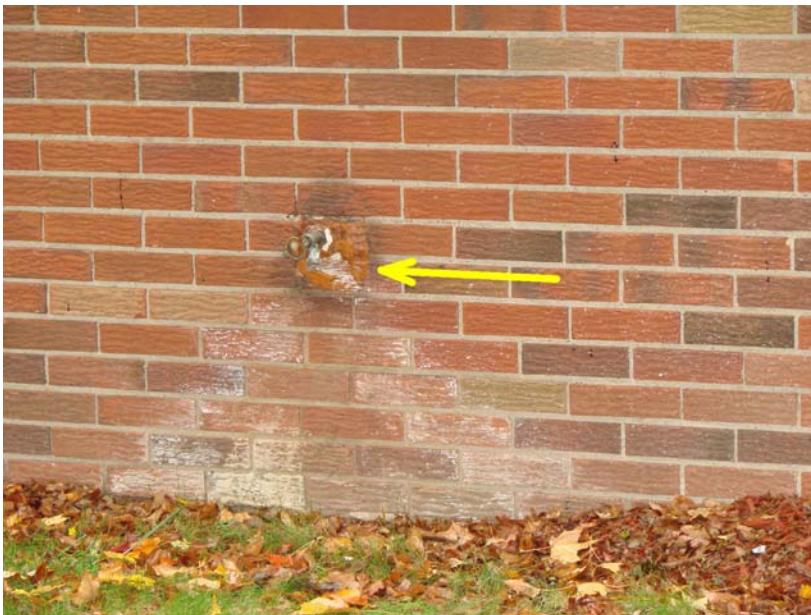
009\_MI\_1: Water faucet - insulation needs to be monitored for deterioration and maintained.

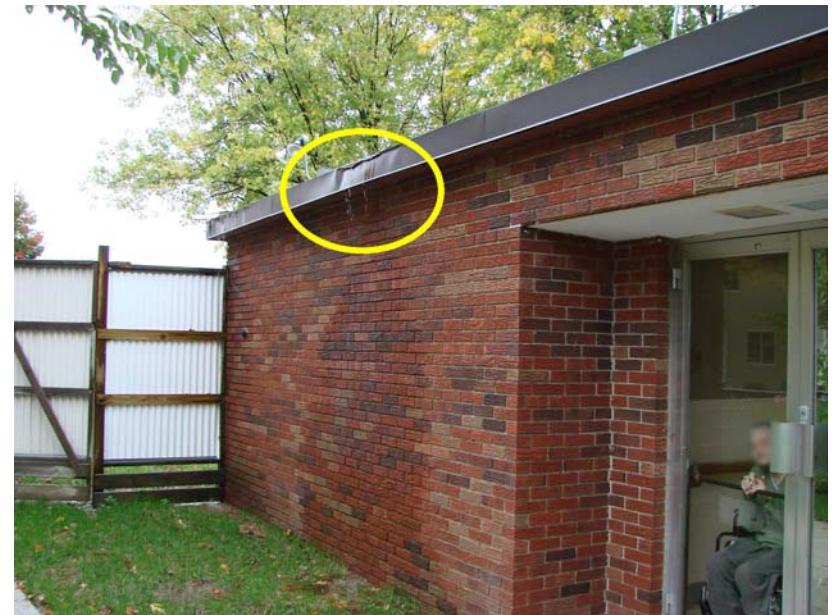
010\_MI\_1: Water running off edge of roof due to poor roof drainage.

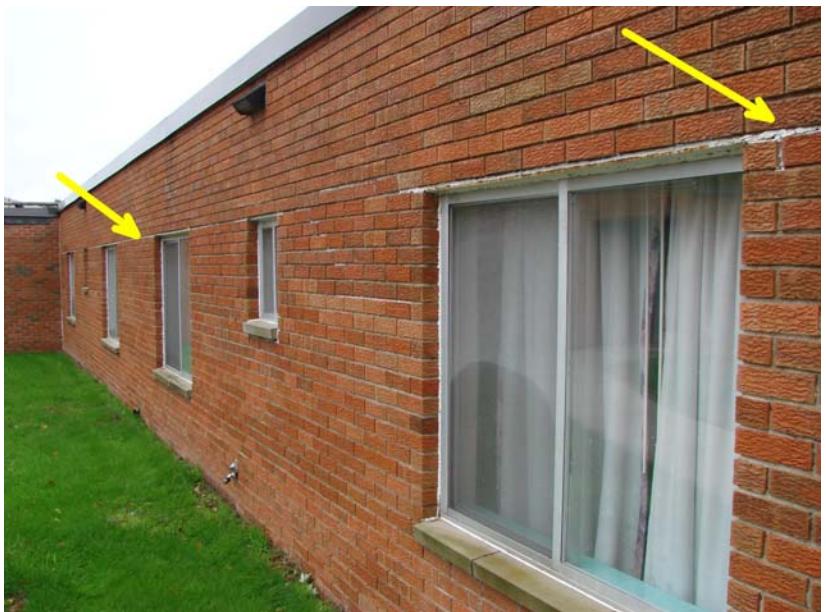
016\_MI\_1: Detail - mortar joint crack at brick lintel - runs length of west elevation of West Hall.

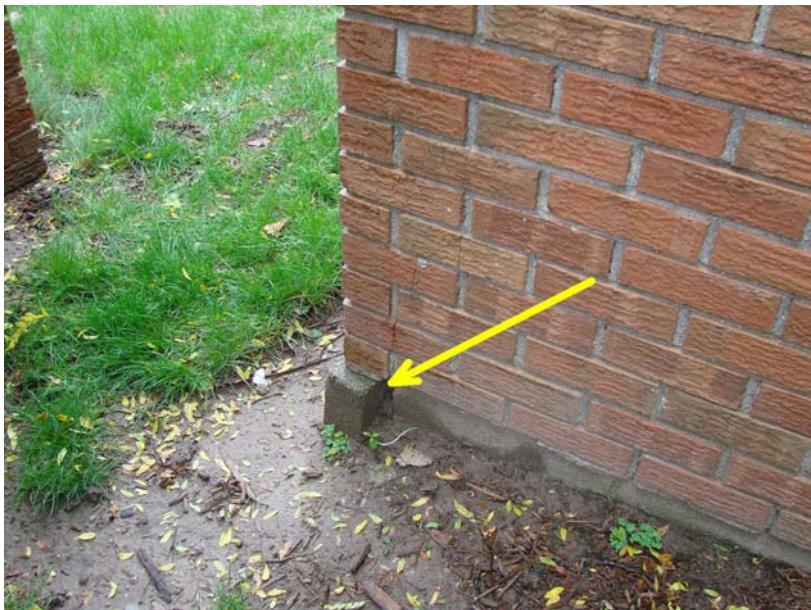
019\_MI\_1: Detail - curious foundation detail - concrete block protrusion.

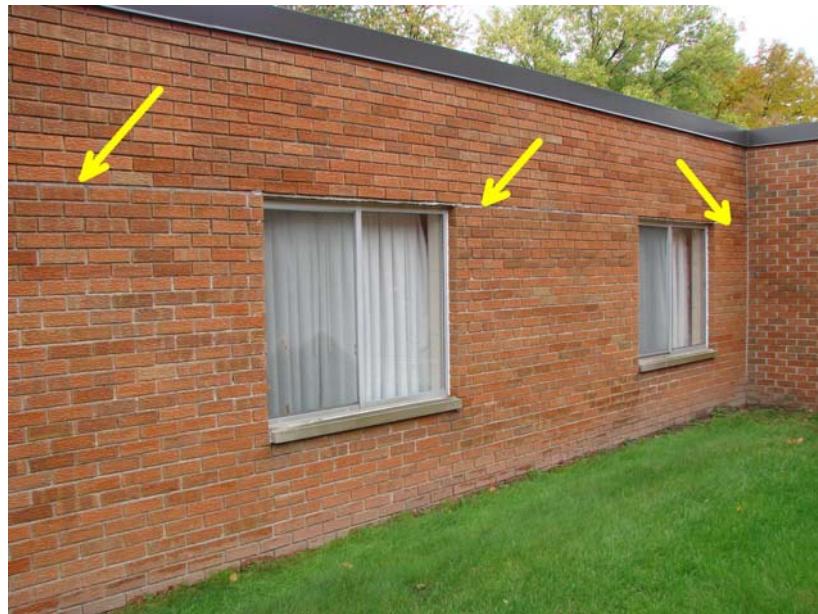
038\_MI\_1: Detail - mortar joint crack at brick lintel - runs length of North elevation oF South 1 Hall.

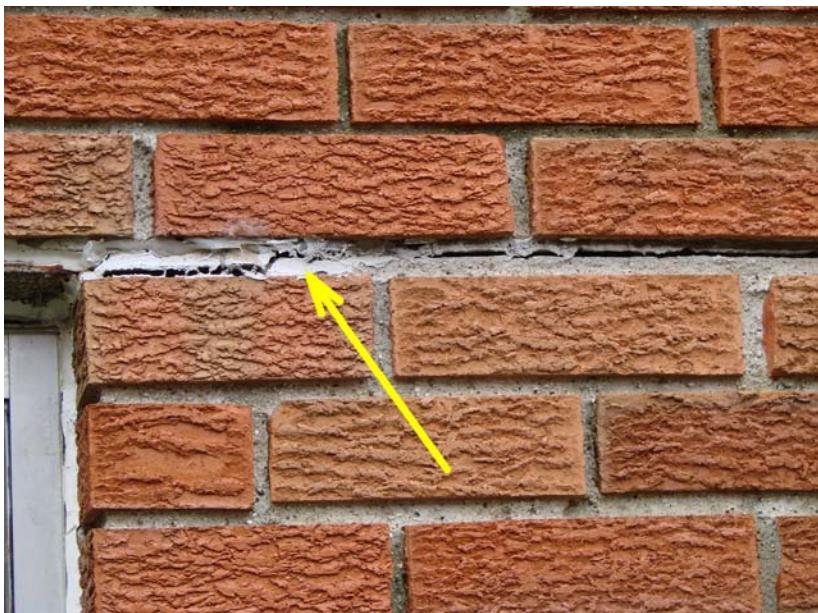
040\_MI\_1: Detail - mortar joint crack at brick lintel.

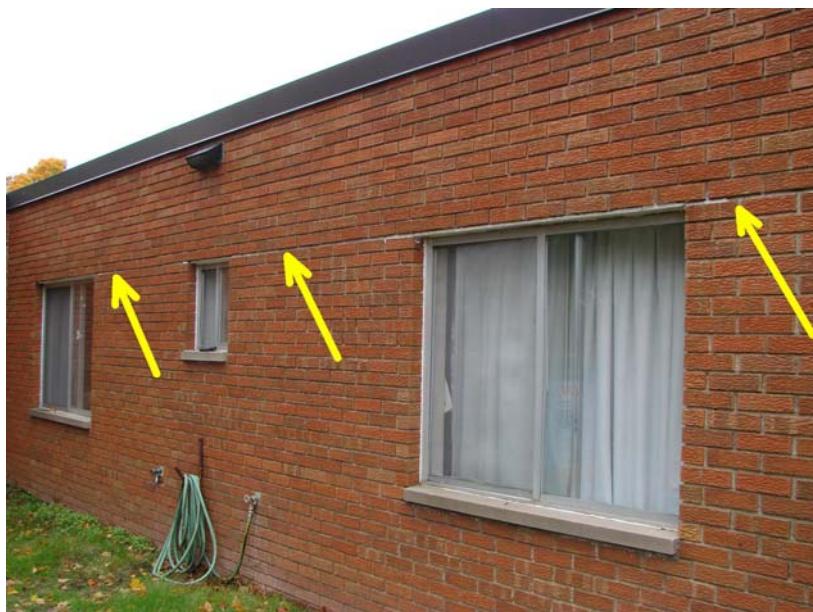
043\_MI\_1: Detail - mortar joint crack at brick lintel - runs length of South elevation of South 1 Hall.

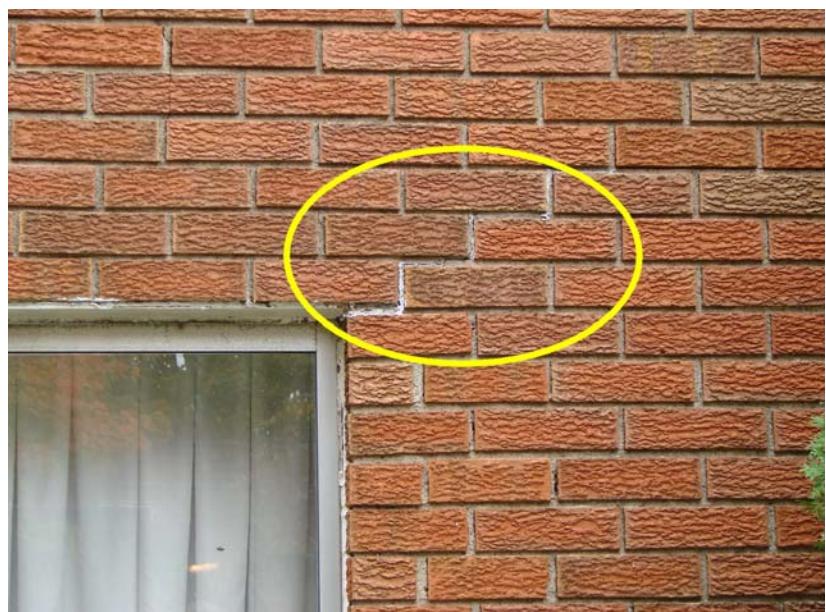
044\_MI\_1: Detail - mortar joint crack in South 2 Hall.

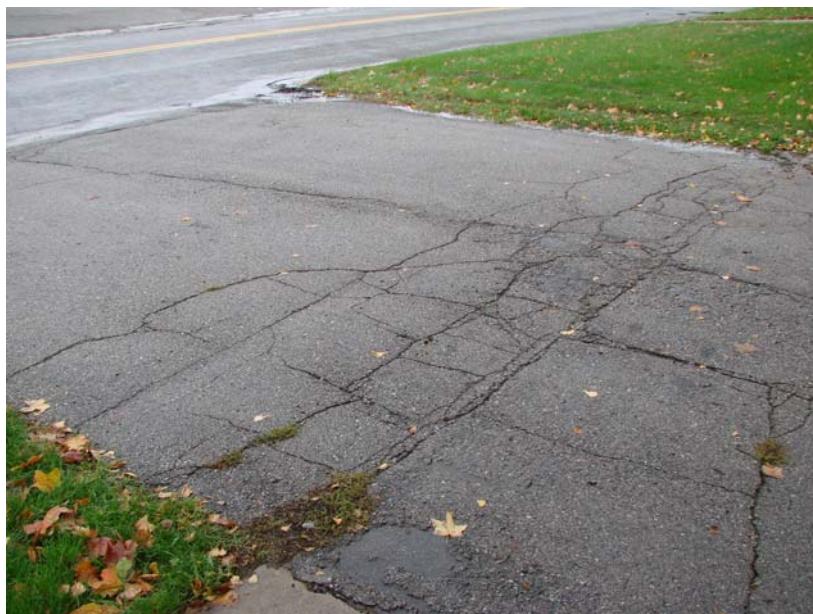
047\_MI\_1: Asphalt paving deterioration at service drive to dumpster on the south side of South 1 Hall.

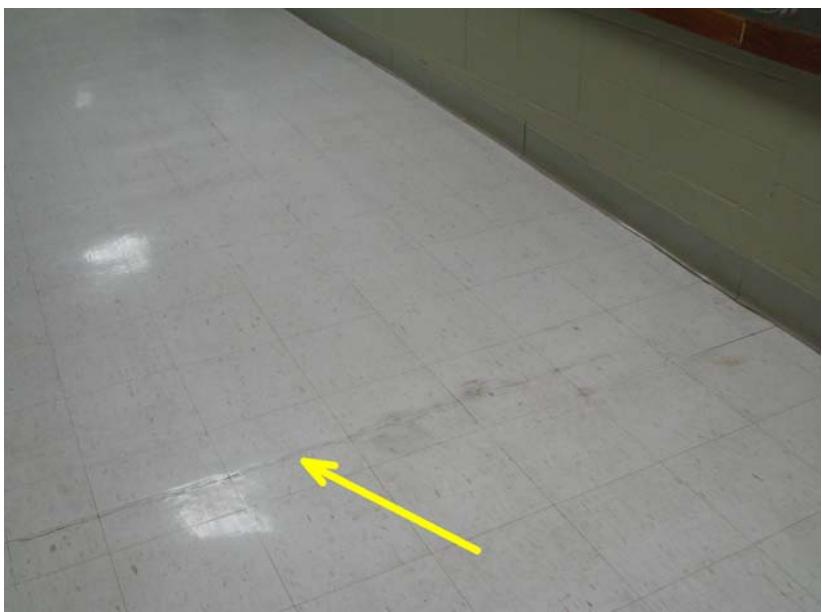
064\_MI\_1: VCT tile crack where corridor floor ramps up from South 1 Hall to center administrative hall.

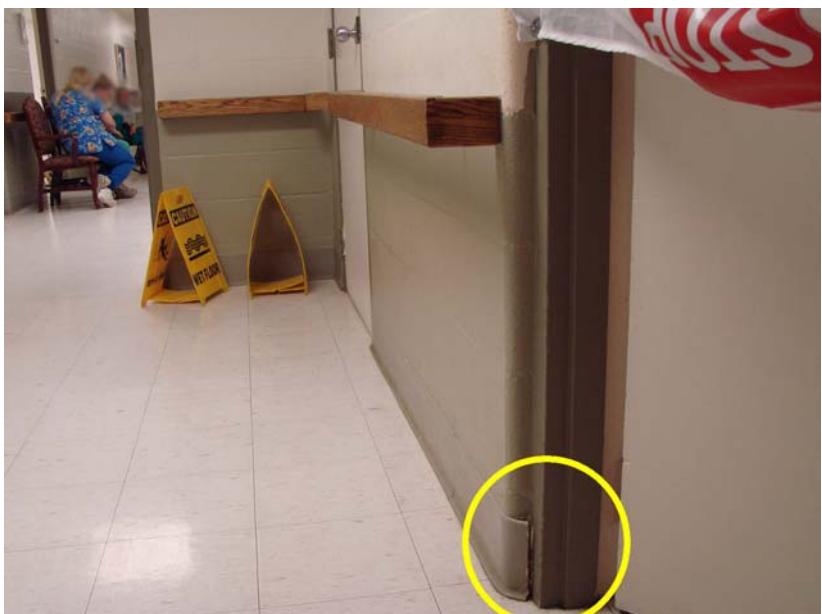
072\_MI\_1: Detail - wall base coming loose at door frame.

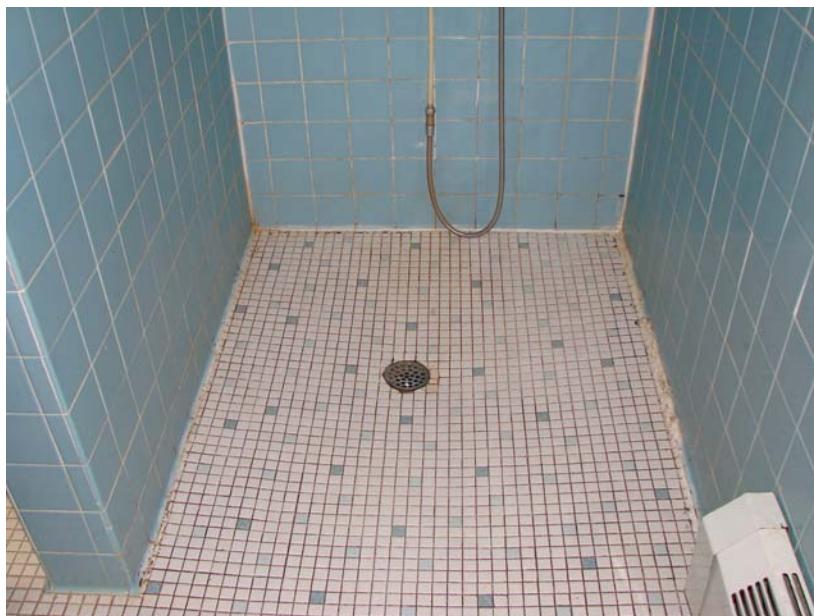
081\_MI\_1: Shower floor - poor-fair condition.

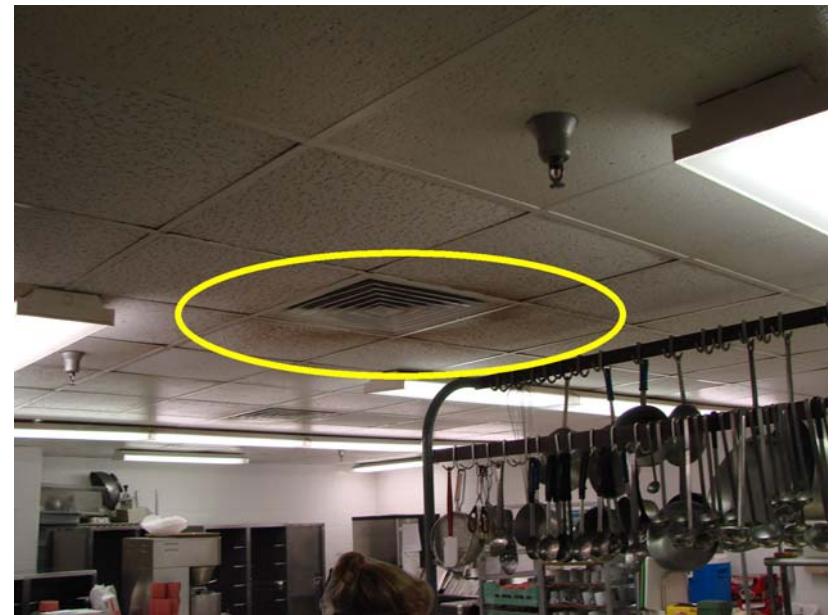
086\_MI\_1: Ceiling detail - dirty ceiling tile at air conditioner vent.

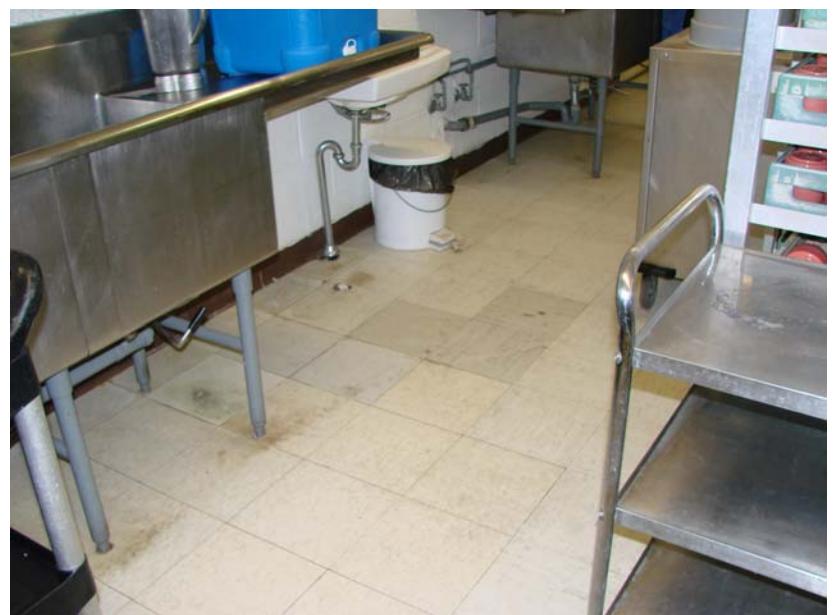
088\_MI\_1: Kitchen - VCT floor tile repairs.

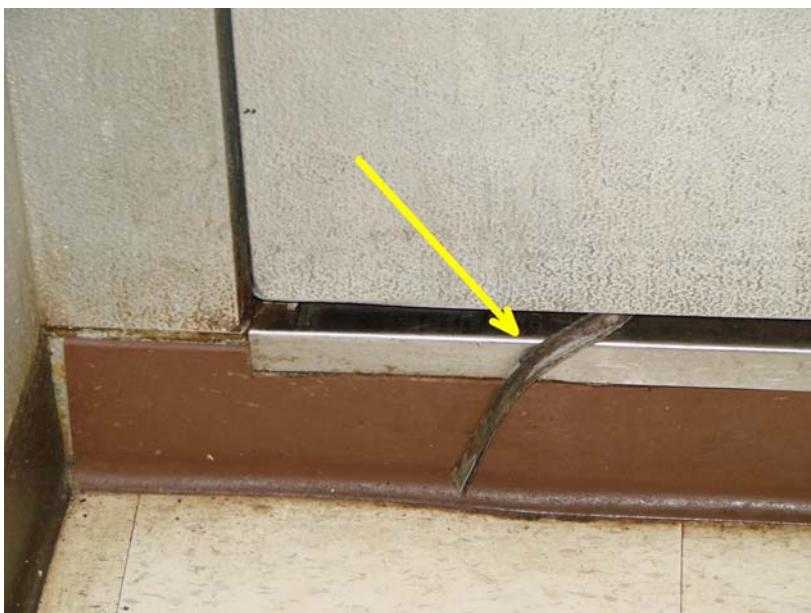
095\_MI\_1: Walk-in cooler door detail - loose seal.

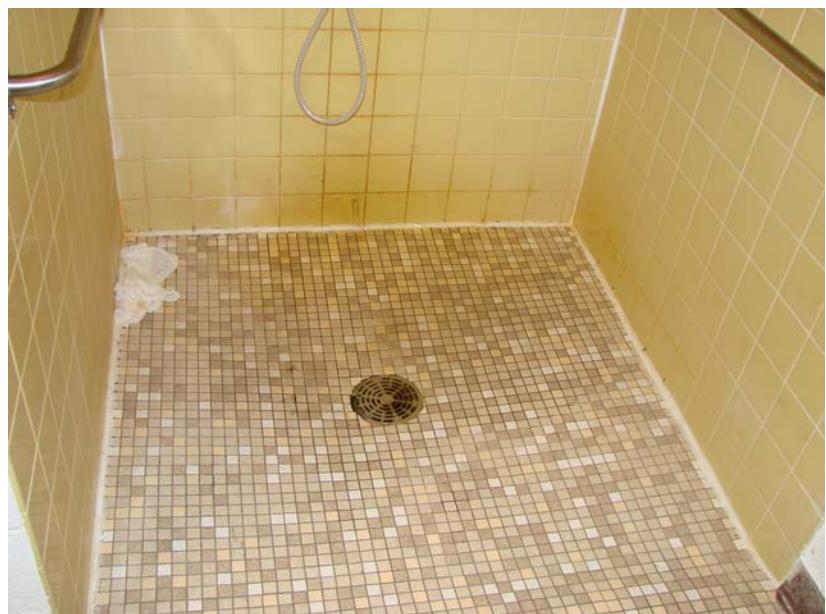
172\_MI\_1: Shower floor detail - average condition.

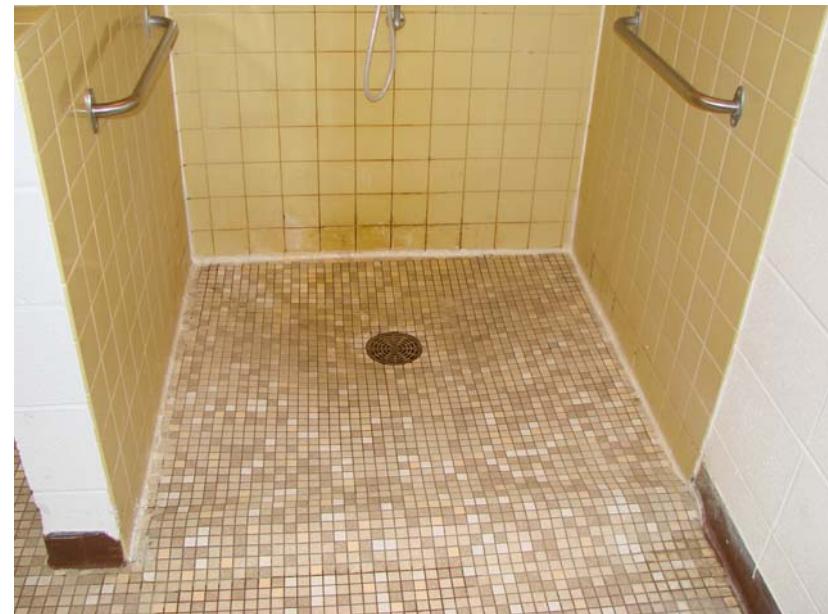
190\_MI\_1: Shower floor detail - average condition.

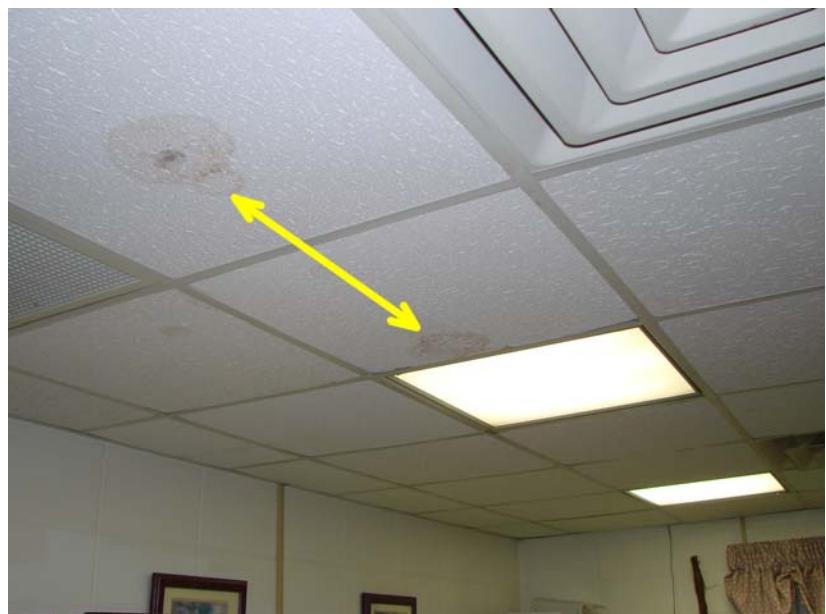
200\_MI\_1: Water stains on ceiling tile in therapy office.

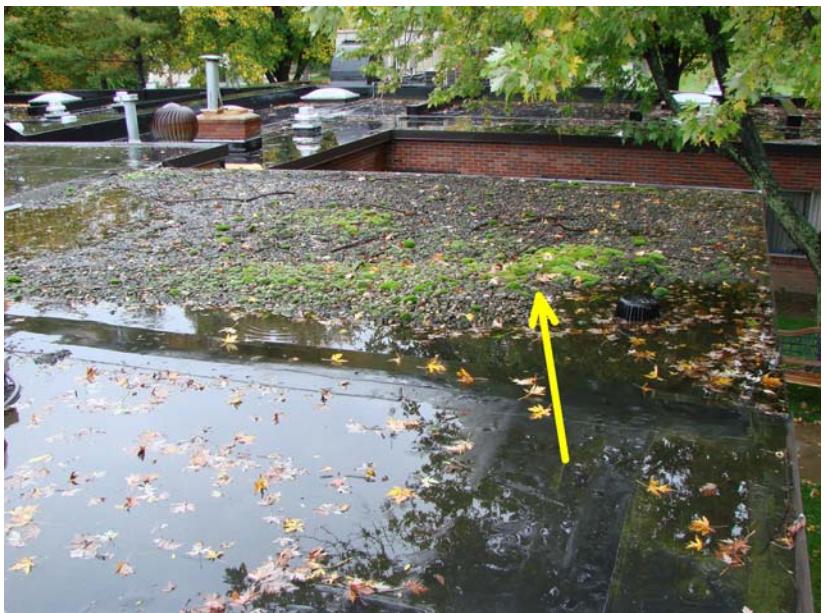
216\_MI\_1: Vegetation growing in roof ballast.

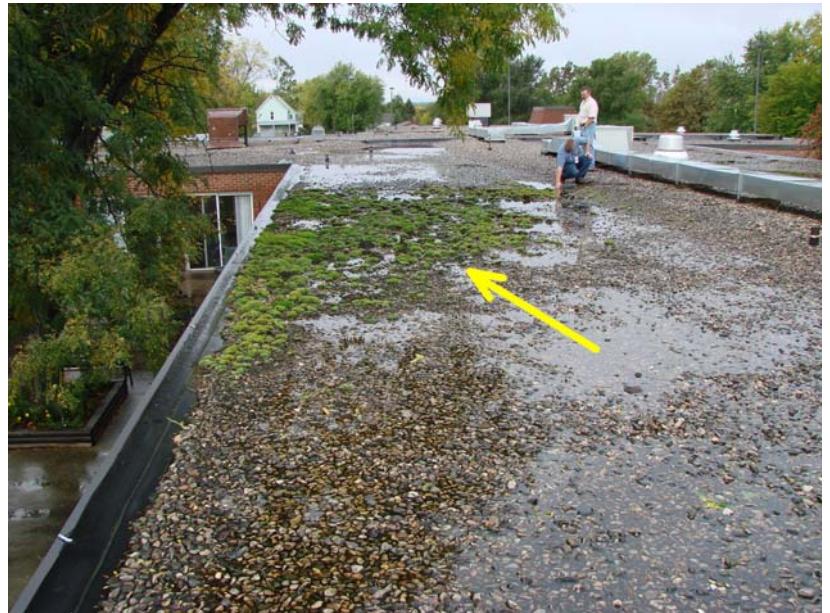
230\_MI\_1: Vegetation growing in roof ballast.
