PROPERTY CONDITION REPORT

The Willows @ Anytown

414 East Street ♦ Anytown, USA 01995

Client: No.1 LTC Operator

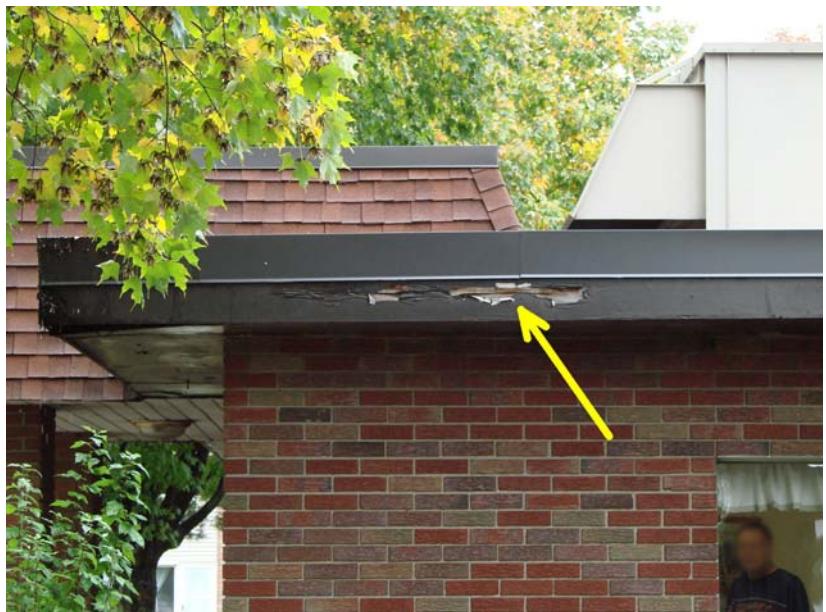
004_MI_1: Fascia detail - fascia needs repairs.

1. Replace rotten wood around fascia & repaint fascia and soffit.
2. Pressure wash & seal masonry veneer; repair mortar joints at brick lintels
3. Roof drainage – research drainage improvements around HVAC ducts.
4. Miscellaneous shingle repairs.
5. Replace roof shingles.
6. Replace ballasted roof (2-5).
7. Replace EPDM (6-10)
8. Concrete pad for rear dumpster.
9. Repair, seal & stripe asphalt paving.

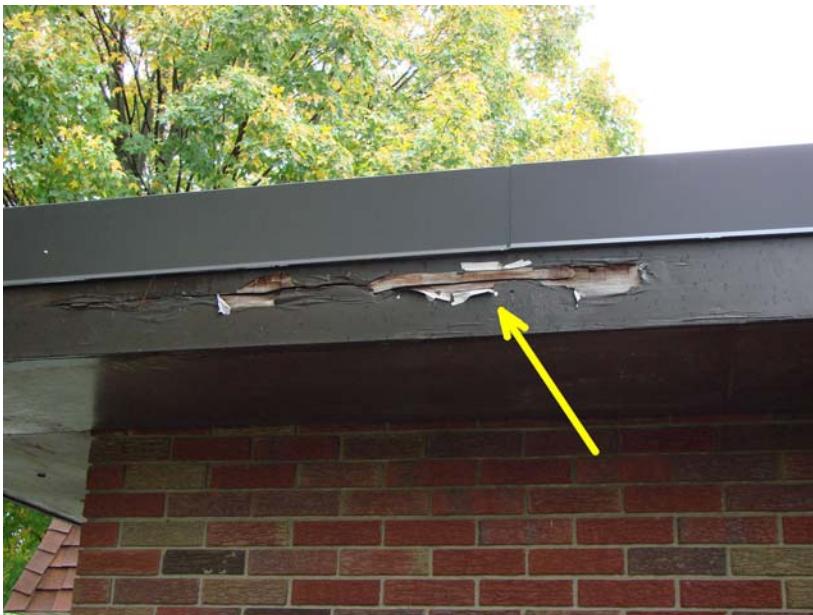
005_MI_1: Fascia detail - fascia needs repairs.

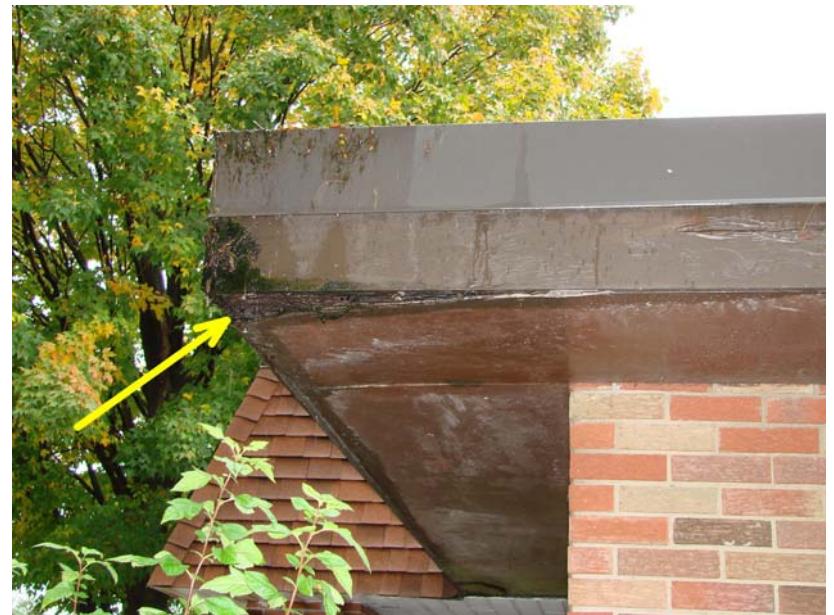
006_MI_1: Fascia detail - fascia needs repairs.

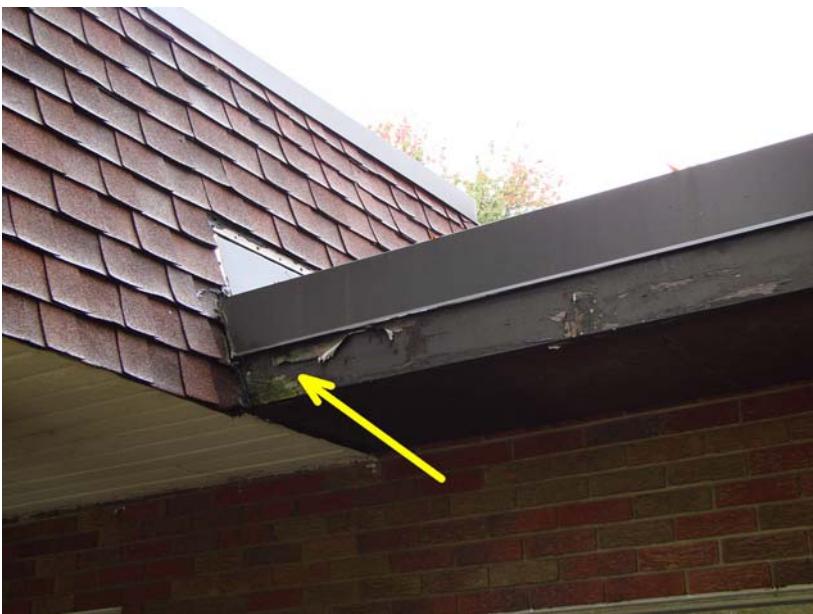
007_MI_1: Fascia detail - fascia needs repairs.

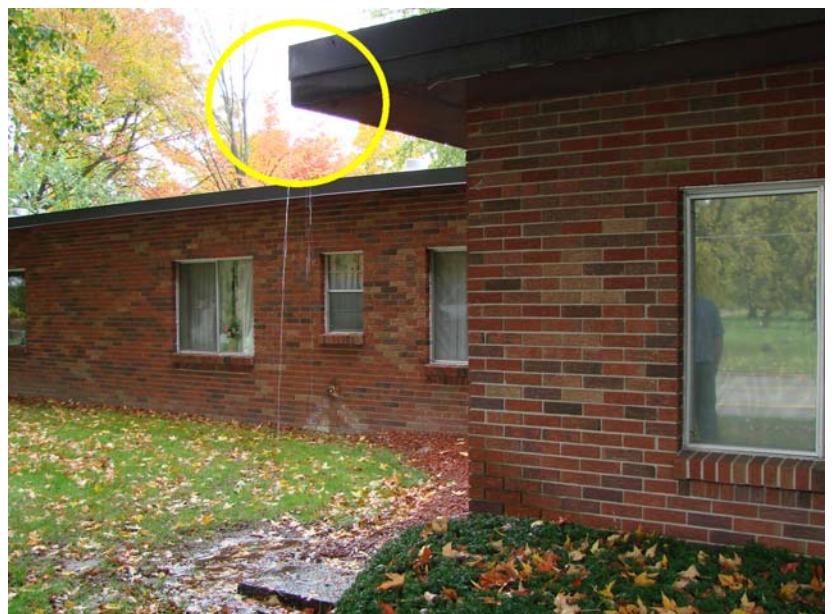
008_MI_1: Water running off edge of roof due to poor roof drainage.

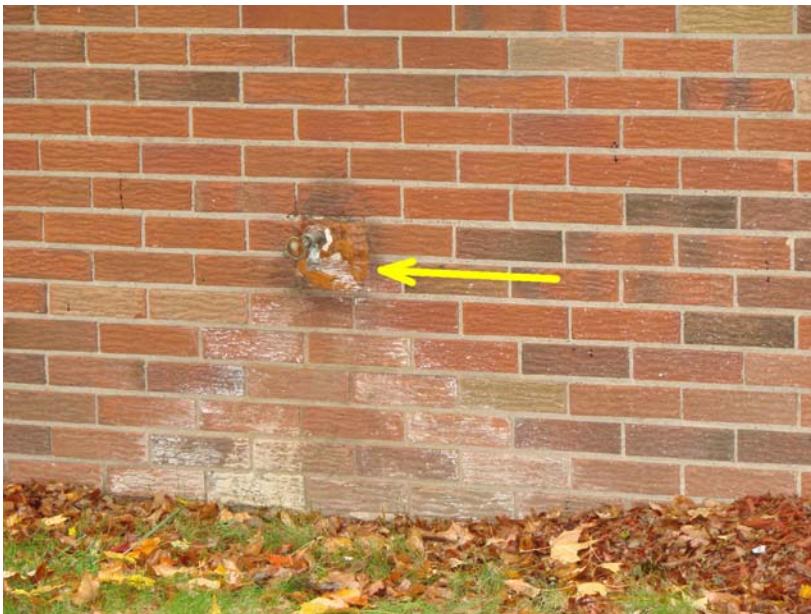
009_MI_1: Water faucet - insulation needs to be monitored for deterioration and maintained.

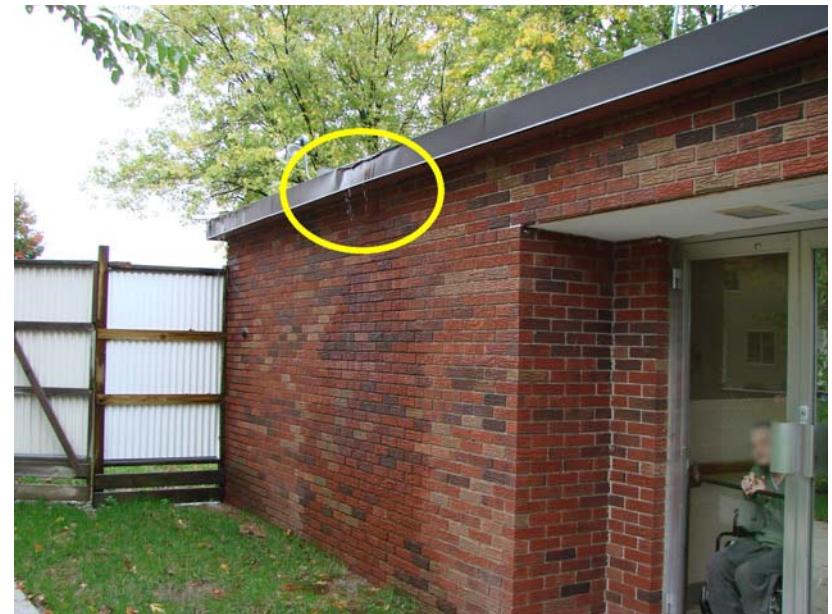
010_MI_1: Water running off edge of roof due to poor roof drainage.

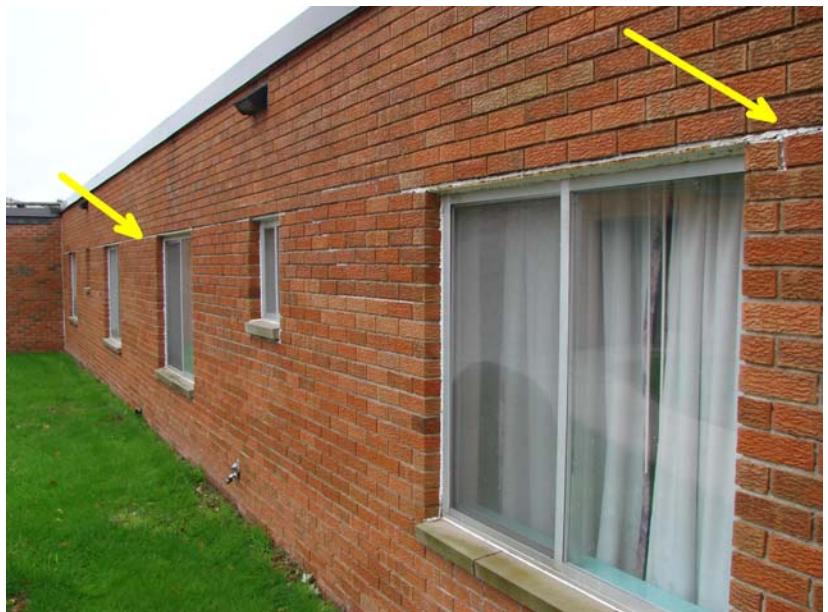
The exterior is generally in average condition and has fair landscaping. The exterior is brick veneer with wood fascia and soffit. The brick veneer is original to the facility and has some cracking at the tops of the windows (016, 038-045). There are also several areas of advanced deterioration on the fascia (004-007). At the time of the survey, it appeared that this deterioration is probably caused by the ponding and draining problems associated with the roofing (008, 010-011). One dumpster is located in the west side parking lot and another dumpster is located on the east side, near the kitchen (021, 048). The dumpsters are already enclosed by privacy fences but should be placed on concrete pads. A storage shed is located in the facility parking lot (025), and is reported to contain miscellaneous maintenance and facility items. There are also two fence-enclosed courtyards available for resident use, one on the east side and the other on the west (127, 128, 222, 233, 234).

016_MI_1: Detail - mortar joint crack at brick lintel - runs length of west elevation of West Hall.

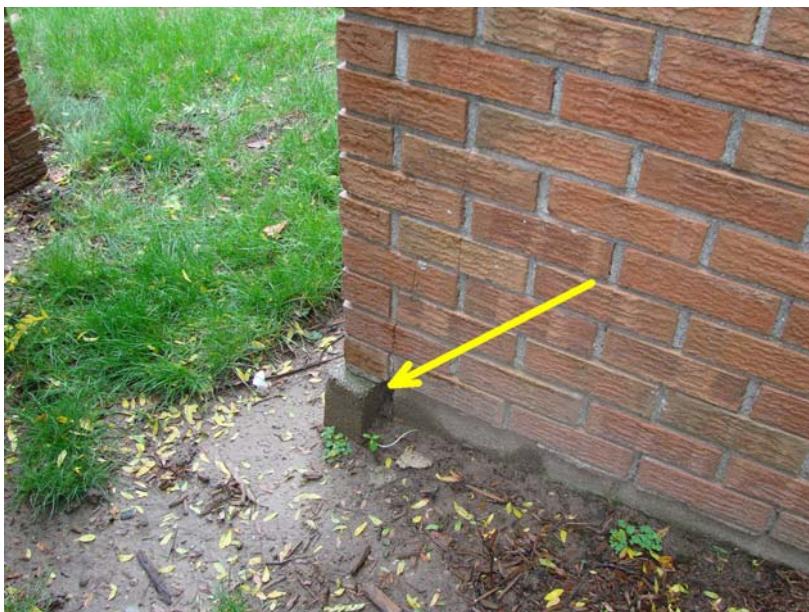
019_MI_1: Detail - curious foundation detail - concrete block protrusion.

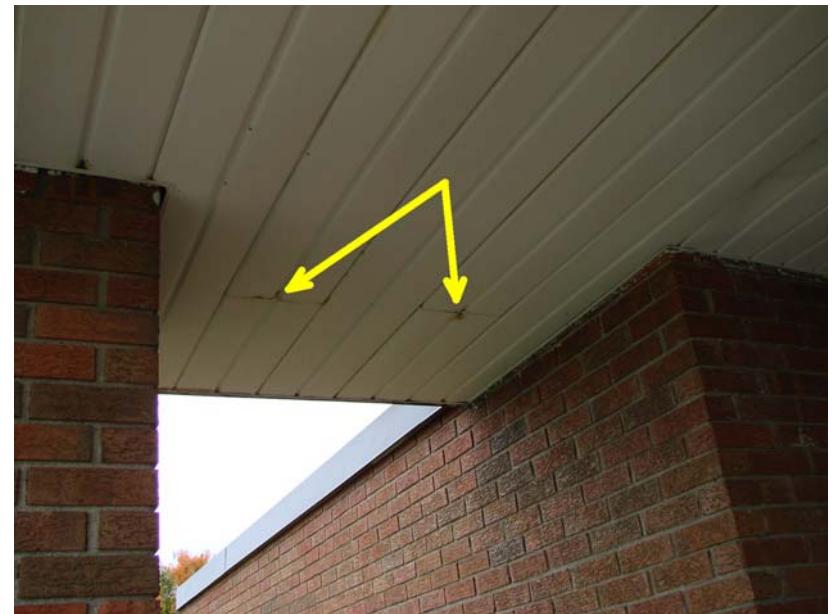
030_MI_1: Rust stains at East Hall exit awning ceiling.

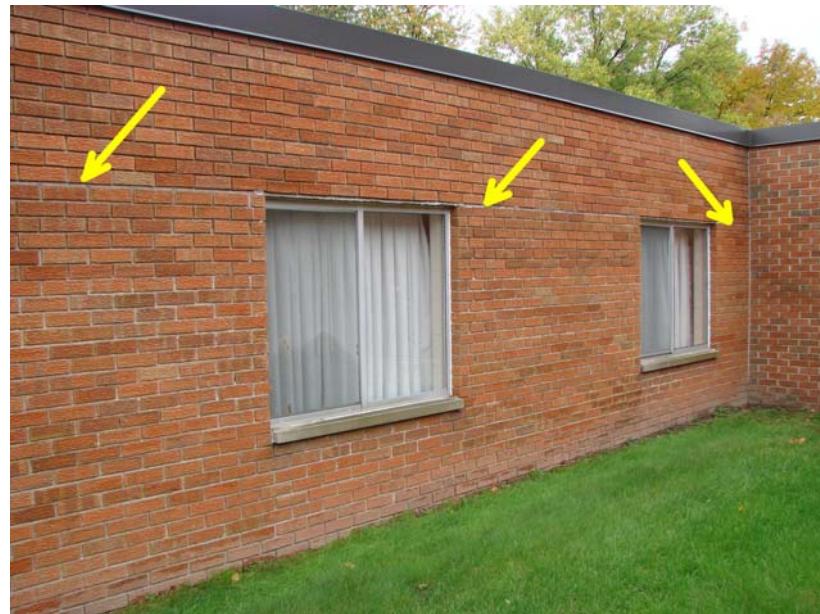
038_MI_1: Detail - mortar joint crack at brick lintel - runs length of North elevation oF South 1 Hall.

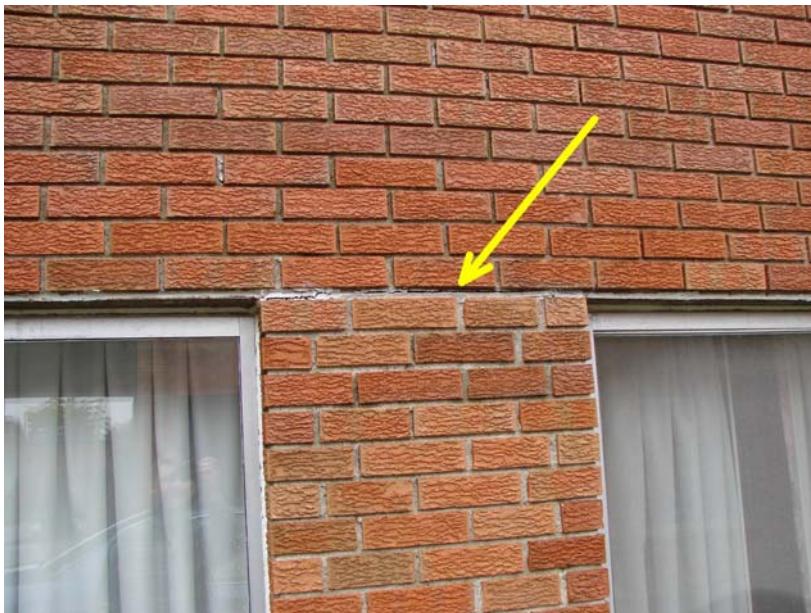
039_MI_1: Cracking mortar joint at brick lintel.

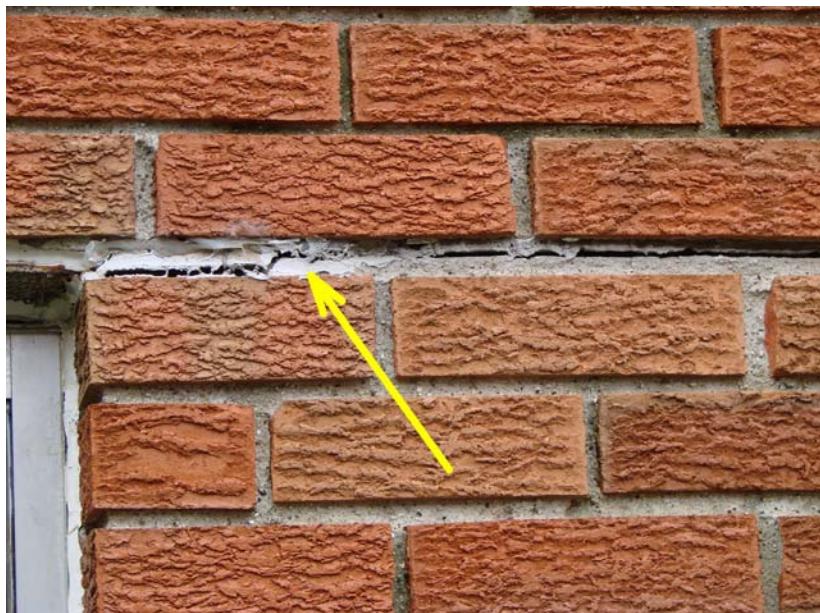
040_MI_1: Detail - mortar joint crack at brick lintel.

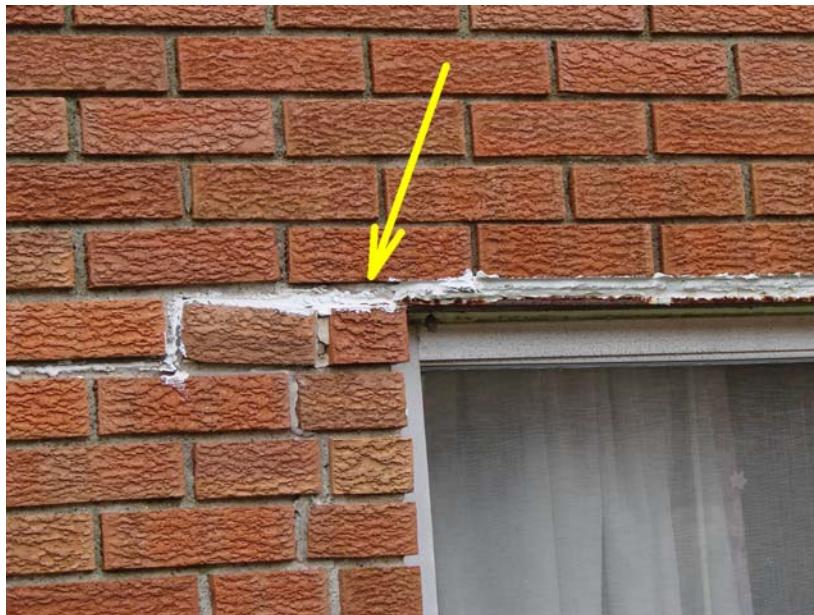
041_MI_1: Detail - mortar joint crack at brick lintel.

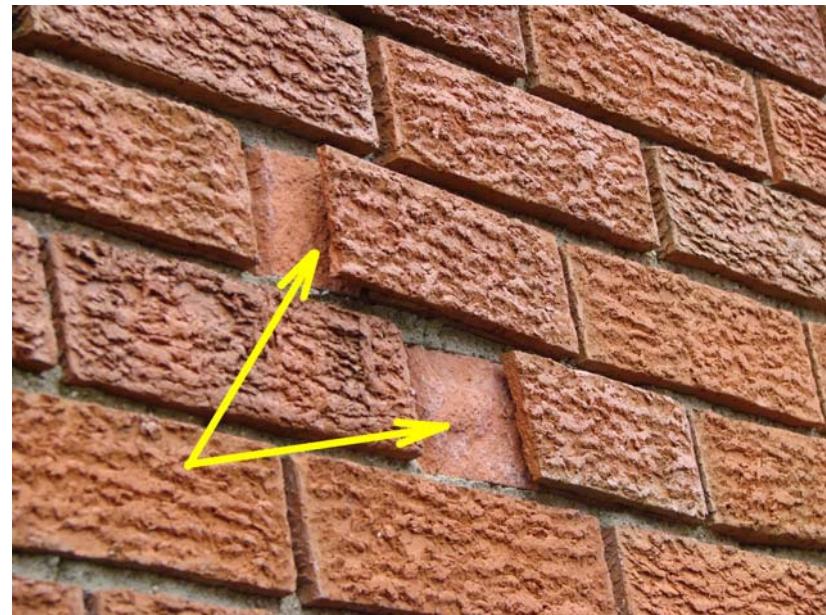
042_MI_1: Brick spalling - likely caused by freeze-thaw cycles.

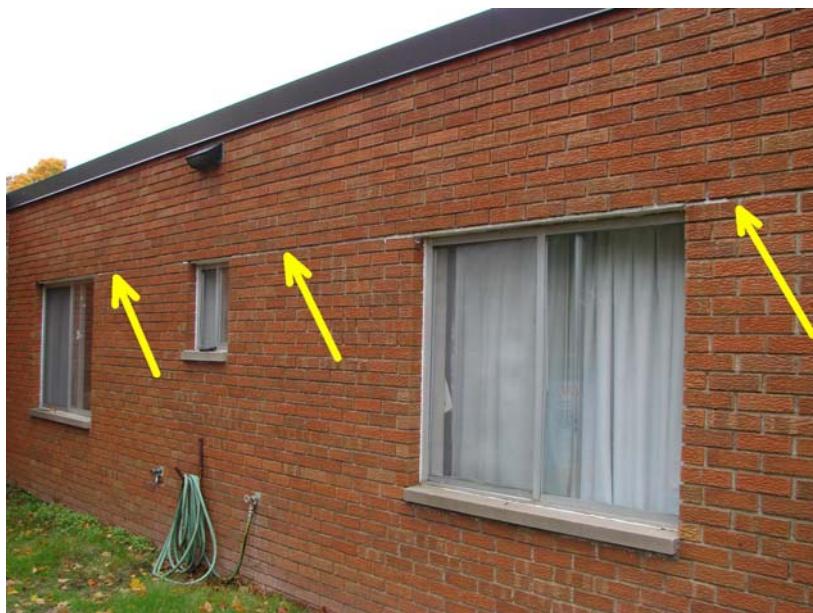
043_MI_1: Detail - mortar joint crack at brick lintel - runs length of South elevation of South 1 Hall.

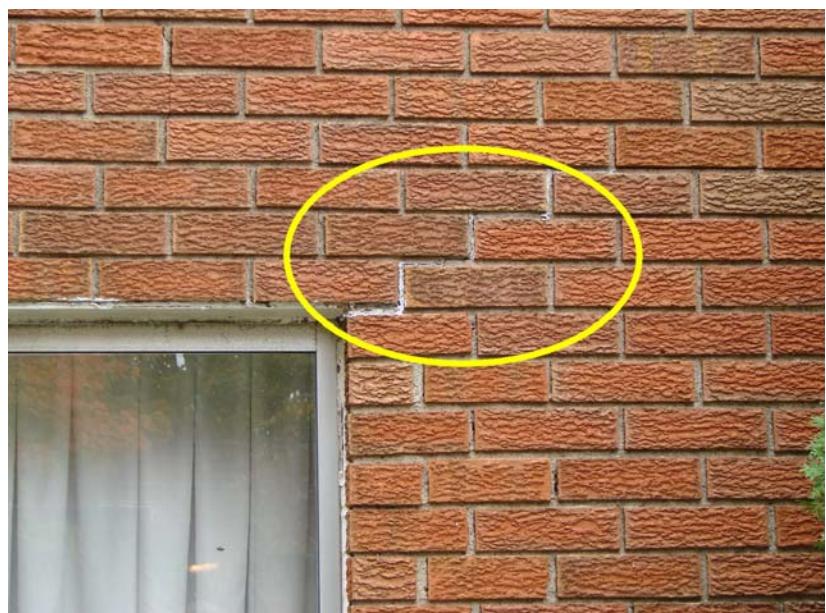
044_MI_1: Detail - mortar joint crack in South 2 Hall.

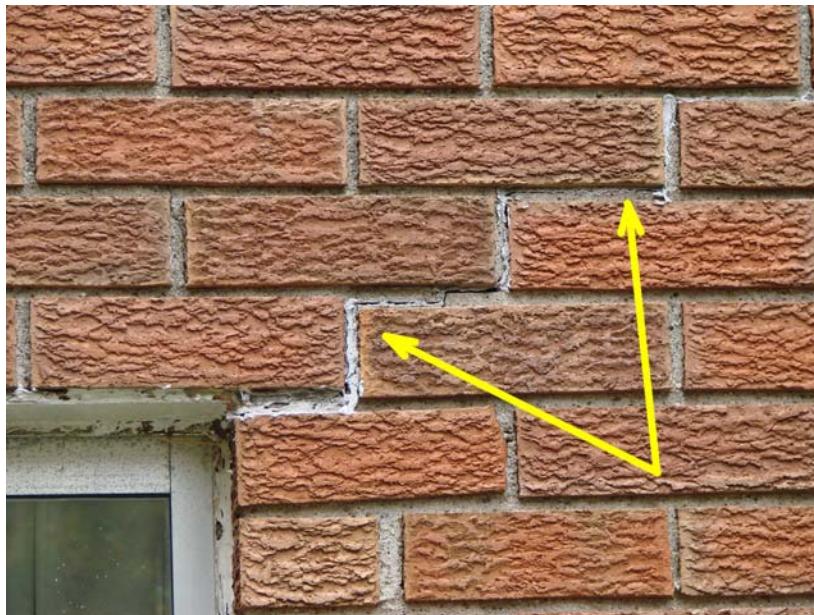
045_MI_1: Detail - mortar joint crack in South 2 Hall.

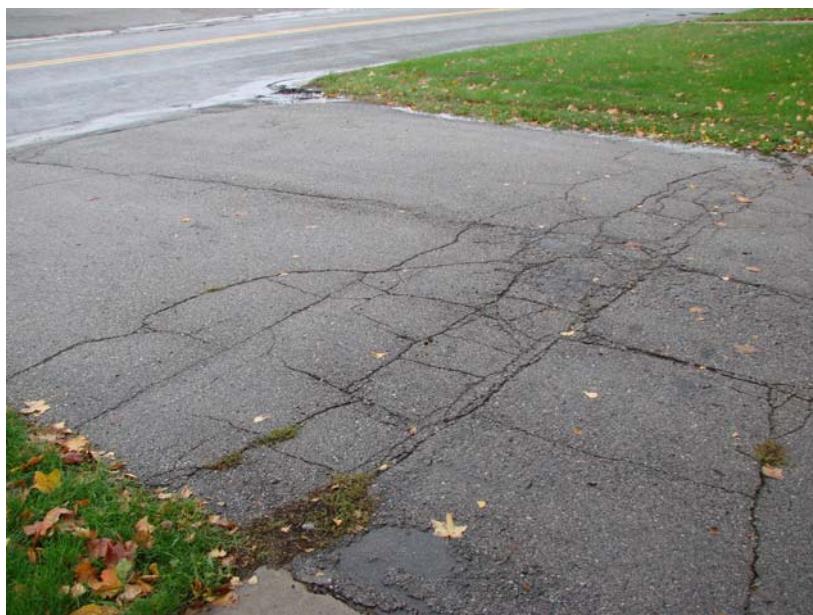
Parking was adequate during the survey visit with 71 asphalt-paved parking stalls and 3 additional handicap-parking stalls. The paved parking is in average overall condition with several areas of advanced deterioration. The asphalt paving has several cracks that should be maintained and the entire paved area should be sealed and restriped (022-026). Exterior lighting appears to be adequate in the parking area and no comments were made by staff that would indicate insufficient parking lot or exterior lighting (025).

047_MI_1: Asphalt paving deterioration at service drive to dumpster on the south side of South 1 Hall.

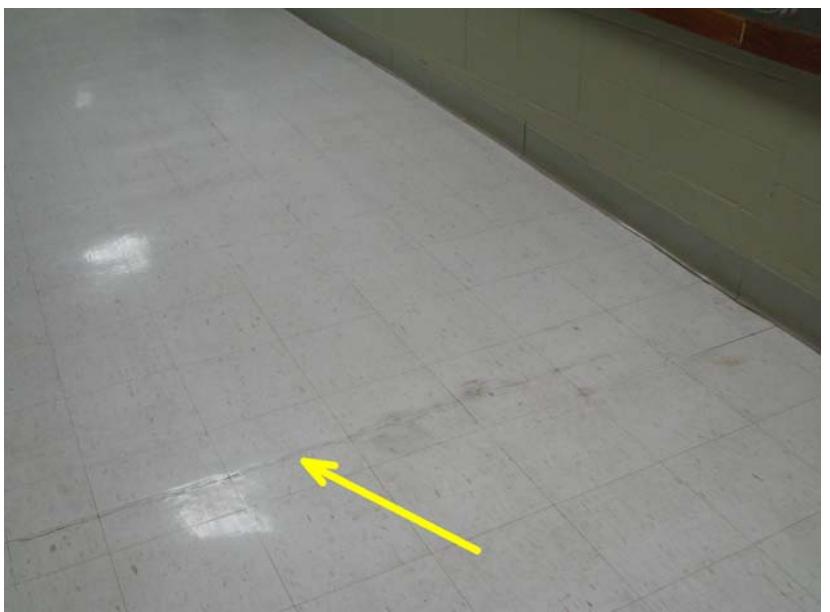
064_MI_1: VCT tile crack where corridor floor ramps up from South 1 Hall to center administrative hall.

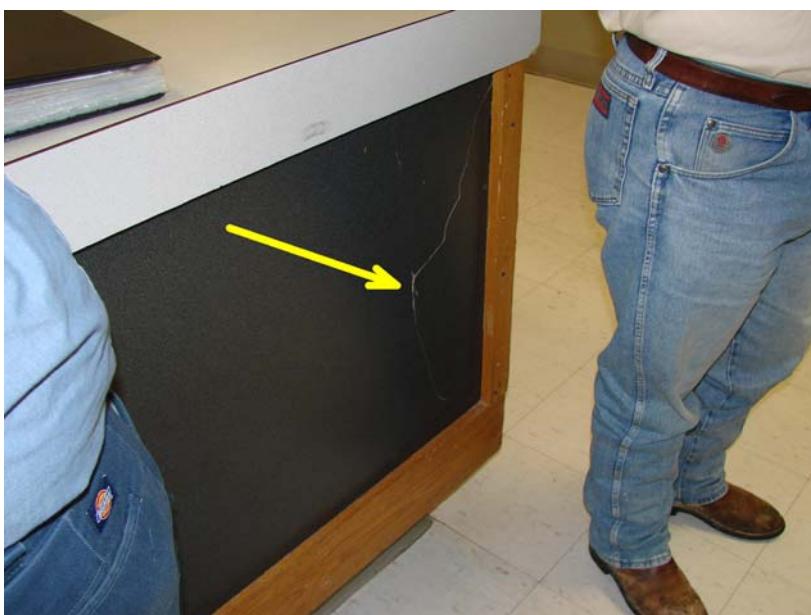
067_MI_1: Nurse station detail - cracked laminate.

10. Replace corridor carpet.
11. Re-laminate nurse stations (3 ea.)
12. Upgrade East/West Halls nurse call system.
13. Paint ceiling grid, replace bowed/yellowed/damaged ceiling tile.
14. Upgrade residential style tubs with new side-entry therapy tubs. (3 ea.)
15. Replace VCT kitchen floor.
16. Repair seal on walk-in cooler/freezer doors.
17. Additional air conditioning in Kitchen
18. Replace water heaters (4 ea. - service life) 8-10 yrs.
19. Replace dryers (2 ea. @ 6-10)
20. Fire sprinkler upgrade to 100% coverage
21. Fire alarm upgrade – if required with sprinkler upgrade
22. Miscellaneous repair allowance.

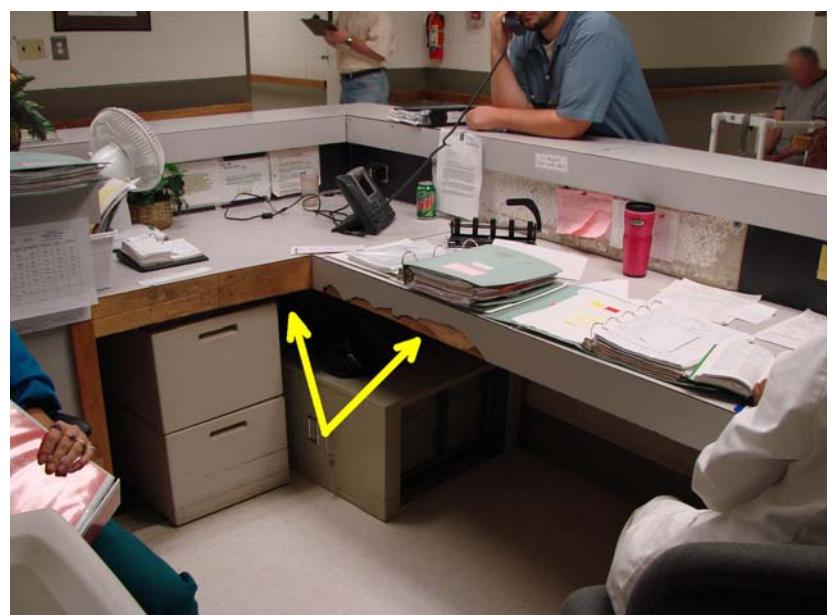
068_MI_1: Damaged laminate at nurse station.

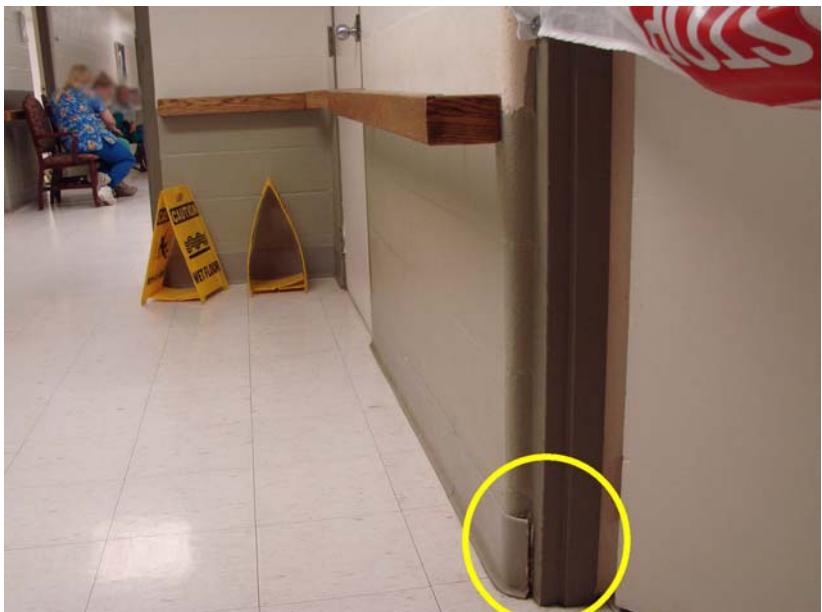
072_MI_1: Detail - wall base coming loose at door frame.

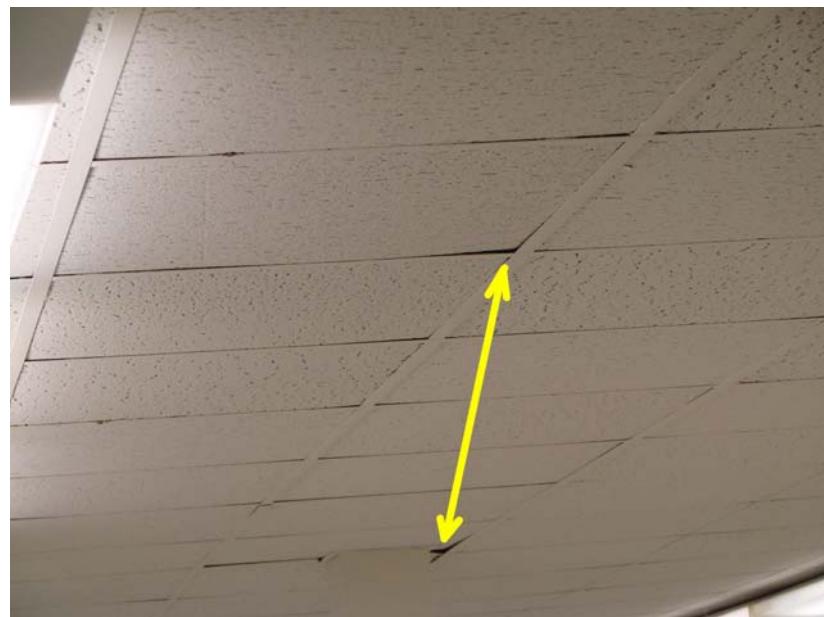
078_MI_1: Dining room ceiling detail - tiles are warping at corners.

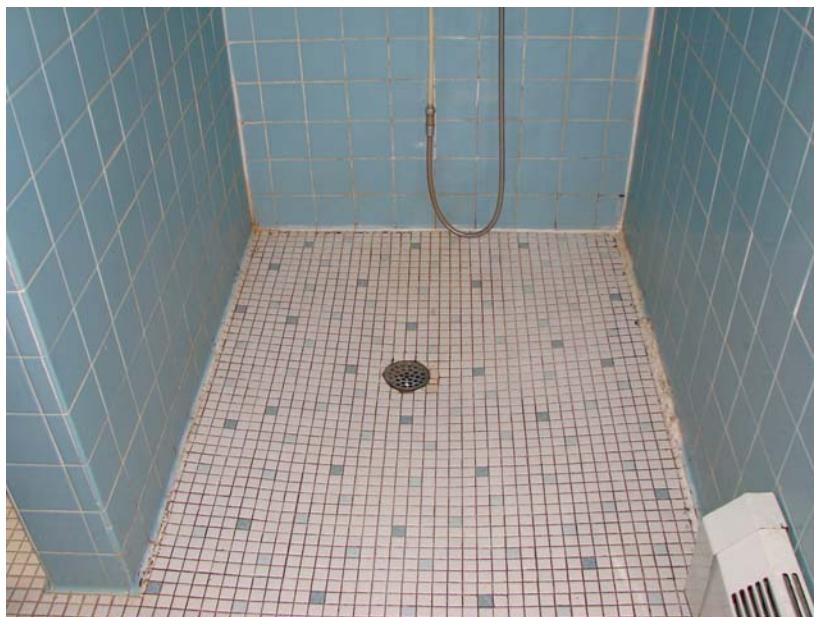
081_MI_1: Shower floor - poor-fair condition.

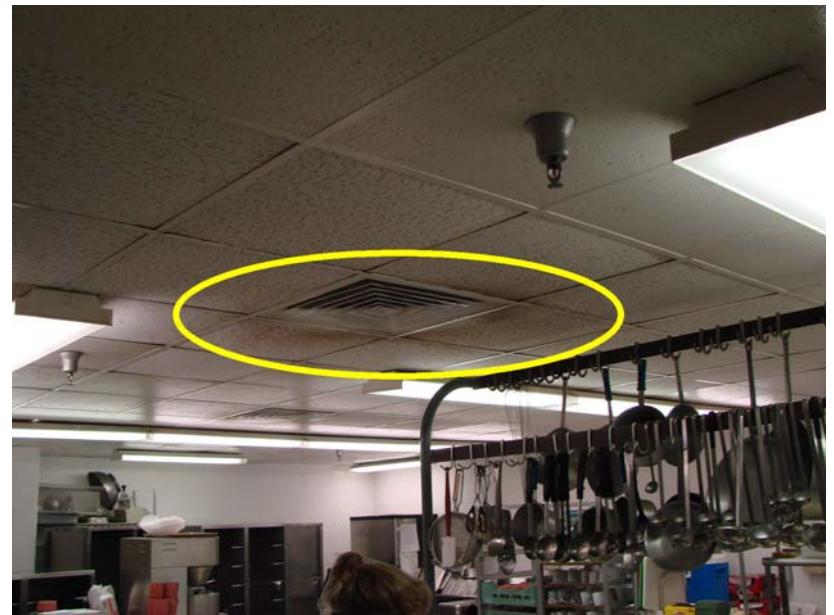
086_MI_1: Ceiling detail - dirty ceiling tile at air conditioner vent.

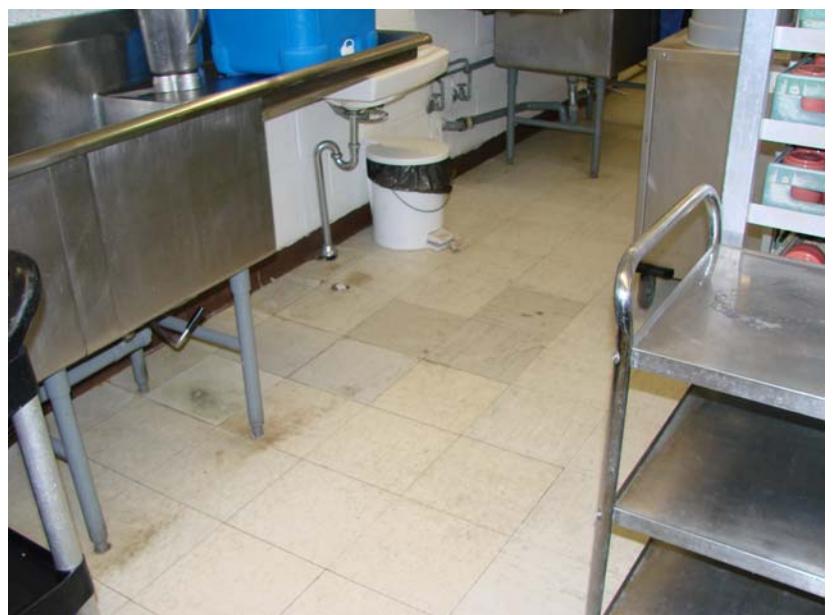
The kitchen is located in the South I corridor and is adjacent to the dining room (084-099). The equipment was in good operating condition during the survey, with no deficiencies reported by the dietary staff. Equipment includes a Southbend gas stove with ten burners and a double oven, Southbend convection oven, new Duke steamer, Thermokool walk-in cooler, Thermokool walk-in freezer, and a True reach-in cooler. The kitchen finishes include VCT tile floor, painted CMU block walls, and lay-in grid ceiling. The only kitchen related issues that were observed and reported during the survey were poorly patched floor tile, worn walk-in

088_MI_1: Kitchen - VCT floor tile repairs.

15 Replace VCT kitchen floor.		4,200		
16 Repair seal on walk-in cooler/freezer doors.		1,500		
17 Additional air conditioning in Kitchen		12,000		
18 Replace water heaters (4 ea. - service life) 8-10 yrs.				18,000
19 Replace dryers (2 ea. @ 6-10)				7,600
20 Fire sprinkler upgrade to 100% coverage		110,000		
21 Fire alarm upgrade – if required with sprinkler upgrade.		25,000		
22 General Maintenance/Miscellaneous repair allowance.		5,000		
Recommendations Total	\$ 30,000	\$ 31,700	\$ 480,563	\$ 225,600
Contingency (10%)	\$ 3,000	\$ 3,170	\$ 48,056	\$ 22,560
Construction Management & Expenses (15%/5%)	<u>6,600</u>	<u>6,974</u>	<u>105,724</u>	<u>49,632</u>
Estimated Total	\$ 39,600	\$ 41,844	\$ 634,343	\$ 297,792
Combined Total	\$ 1,013,579

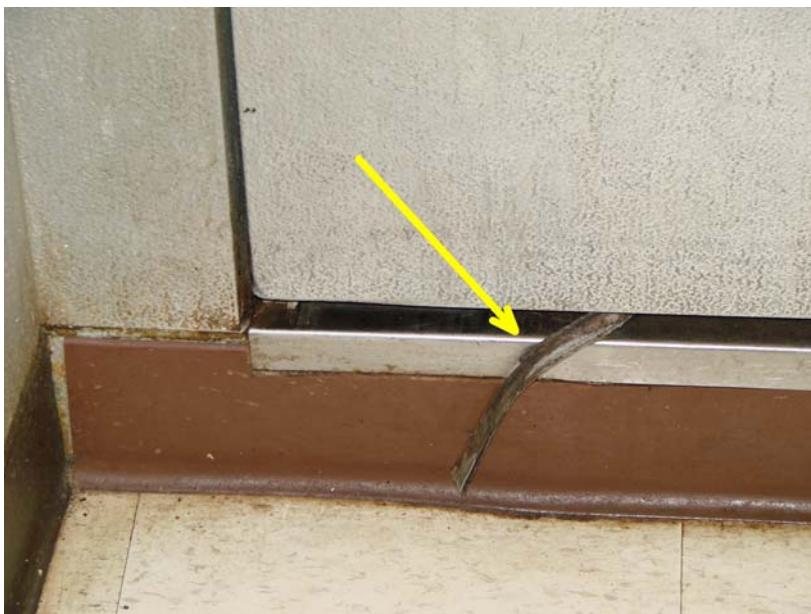
cooler/freezer weather stripping and ceiling tile replacement.

095_MI_1: Walk-in cooler door detail - loose seal.

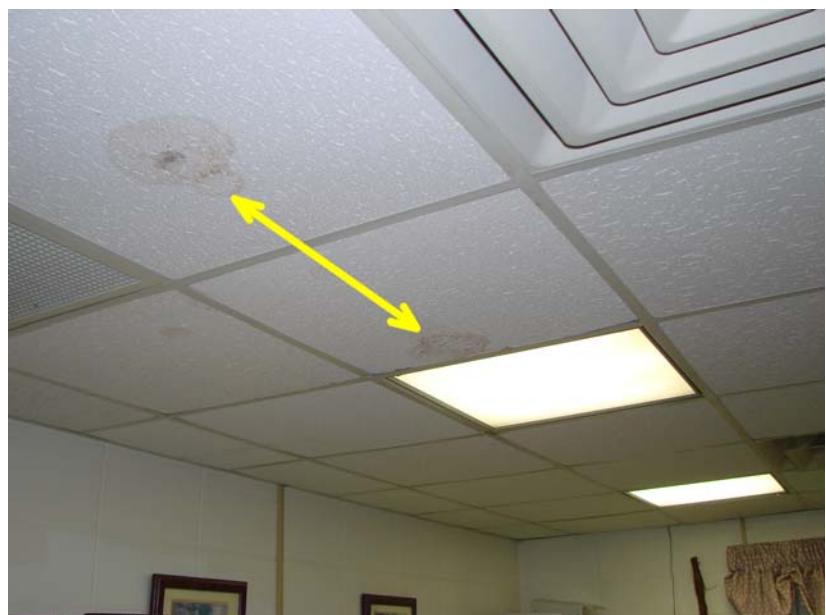
200_MI_1: Water stains on ceiling tile in therapy office.

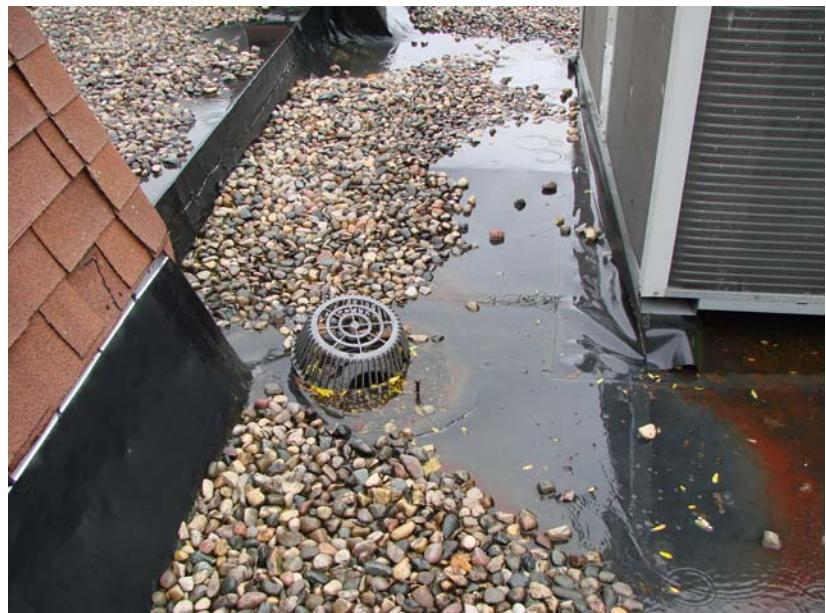
The facility is partially covered by a flat, 60-mil EPDM rubber membrane Firestone roof that is in average condition with several reported leaks and needs to be patched. The other areas of the facility are covered with a ballasted roof that has several leaks and needs near term replacement. Due to a central air conditioning system being installed in recent years, the roof has several areas of advanced ponding. This is caused by improper duct installation on the rooftop. The ductwork needs to be lifted and set on roof curbs to ensure proper drainage to the roof drains (201, 202, 204-207, 209-221, 225-230).

204_MI_1: Roof drain dislodged from its correct position.

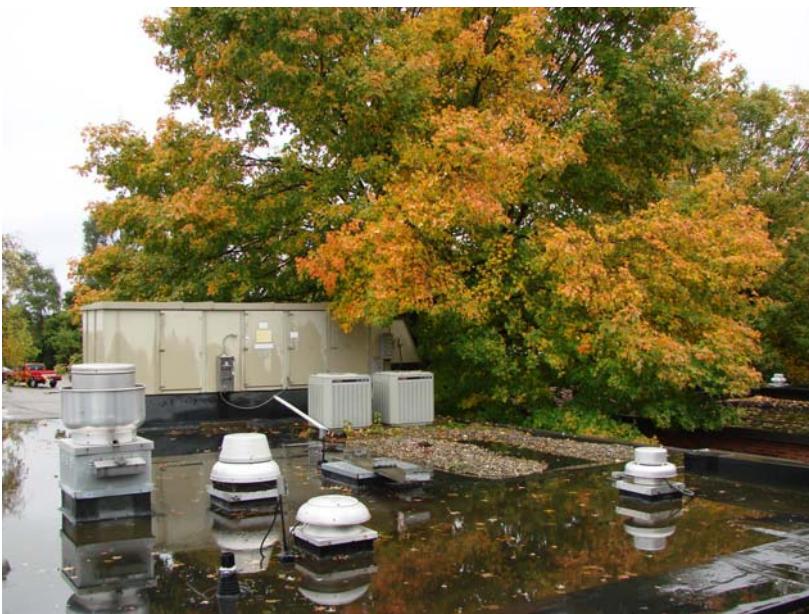
215_MI_1: Tree growing between South 1 and South 2 Halls needs to be trimmed away from air conditioners.

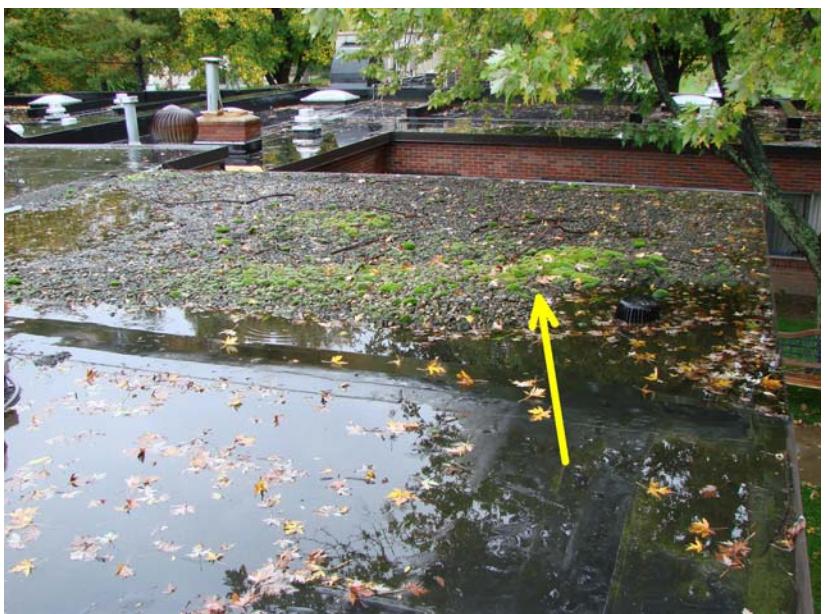
216_MI_1: Vegetation growing in roof ballast.

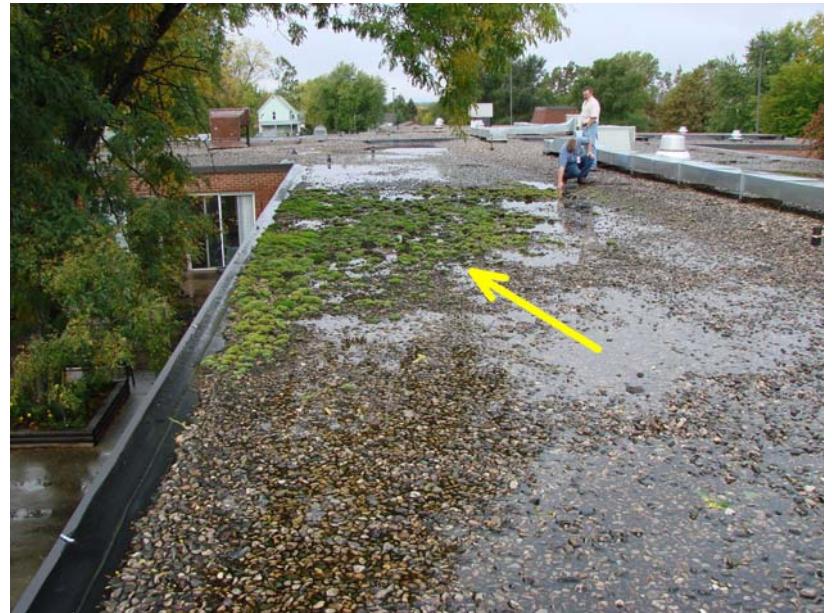
230_MI_1: Vegetation growing in roof ballast.
