The Palms - PALM EAST
351 East Palm Drive, Anytown, USA 01995
PH 987-654-3210 * FAX 987-654-3211

The Palms - PALM EAST

Anytown, USA; May 2, 2007

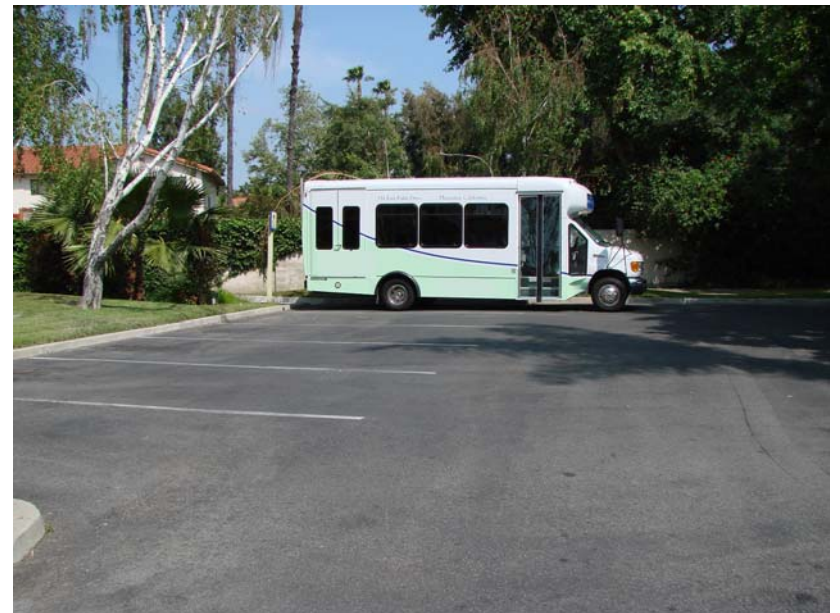
009 P_E: East parking area and facility van.

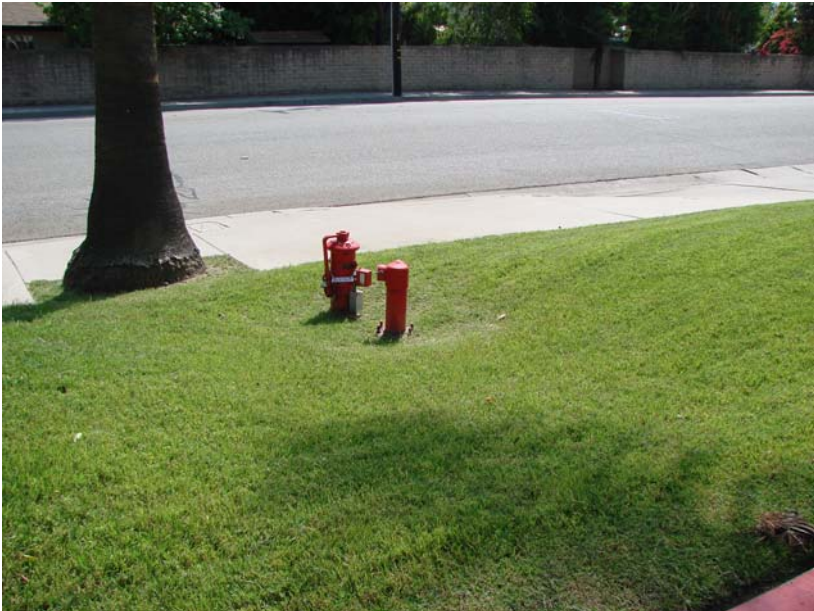
012 P_E: Fire sprinkler stand pipe.

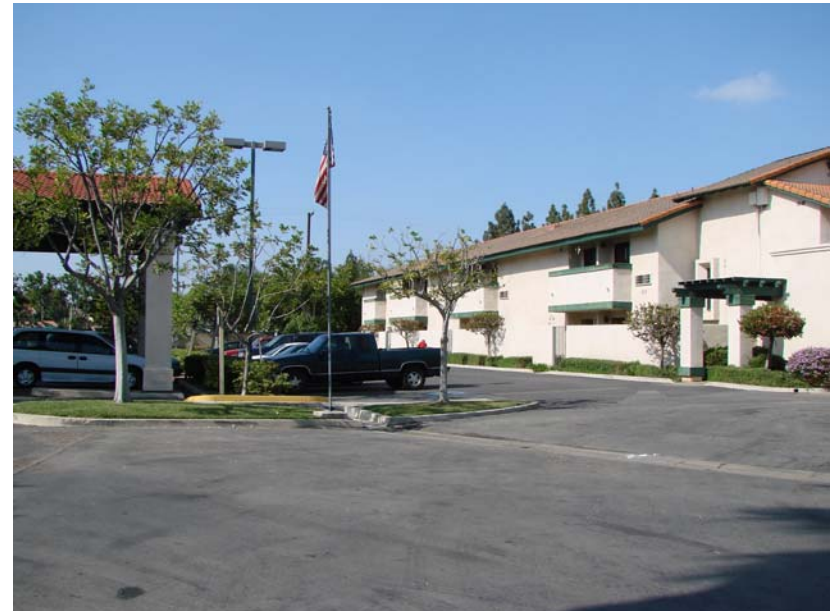
013 P_E: West elevation of Palm East (looking north).

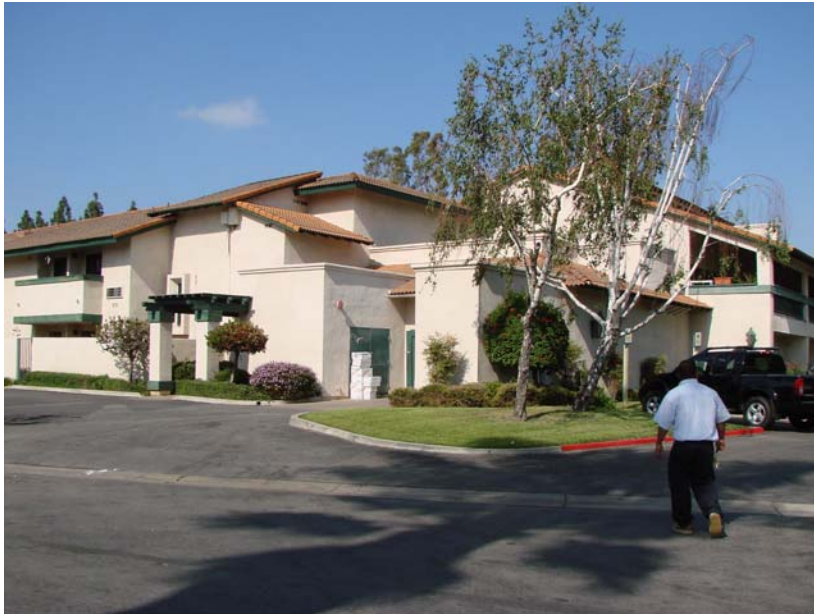
014 P_E: Palm East service entrance - water heater room & kitchen delivery area.

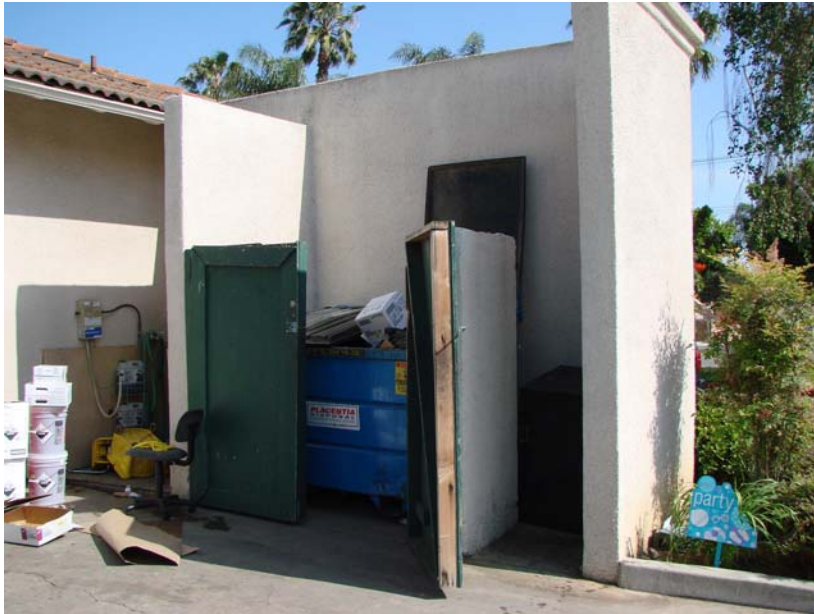
018 P_E: Trash dumpster at service area.

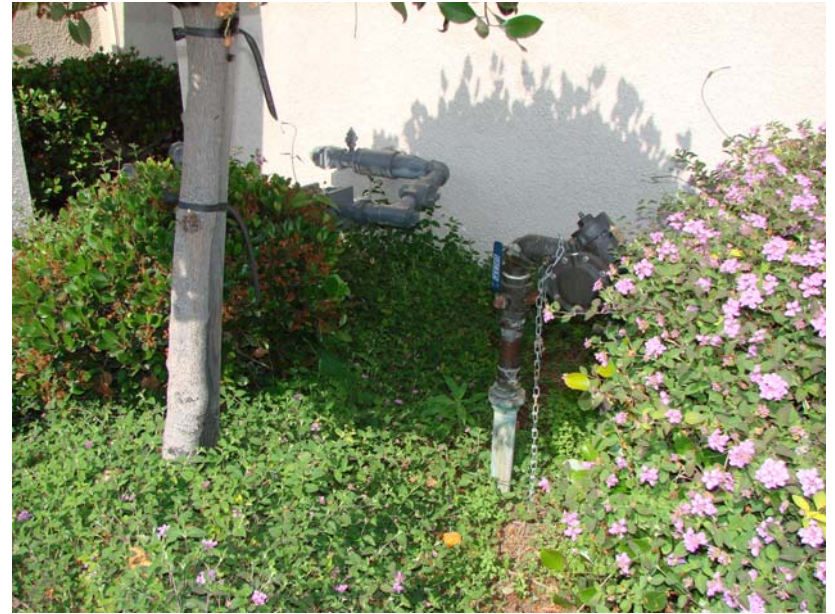
019 P_E: Irrigation sprinkler supply and gas meter.

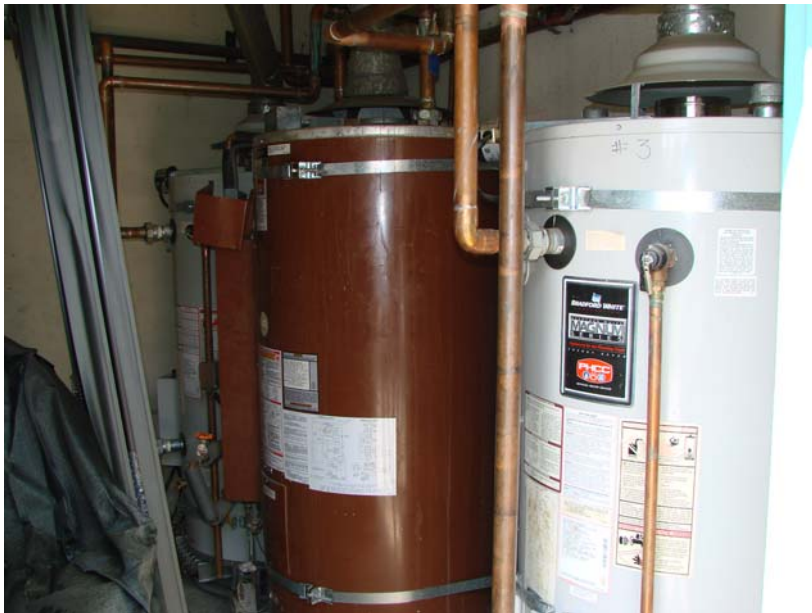
020 P_E: Water heaters - two for residential-domestic use; one for kitchen.

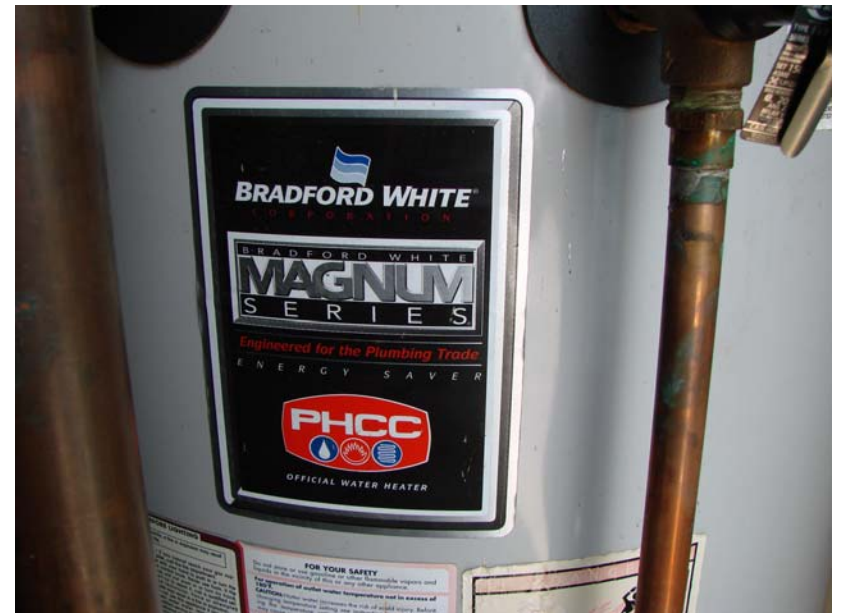
021 P_E: Bradford White water heater (#3), 80-gal, 180,000 BTUH.

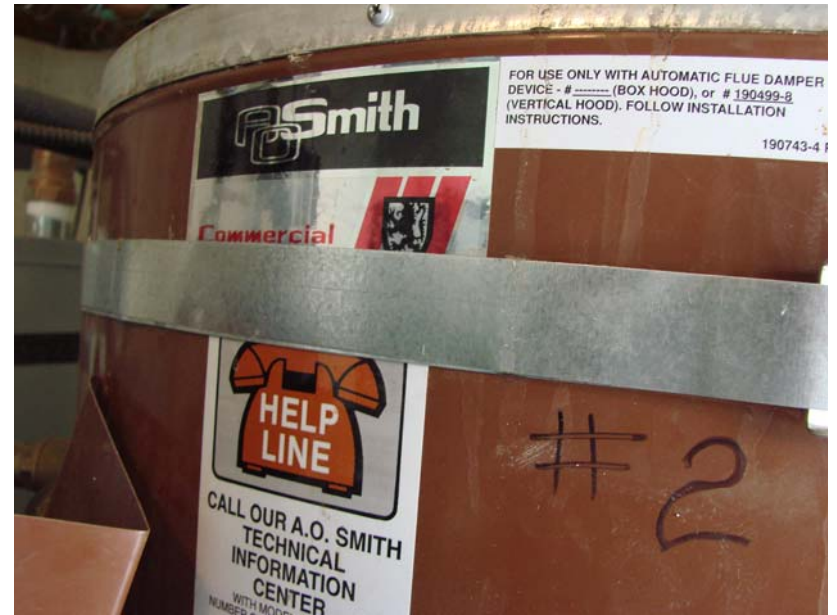
023 P_E: A.O. Smith water heater (#2) - 100-gal, 250,000 BTUH.

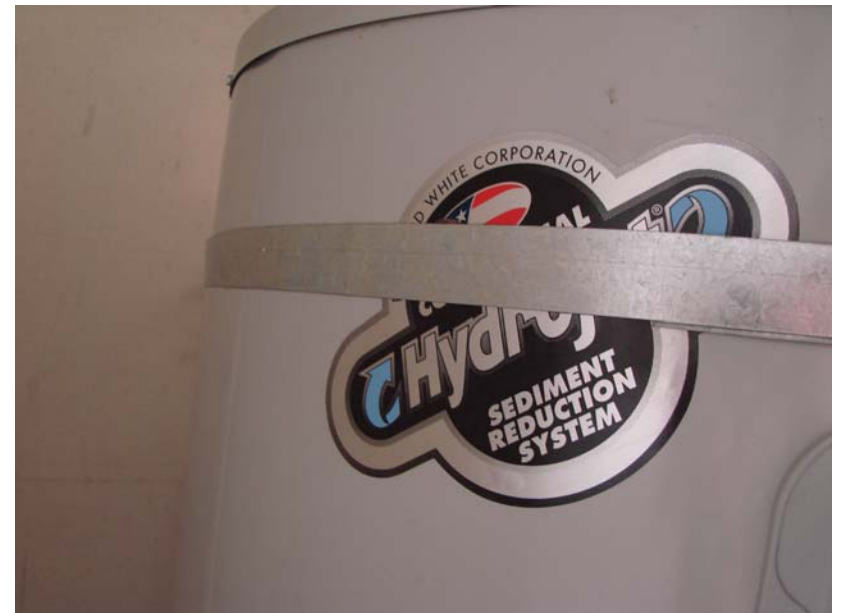
025 P_E: Bradford White water heater (#1) 100-gal, 270,000 BTUH.

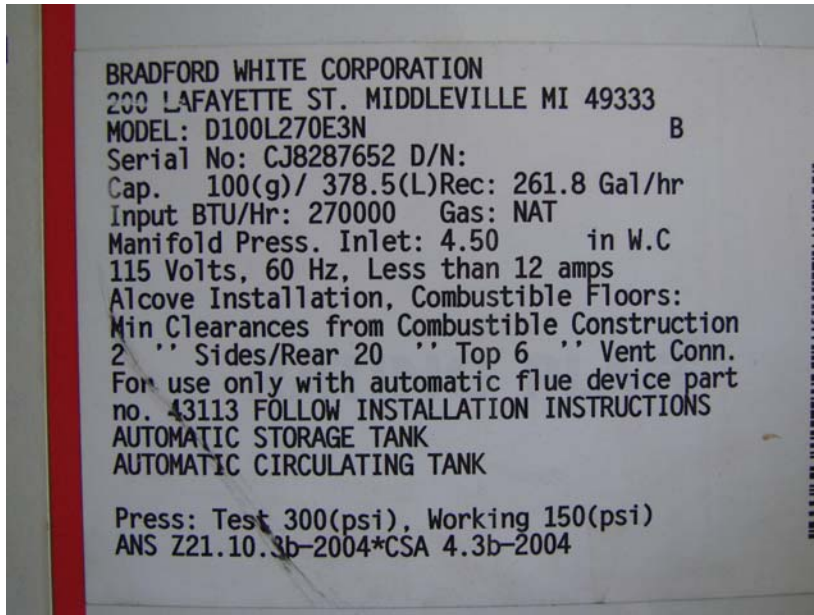
026 P_E: Bradford White water heater (#1) 100-gal, 270,000 BTUH.

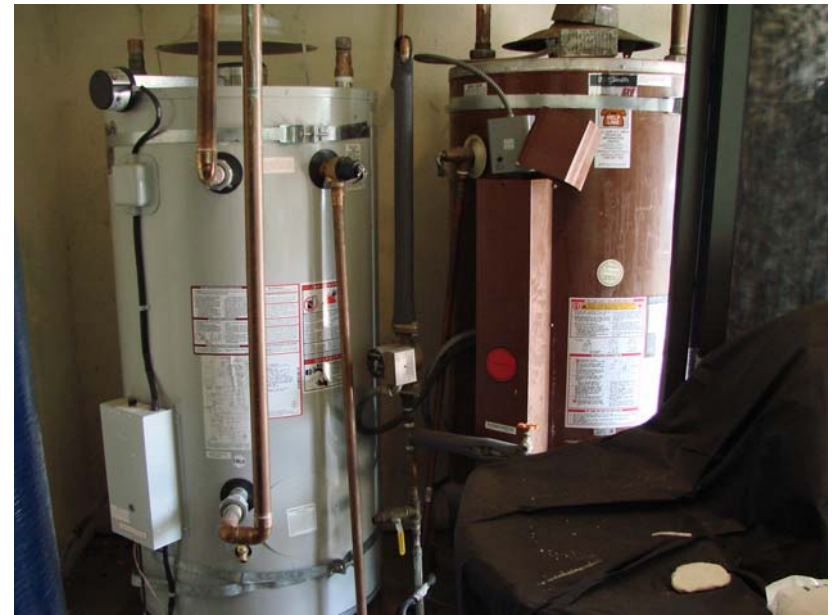
027 P_E: Water heaters #1 & 2.

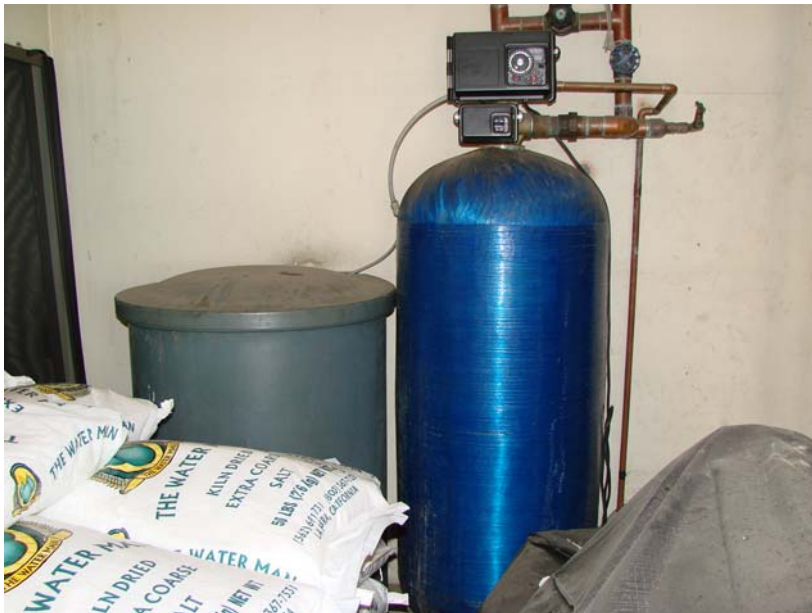
028 P_E: Culligan water treatment system.

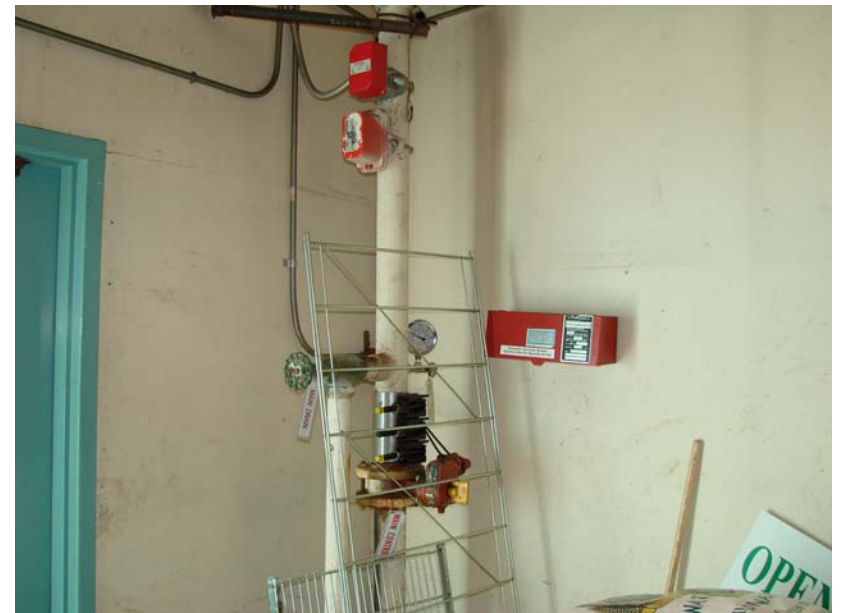
029 P_E: Fire sprinkler riser.

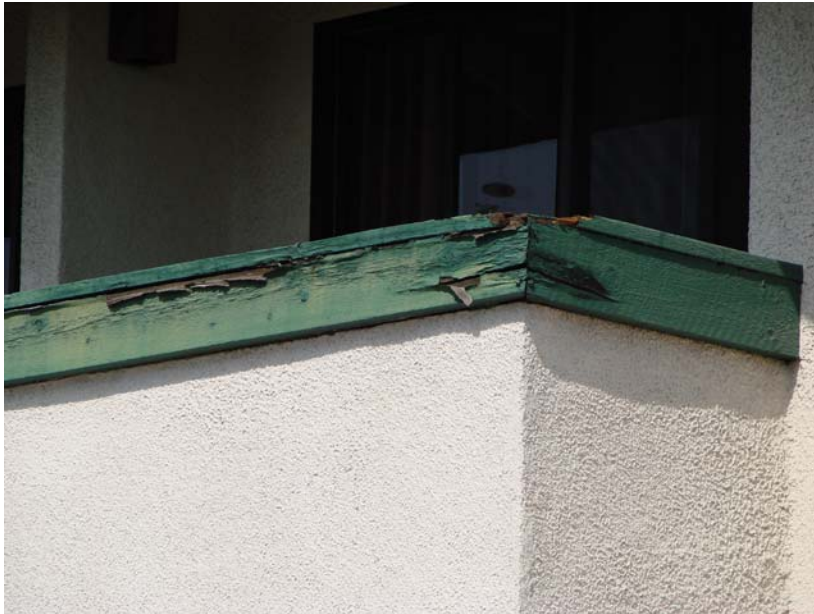
034 P_E: Detail - rotten wood trim on 2nd floor balconies.

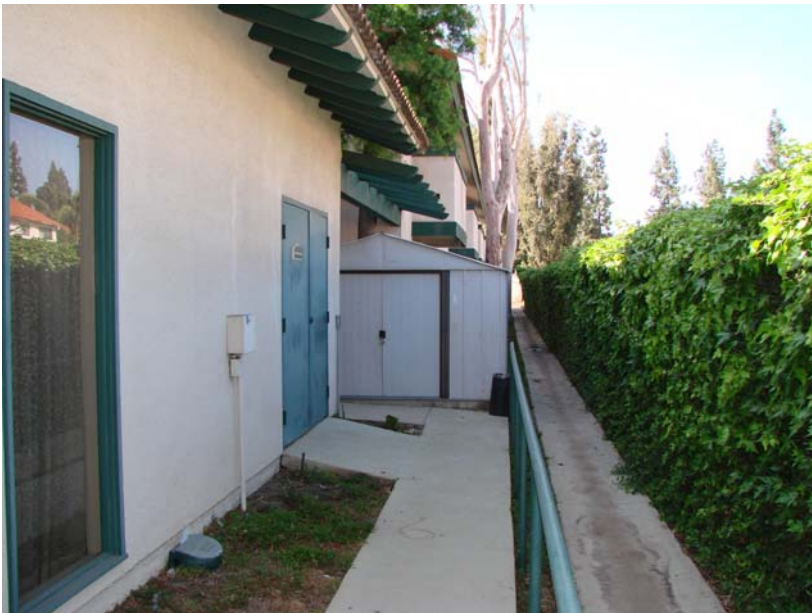
036 P_E: Palm East east elevation looking north. Storage building and main electrical closet at stair well #3.

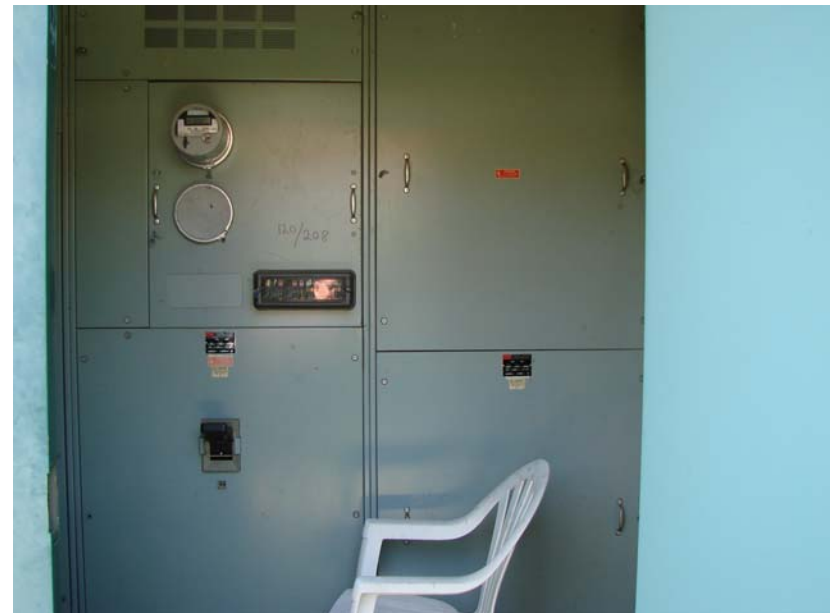
037 P_E: 2000 Amp main electric panel (Palm East).

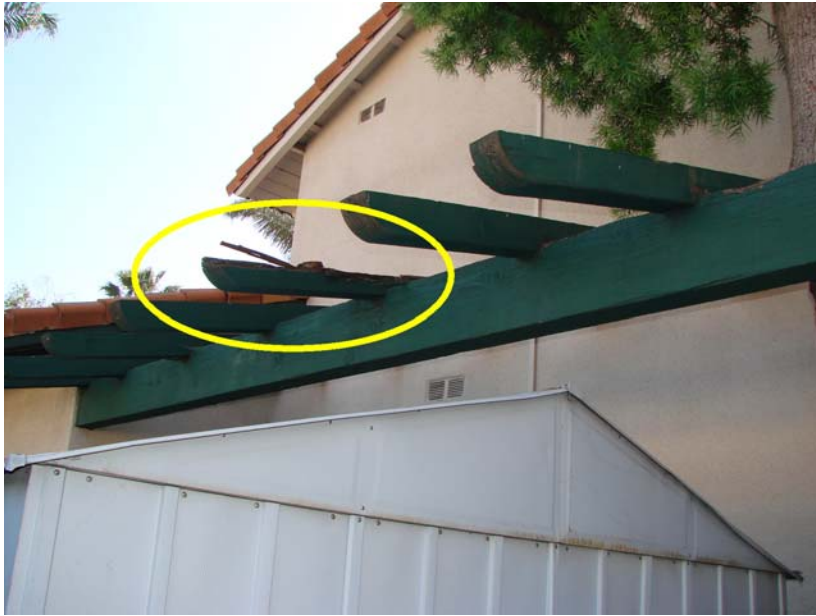
038 P_E: Detail - rotten beam.

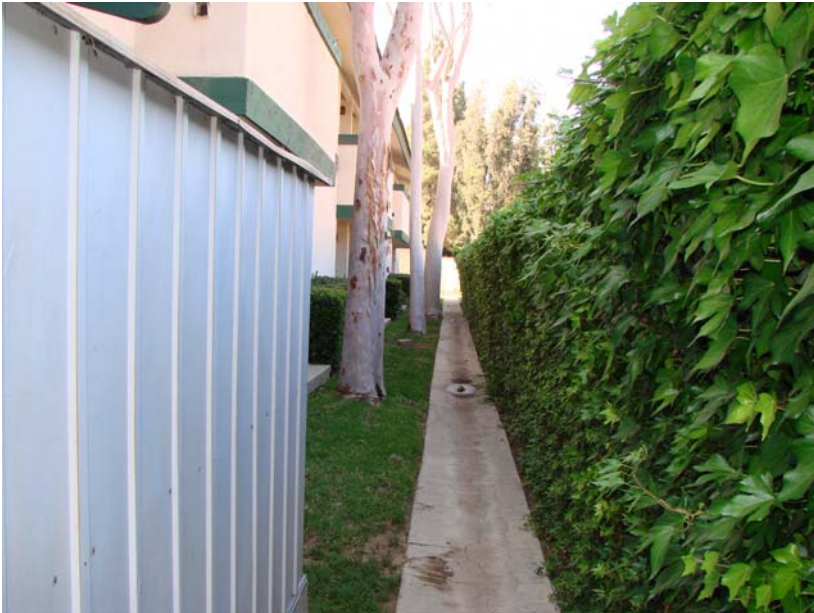
040 P_E: Palm East east elevation looking north.

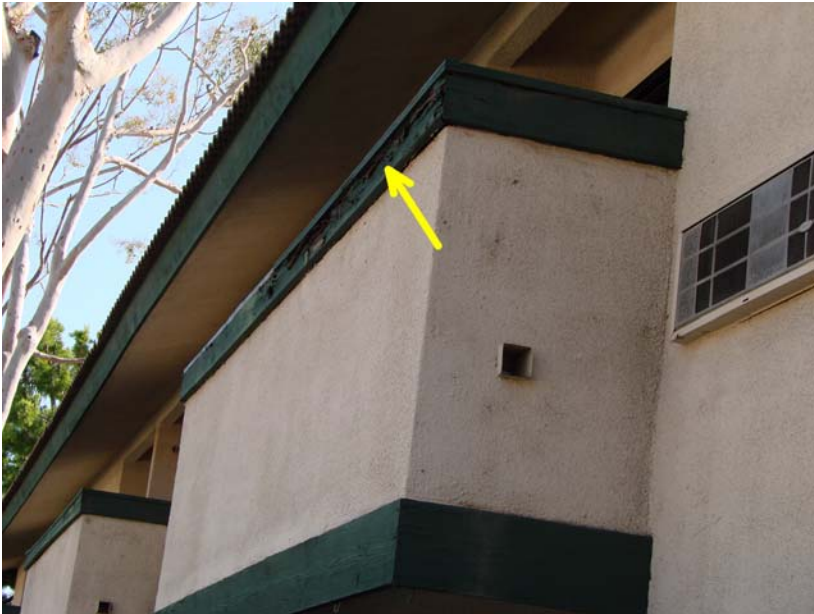
042 P_E: Detail - rotten trim on 2nd floor balcony.

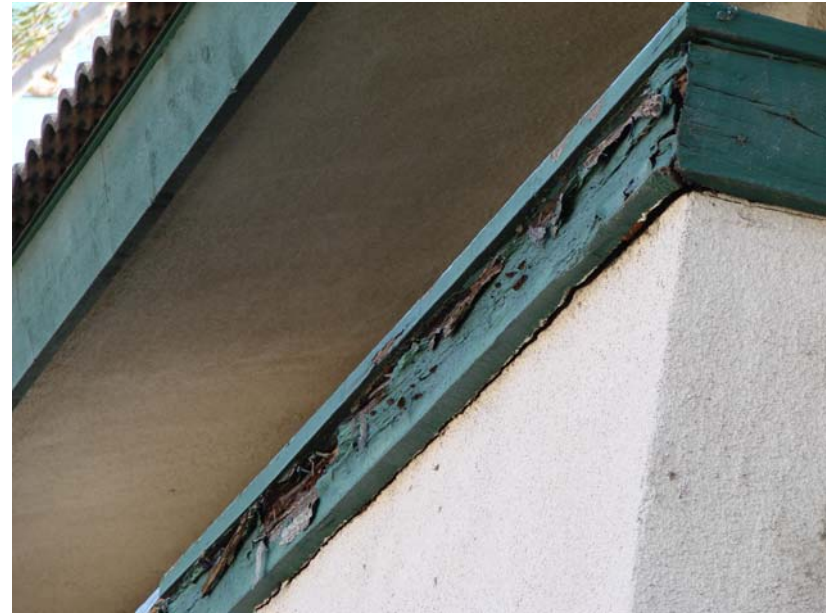
043 P_E: Detail - rotten trim on 2nd floor balcony.

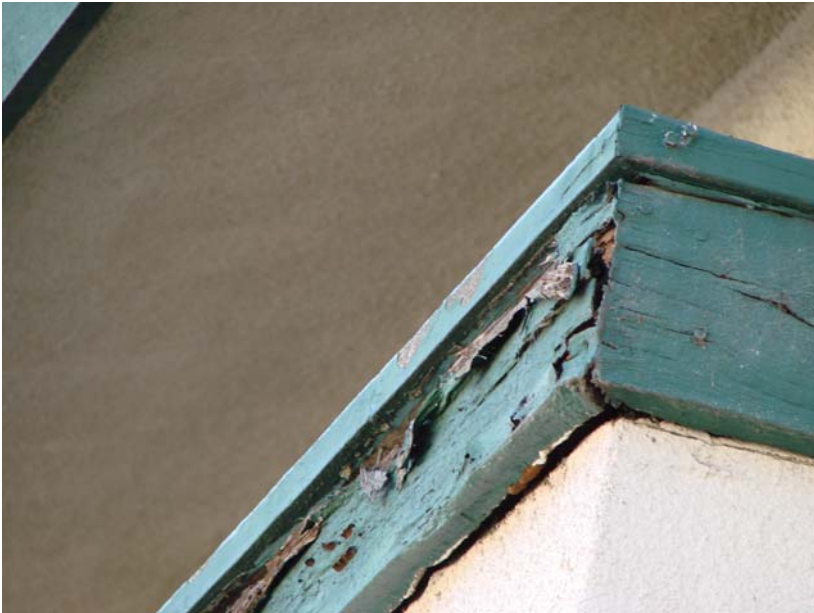
044 P_E: Detail - rotten trim on 2nd floor balcony.

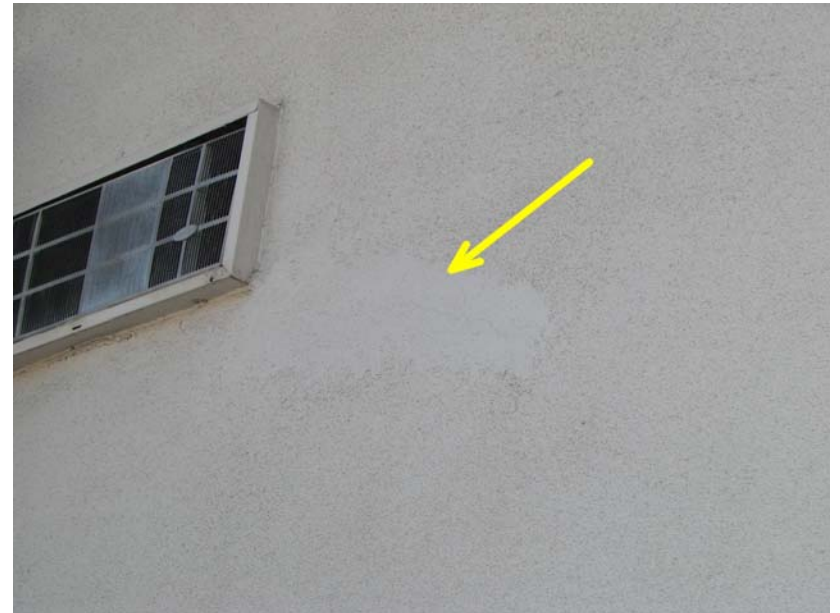
045 P_E: Wall patch on east elevation at PTAC unit.

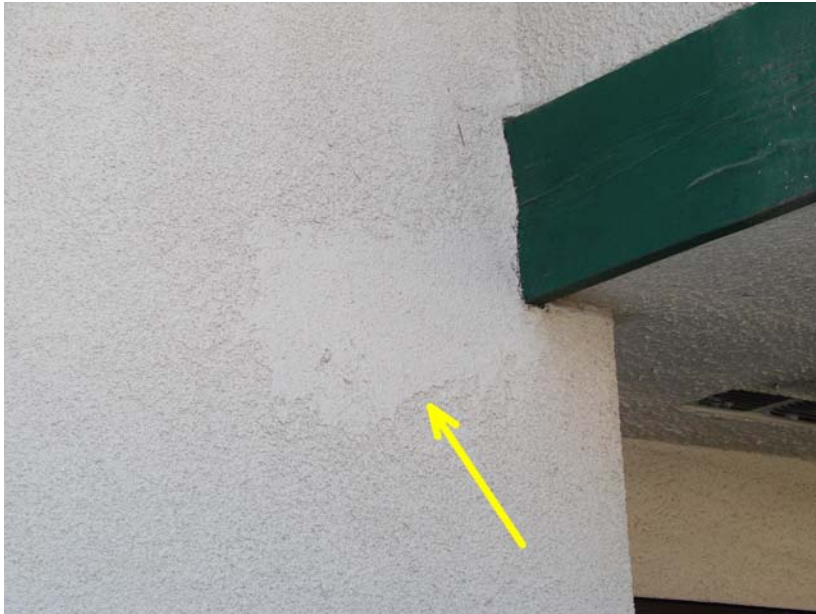
046 P_E: Wall patch on east elevation at balcony.

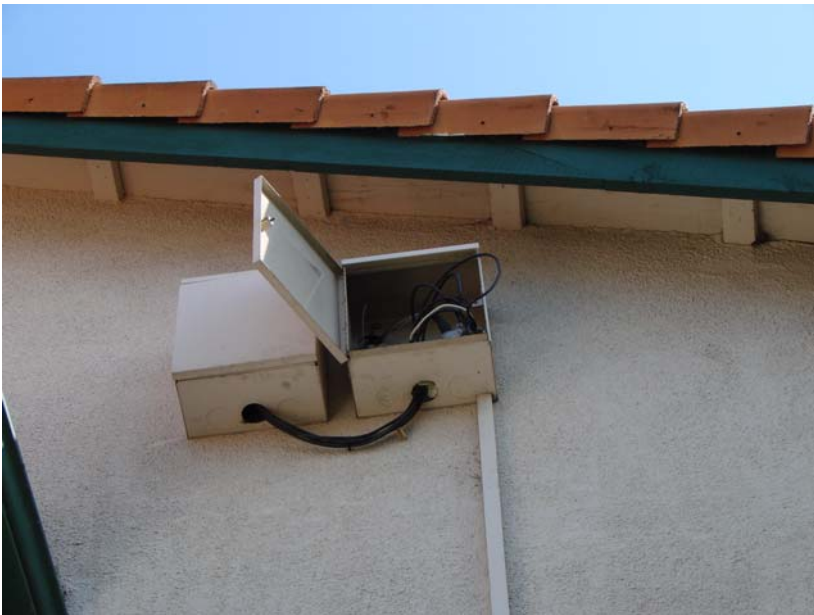
048 P_E: Open CATV junction box.

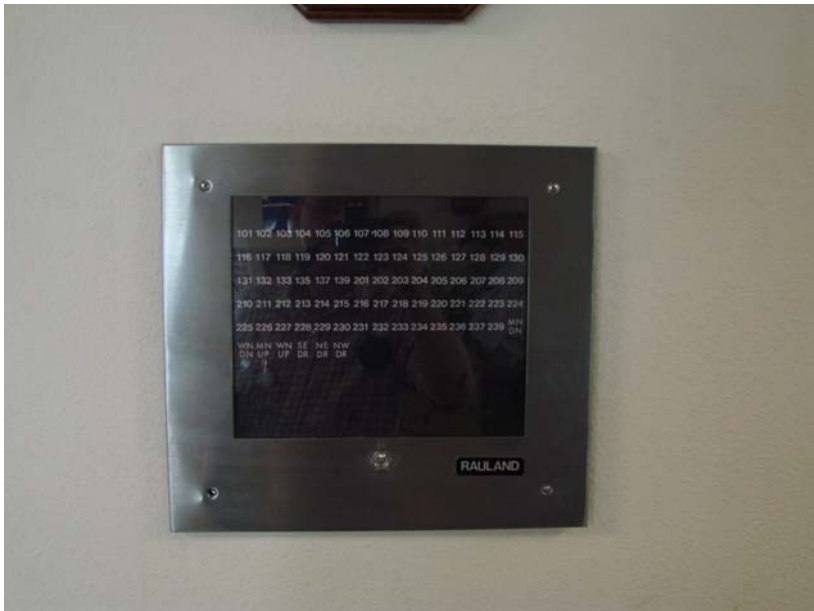
056 P_E: Rauland emergency-nurse call annunciator panel at front entry reception desk.

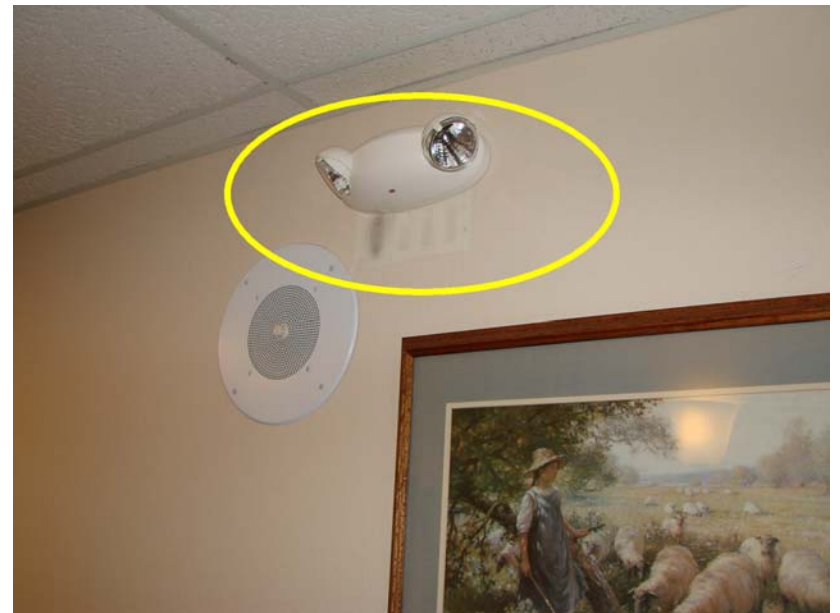
085 P_E: New emergency light. Note paint mark from original light outline.

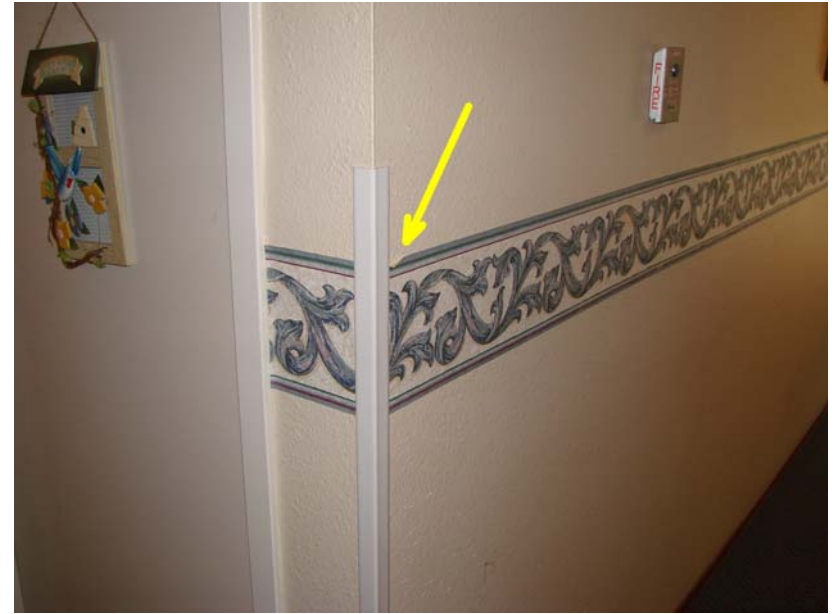
087 P_E: Detail - wallpaper border peeling at wall corner. (Note - staff has not yet begun 1st floor painting improvements.

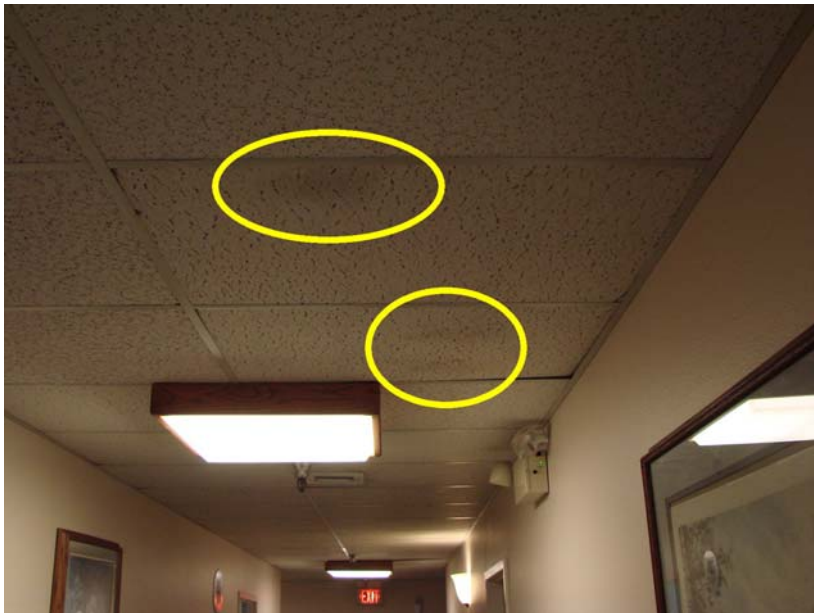
088 P_E: Darks spots on ceiling tile - consider repainting grid and replacing-painting ceiling tile.

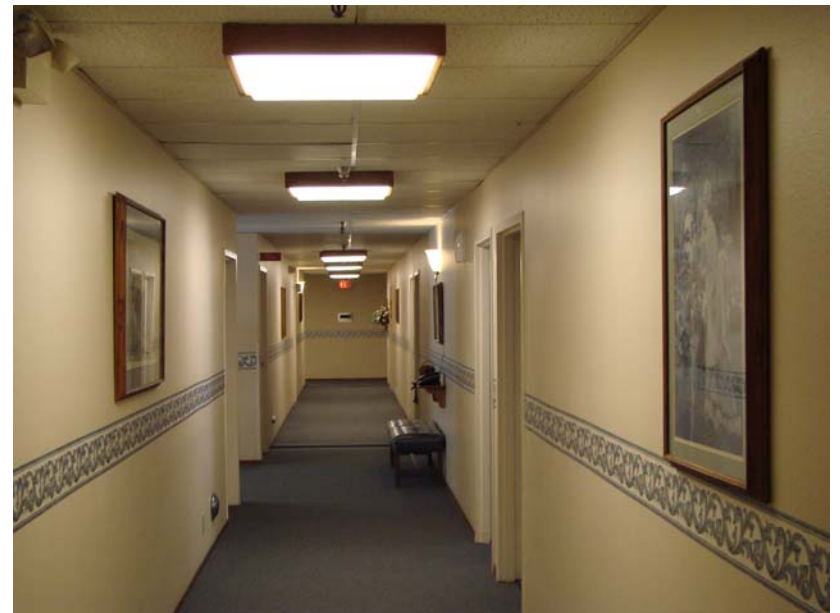
089 P_E: Typical 1st floor corridor - carpet, wood base, painted walls, wallpaper border at handrail height.

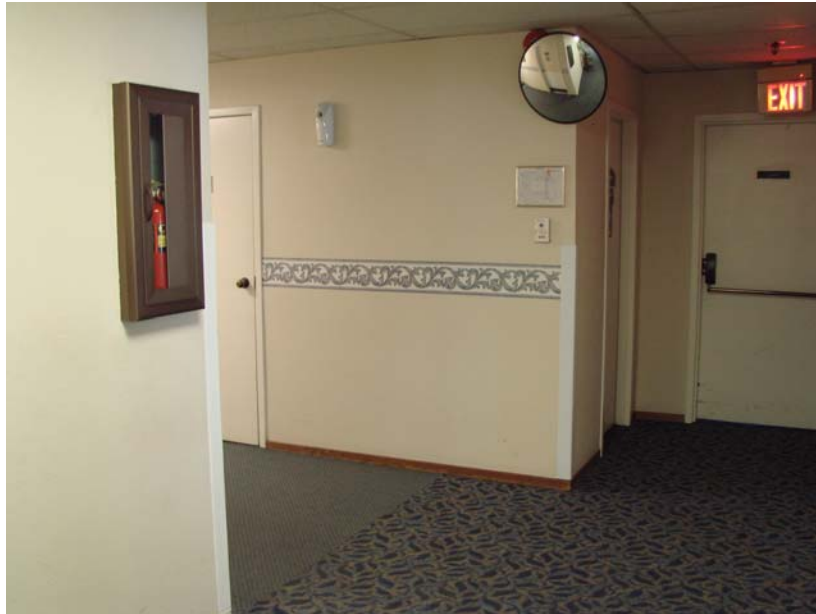
090 P_E: Transition from front (south) corridor to East Hall. Note carpet change.

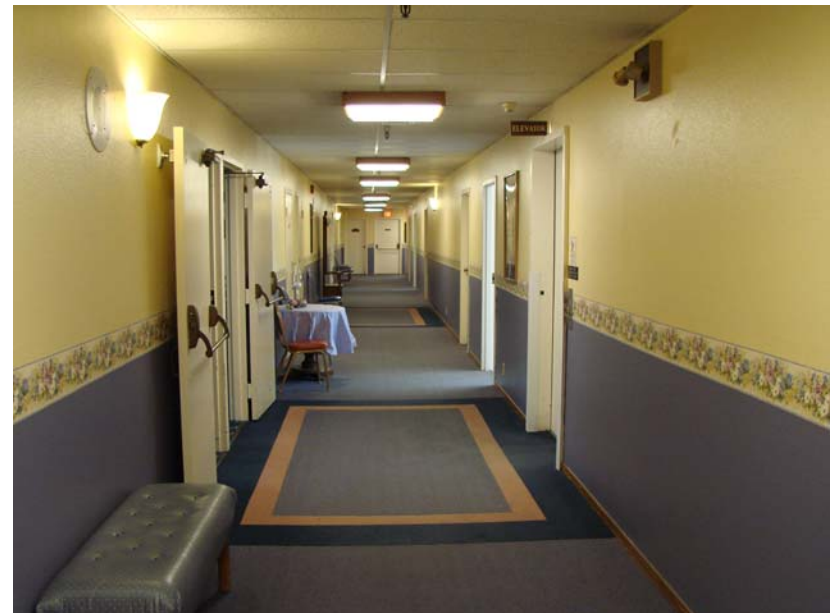
093 P_E: Palm East - typical 2nd floor corridor. Wood base, painted walls, no handrails, wallpaper border transition. Paint and border are currently being

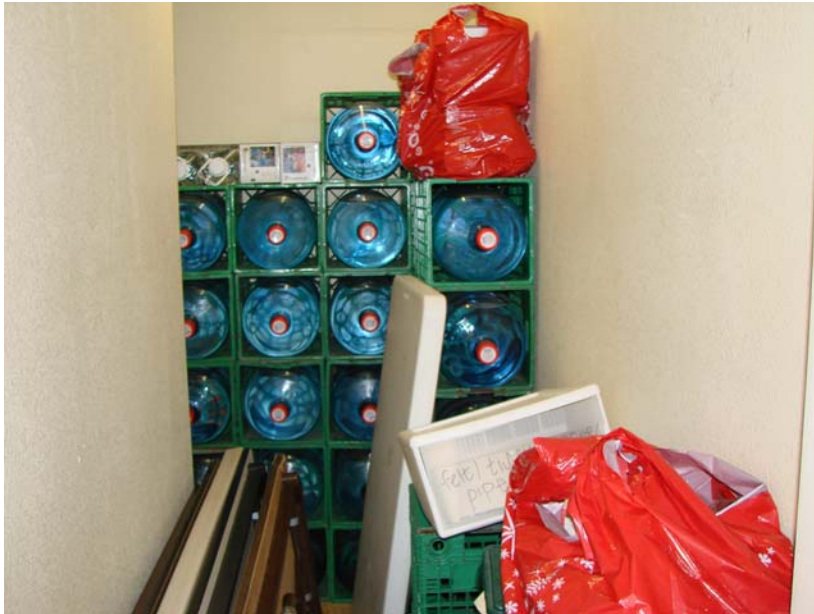
094 P_E: 2nd floor storage closet at #3 Stairs - emergency water supply. (note - maint. supv. did not know age of water canisters or rotation schedule.)

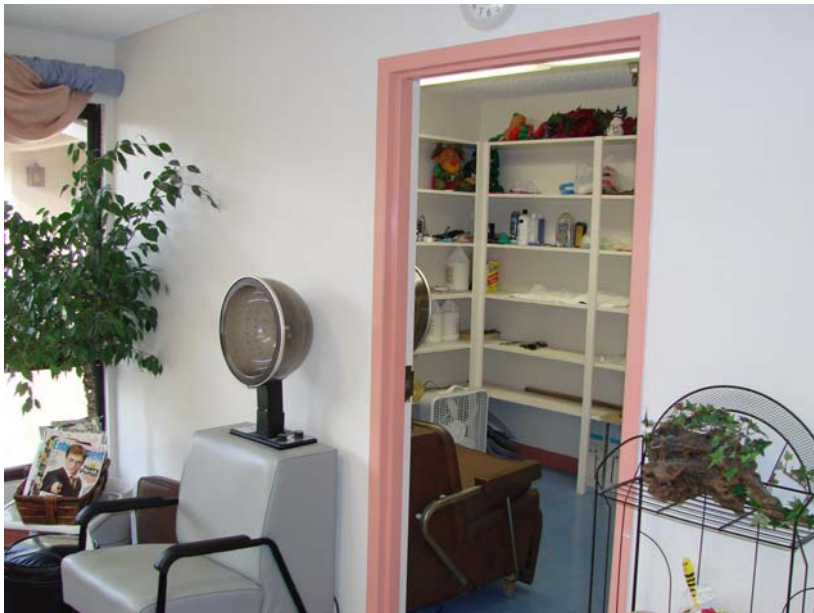
100 P_E: Beauty shop storage - consider removing wall to enlarge beauty shop.

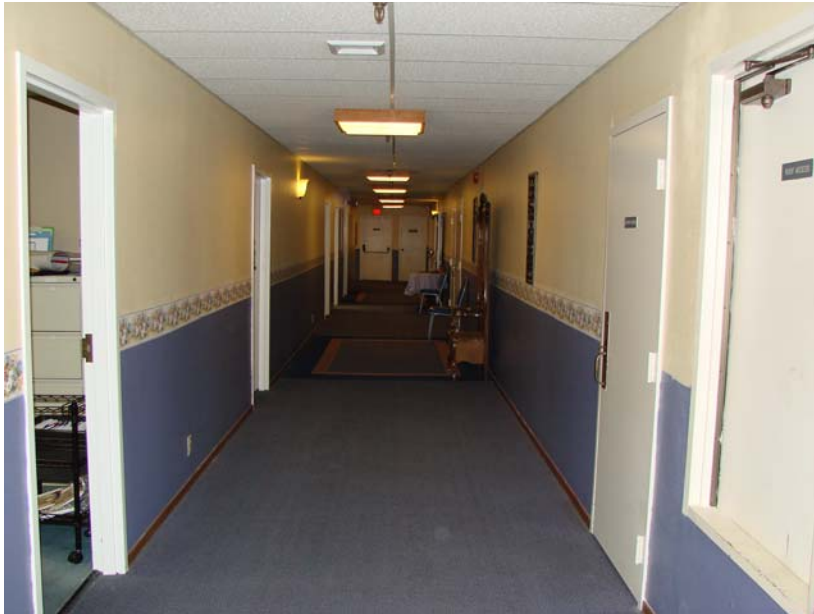
114 P_E: Palm East - typical 2nd floor corridor. Wood base, painted walls, no handrails, wallpaper border transition. Paint and border are currently being

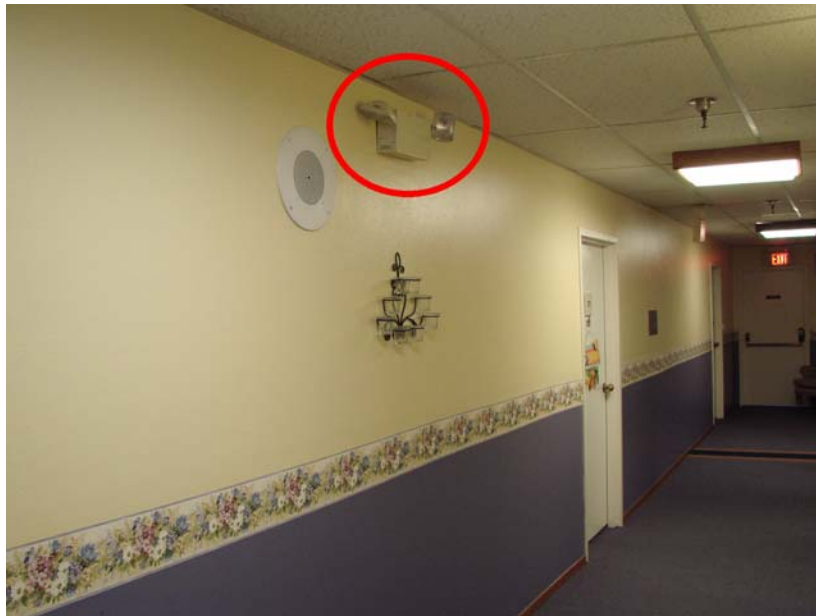
118 P_E: Public Address speaker, battery back-up emergency lighting (no emergency generator).

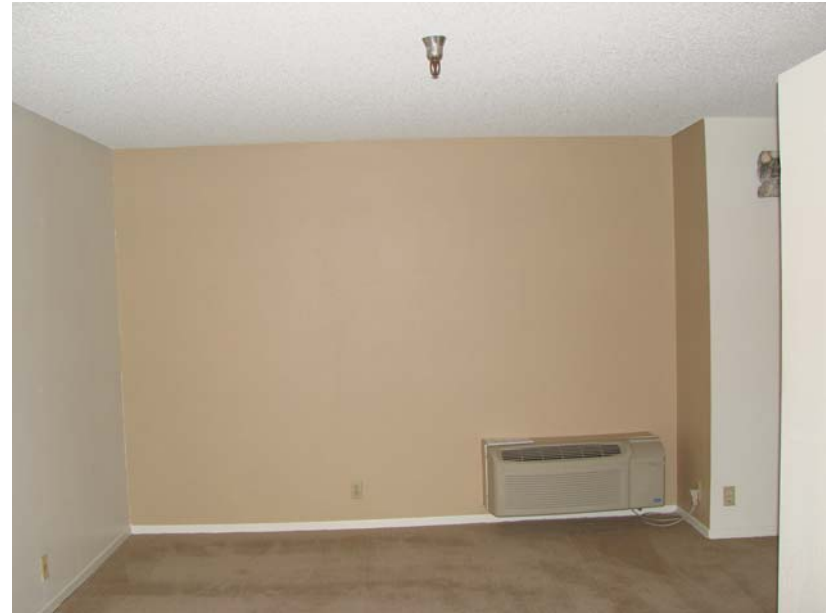
127 P_E: Typical resident unit. Remodel in process between residents. Note use of accent wall; new PTAC unit.

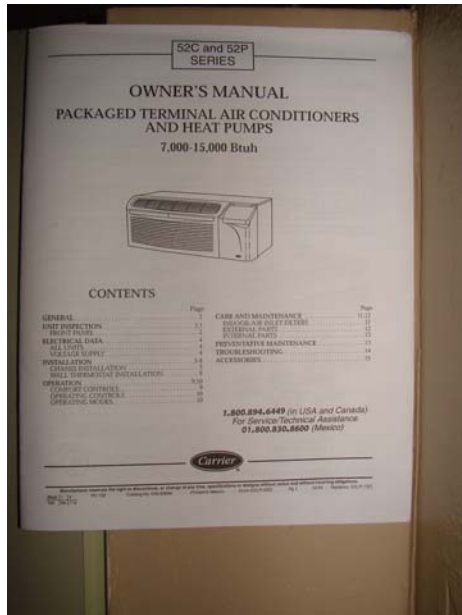
130 P_E: New PTAC operating manual in room 229 - facility is routinely replacing older PTAC units in resident rooms.

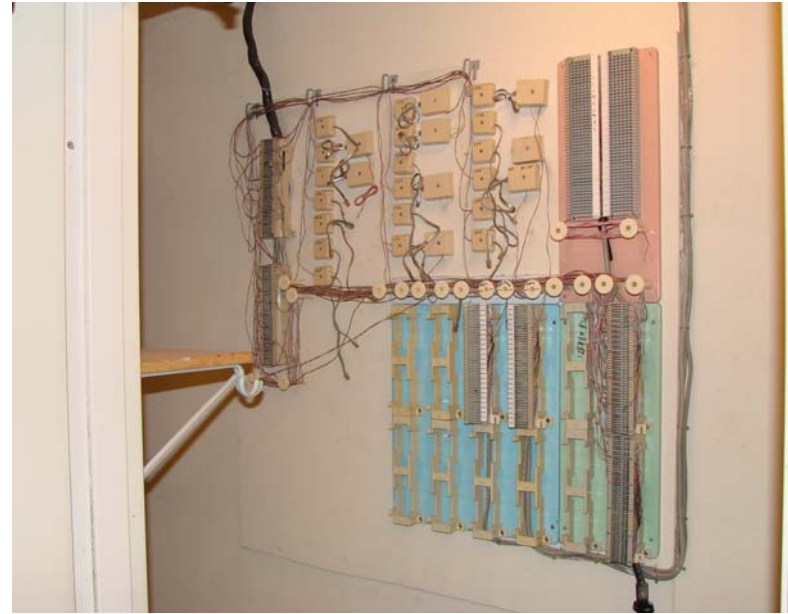
139 P_E: 2nd floor electric closet - telephone patch panel.

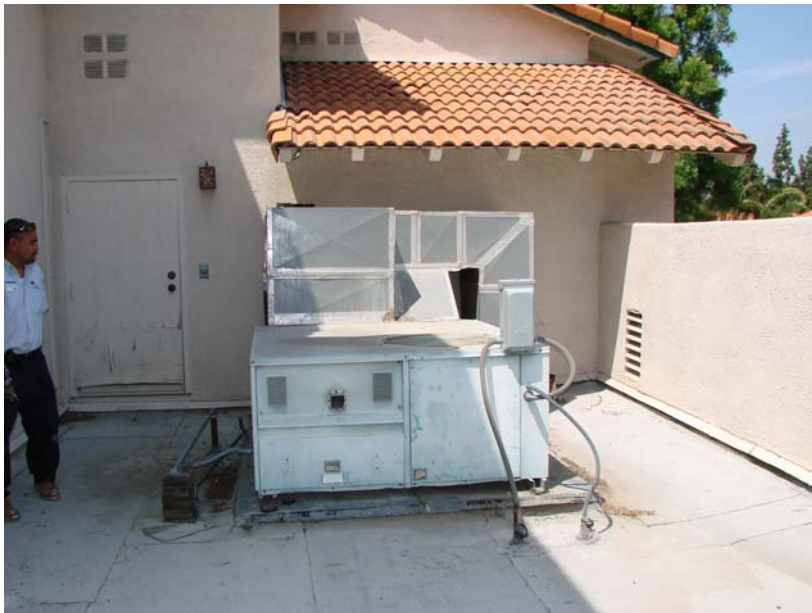
140 P_E: Palm East - Carrier Weathermaker rooftop HVAC unit - AC & gas heat.

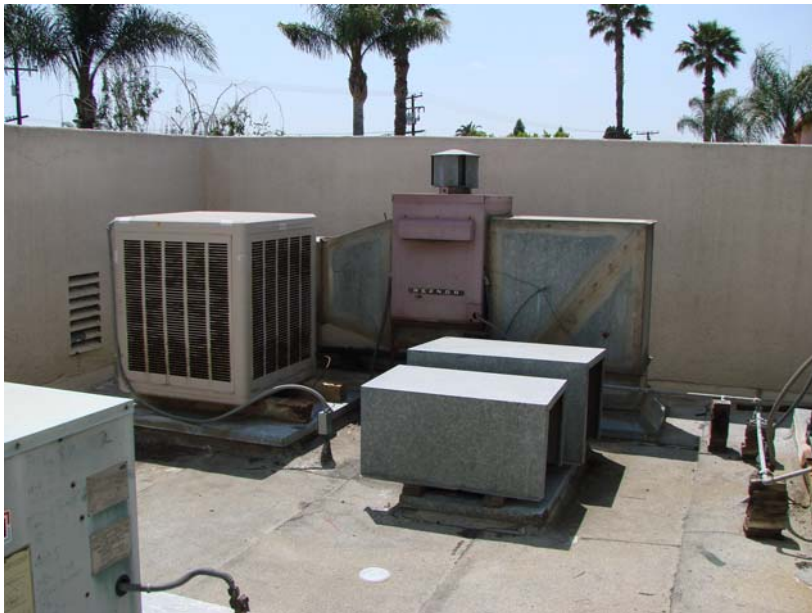
144 P_E: Roof top HVAC units - Kitchen swamp cooler.

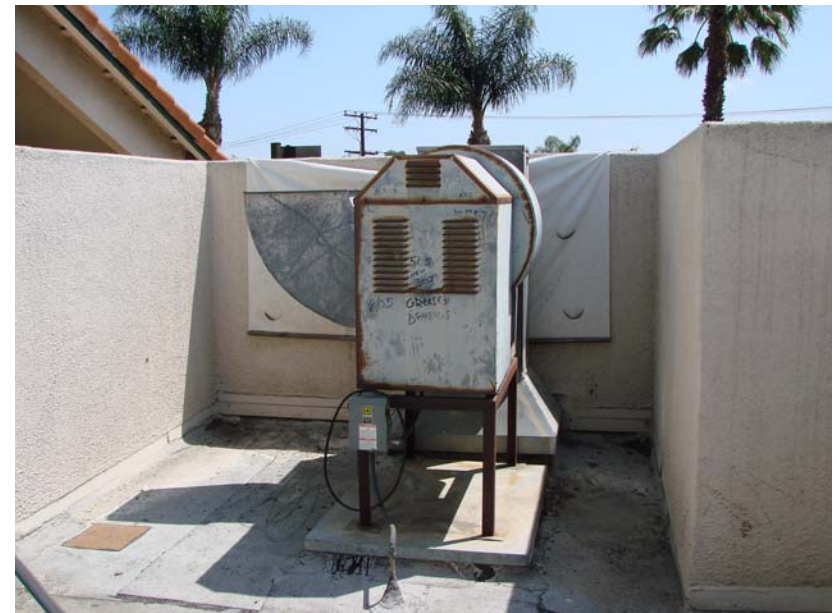
145 P_E: Kitchen air handler.

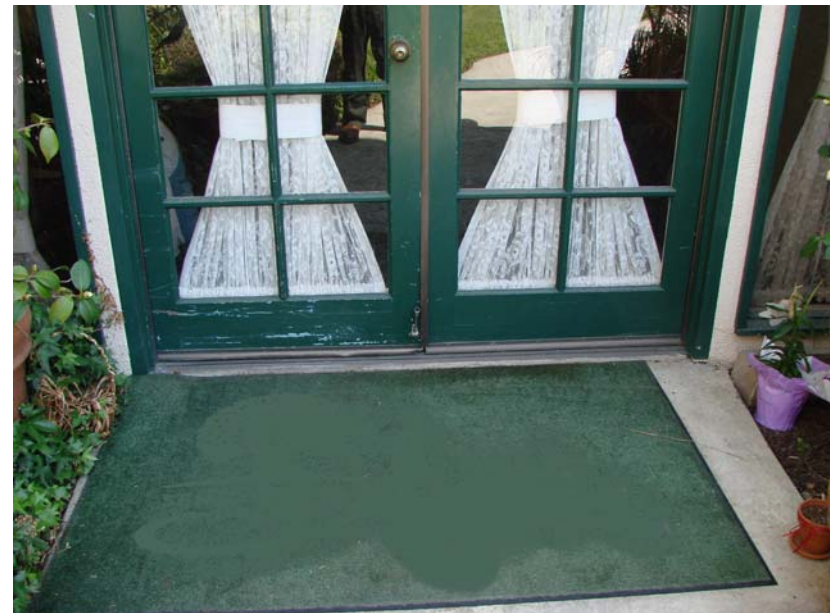
157 P_E: Detail - courtyard doors need repainting.

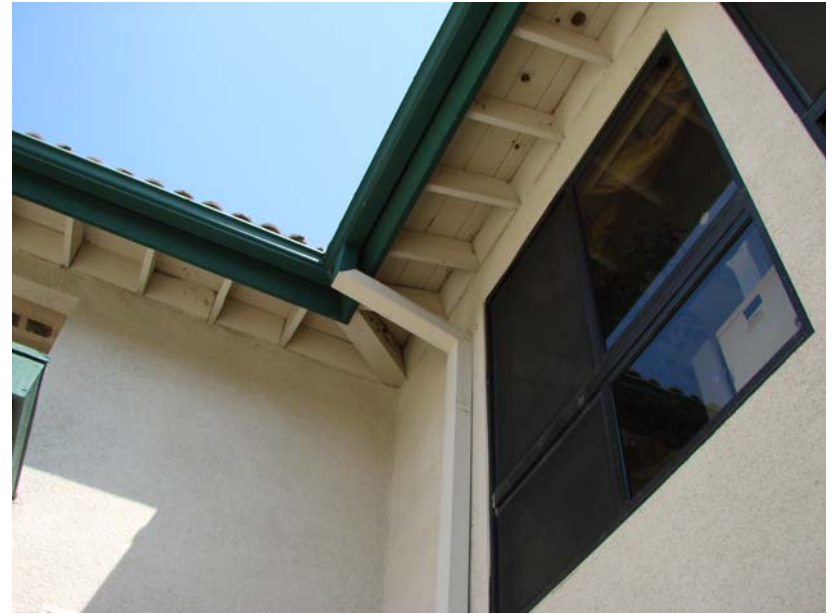
163 P_E: Detail - gutter, wasp nest under soffit.
