The Palms - PALM EAST
351 East Palm Drive, Anytown, USA 01995
PH 987-654-3210 * FAX 987-654-3211

The Palms - PALM EAST

Anytown, USA; May 2, 2007

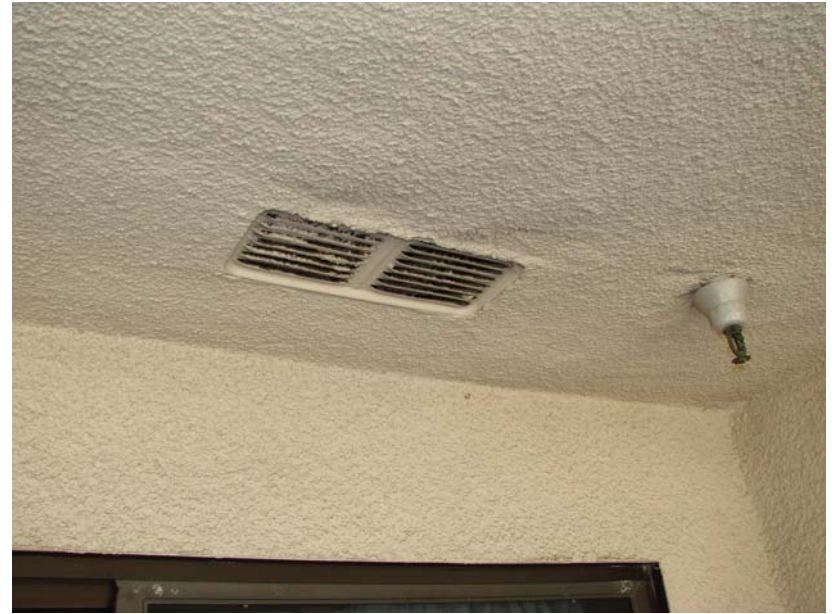
175 P_E: Soffit vent - needs to be cleaned.

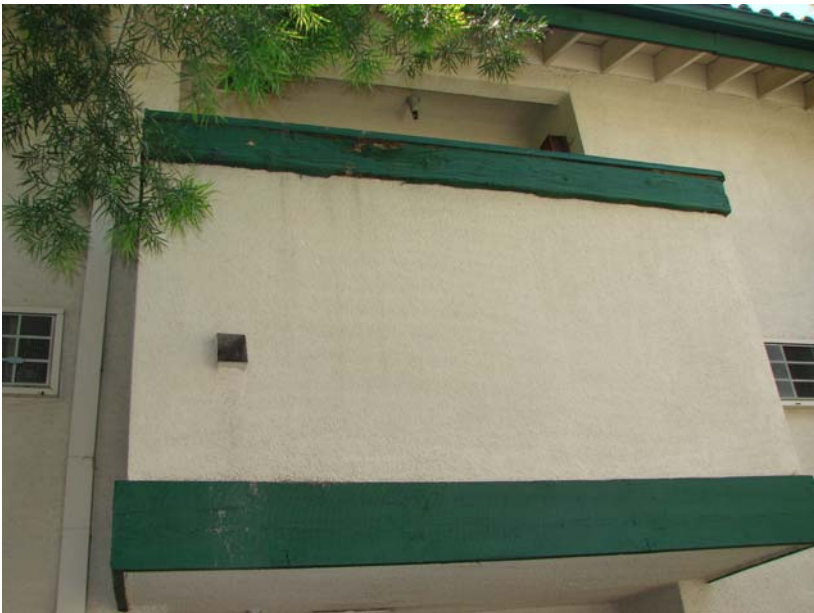
176 P_E: Detail - rotten wood trim on 2nd floor balconies.

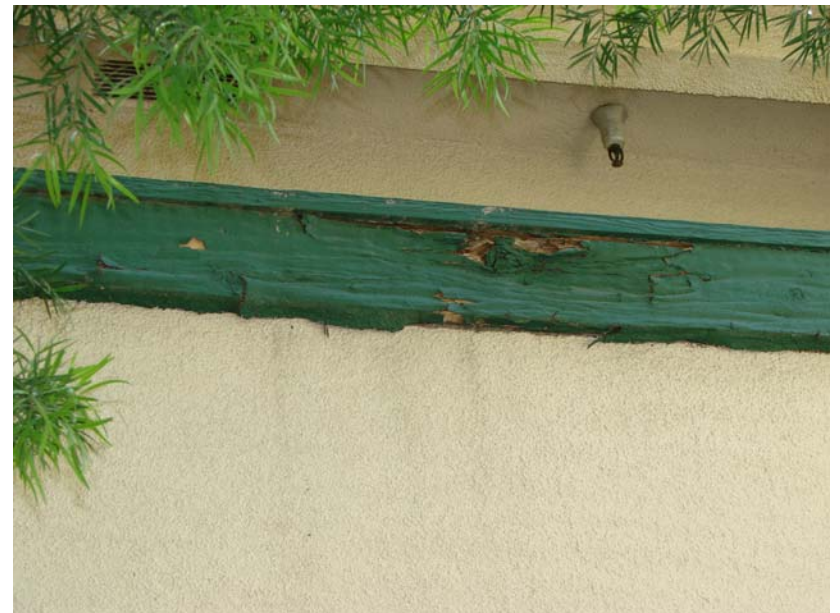
177 P_E: Detail - rotten wood trim on 2nd floor balconies.

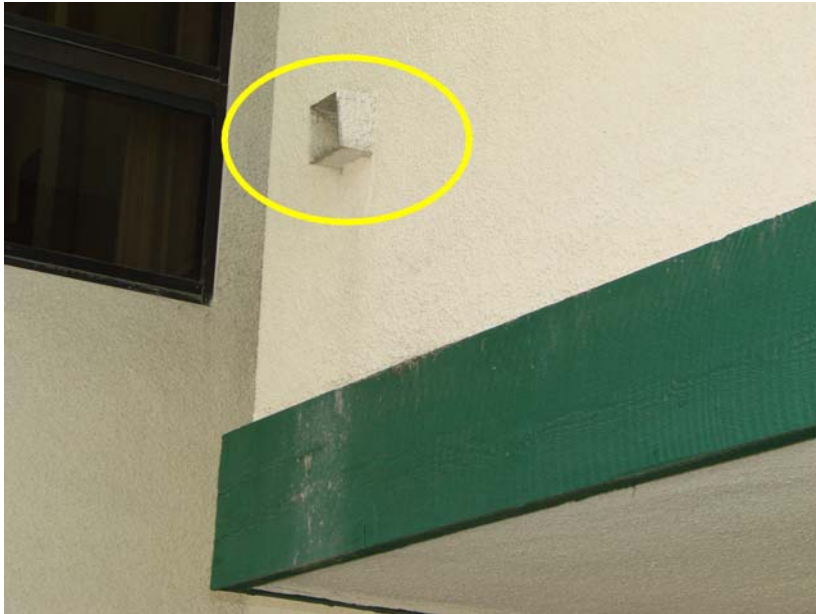
178 P_E: Detail - balcony drain. Consider adding drain scuppers to extend runoff beyond balcony wall.

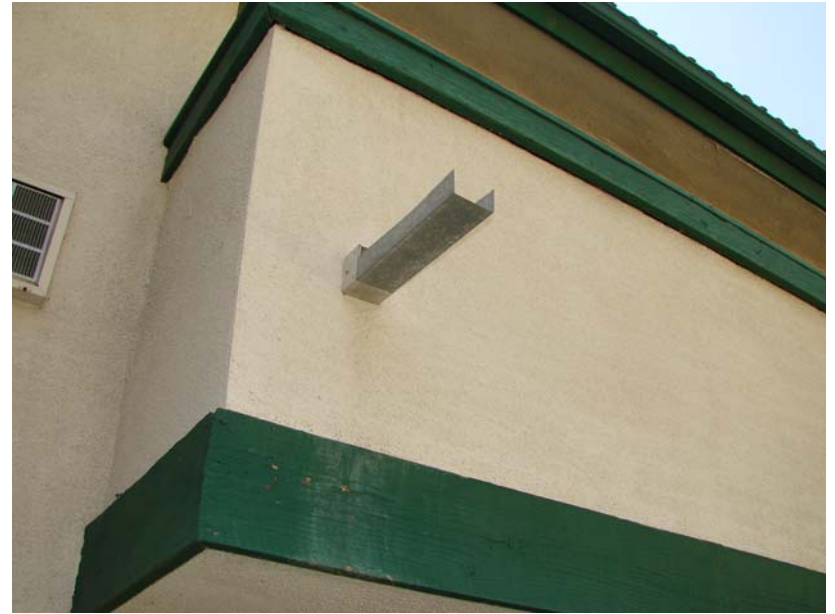
179 P_E: Balcony drain scupper with extension.

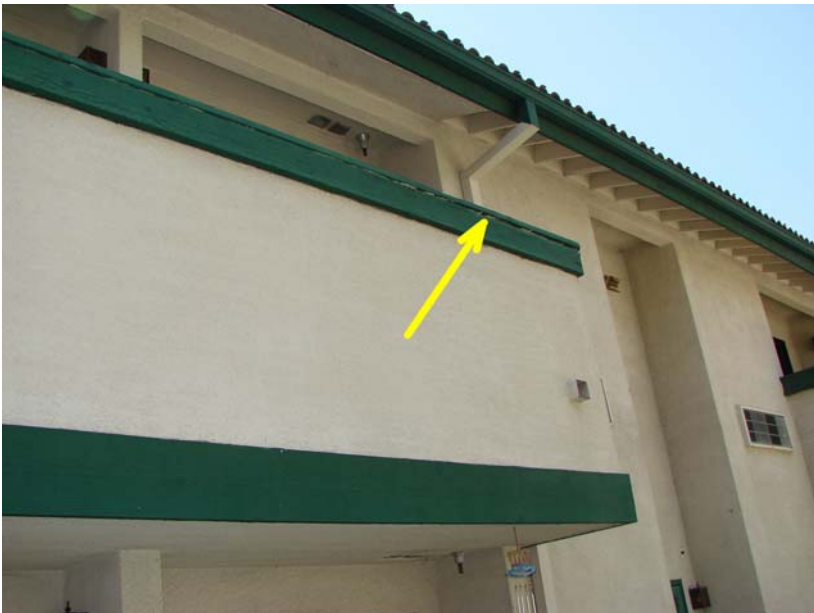
180 P_E: Detail - rotten wood trim on 2nd floor balconies.

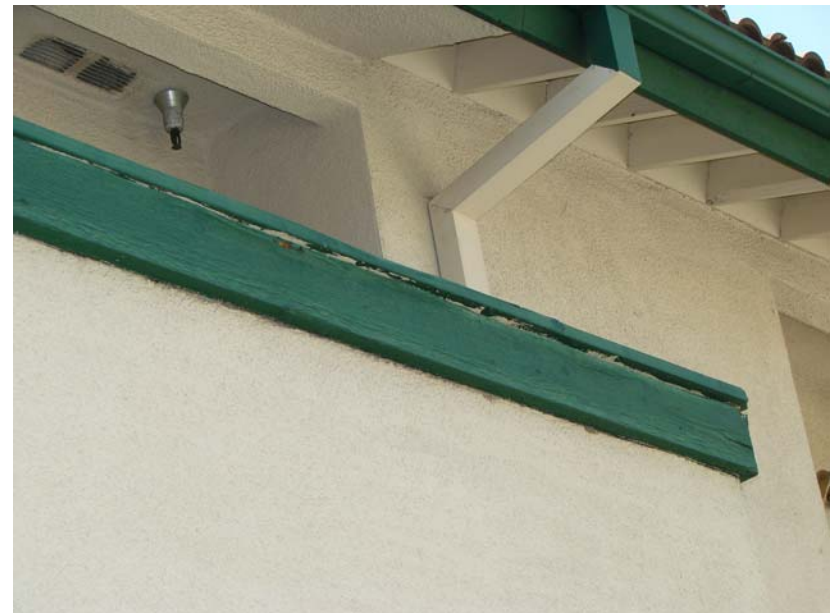
181 P_E: Detail - rotten wood trim on 2nd floor balconies.

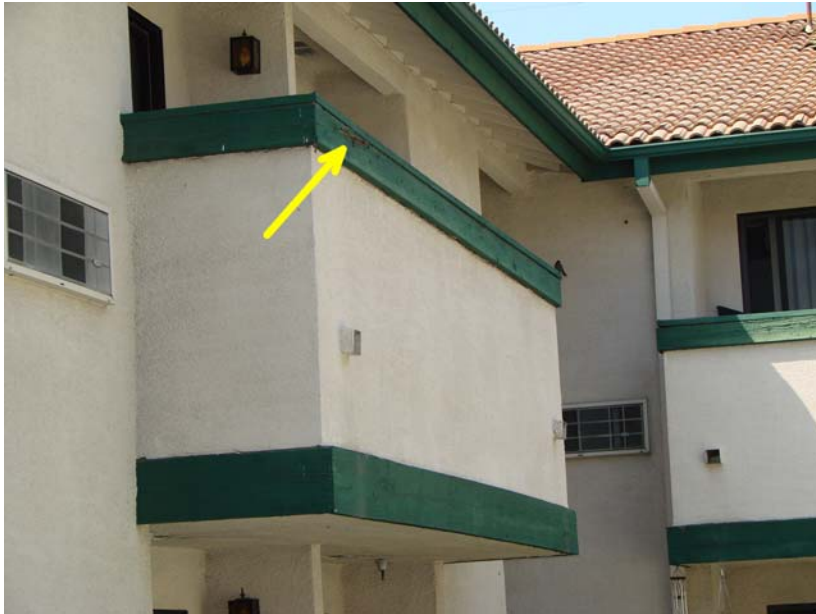
182 P_E: Detail - rotten wood trim on 2nd floor balconies.

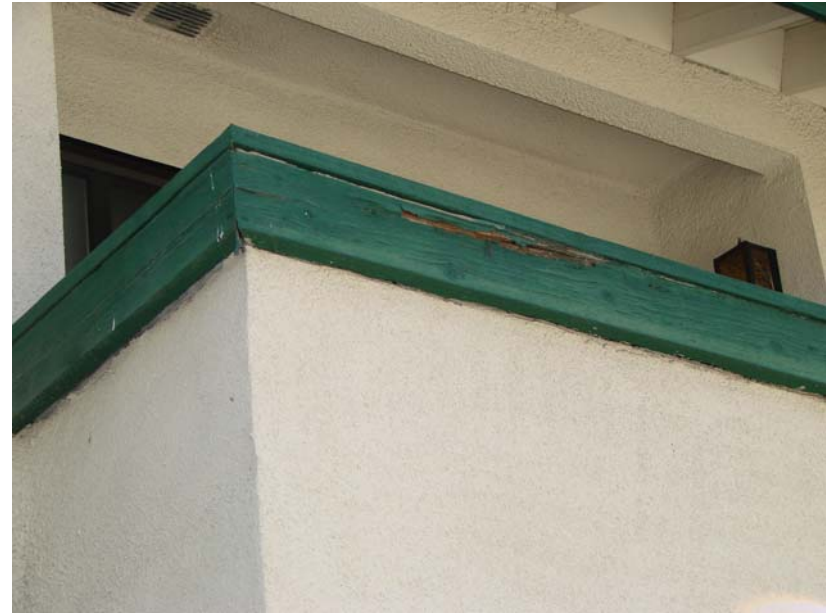
183 P_E: Detail - rotten wood trim on 2nd floor balconies.

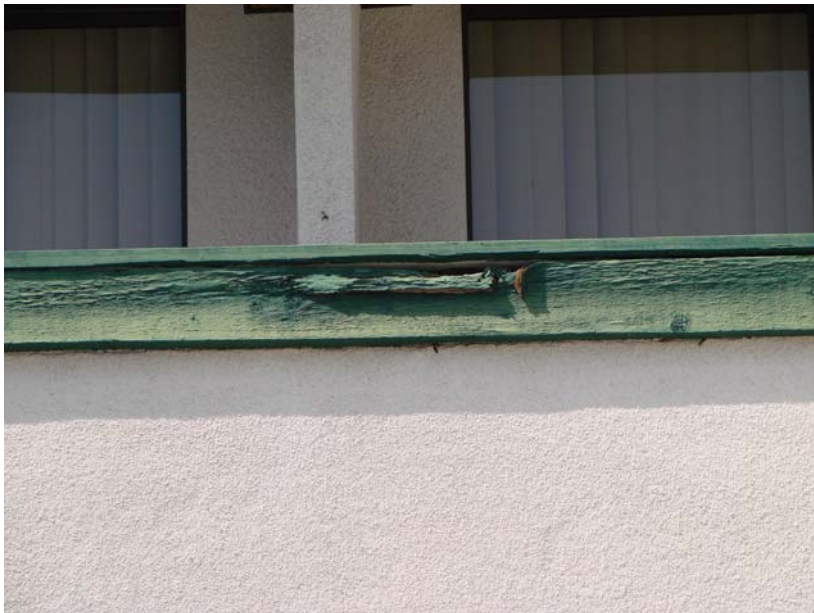
184 P_E: Detail - rotten wood trim on 2nd floor balconies.

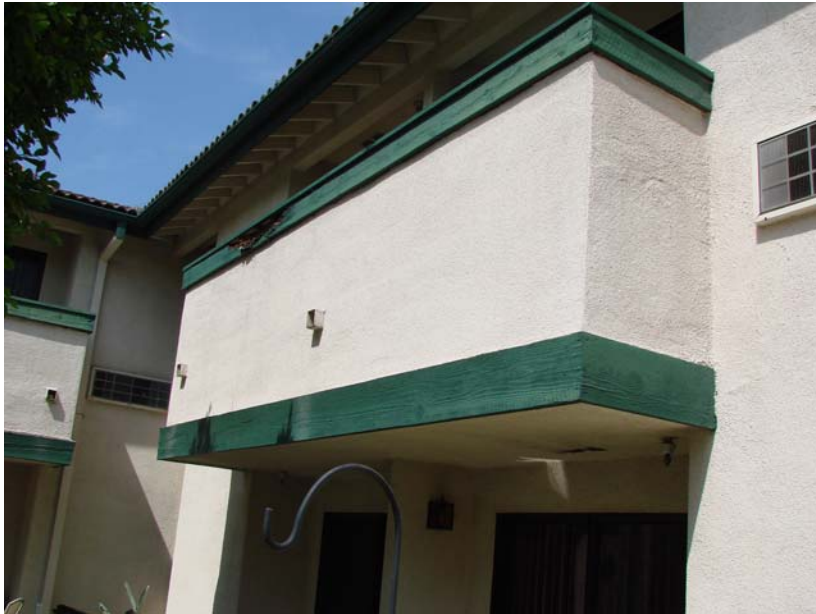
186 P_E: Detail - rotten wood trim on 2nd floor balconies.

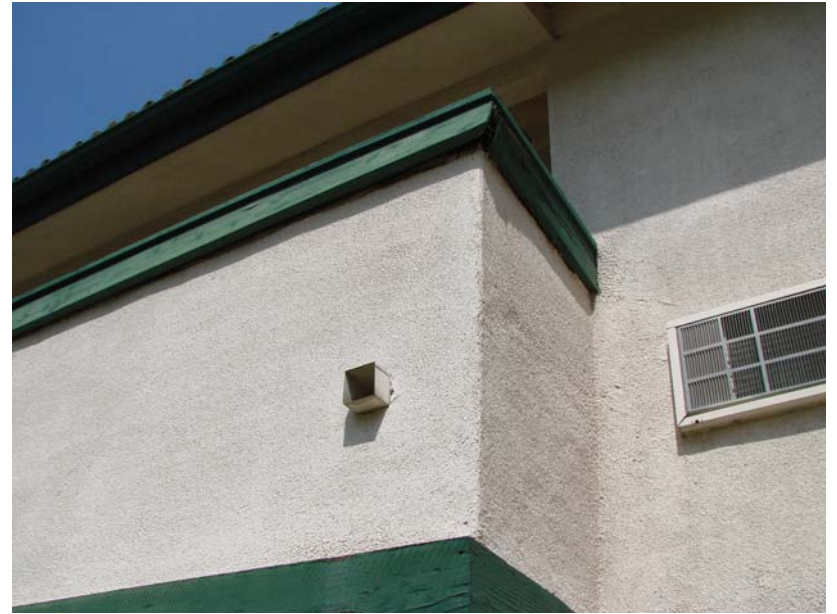
187 P_E: Detail - rotten wood trim on 2nd floor balconies.

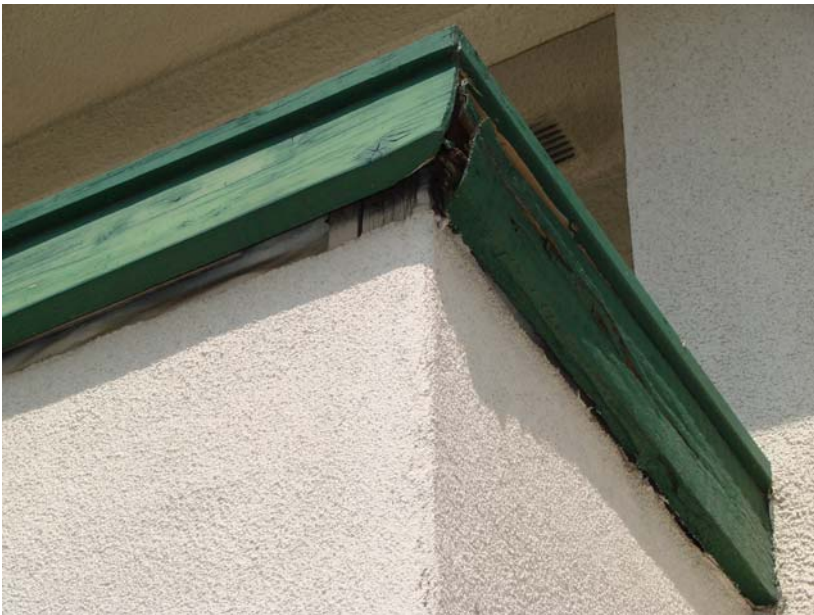
188 P_E: Detail - rotten wood trim on 2nd floor balconies.

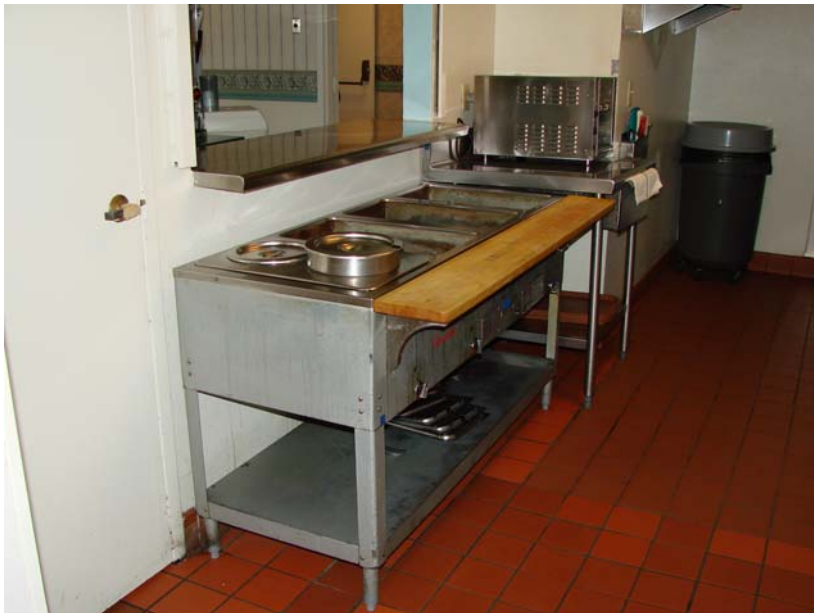
016 P_W: Aerohot steam table - consider replacing.

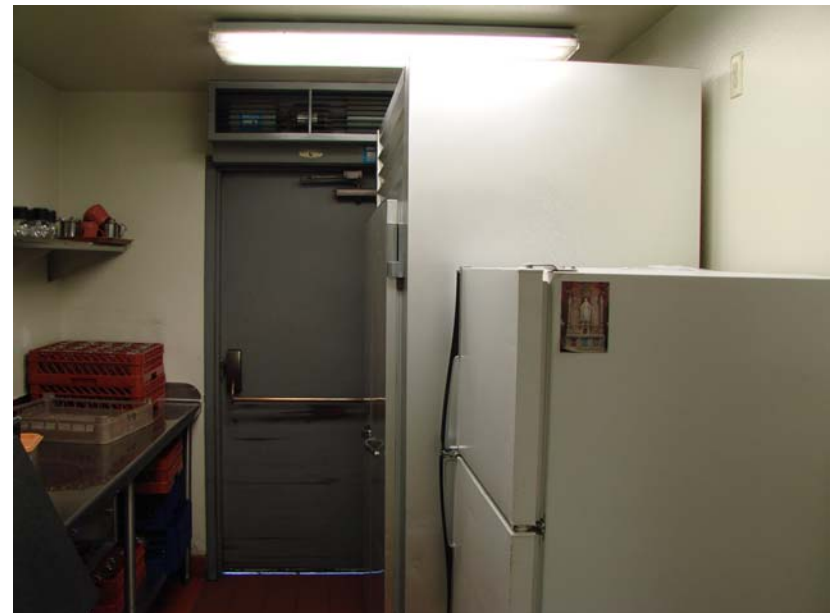
021 P_W: Kitchen - residential refrigerator, Traulsen 2-door freezer. (Note - freezer compressor was replaced 5-2-07).

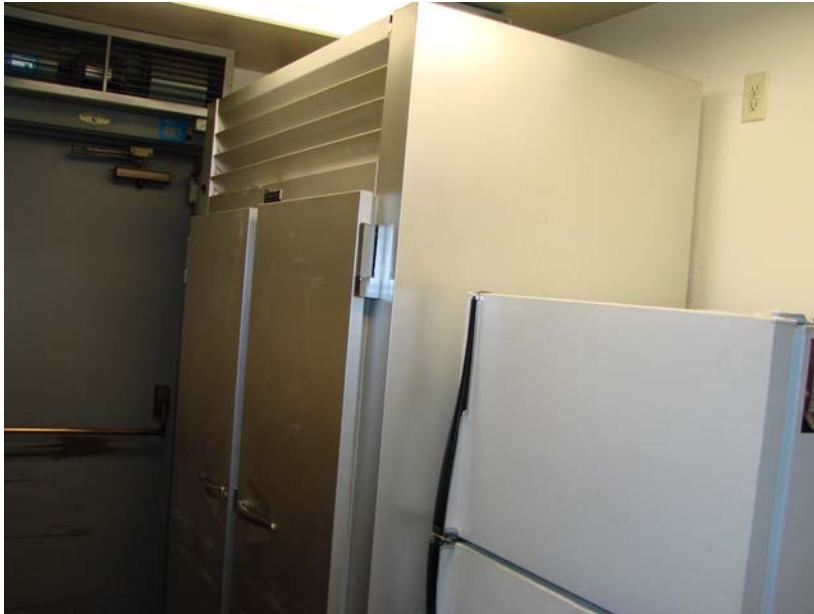
022 P_W: Kitchen - residential refrigerator, Traulsen 2-door freezer. (Note - freezer compressor was replaced 5-2-07).

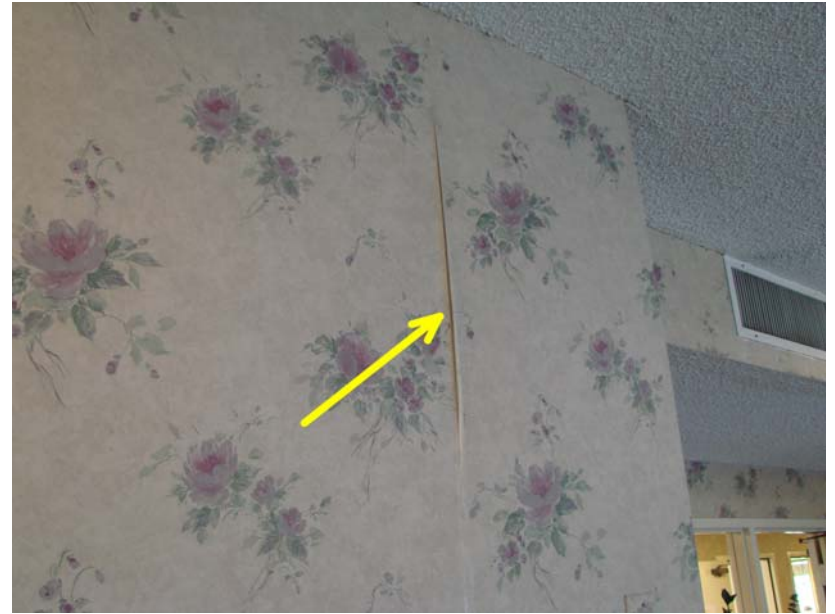
031 P_W: Living room - peeling wallpaper.

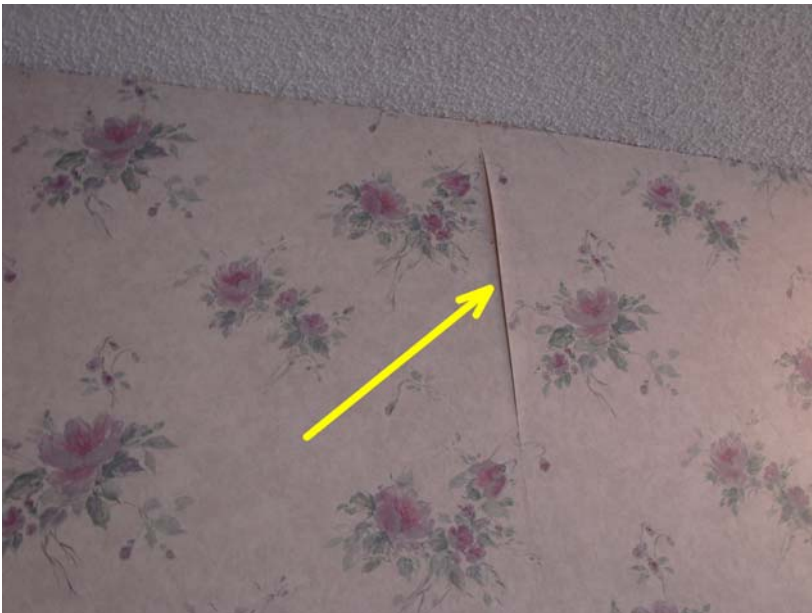
032 P_W: Living room - peeling wallpaper.

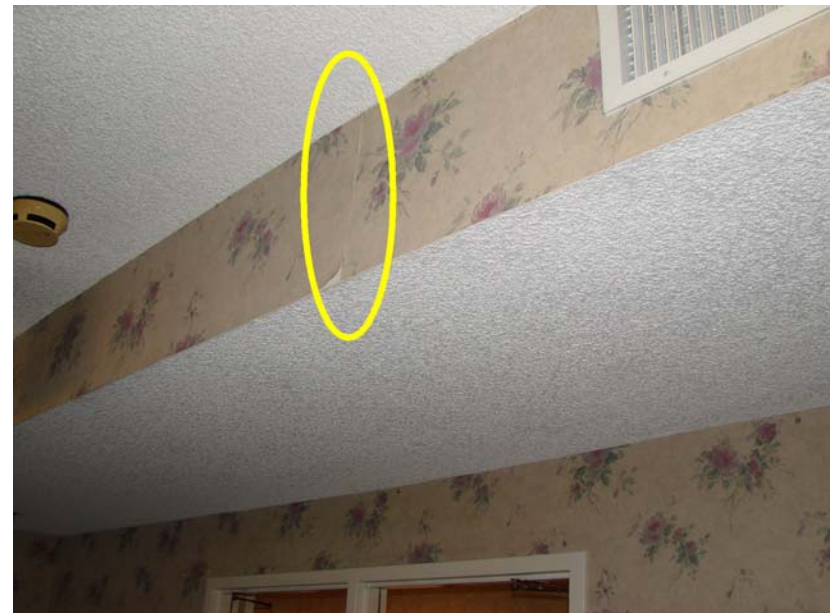
033 P_W: Living room - peeling wallpaper.

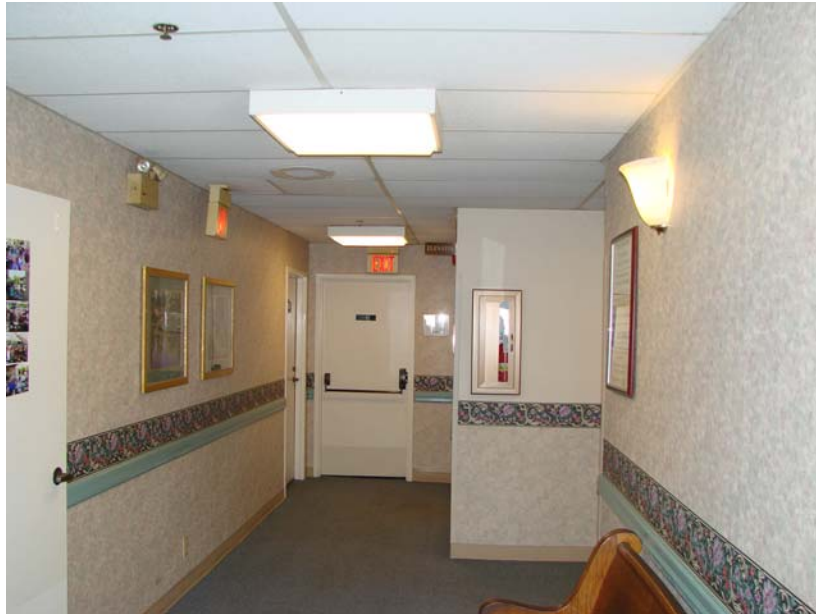
034 P_W: West end of South Hall; elevator. Note batter backup emergency light. Also note carpet, rubber wall base, wall paper, chair rail at handrail height,

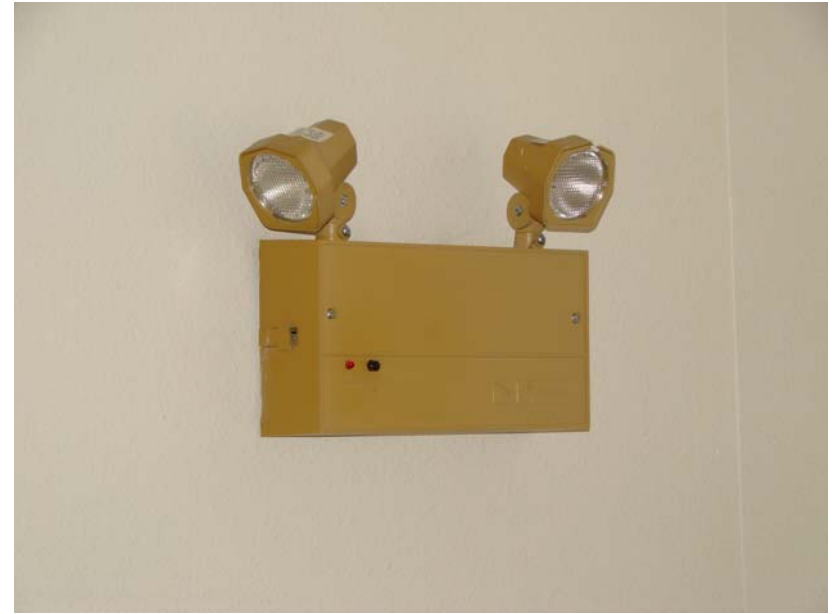
035 P_W: Original fixture - battery backup emergency lighting, some are being replaced.

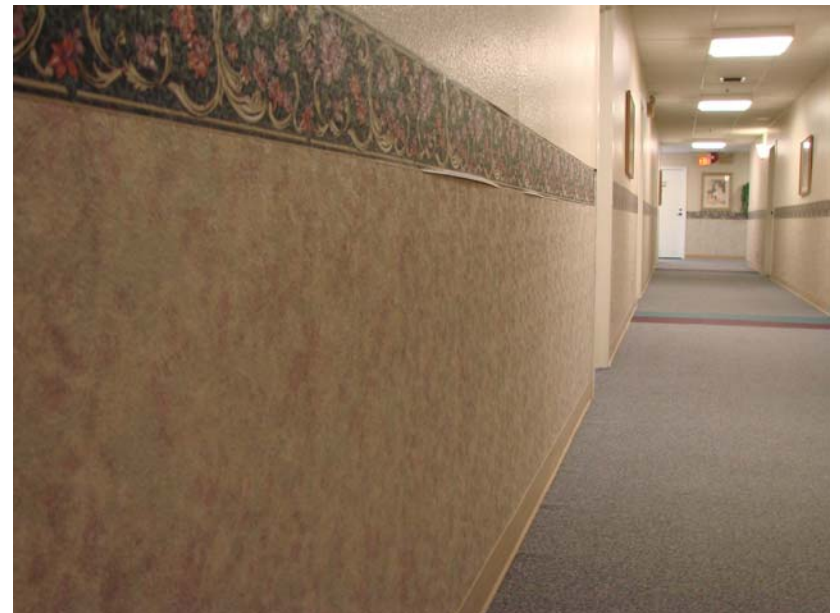
037 P_W: Detail - West Hall - wall covering below border, paint above.

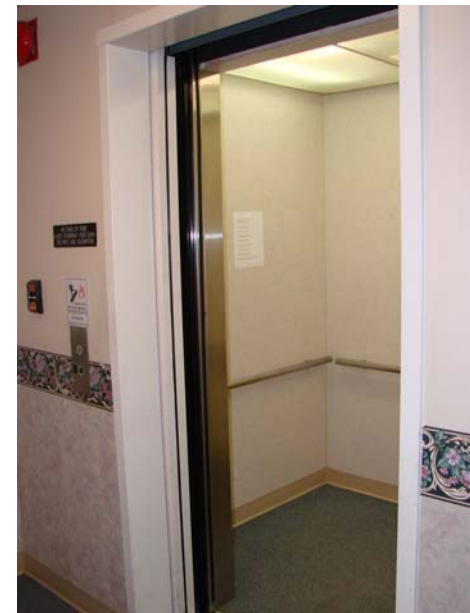
041 P_W: Elevator interior detail.

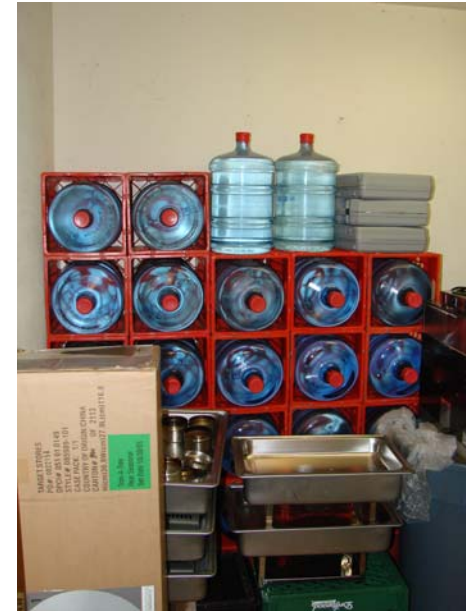
043 P_W: 2nd floor storage closet - emergency water supply. (note - maint. supv. did not know age of water canisters or rotation schedule.)

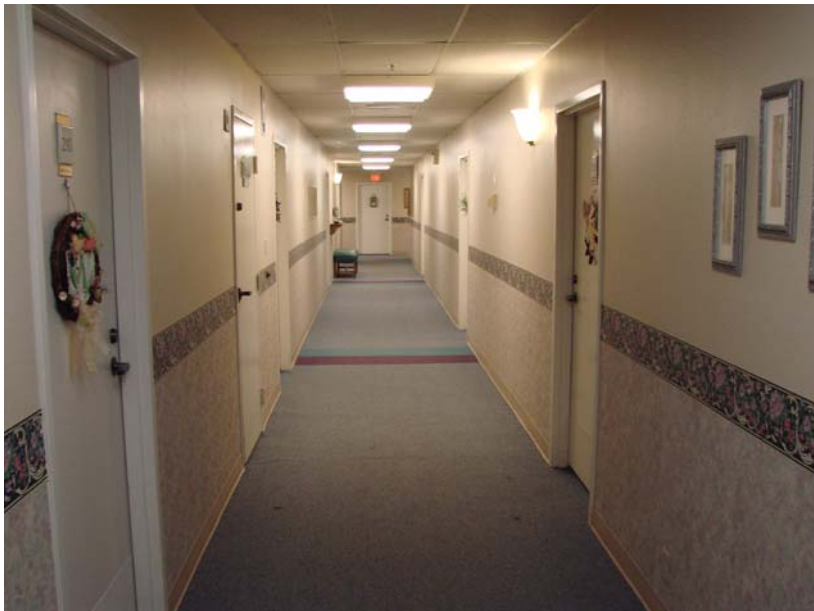
044 P_W: Typical 2nd floor corridor - note carpet, rubber base, wallpaper below border, paint above.

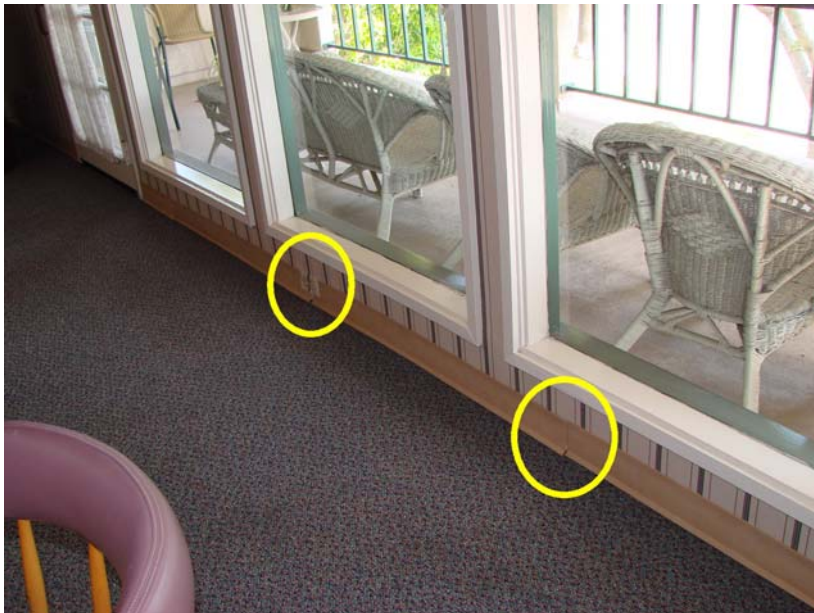
048 P_W: Detail - poor floor base installation.

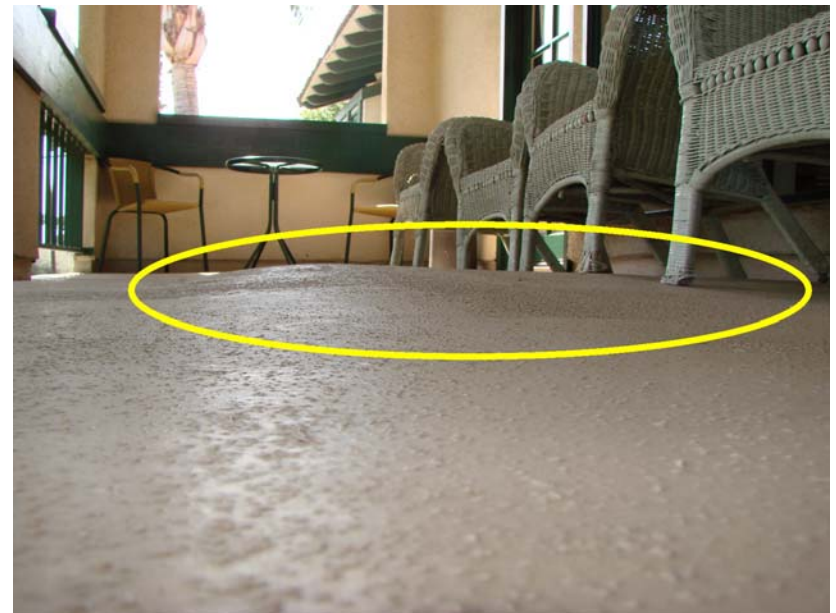
053 P_W: Detail - unusual floor topography on 2nd floor patio.

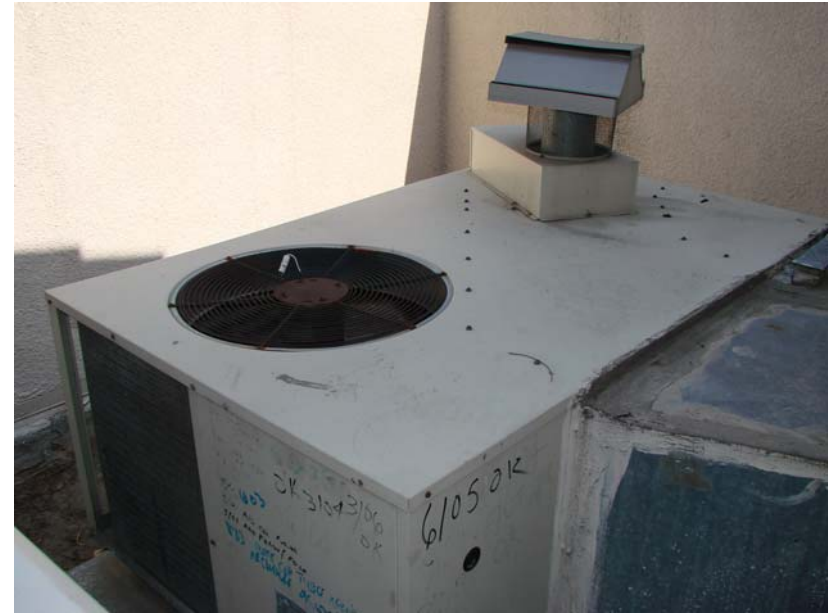
055 P_W: Payne HVAC unit (AC & gas heat) in roof well.

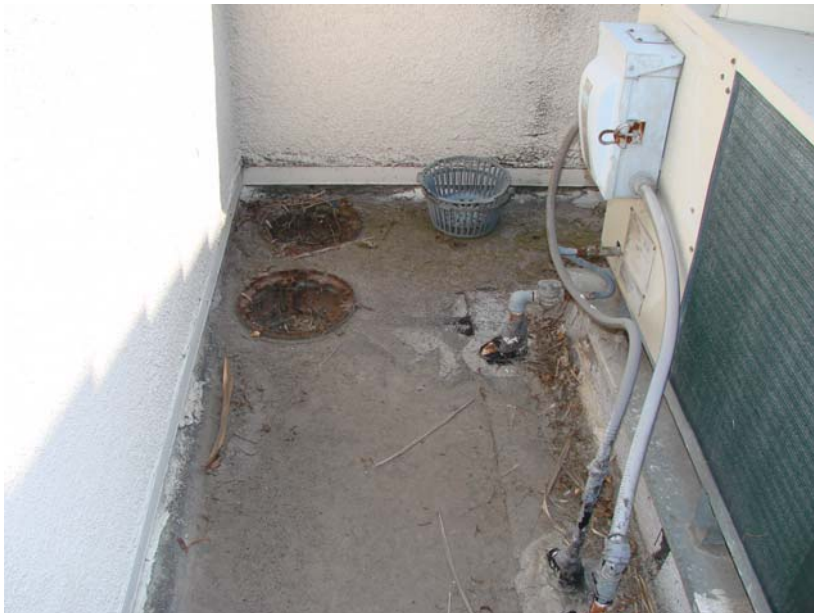
056 P_W: Roof drain in roof well - note drain covers out of place.

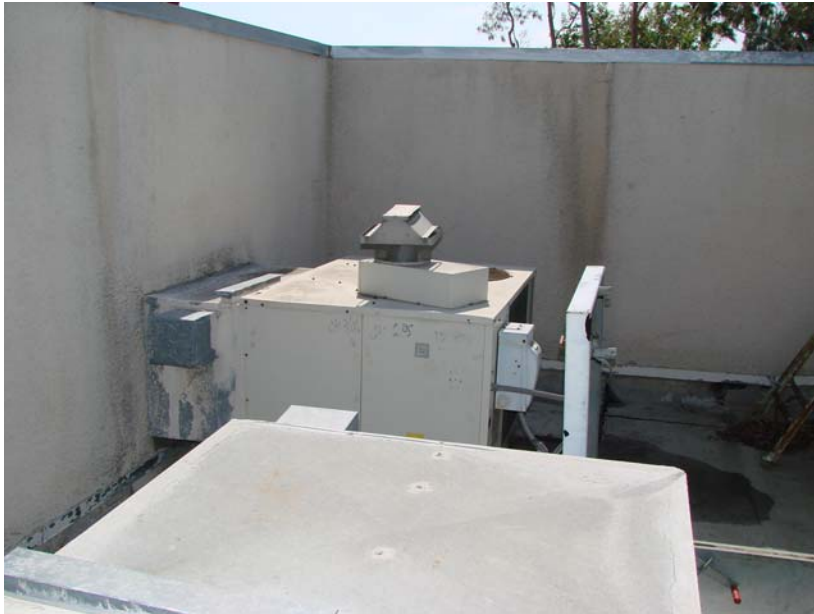
058 P_W: Day & Night HVAC unit in roof well - AC & gas heat.

059 P_W: Day & Night HVAC unit in roof well - AC & gas heat.

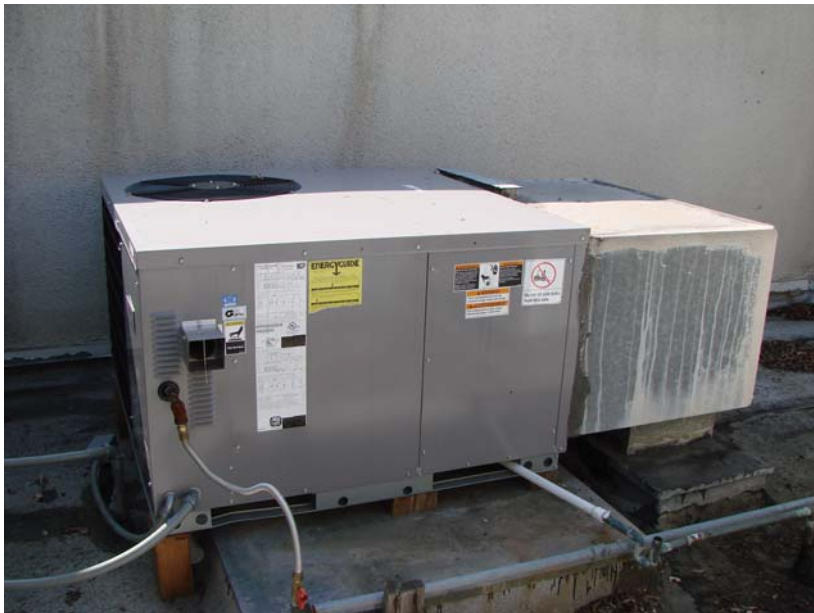
060 P_W: Heil HVAC unit in roof well - AC & gas heat.

061 P_W: Heil HVAC unit in roof well - AC & gas heat.

062 P_W: Heil HVAC unit in roof well - AC & gas heat.

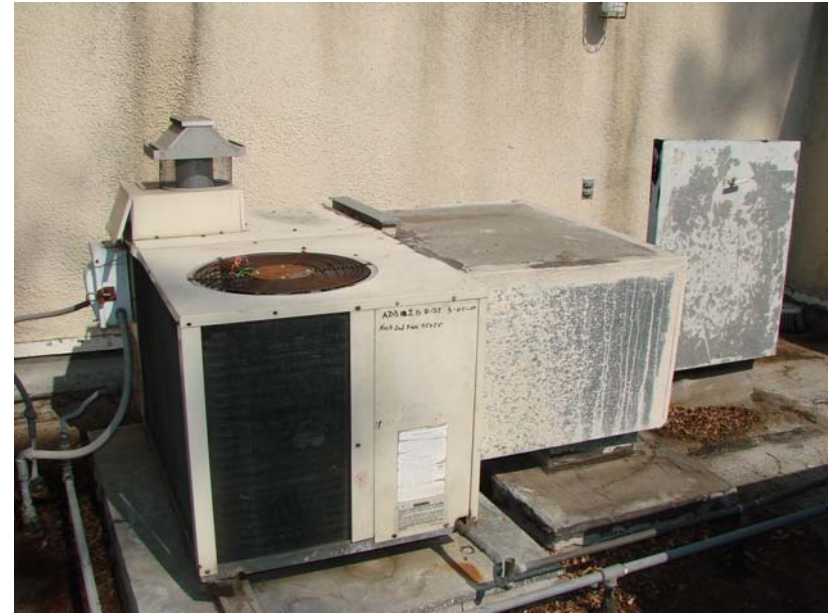
063 P_W: Day & Night HVAC unit in roof well - AC & gas heat.

064 P_W: Day & Night HVAC unit in roof well - AC & gas heat.

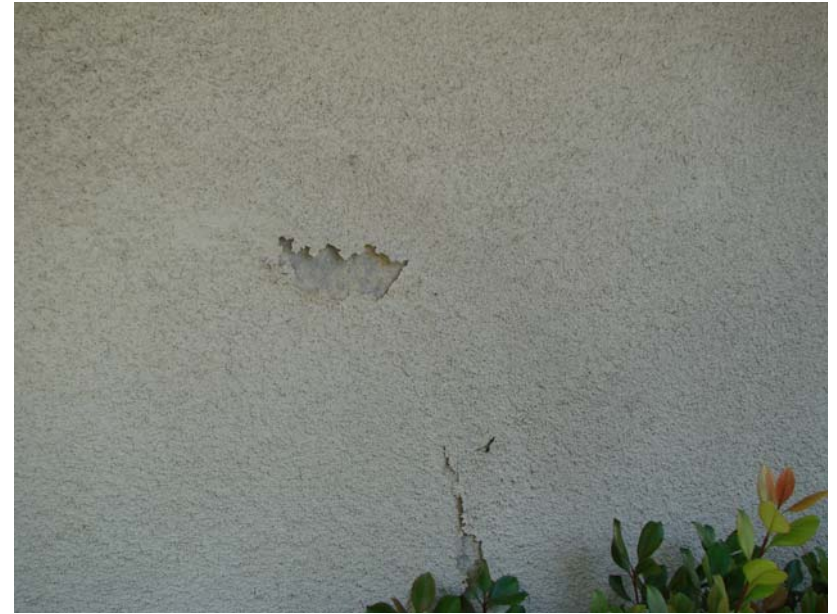
067 P_W: Exterior finish coming off building.

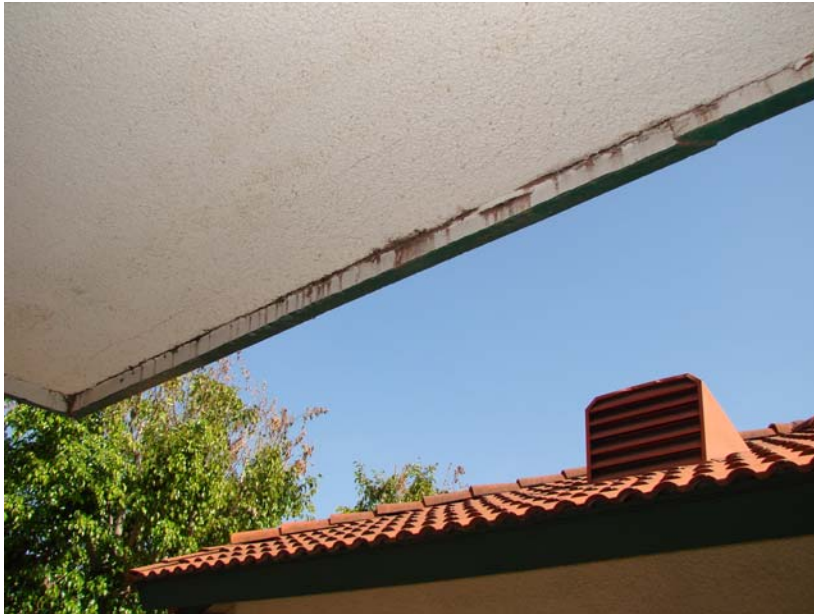
070 P_W: Rotten wood trim on 2nd floor balcony - water penetration behind wood.

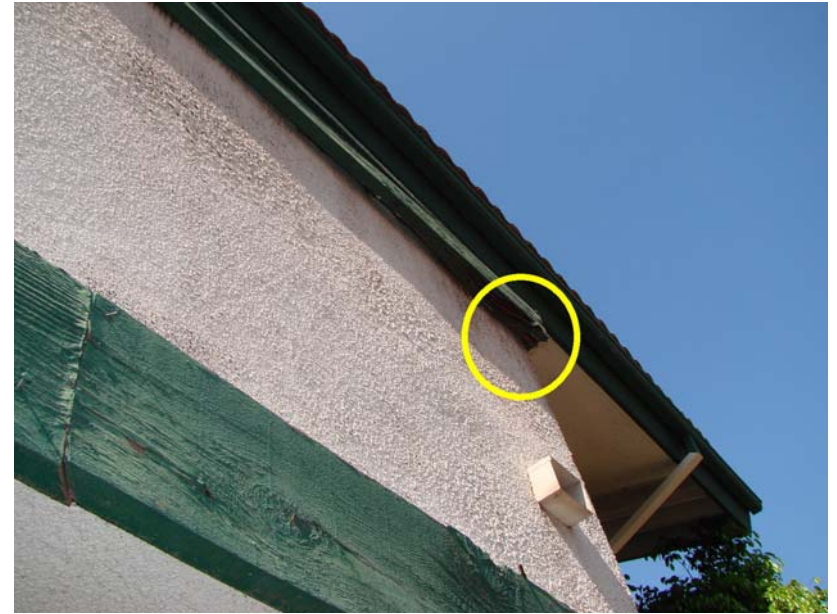
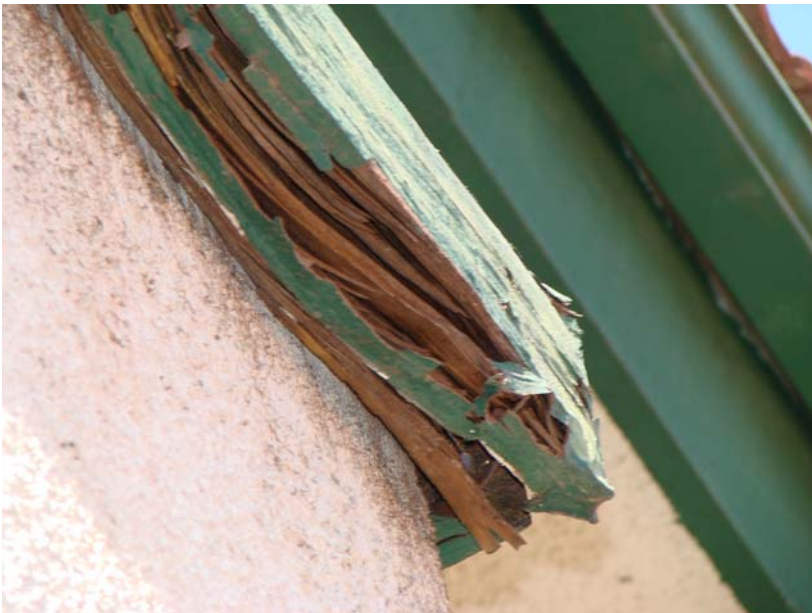
071 P_W: Detail - rotten wood trim on 2nd floor balconies.

072 P_W: Detail - rotten wood trim on 2nd floor balconies.

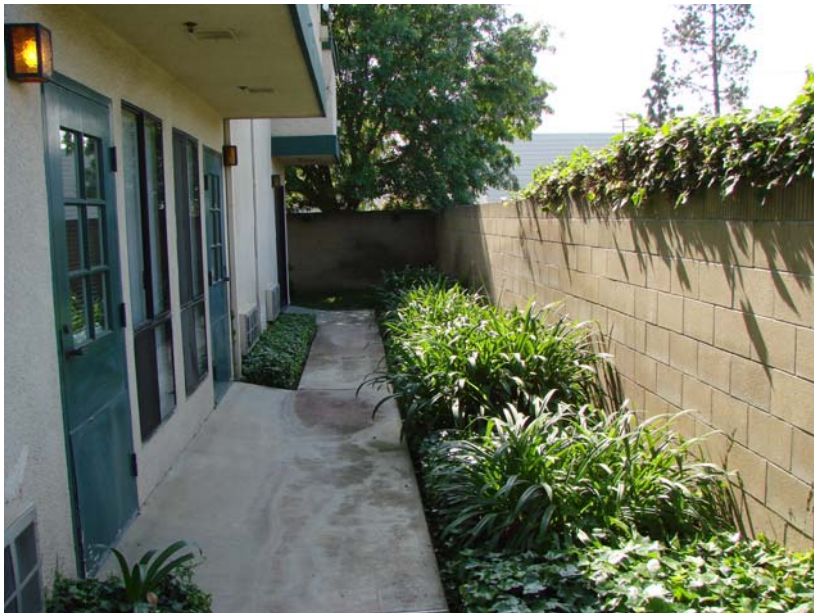
076 P_W: Sidewalk detail - slopes away from building, appears to pond some water.

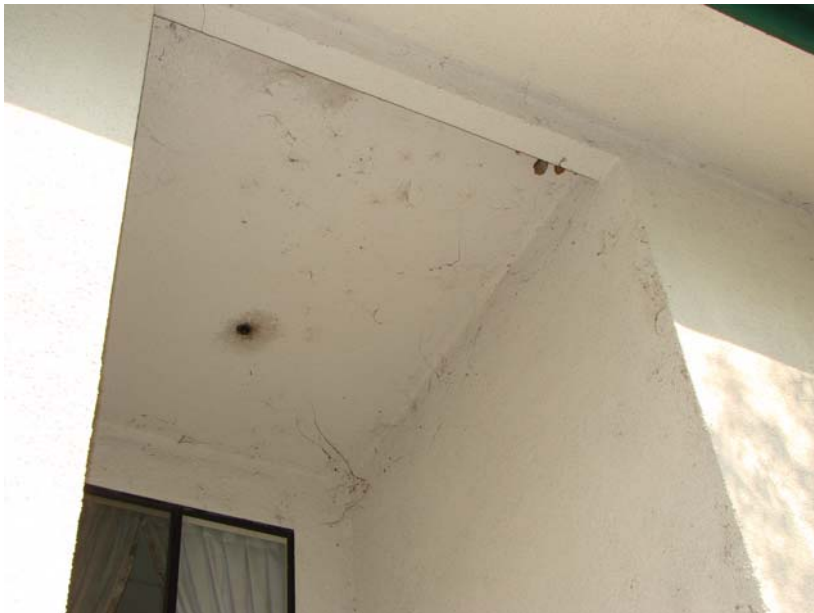
080 P_W: Spider webs in exterior alcove - building exterior should be pressure washed.

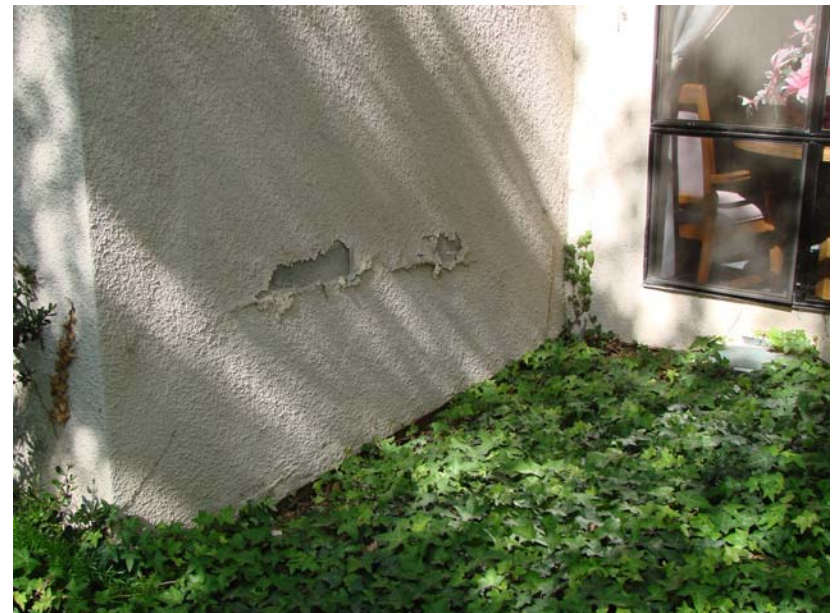
081 P_W: Exterior finish coming off building.

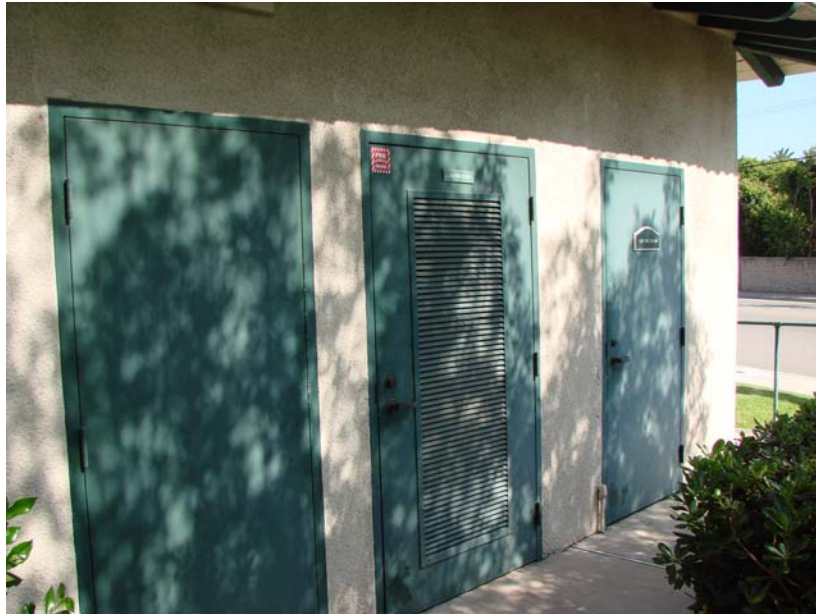
082 P_W: Electrical closet & elevator equipment rooms.

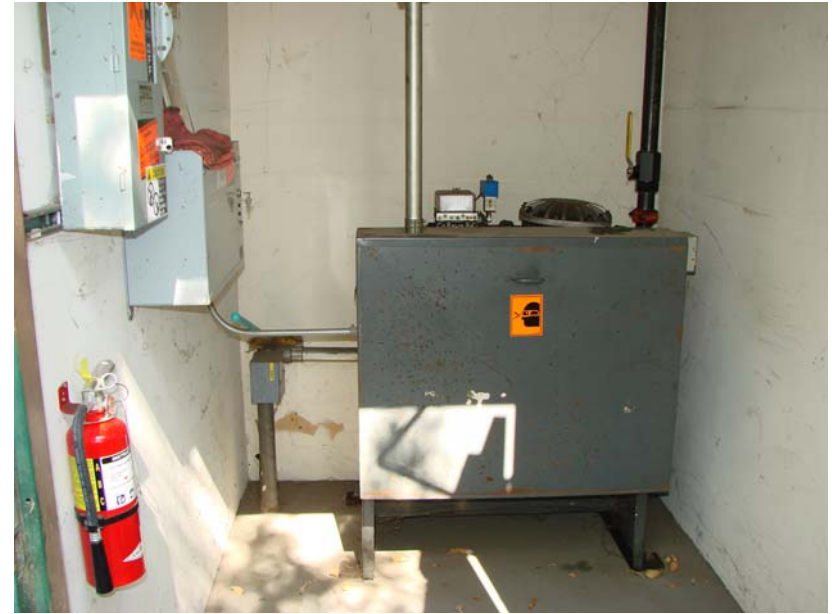
083 P_W: Hydraulic elevator equipment room.

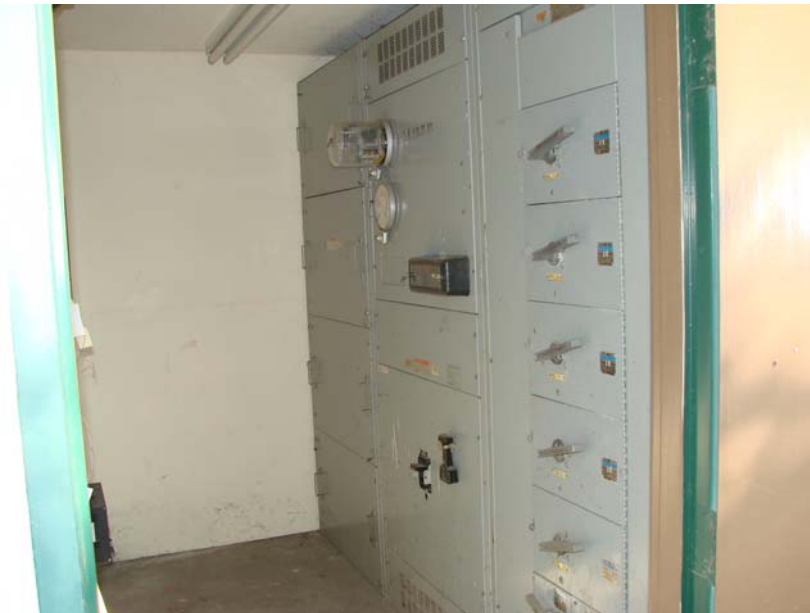
084 P_W: Main electric service - 1000 Amp main panel.

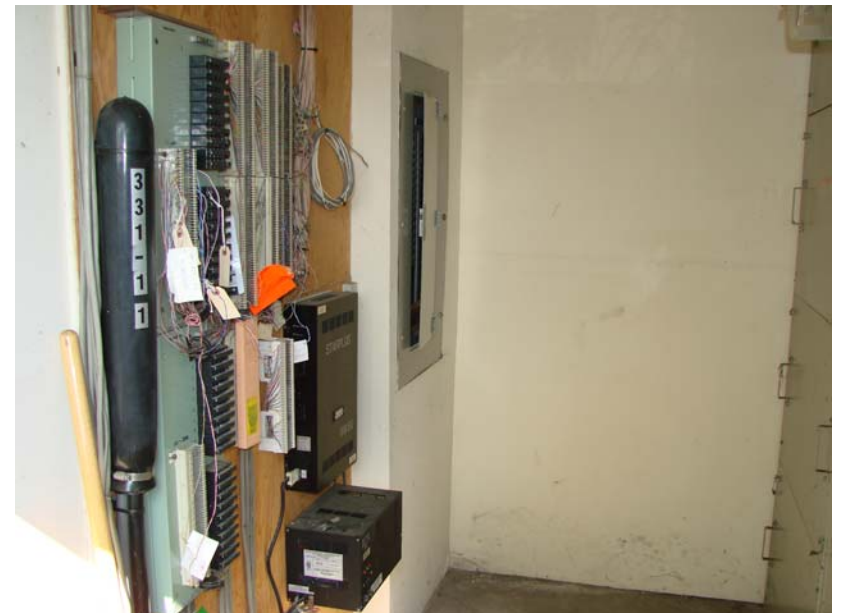
085 P_W: Main telephone patch panel in electrical room.

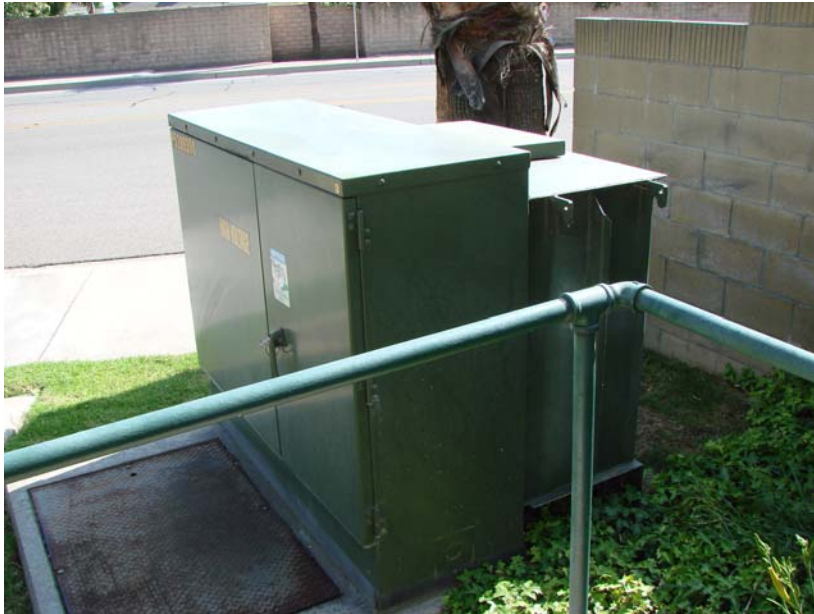
086 P_W: Pad mounted electrical transformer.

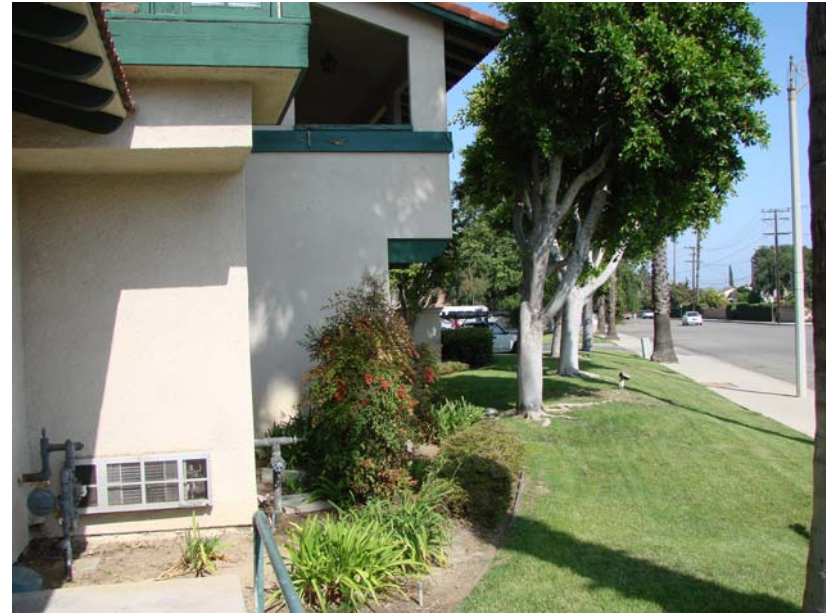
087 P_W: Southwest property line looking east along road frontage.
