The Palms - PALM EAST
351 East Palm Drive, Anytown, USA 01995
PH 987-654-3210 * FAX 987-654-3211

The Palms - PALM EAST

Anytown, USA; May 2, 2007

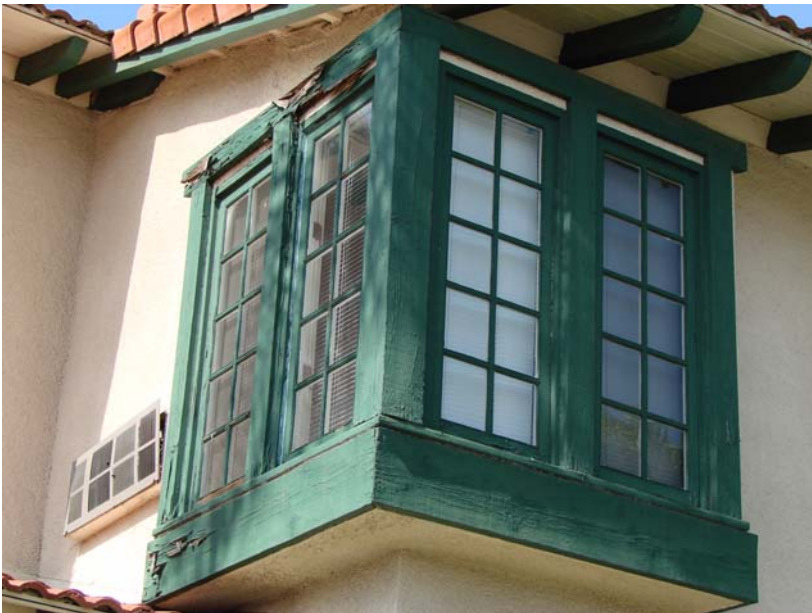
088 P_W: Rotten wood trim on windows.

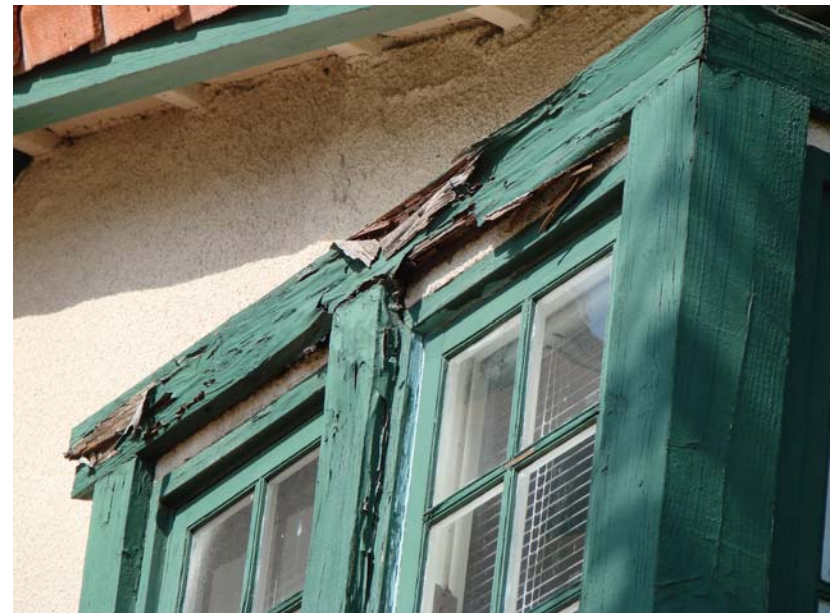
089 P_W: Rotten wood trim on windows.

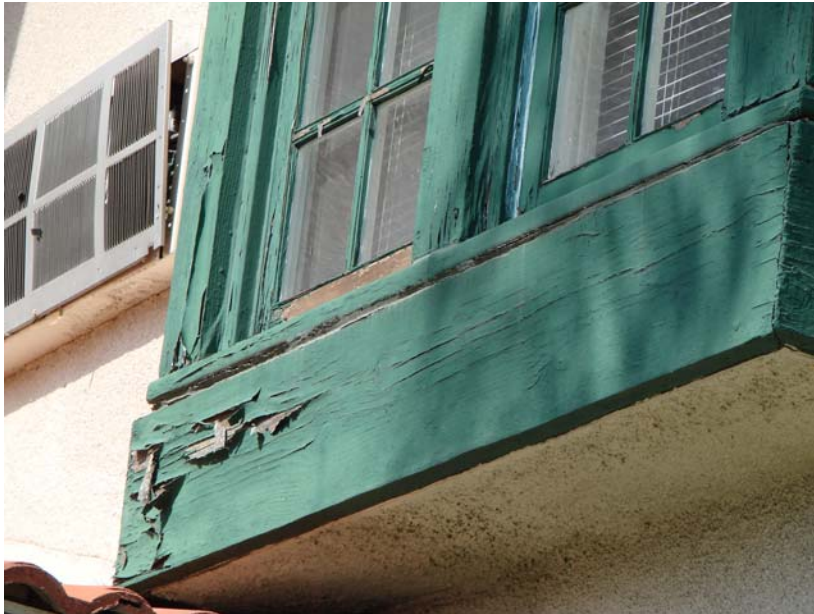
090 P_W: Rotten wood trim on windows.

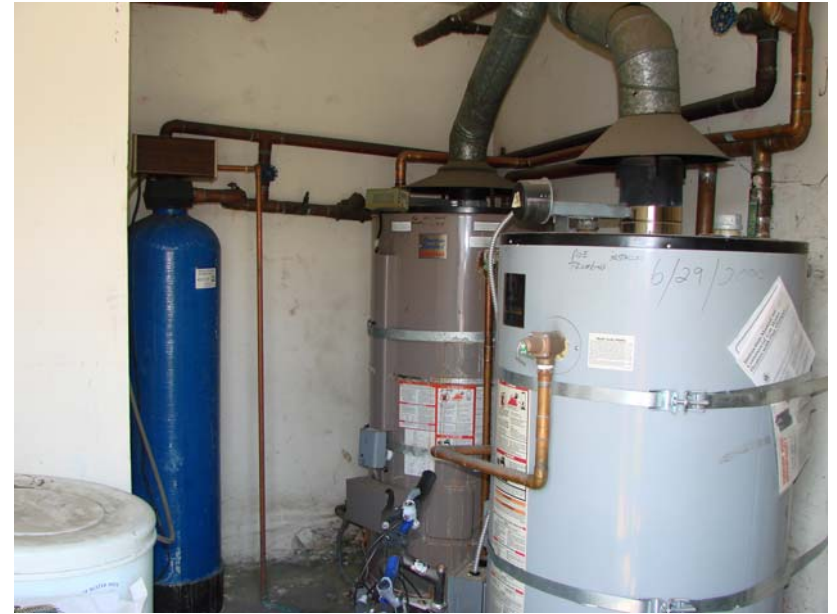
091 P_W: American Standard & State 100-gallon water heaters with water treatment system.

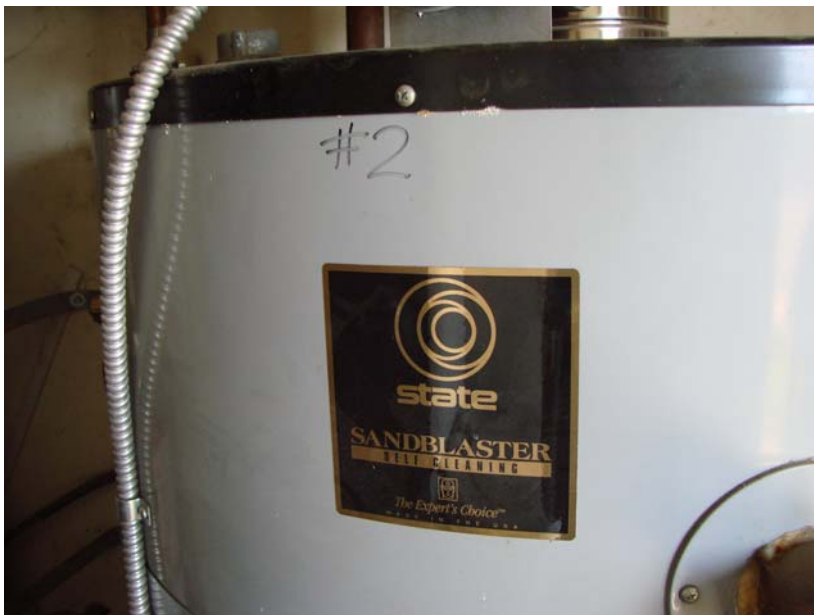
092 P_W: State water heater (#2), 100-gal, 260,000 BTUH.

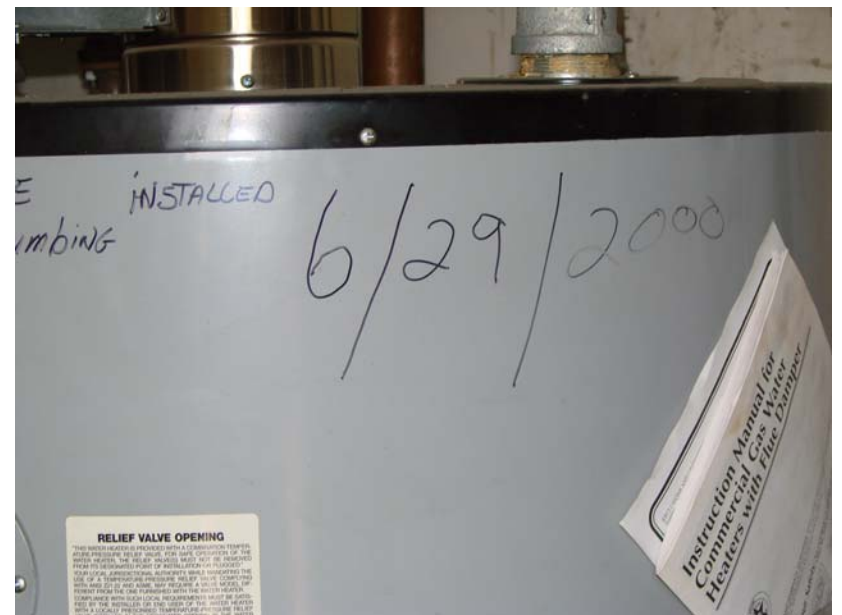
093 P_W: State water heater (#2), 100-gal, 260,000 BTUH.

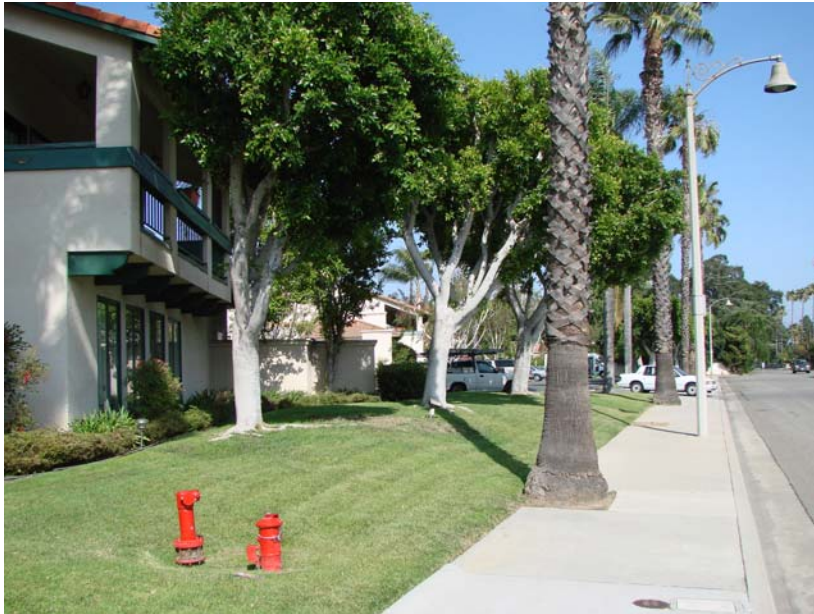
098 P_W: Southwest property line looking east along road frontage. Fire stand pipe.
