PROPERTY CONDITION REPORT OUTLINE

May 2, 2007

The Palms

Prepared for:
No. 1 LTC Operator, Anytown, USA

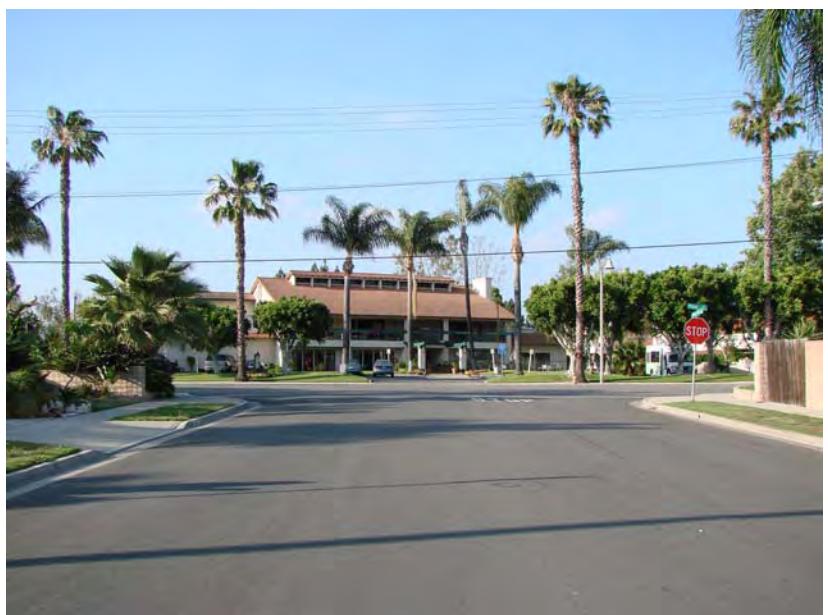
004 P_E: Broken light detail.

2. Update identification sign to reflect change in ownership.
3. Repair broken lighting at identification sign, enhance landscaping around sign.
4. Minor asphalt maintenance, reseal & restripe.
5. Replace & repaint all exterior wood trim & fascia.
6. Pressure wash buildings, minor exterior wall repairs where paint has “bubbled” and peeled.
7. Consider investigating adding an emergency generator.
8. Emergency reserve for replacing/repairing older central HVAC equipment.

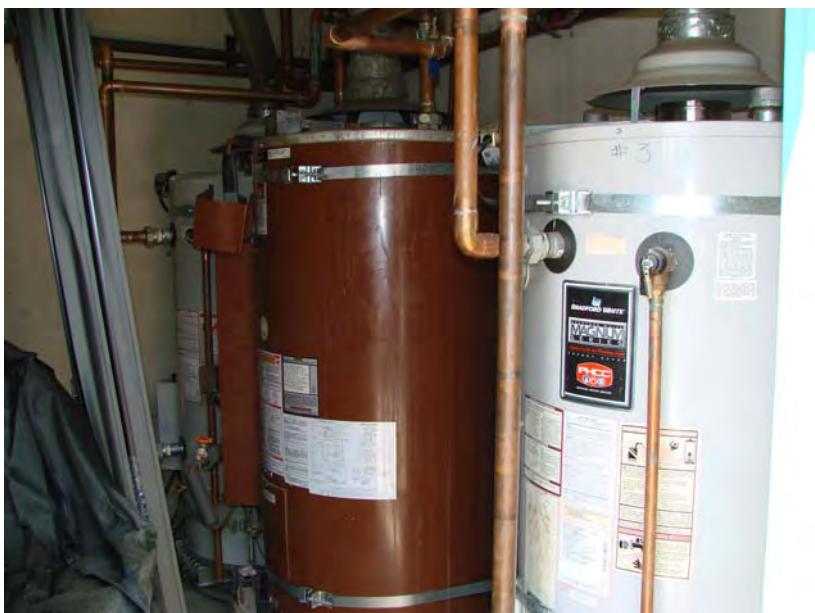
Water heating: Gas water heaters – Palm East – three heaters; Palm West – two heaters; various ages, all working properly. Will need routine replacement as equipment ages through normal useful life.

020 P_E: Water heaters - two for residential-domestic use; one for kitchen.

- a. Add one additional set of washer/dryer to each building.
 - b. Look in to retro-fit for commercial washer & dryer 35#/50#.
18. Replace water heaters (3) in upcoming years.

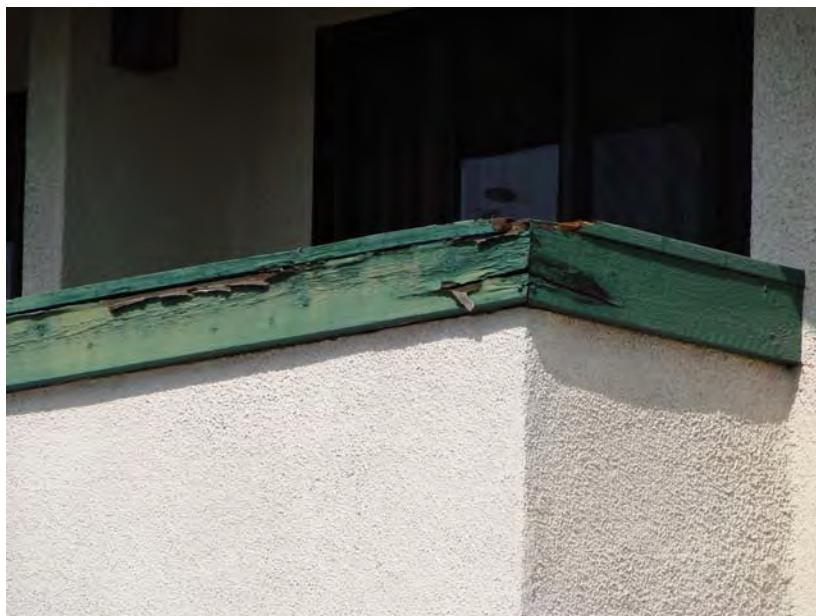
Condition: All wood trim is rotten and needs to be replaced.

034 P_E: Detail - rotten wood trim on 2nd floor balconies.

3 Repair rotten wood trim on building exterior. \$ 18,000

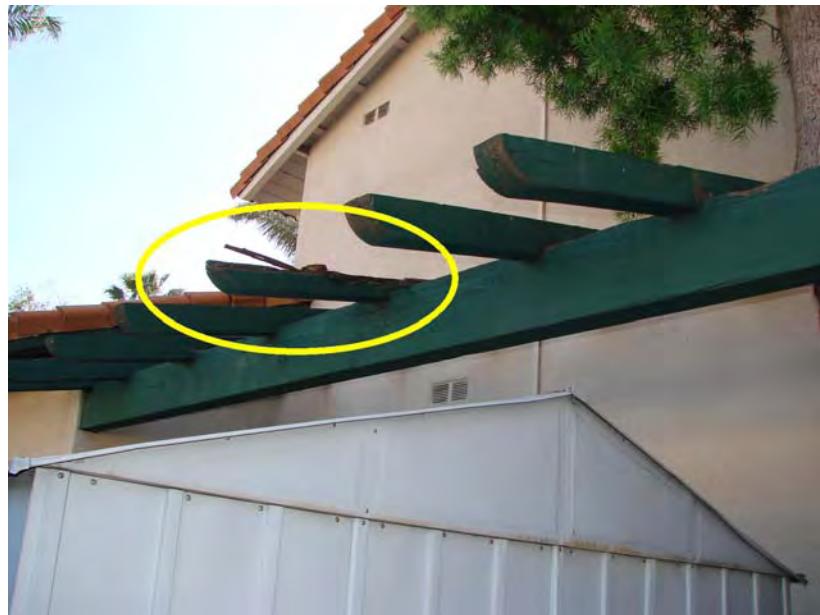
038 P_E: Detail - rotten beam.

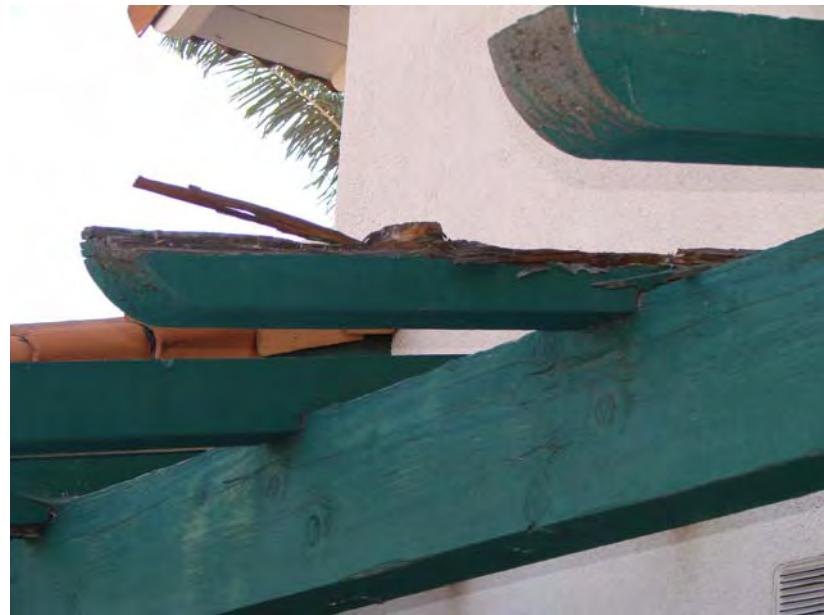
039 P_E: Detail - rotten beam.

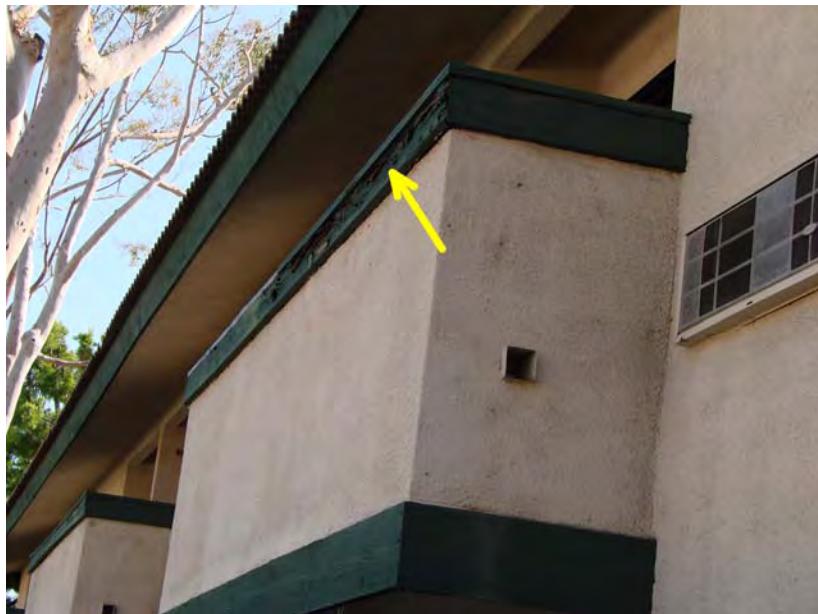
042 P_E: Detail - rotten trim on 2nd floor balcony.

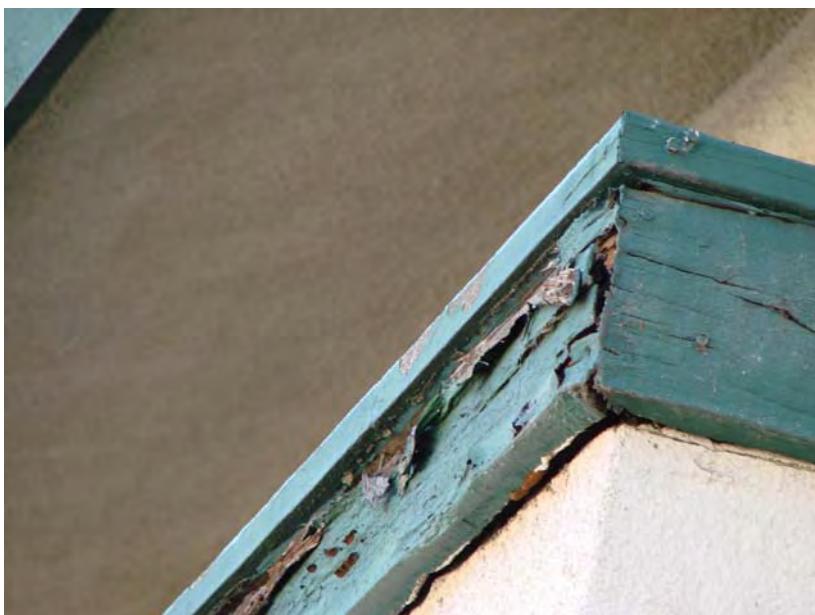
044 P_E: Detail - rotten trim on 2nd floor balcony.

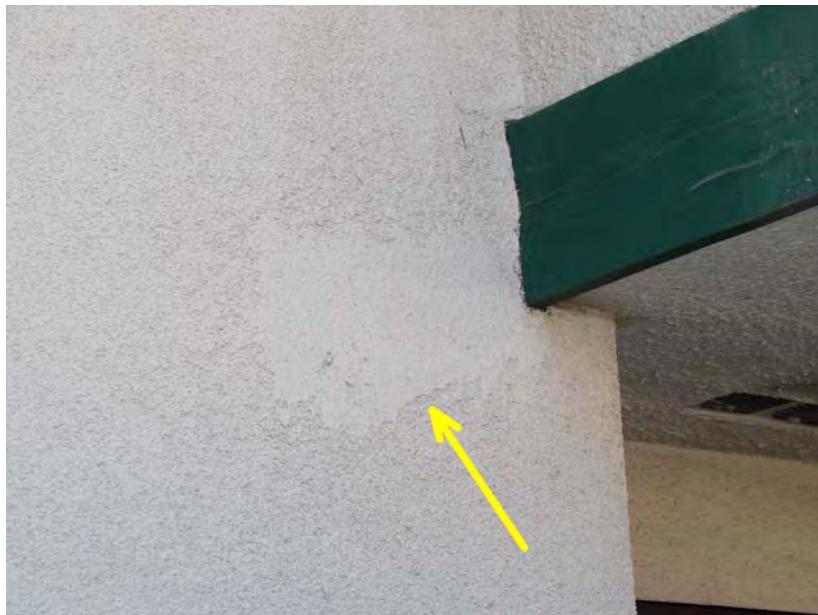
046 P_E: Wall patch on east elevation at balcony.

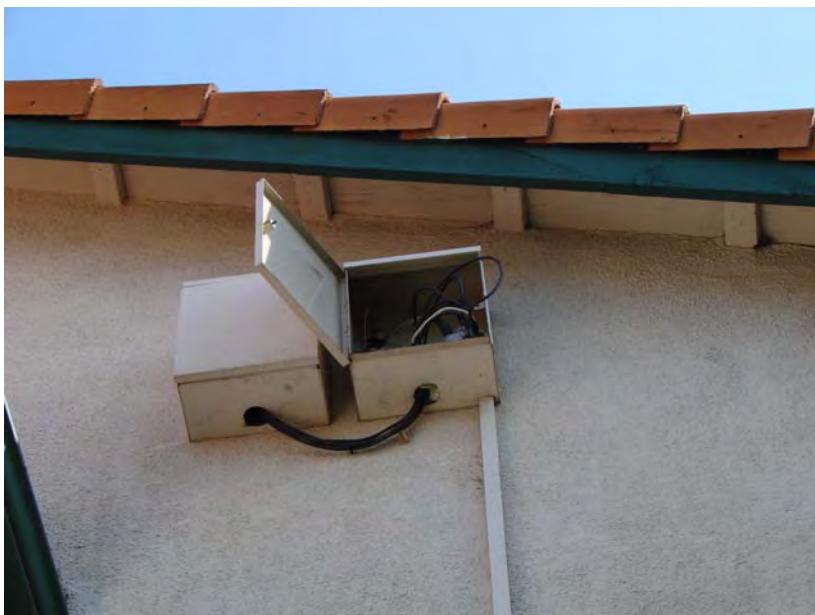
048 P_E: Open CATV junction box.

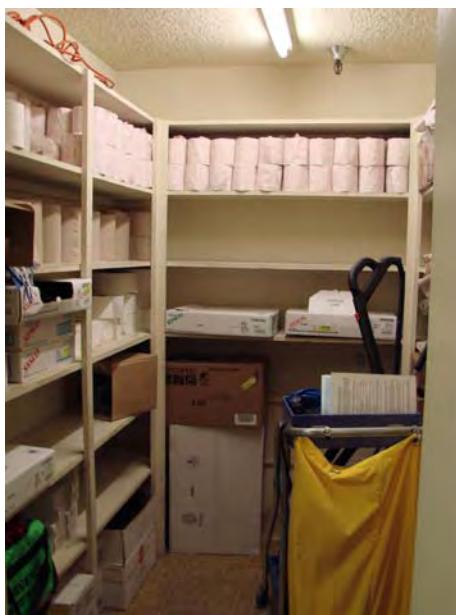
076 P_E: 1st floor West Hall storage closet.

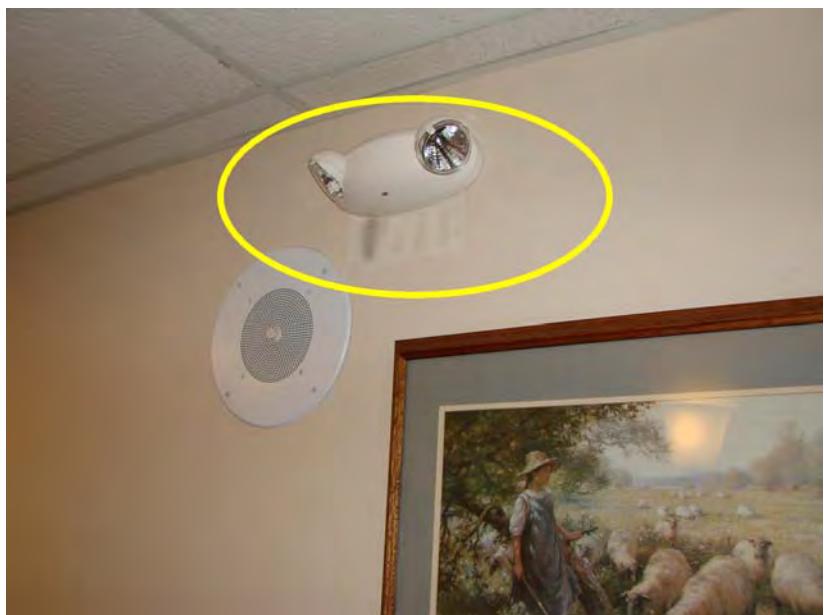
085 P_E: New emergency light. Note paint mark from original light outline.

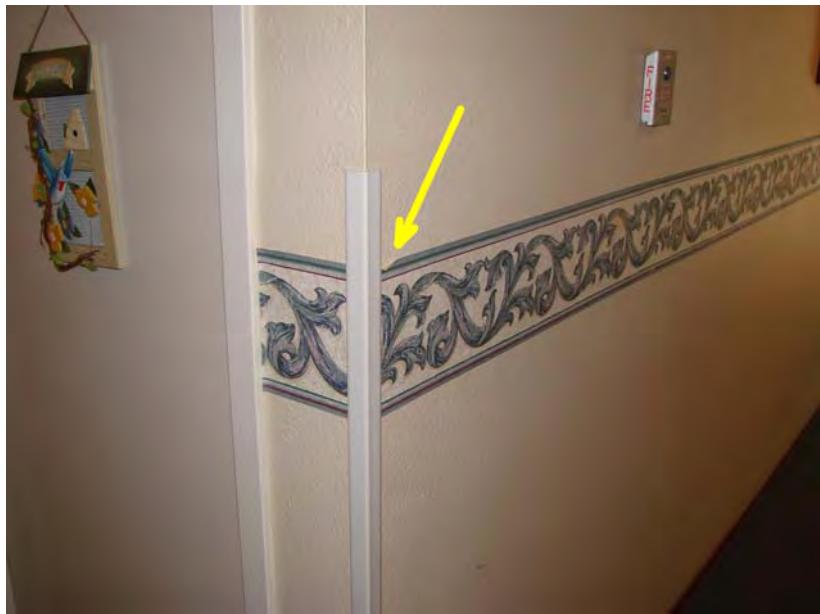
087 P_E: Detail - wallpaper border peeling at wall corner. (Note - staff has not yet begun 1st floor painting improvements.

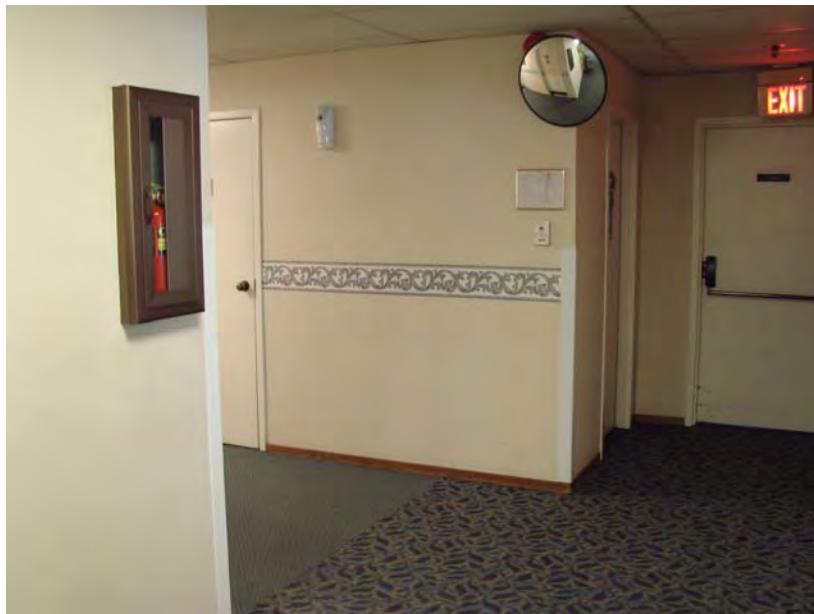
090 P_E: Transition from front (south) corridor to East Hall. Note carpet change.

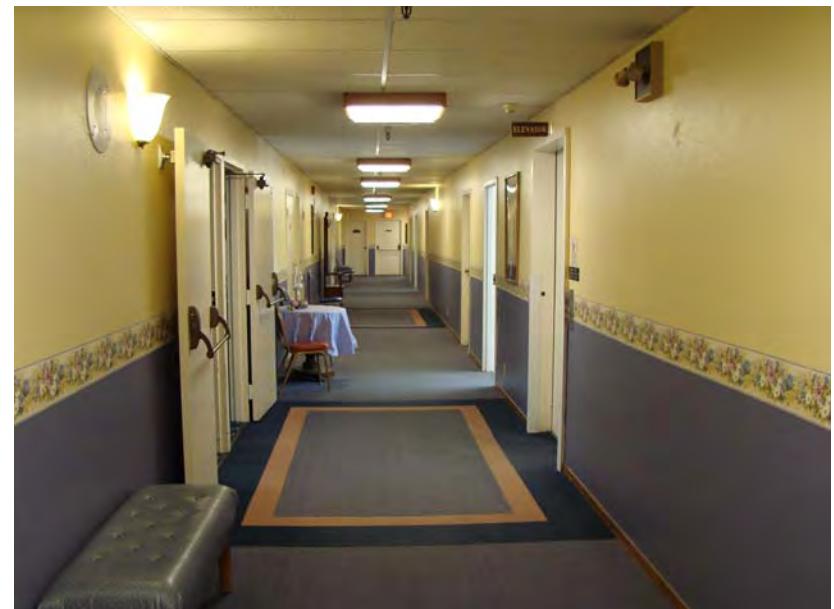
093 P_E: Palm East - typical 2nd floor corridor. Wood base, painted walls, no handrails, wallpaper border transition. Paint and border are currently being

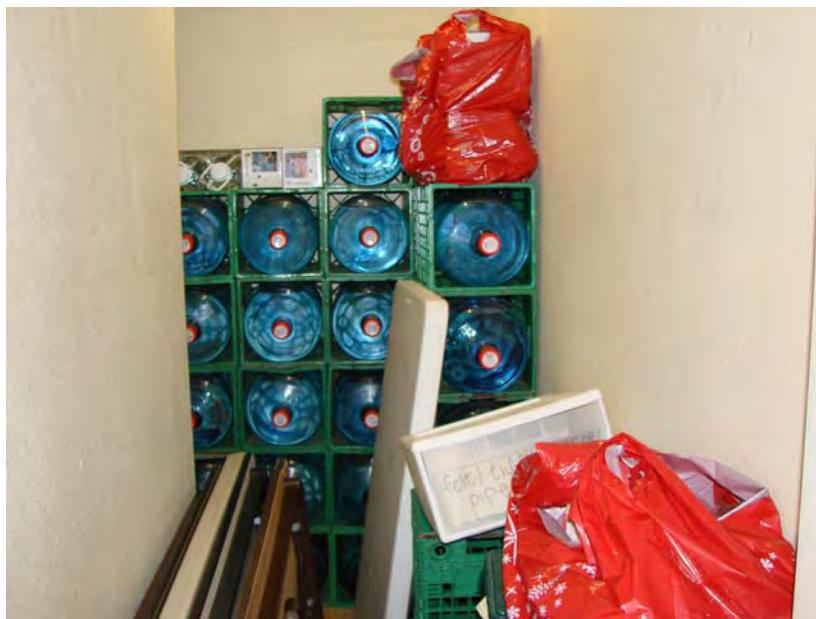
094 P_E: 2nd floor storage closet at #3 Stairs - emergency water supply. (note - maint. supv. did not know age of water canisters or rotation schedule.)

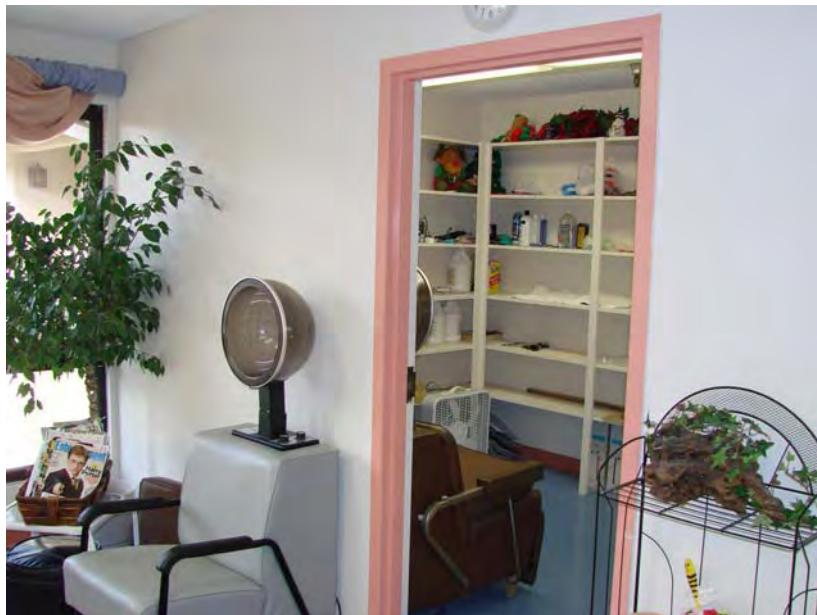
100 P_E: Beauty shop storage - consider removing wall to enlarge beauty shop.

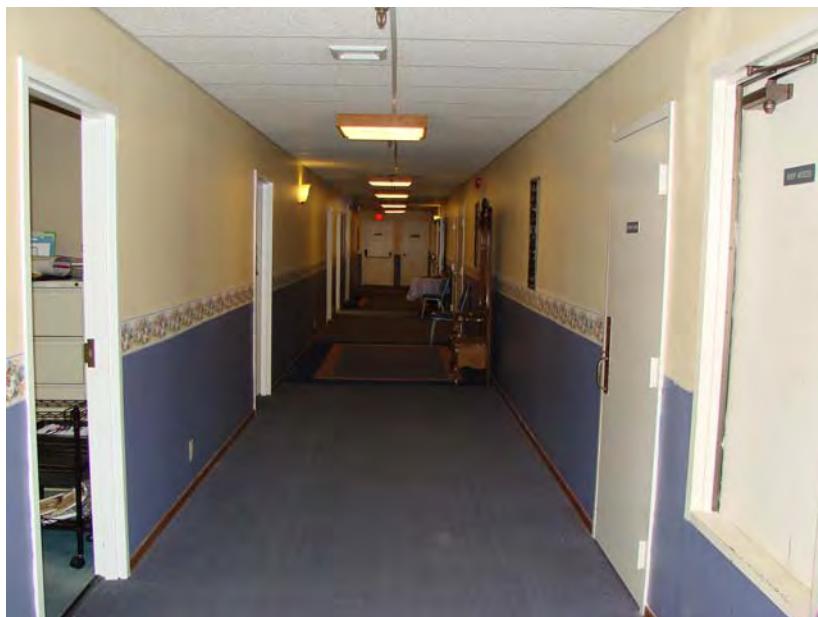
114 P_E: Palm East - typical 2nd floor corridor. Wood base, painted walls, no handrails, wallpaper border transition. Paint and border are currently being

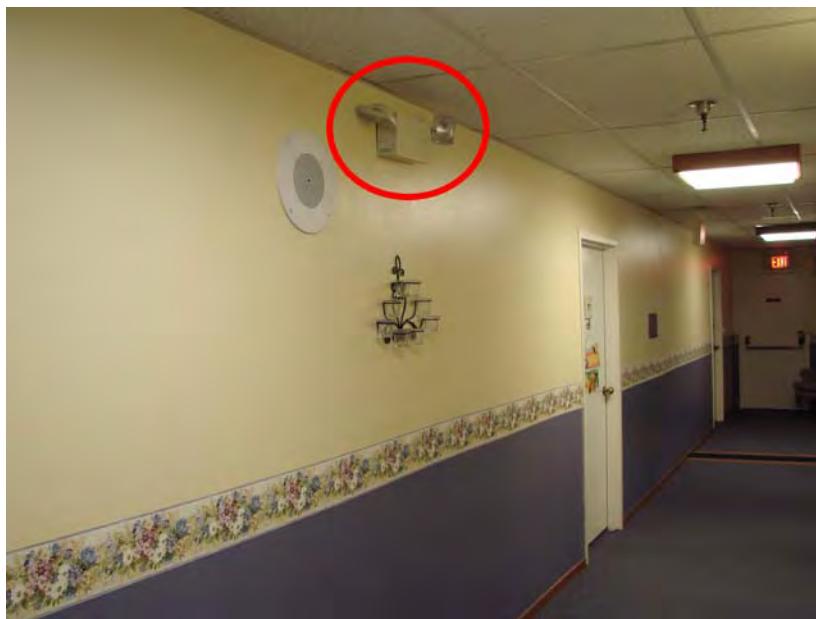
118 P_E: Public Address speaker, battery back-up emergency lighting (no emergency generator).

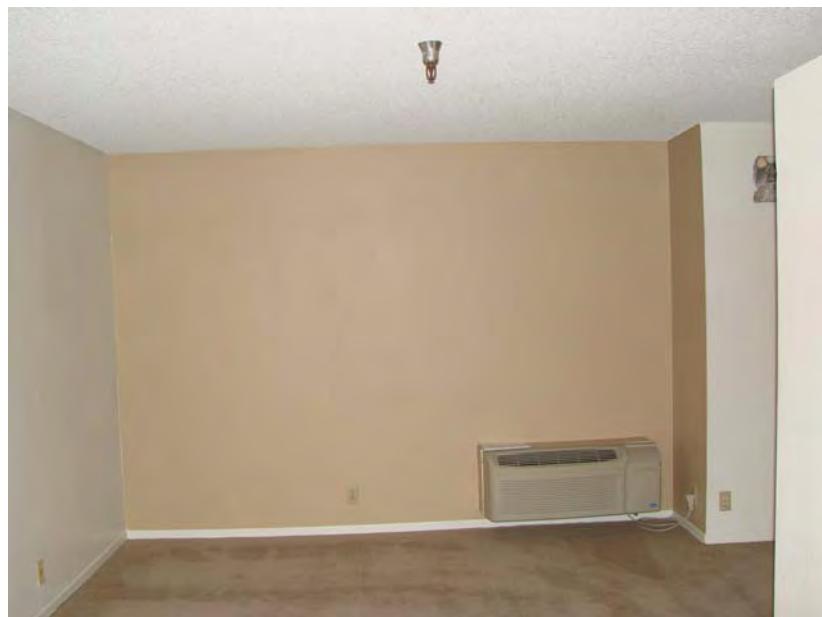
127 P_E: Typical resident unit. Remodel in process between residents. Note use of accent wall; new PTAC unit.

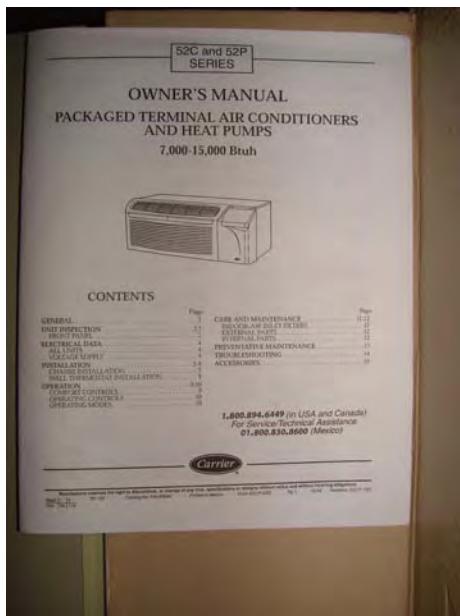
130 P_E: New PTAC operating manual in room 229 - facility is routinely replacing older PTAC units in resident rooms.

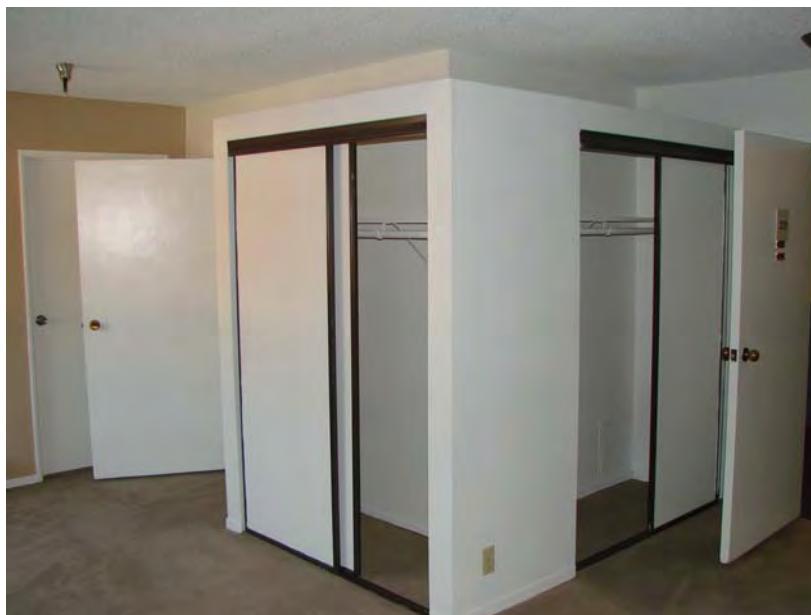
132 P_E: Typical resident unit. Remodel in process between residents.

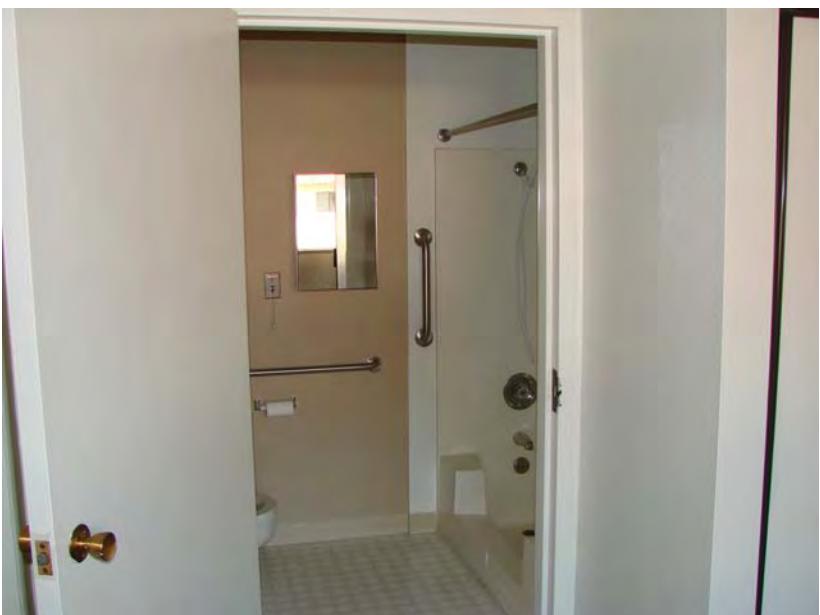
133 P_E: Typical resident unit. Remodel in process between residents.

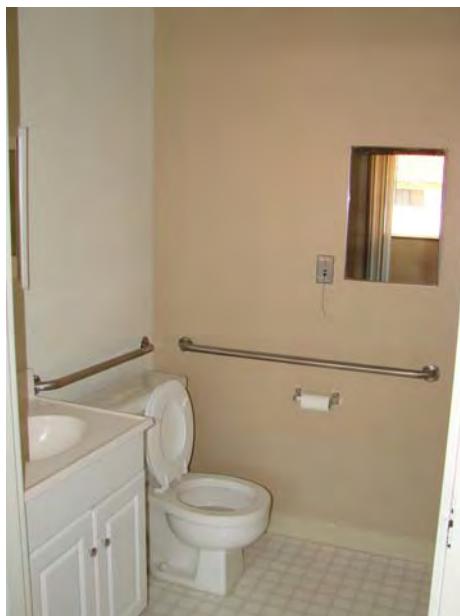
134 P_E: Typical resident unit. Remodel in process between residents.

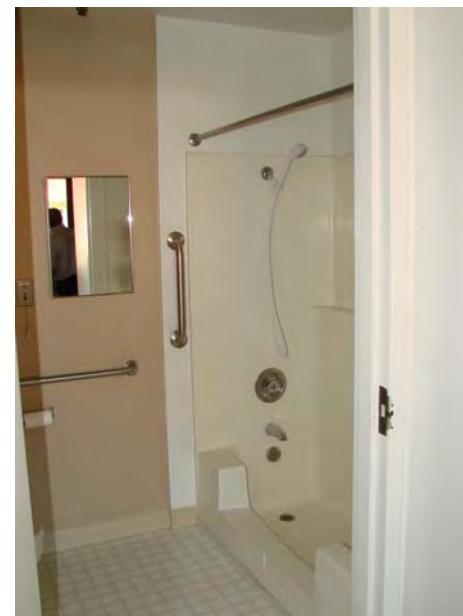
135 P_E: Typical resident unit. Remodel in process between residents.

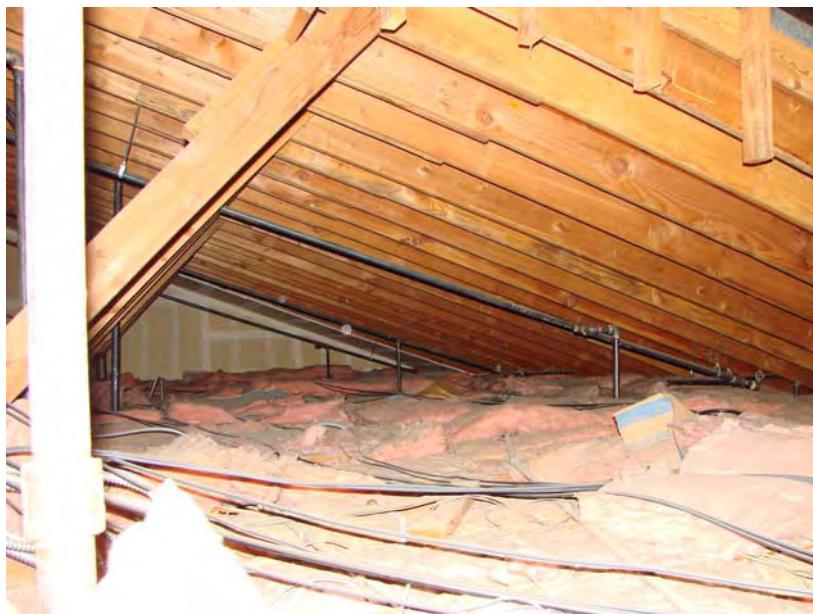
136 P_E: Palm East - typical attic detail.

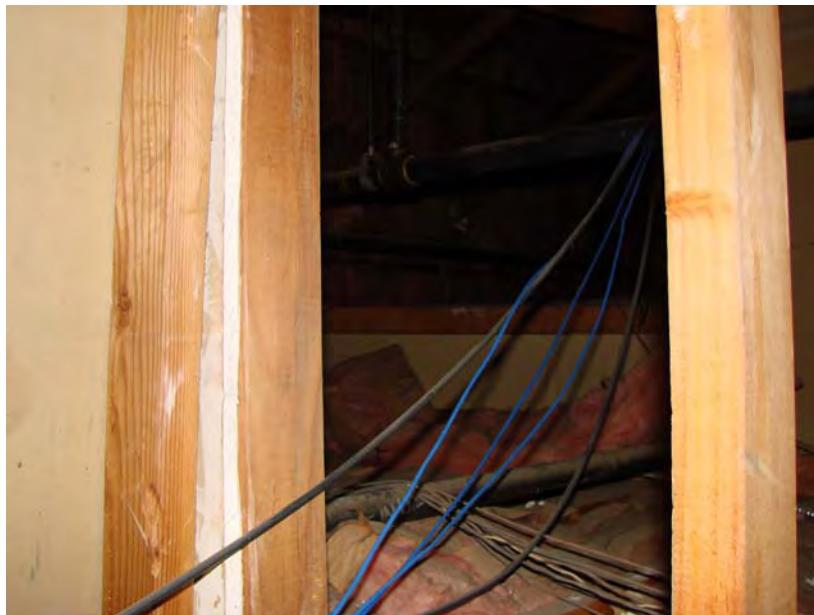
138 P_E: Palm East - typical attic detail.

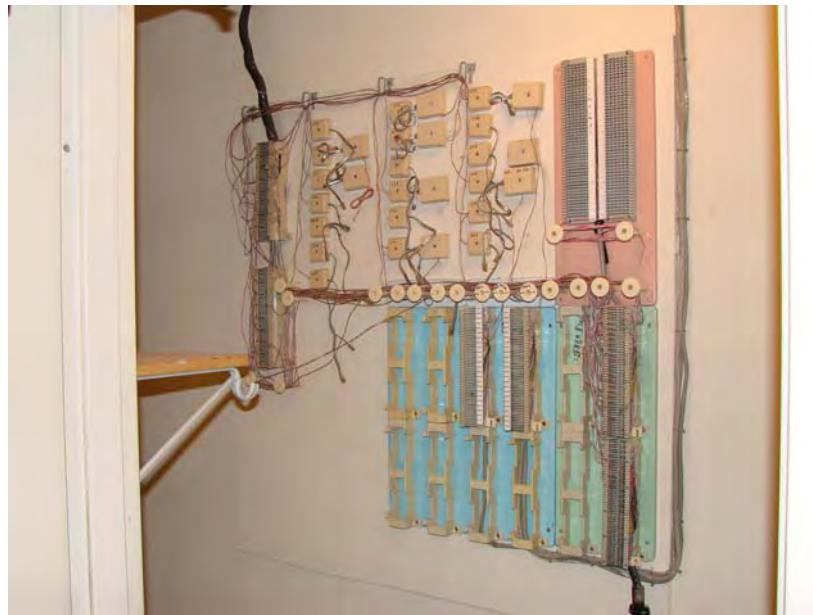
139 P_E: 2nd floor electric closet - telephone patch panel.

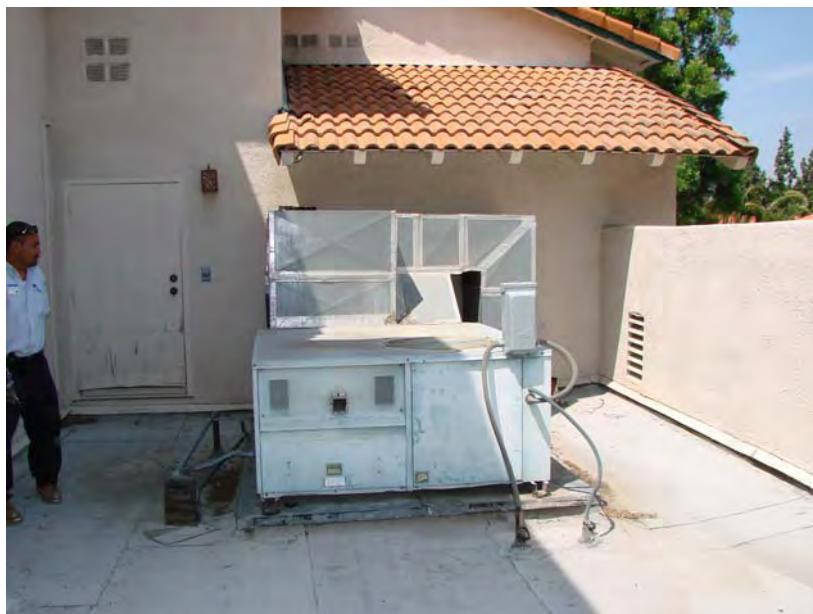
140 P_E: Palm East - Carrier Weathermaker rooftop HVAC unit - AC & gas heat.

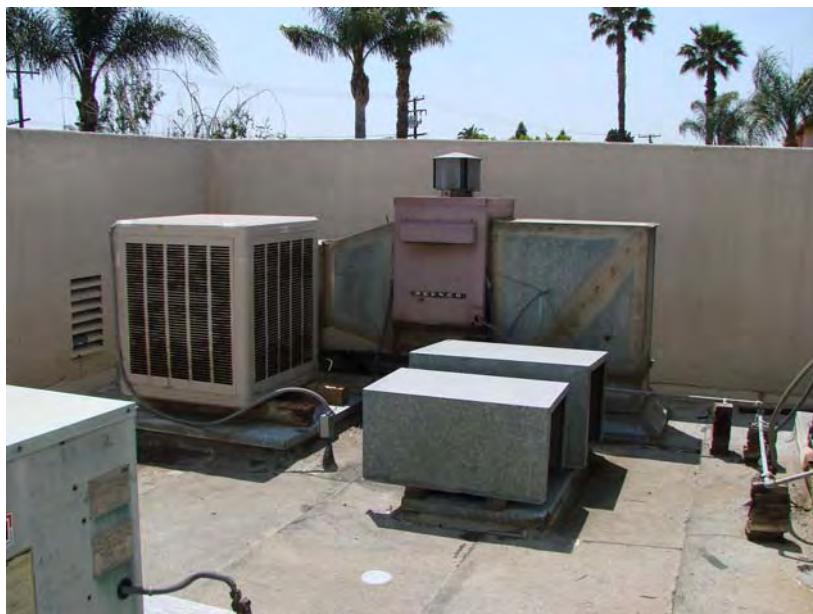
144 P E: Roof top HVAC units - Kitchen swamp cooler.

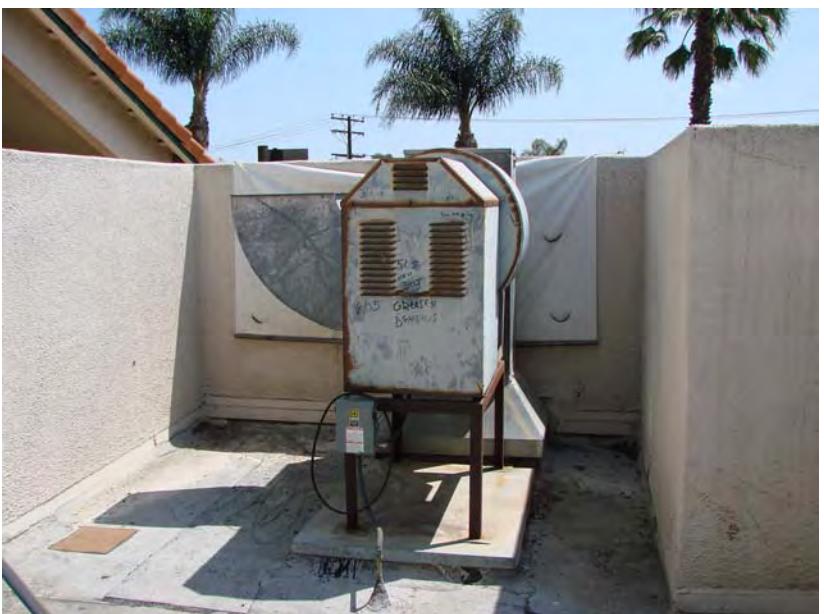
145 P E: Kitchen air handler.

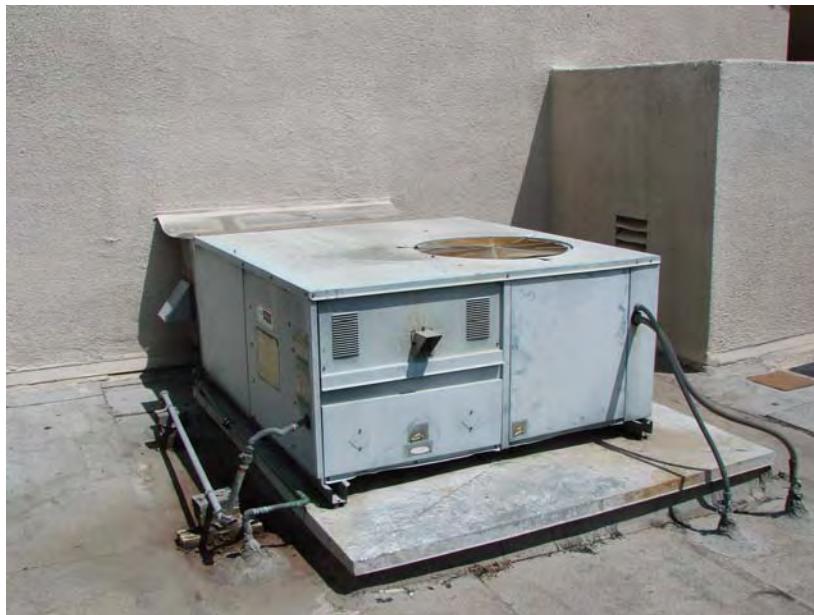
146 P_E: Carrier Weathermaker Rooftop HVAC unit - AC & gas heat.

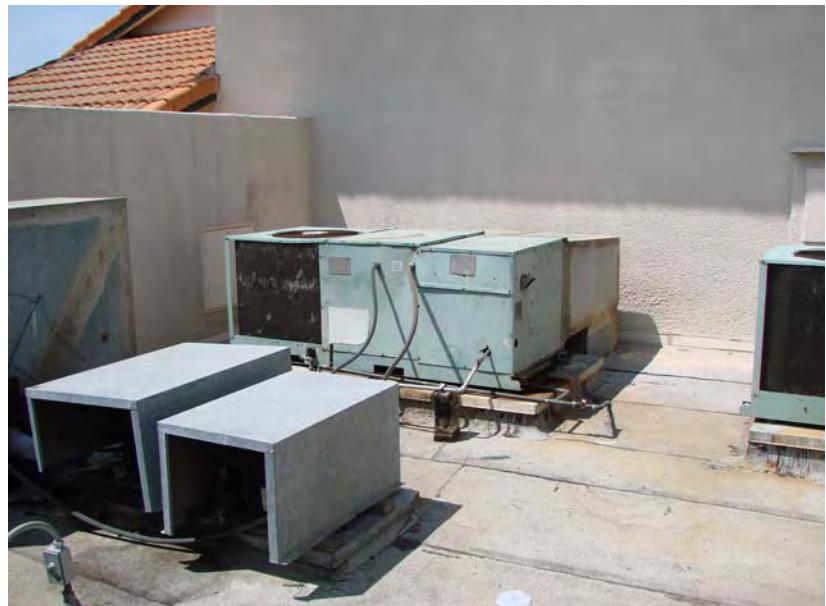
149 P_E: Rooftop HVAC unit - AC & gas heat; Kitchen walk-in cooler-freezer compressors.

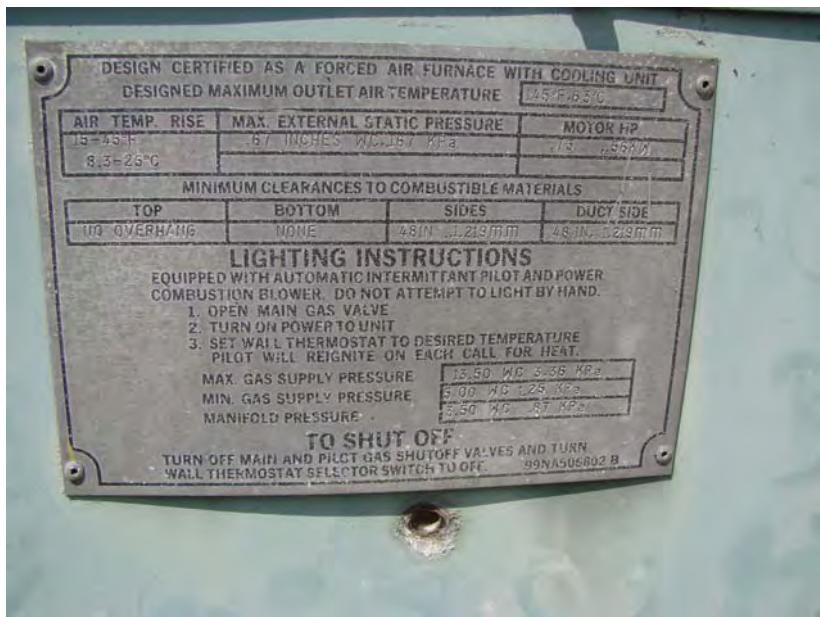
151 P_E: Rooftop HVAC unit - AC & gas heat.

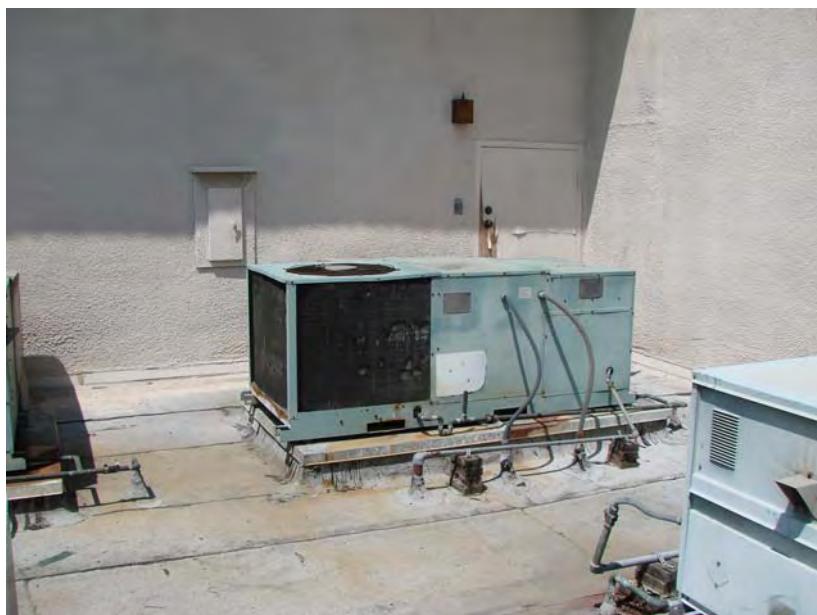
152 P_E: Rooftop HVAC unit - AC & gas heat.

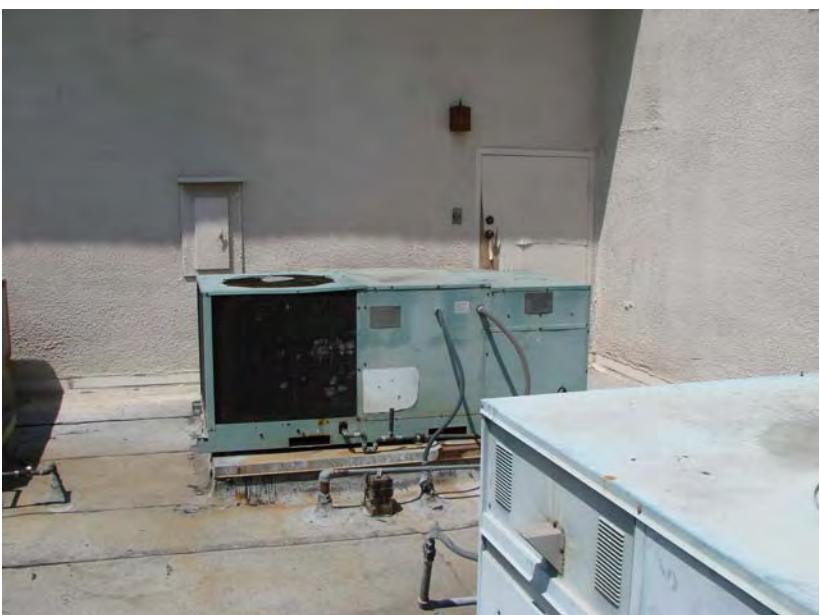
153 P_E: Rooftop HVAC unit - AC & gas heat.

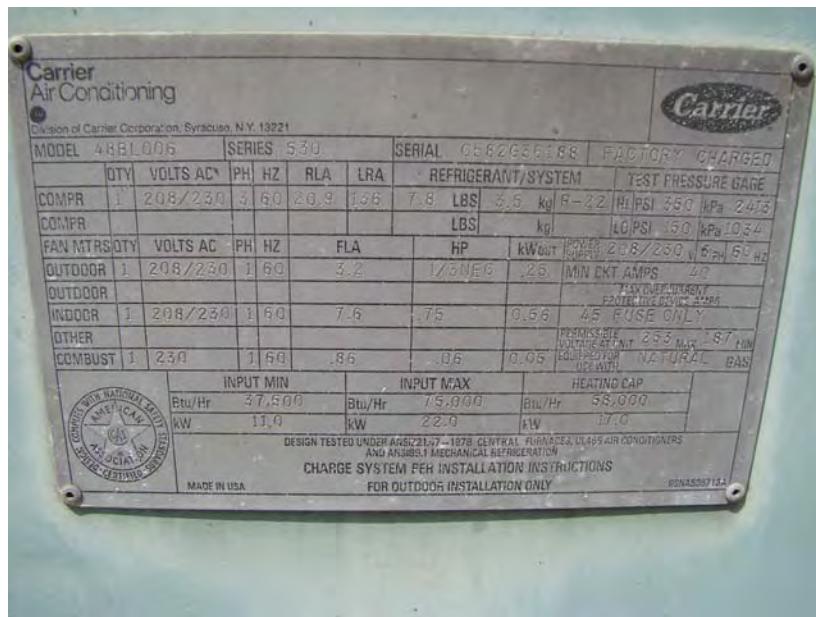
154 P_E: Rooftop HVAC unit - AC & gas heat.

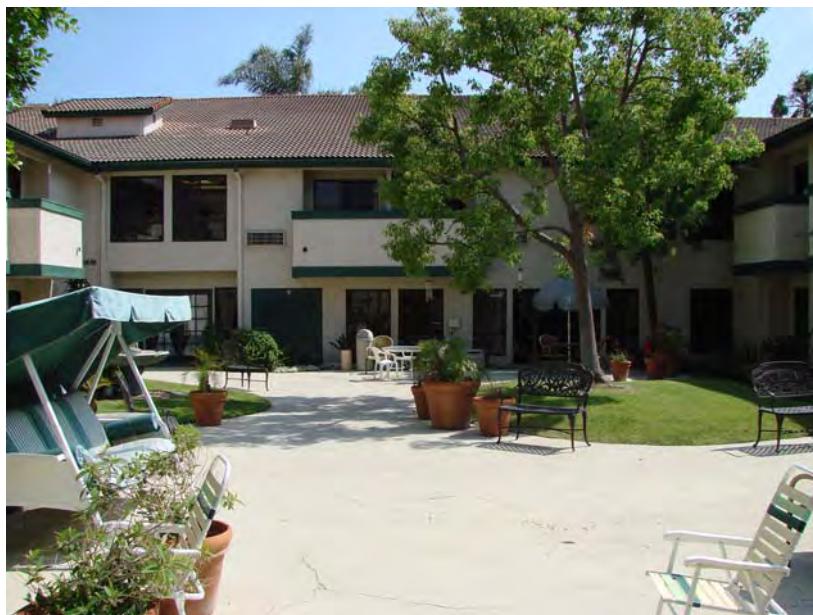
156 P_E: Interior courtyard.

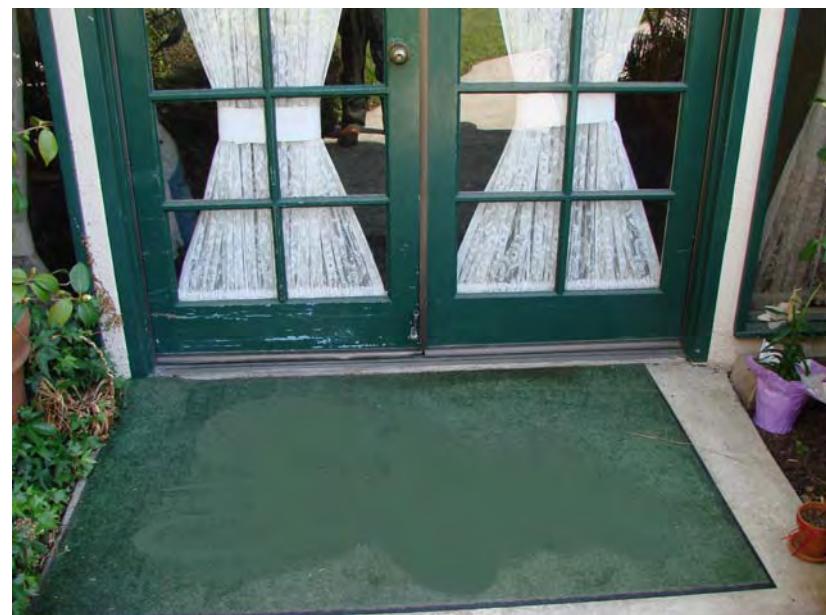
157 P_E: Detail - courtyard doors need repainting.

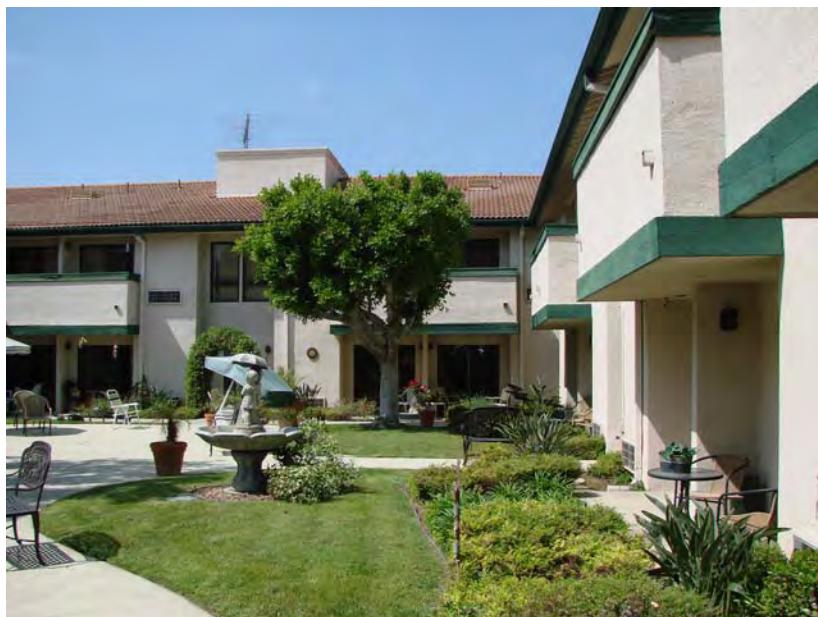
158 P_E: Interior courtyard.

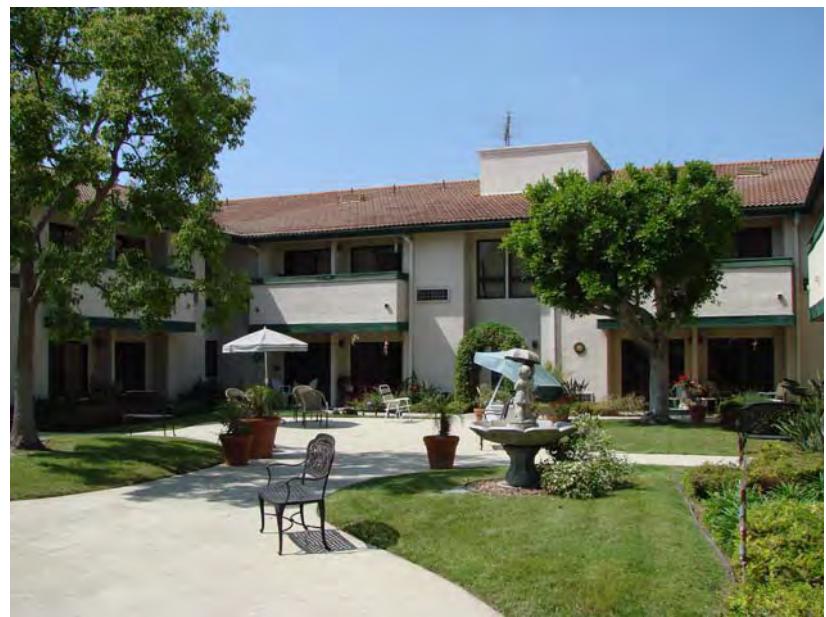
159 P_E: Interior courtyard.

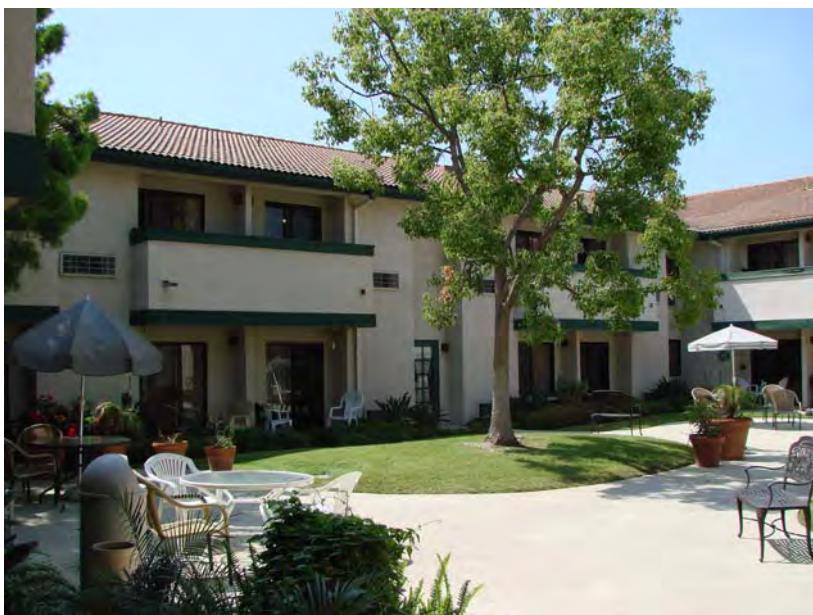
160 P_E: Interior courtyard.

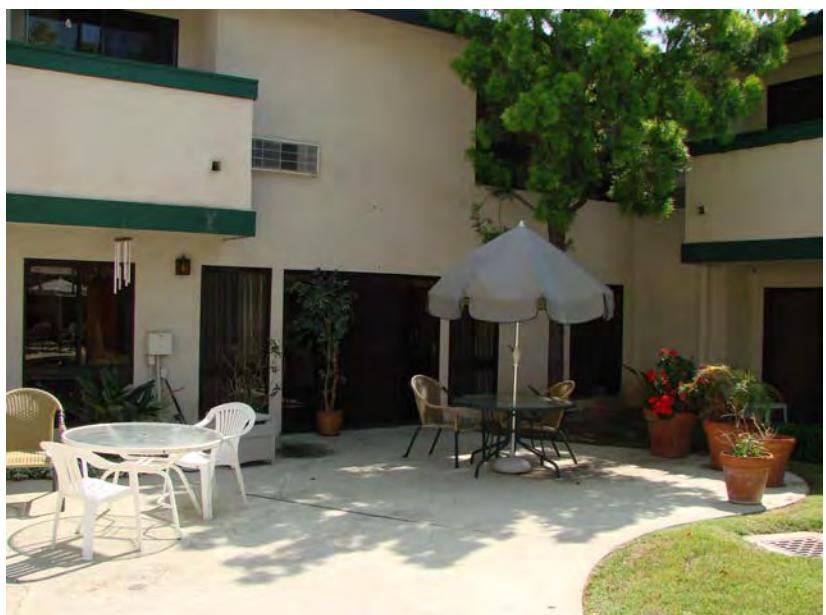
161 P_E: Interior courtyard.

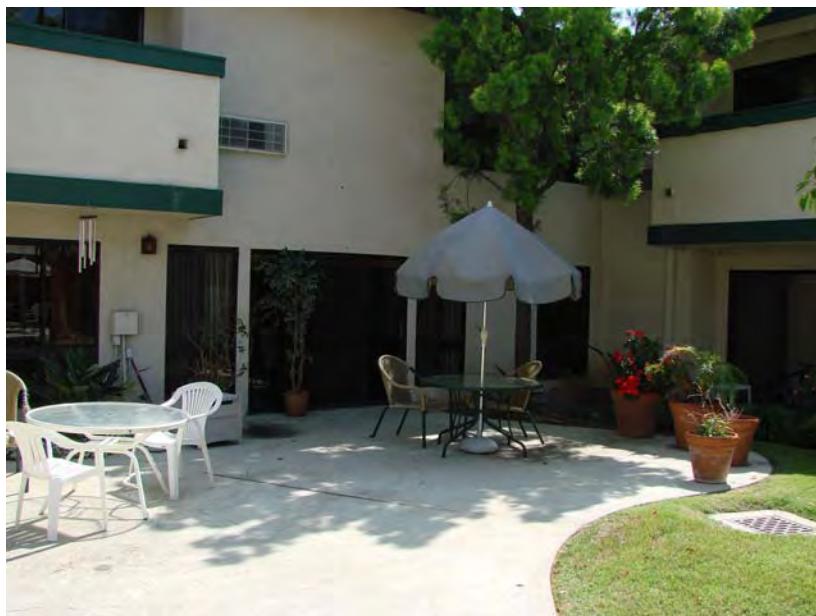
162 P_E: Interior courtyard.

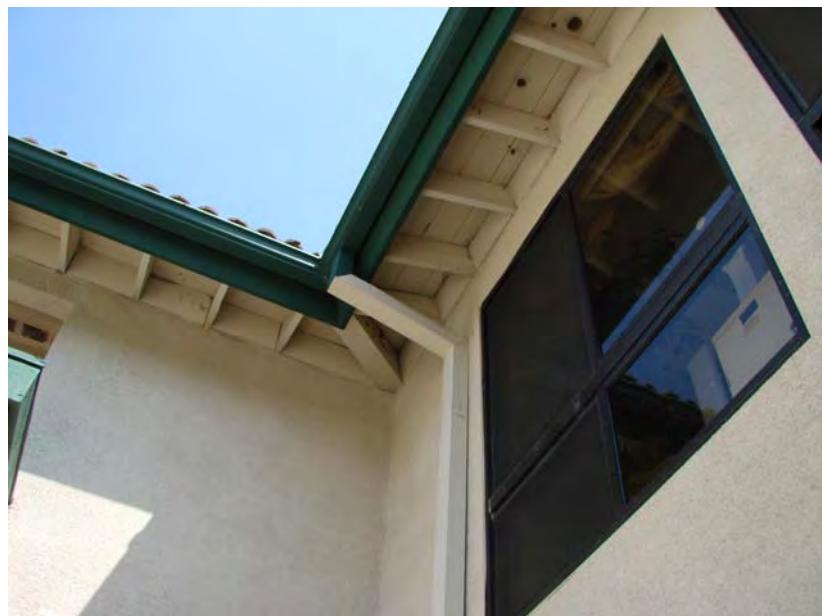
163 P_E: Detail - gutter, wasp nest under soffit.

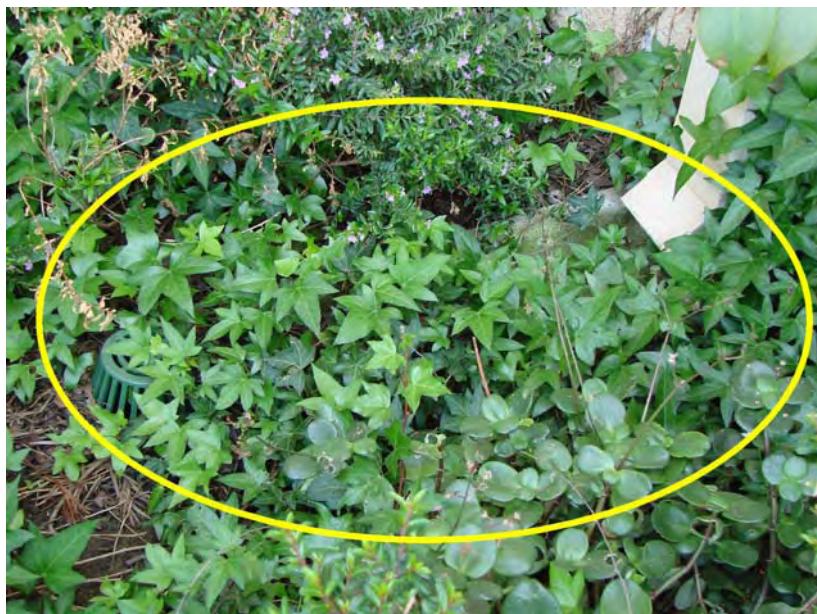
164 P_E: Detail - courtyard gutter surface drains to courtyard area drain.
