PROPERTY CONDITION REPORT OUTLINE

May 2, 2007

The Palms

Prepared for:
No. 1 LTC Operator, Anytown, USA

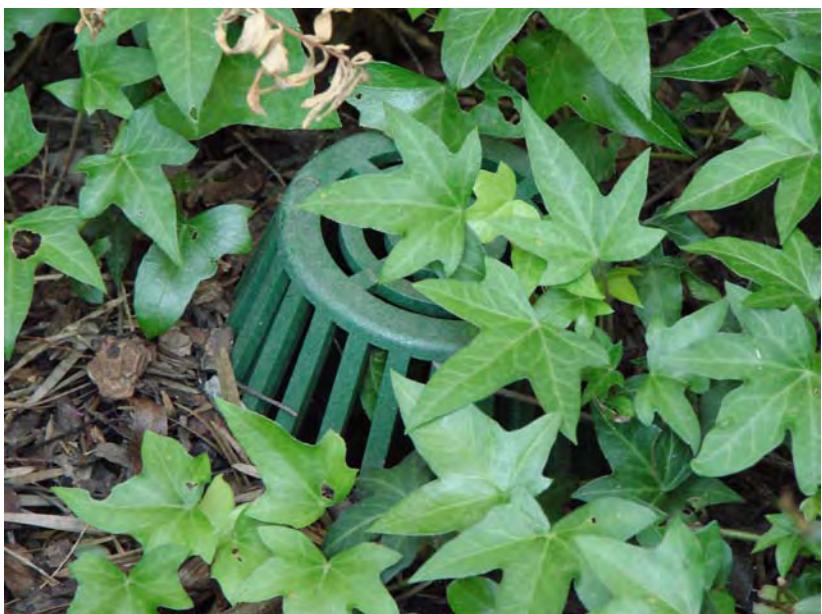
165 P_E: Area drain detail in courtyard.

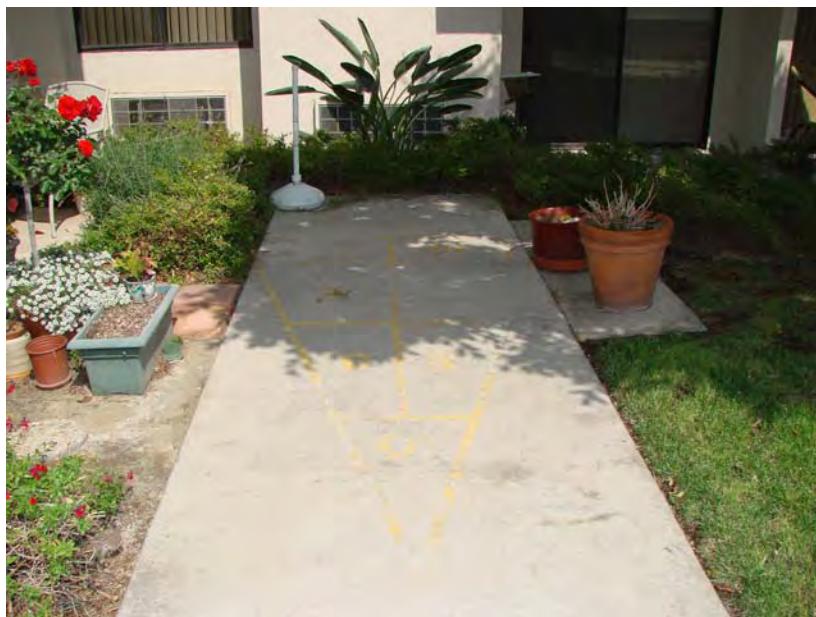
166 P_E: Faded shuffleboard court.

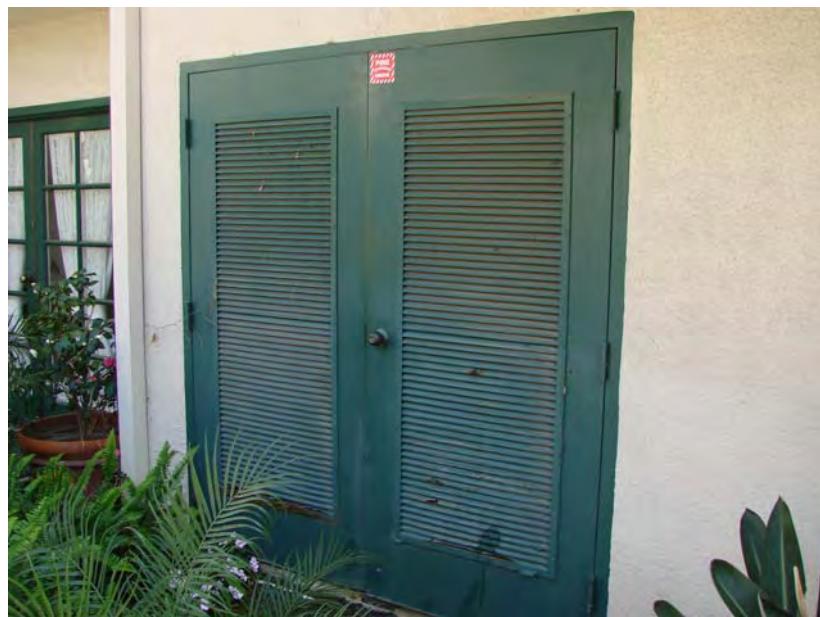
167 P_E: Elevator equipment room in courtyard.

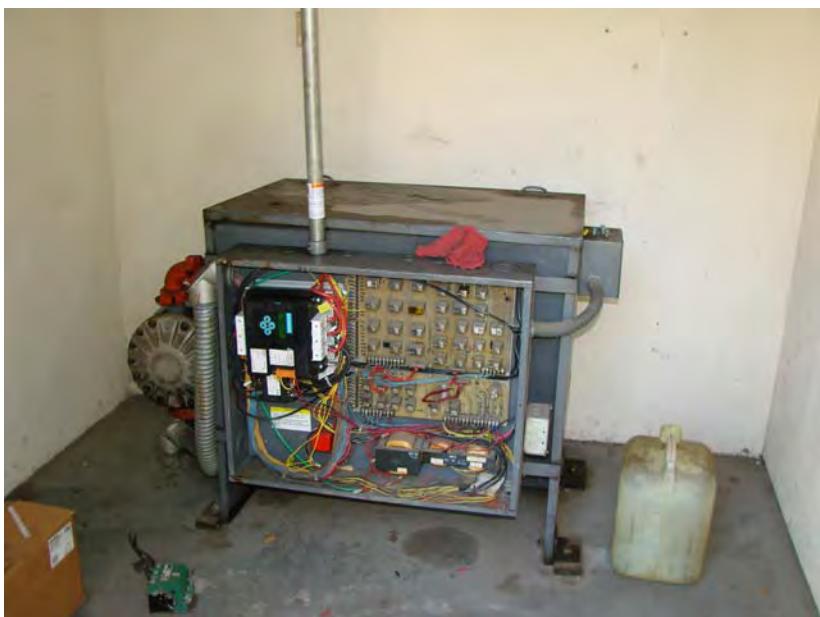
169 P_E	Hydraulic elevator equipment - recent repairs/maintenance.
170 P_E	Courtyard detail - water damage outside private dining room (possibly from sprinklers?).
171 P_E	Water damage detail.
172 P_E	Courtyard detail - water damage outside private dining room (possibly from sprinklers?).
173 P_E	Laundry dryer vents - consider adding a wire cage lint trap.
174 P_E	Laundry dryer vents - consider adding a wire cage lint trap.
175 P_E	Soffit vent - needs to be cleaned.
176 P_E	Detail - rotten wood trim on 2nd floor balconies.
177 P_E	Detail - rotten wood trim on 2nd floor balconies.
178 P_E	Detail - balcony drain. Consider adding drain scuppers to extend runoff beyond balcony wall.
179 P_E	Balcony drain scupper with extension.

169 P_E: Hydraulic elevator equipment - recent repairs-maintenance.

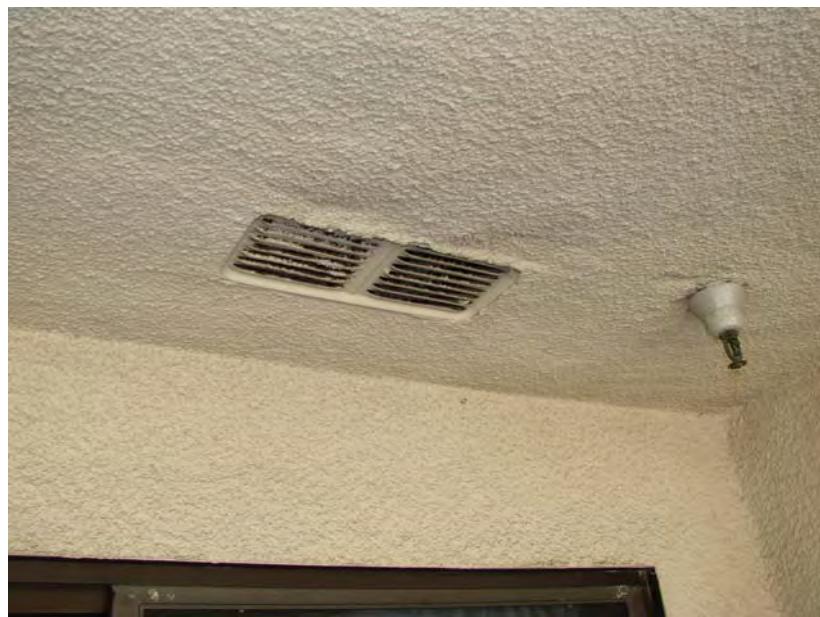
175 P_E: Soffit vent - needs to be cleaned.

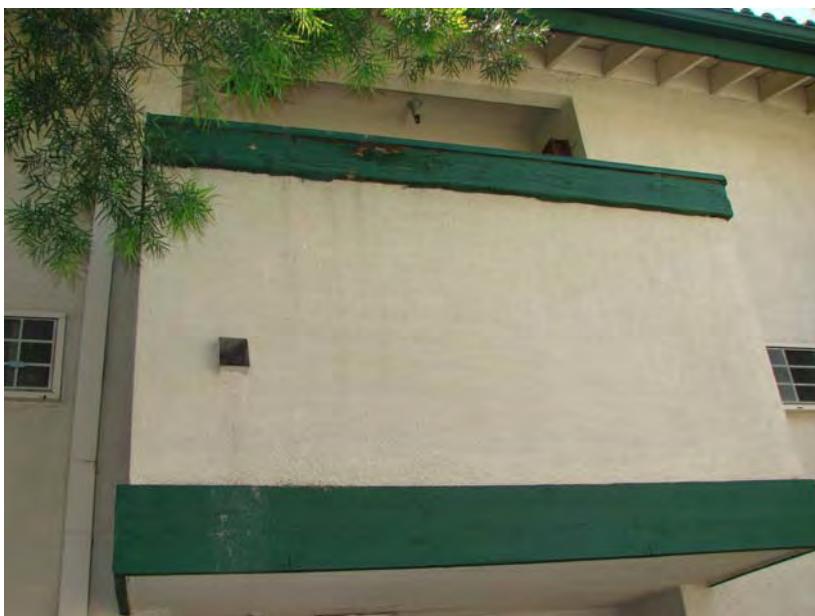
176 P_E: Detail - rotten wood trim on 2nd floor balconies.

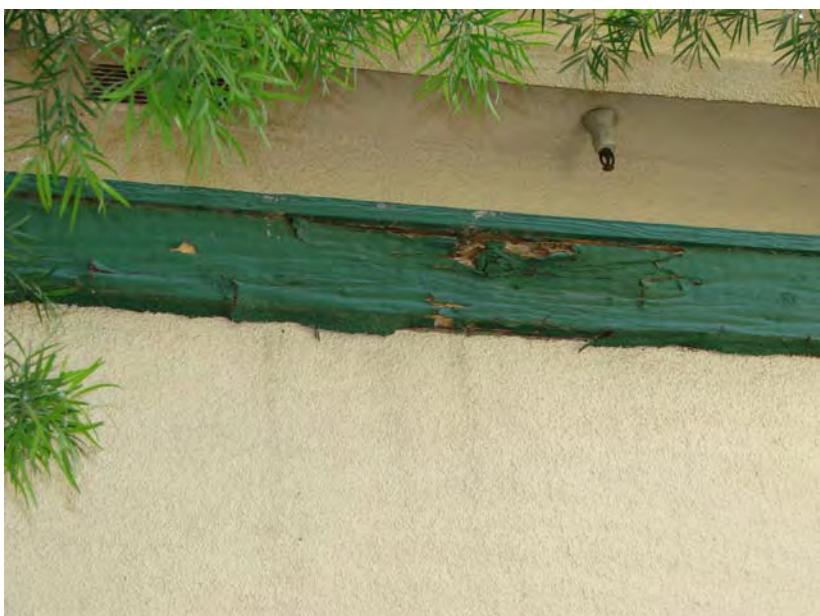
177 P_E: Detail - rotten wood trim on 2nd floor balconies.

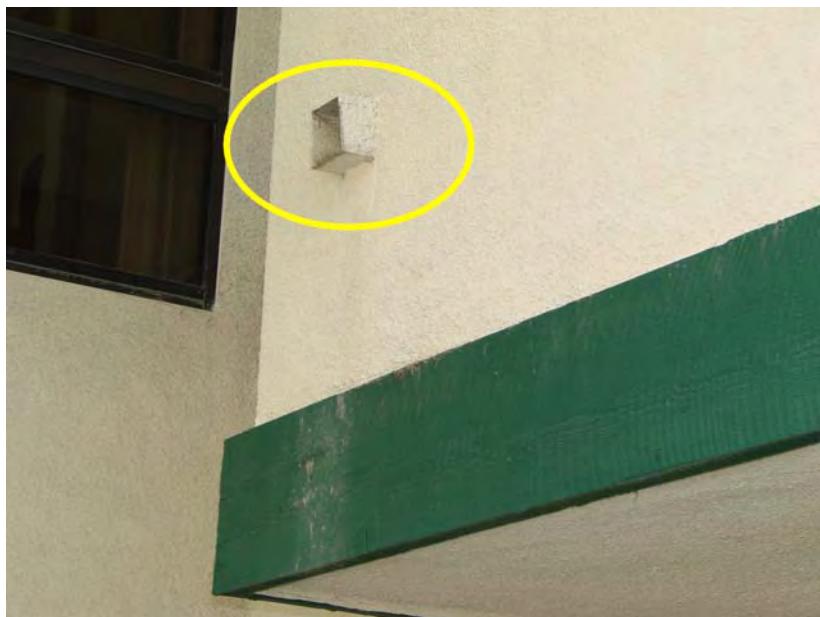
178 P_E: Detail - balcony drain. Consider adding drain scuppers to extend runoff beyond balcony wall.

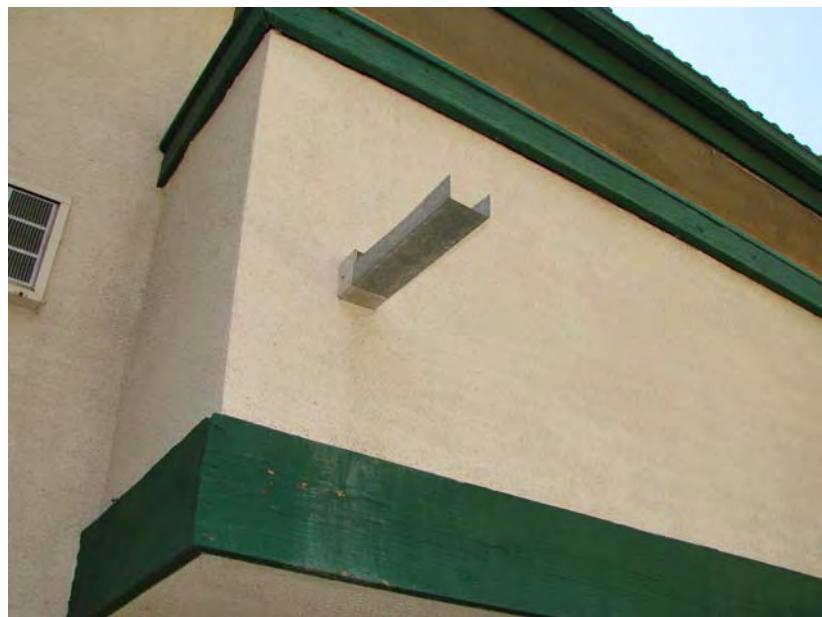
179 P_E: Balcony drain scupper with extension.

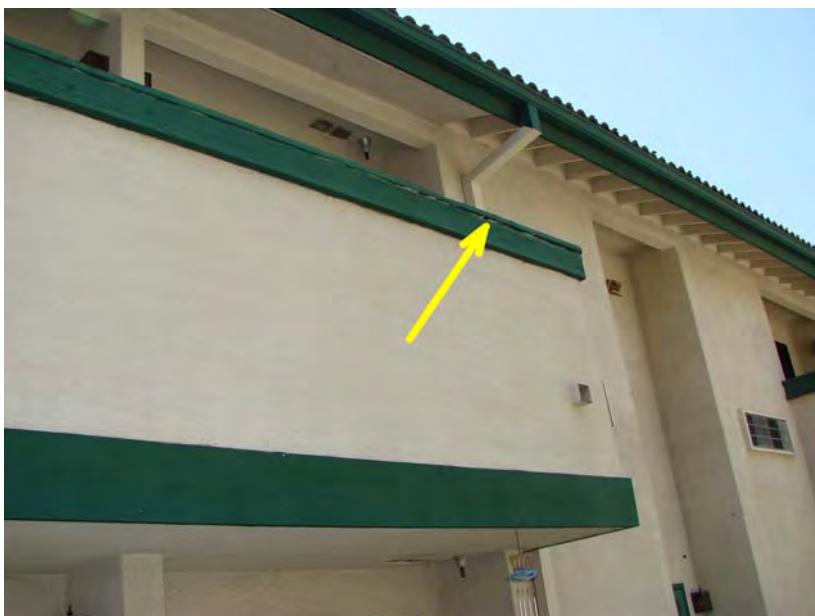
180 P_E: Detail - rotten wood trim on 2nd floor balconies.

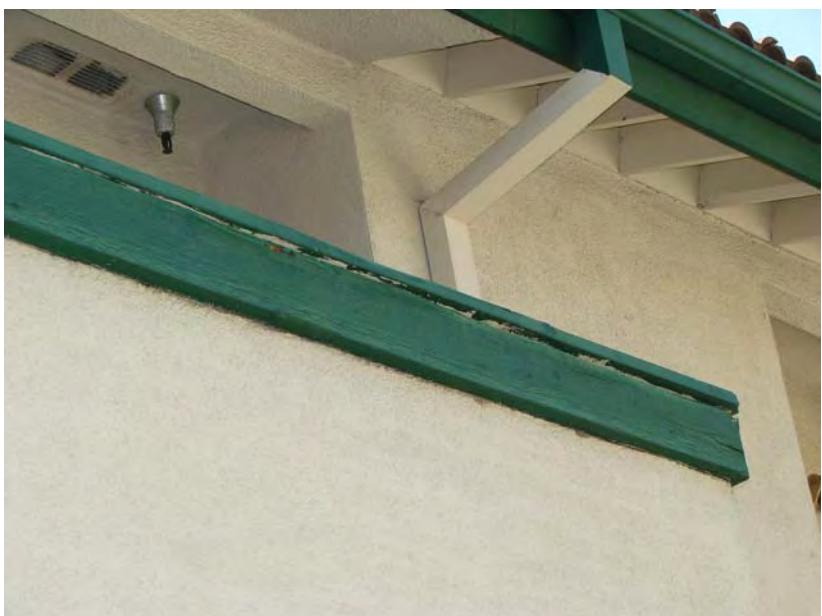
181 P_E: Detail - rotten wood trim on 2nd floor balconies.

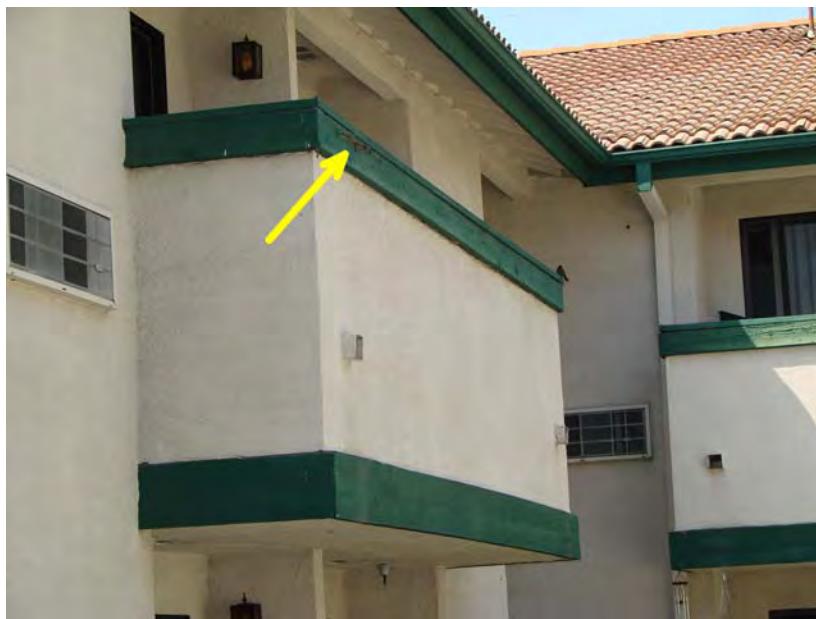
182 P_E: Detail - rotten wood trim on 2nd floor balconies.

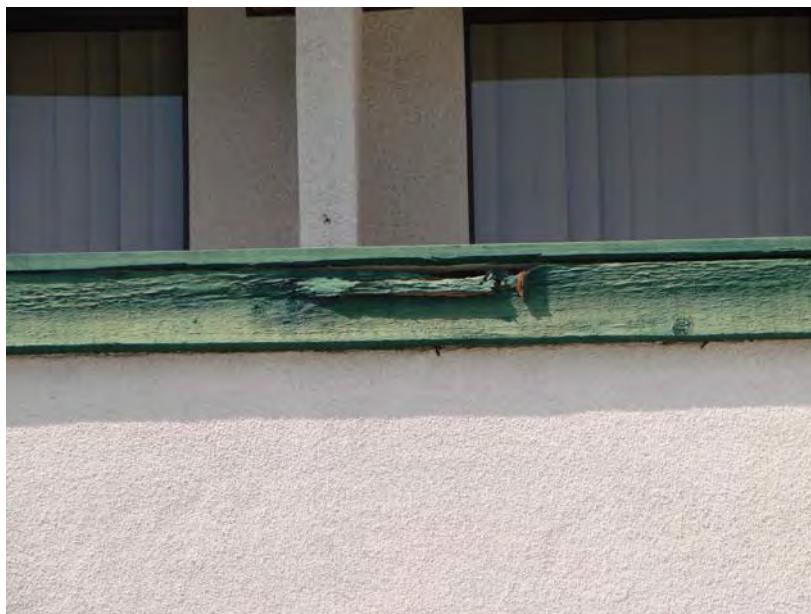
184 P_E: Detail - rotten wood trim on 2nd floor balconies.

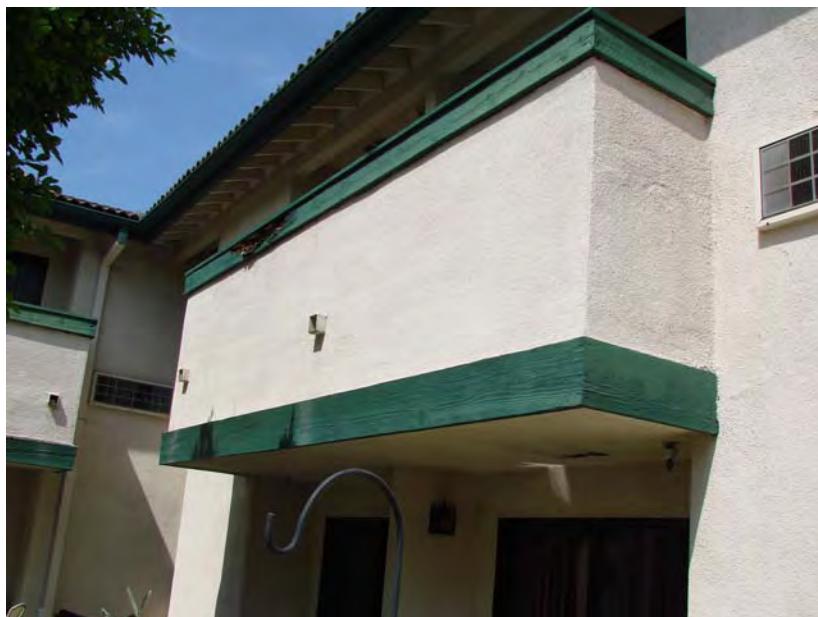
186 P_E: Detail - rotten wood trim on 2nd floor balconies.

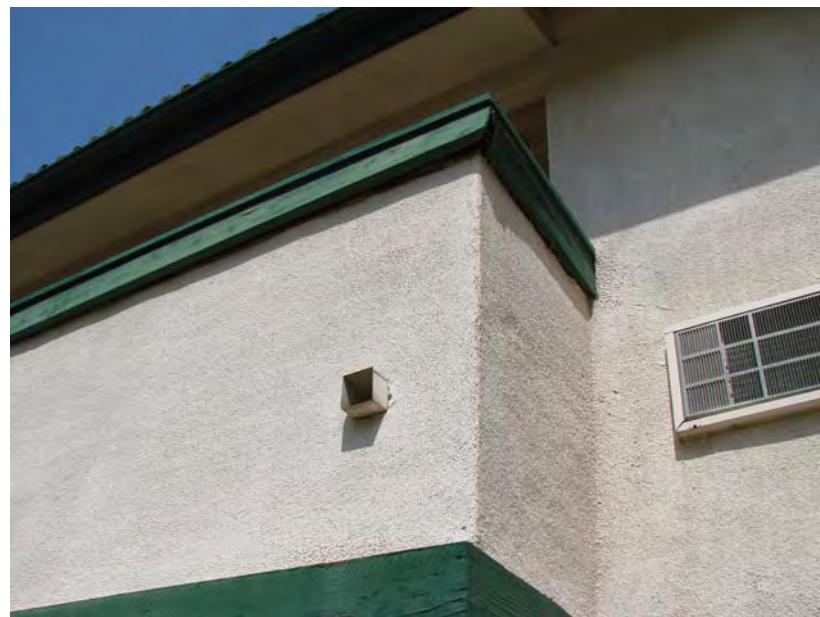
187 P_E: Detail - rotten wood trim on 2nd floor balconies.

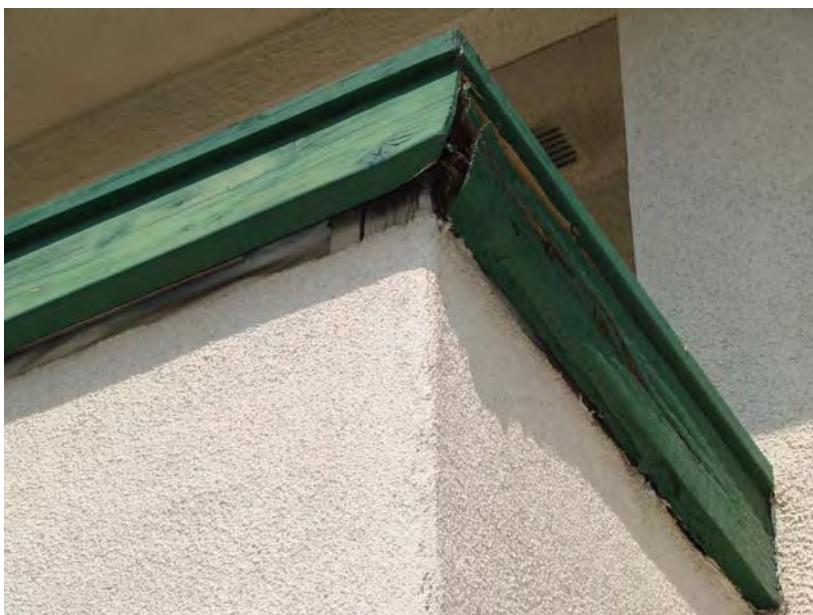
188 P_E: Detail - rotten wood trim on 2nd floor balconies.

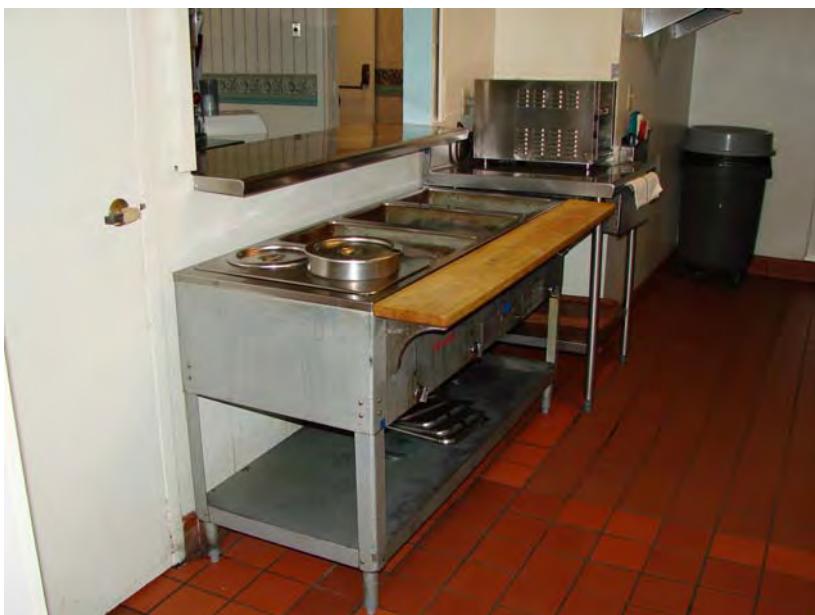
016 P_W: Aerohot steam table - consider replacing.

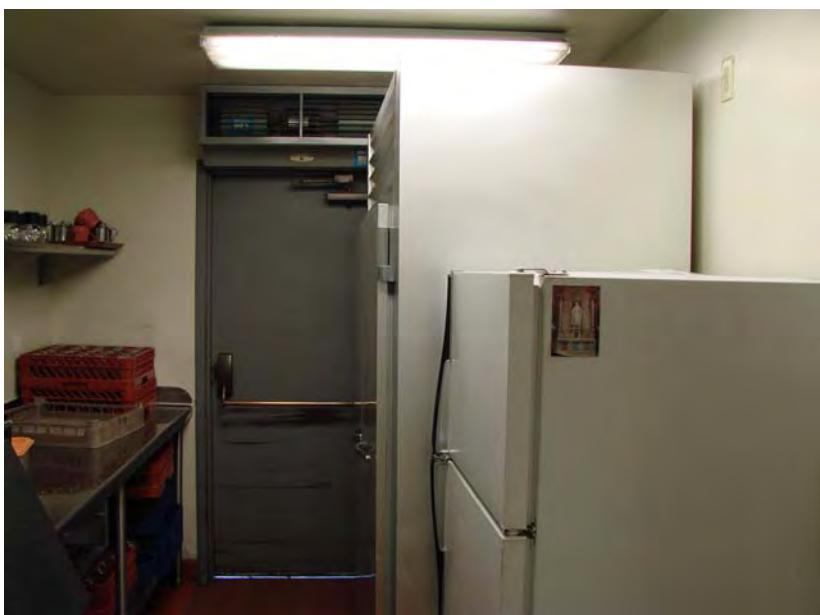
021 P_W: Kitchen - residential refrigerator, Traulsen 2-door freezer. (Note - freezer compressor was replaced 5-2-07).

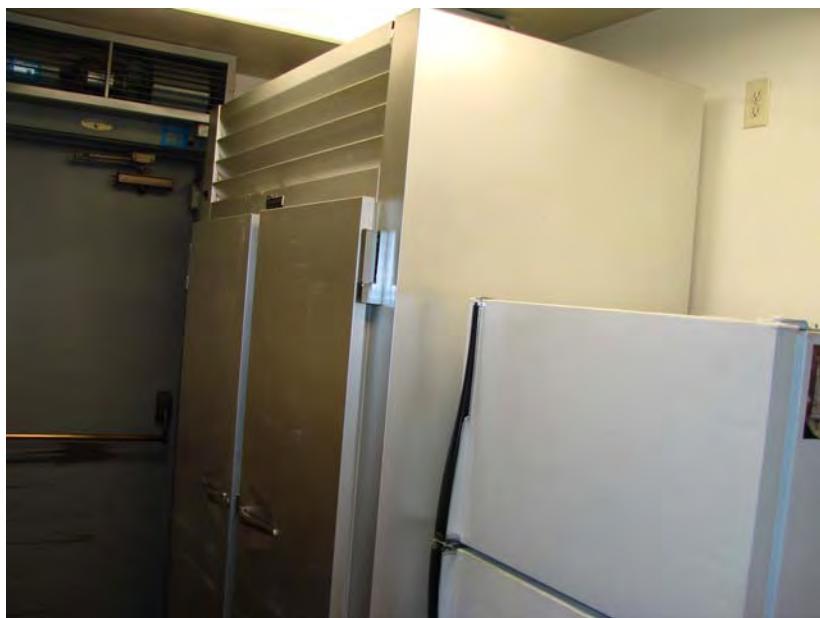
022 P_W: Kitchen - residential refrigerator, Traulsen 2-door freezer. (Note - freezer compressor was replaced 5-2-07).

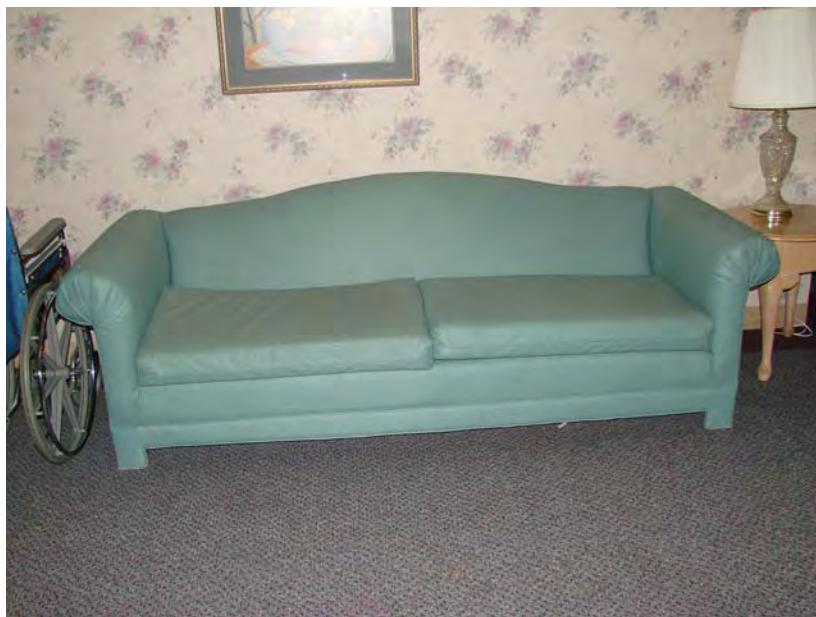
030 P_W: Living room - dated furniture.

10 Replace living room furniture. \$ 15,000

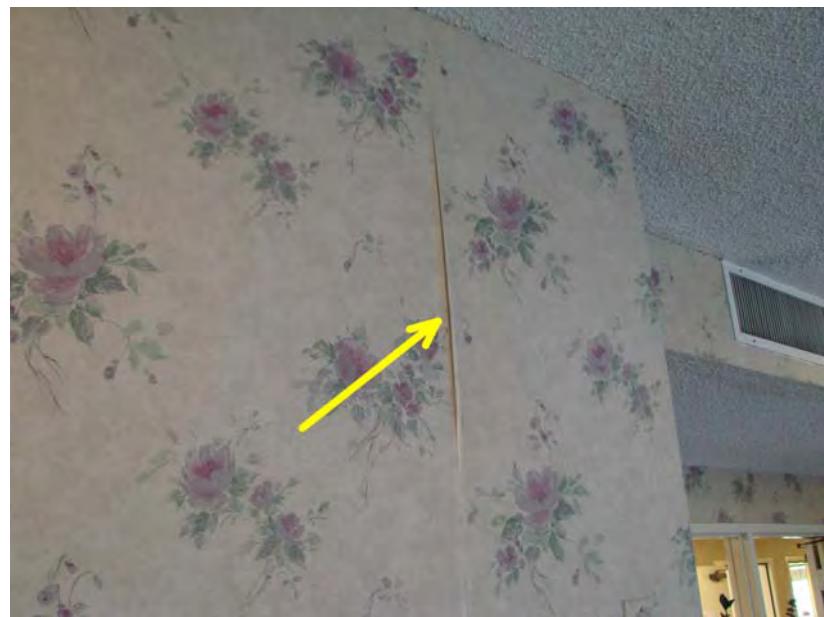
031 P_W: Living room - peeling wallpaper.

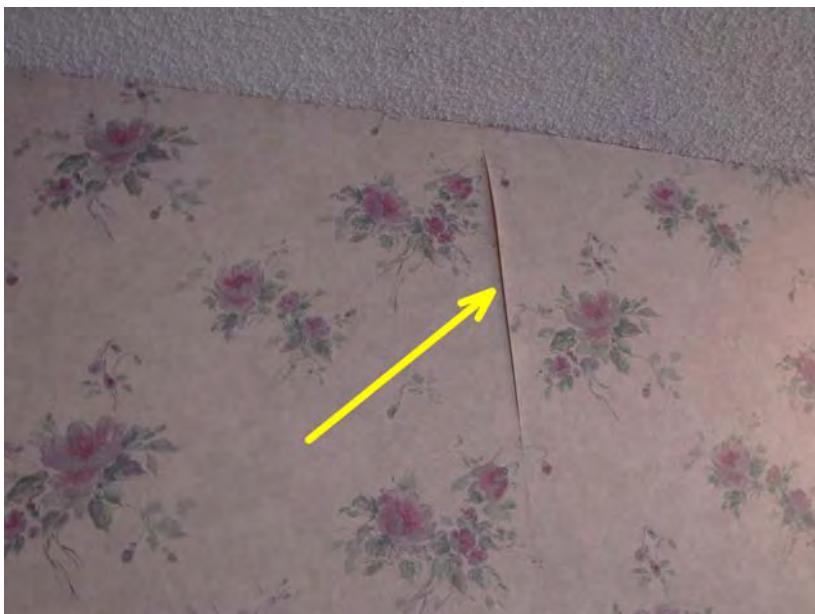
032 P_W: Living room - peeling wallpaper.

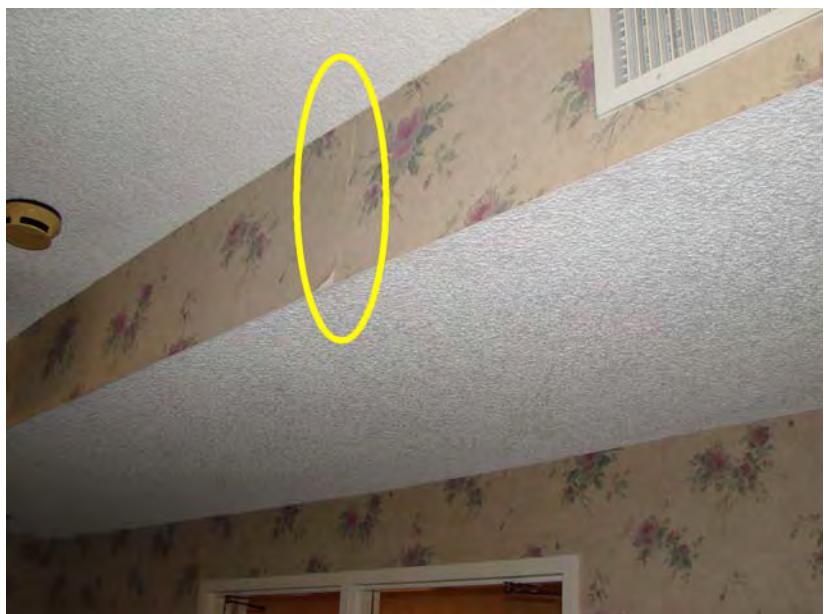
033 P_W: Living room - peeling wallpaper.

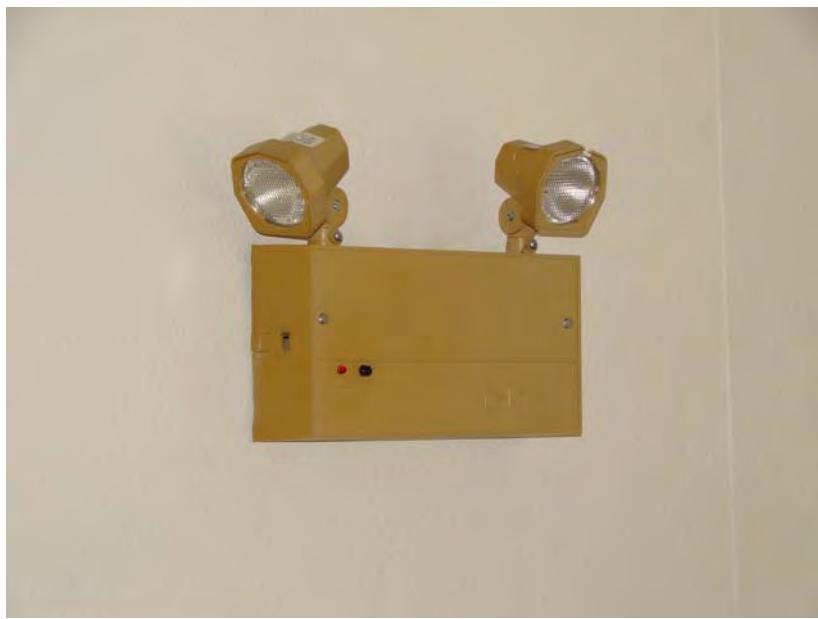
035 P_W: Original fixture - battery backup emergency lighting, some are being replaced.

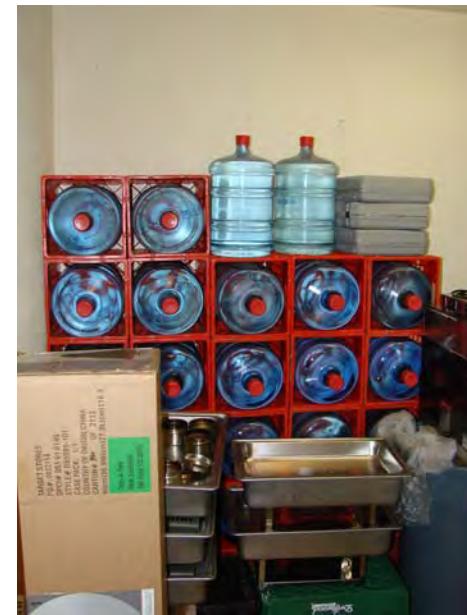
043 P_W: 2nd floor storage closet - emergency water supply. (note - maint. supv. did not know age of water canisters or rotation schedule.)

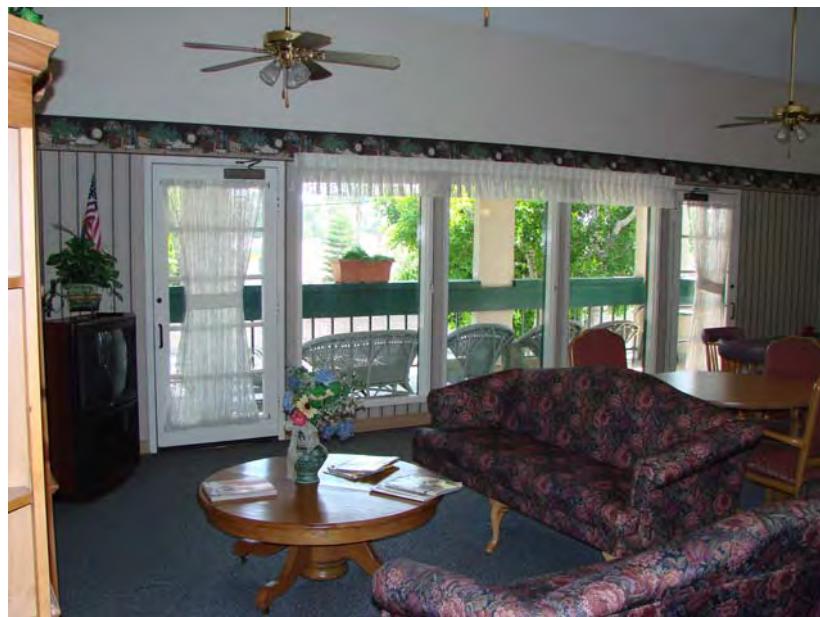
048 P_W: Detail - poor floor base installation.

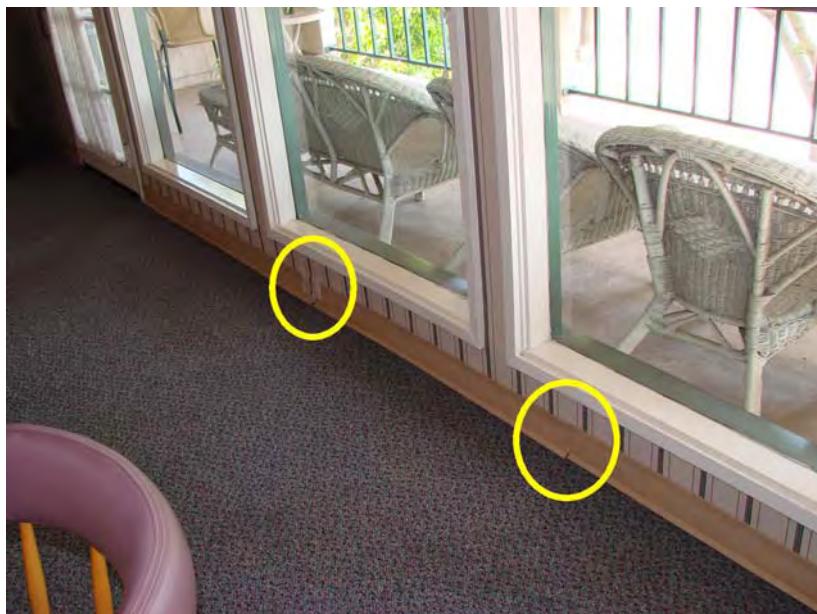
049 P_W: Detail - poor floor base installation.

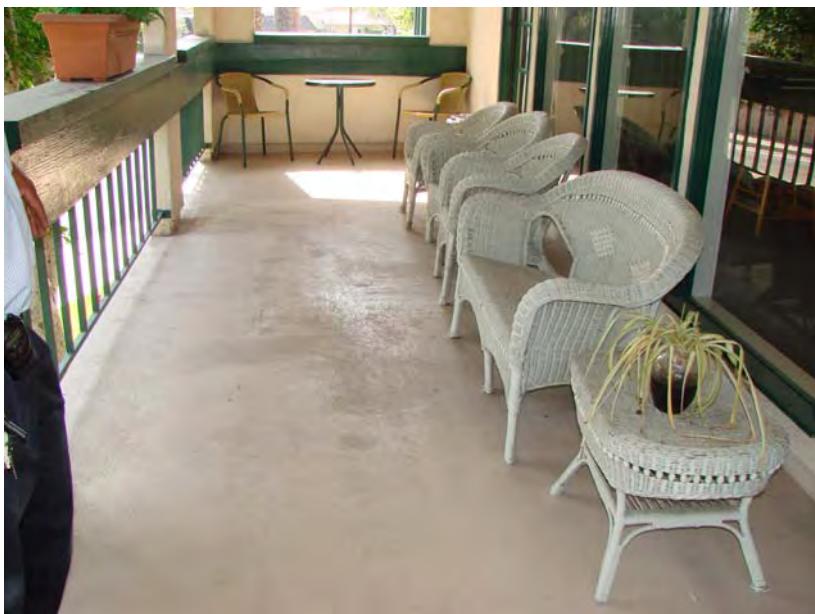
053 P_W: Detail - unusual floor topography on 2nd floor patio.

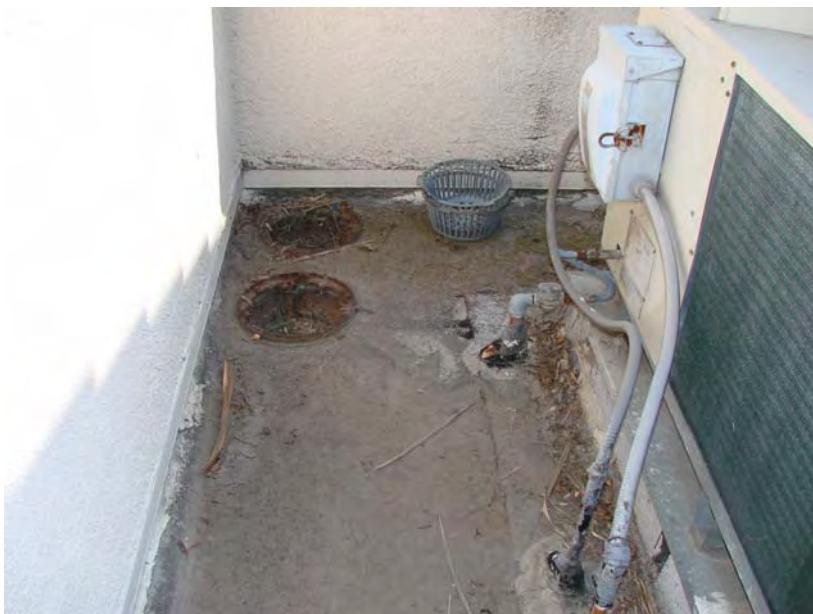
056 P_W: Roof drain in roof well - note drain covers out of place.

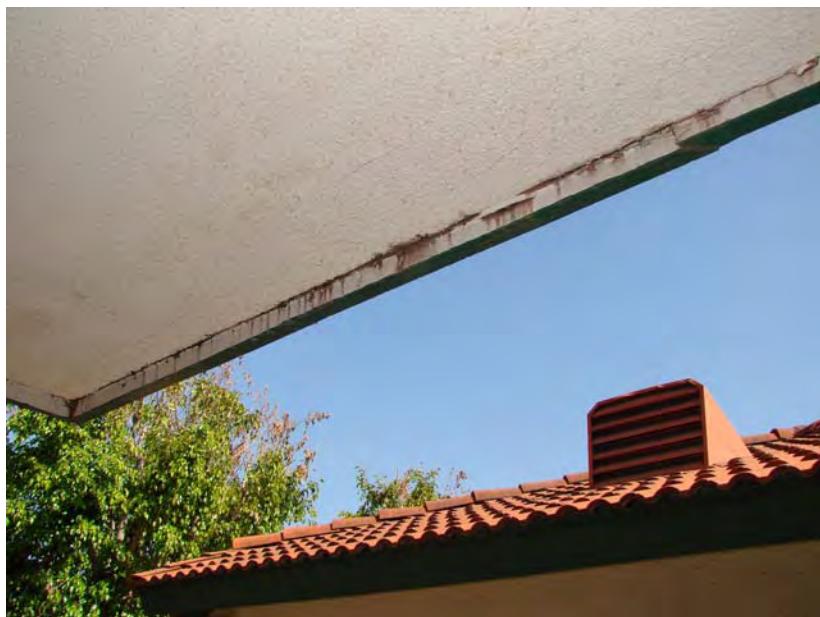
070 P_W: Rotten wood trim on 2nd floor balcony - water penetration behind wood.

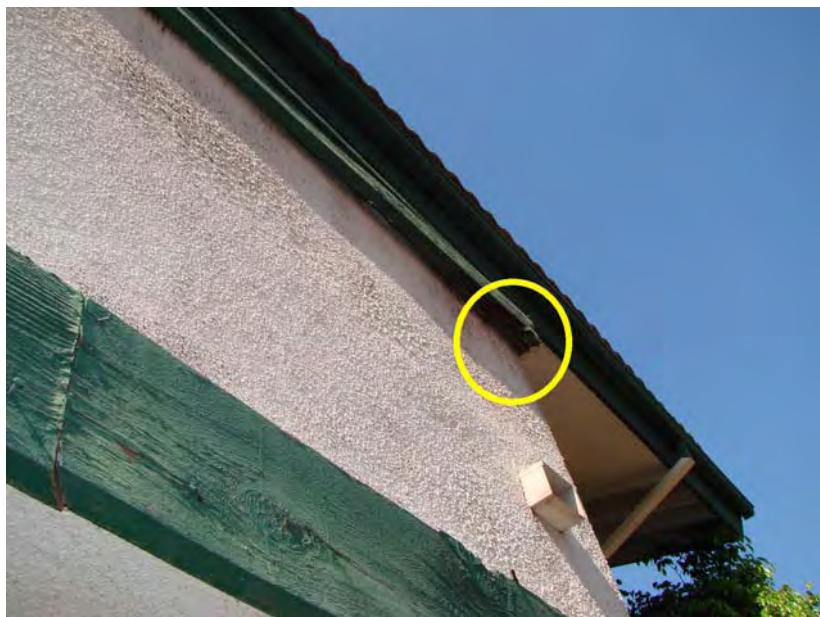
071 P_W: Detail - rotten wood trim on 2nd floor balconies.

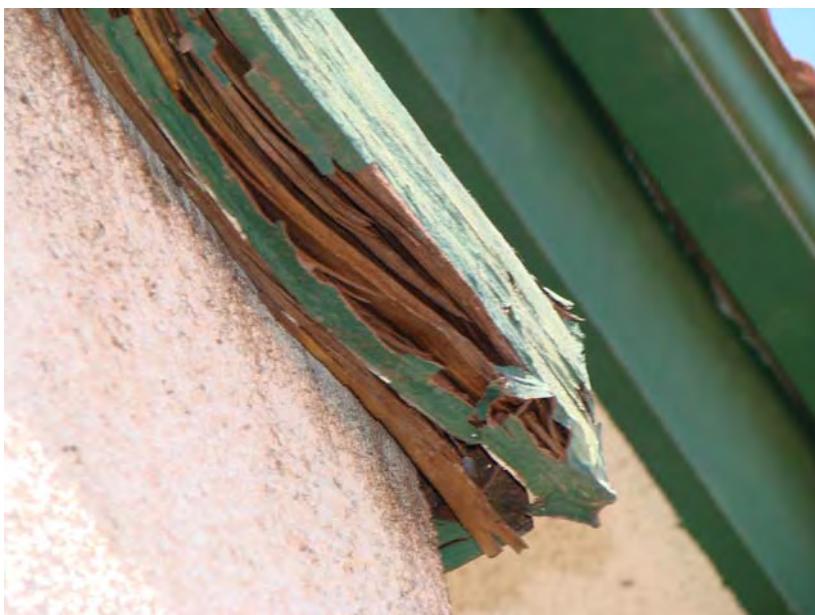
072 P_W: Detail - rotten wood trim on 2nd floor balconies.

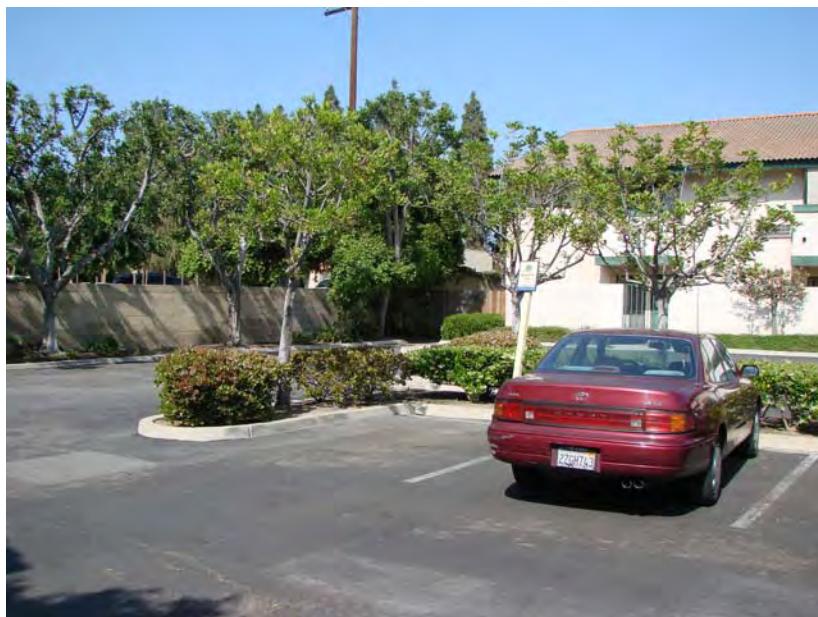
074 P_W: Parking between buildings - northwest elevation of Palm East.

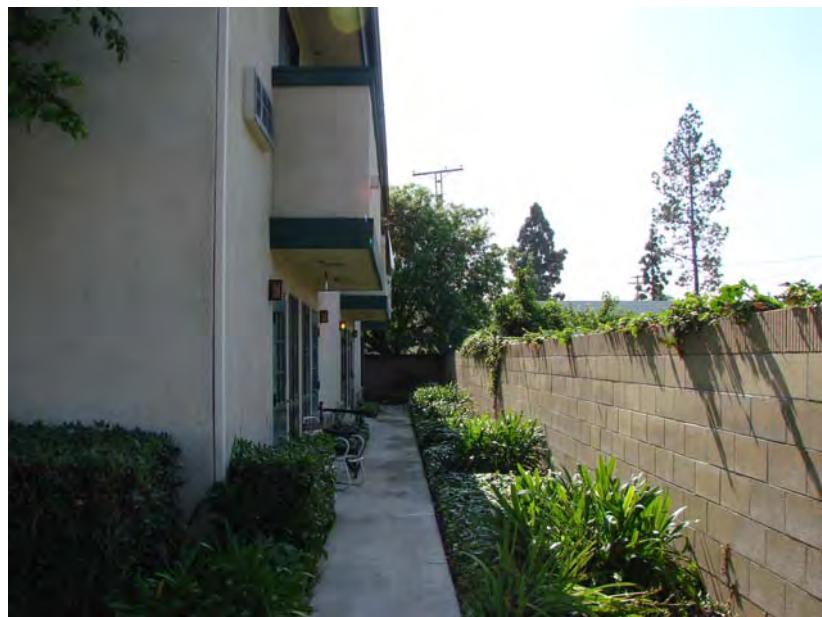
075 P_W: North elevation of Palm West looking west.

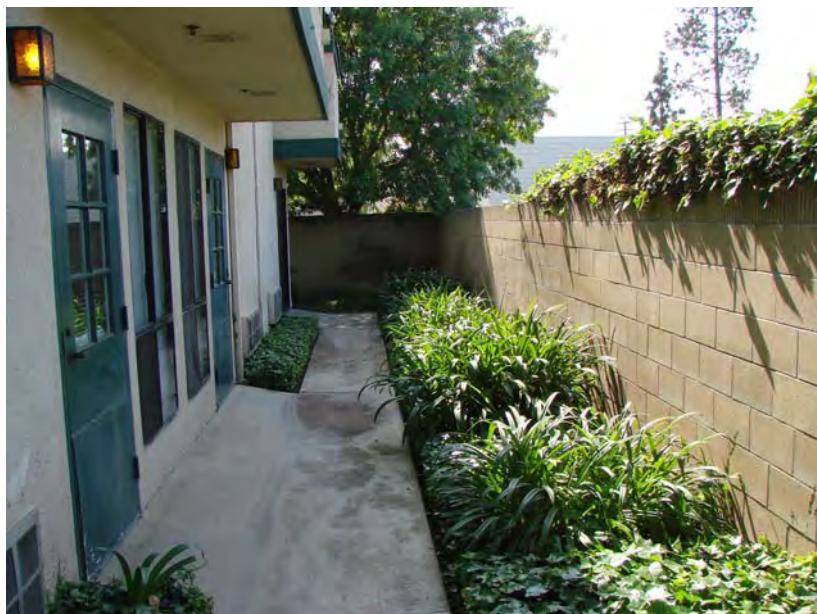
076 P_W: Sidewalk detail - slopes away from building, appears to pond some water.

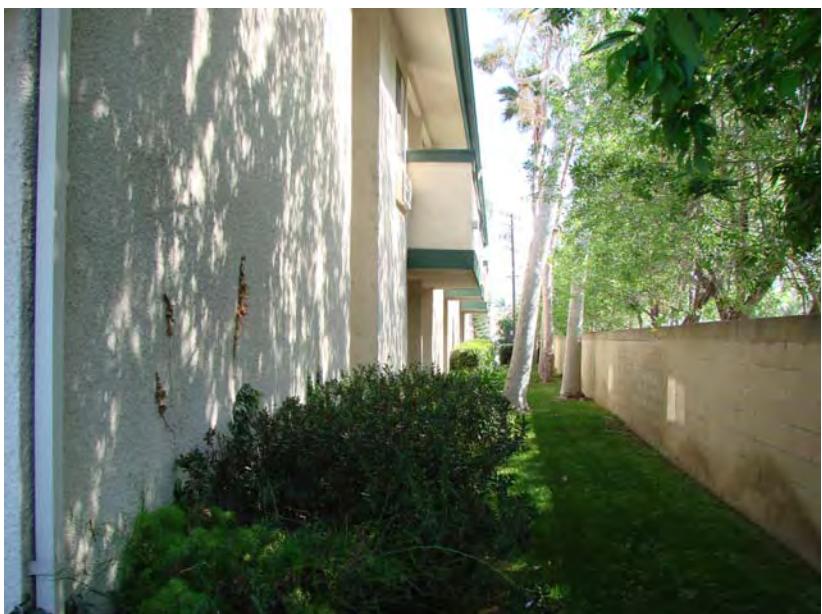
077 P_W: Palm West west elevation looking south.

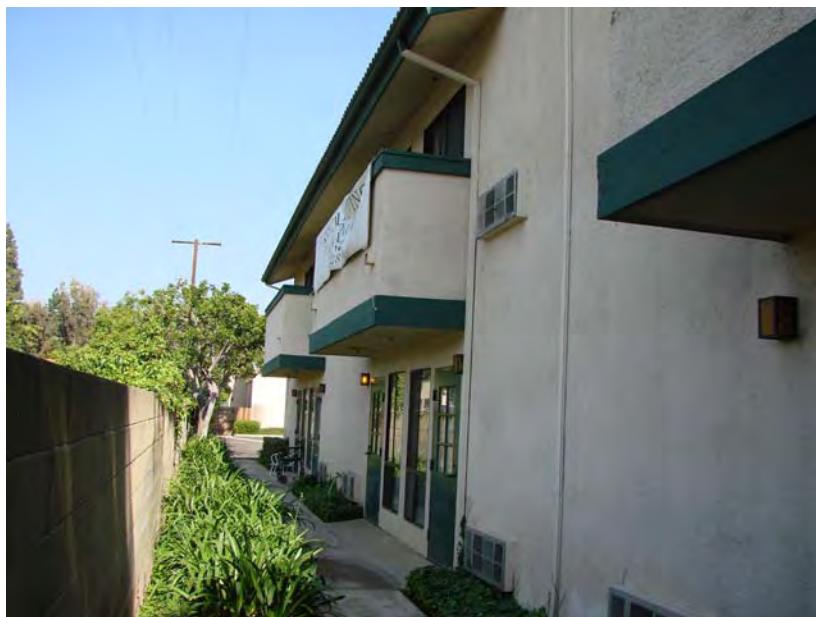
078 P_W: Marketing sign on balcony overlooking north property line.

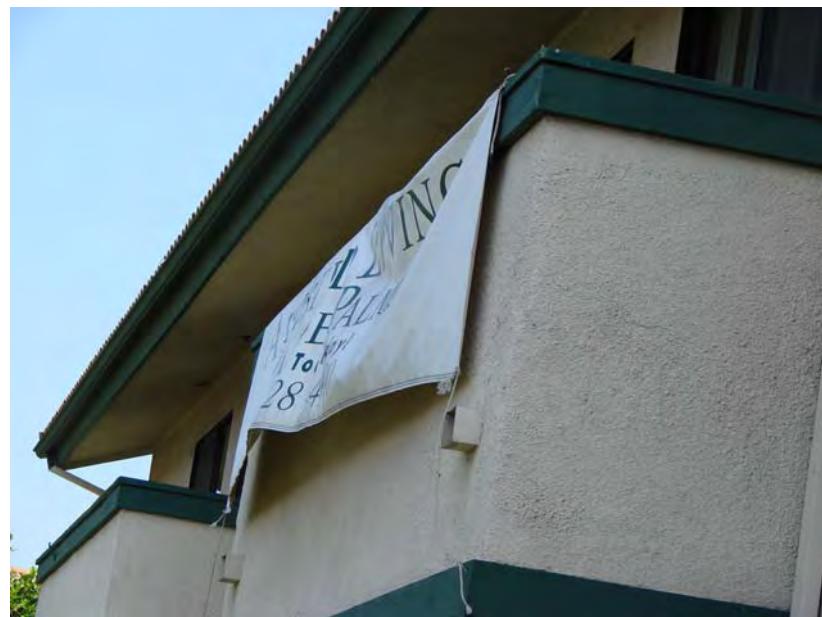
079 P_W: Marketing sign on balcony overlooking north property line.

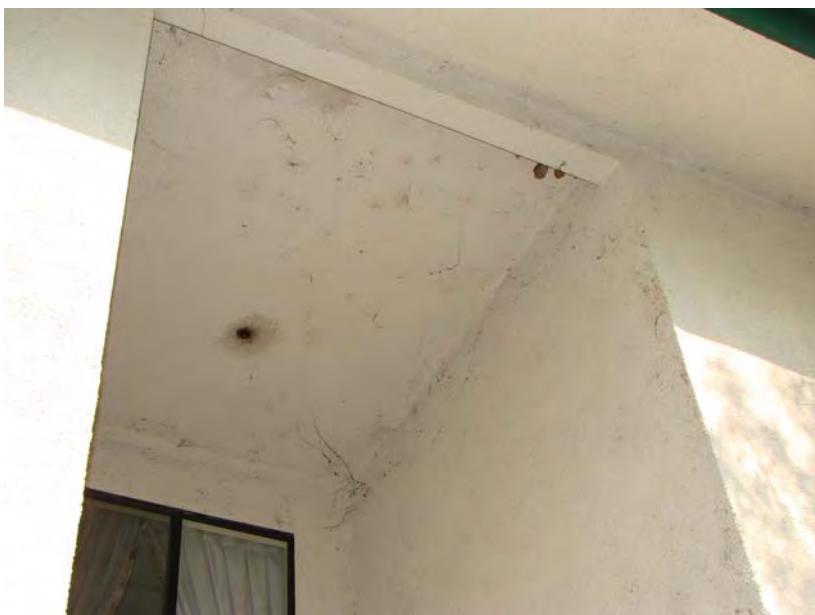
080 P_W: Spider webs in exterior alcove - building exterior should be pressure washed.

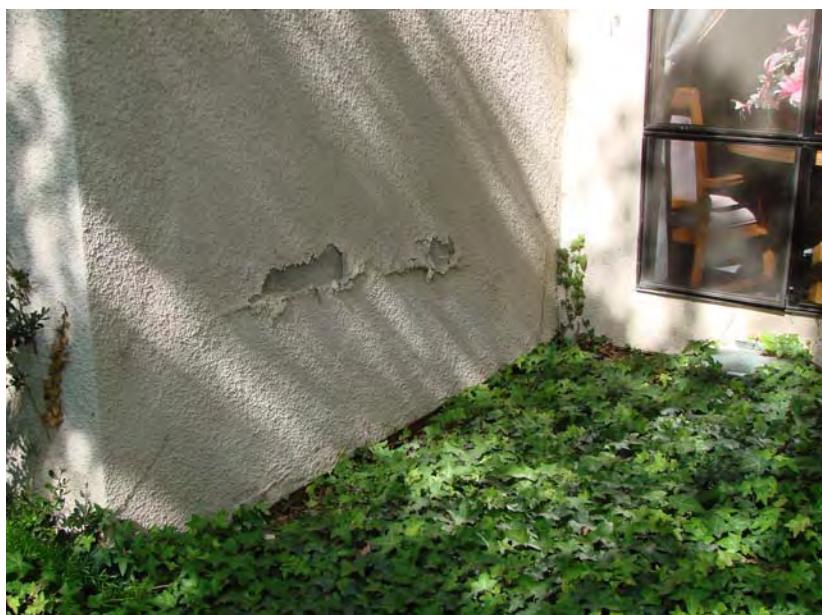
081 P_W: Exterior finish coming off building.

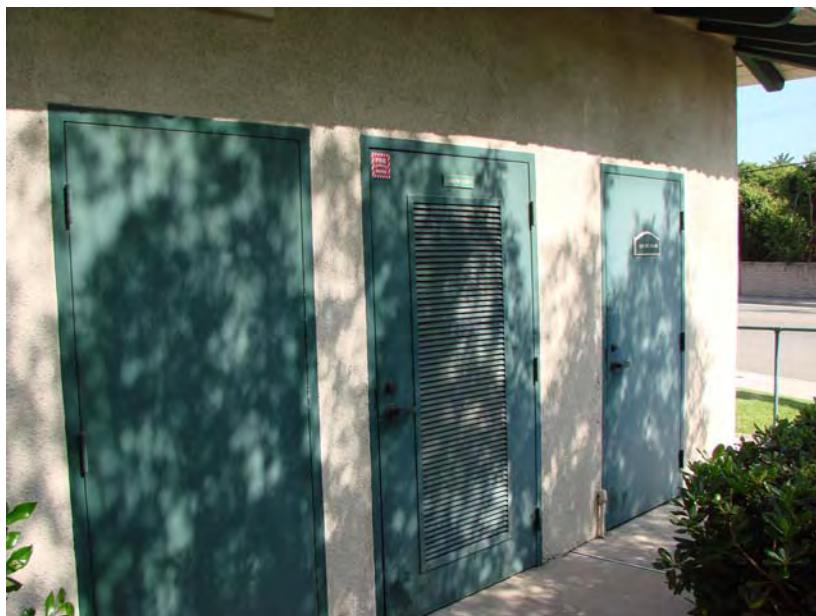
082 P_W: Electrical closet & elevator equipment rooms.

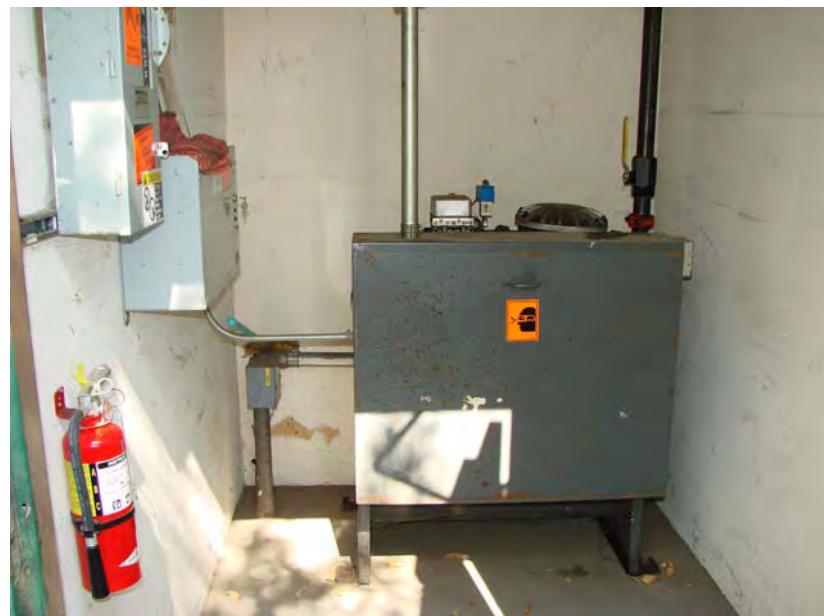
083 P_W: Hydraulic elevator equipment room.

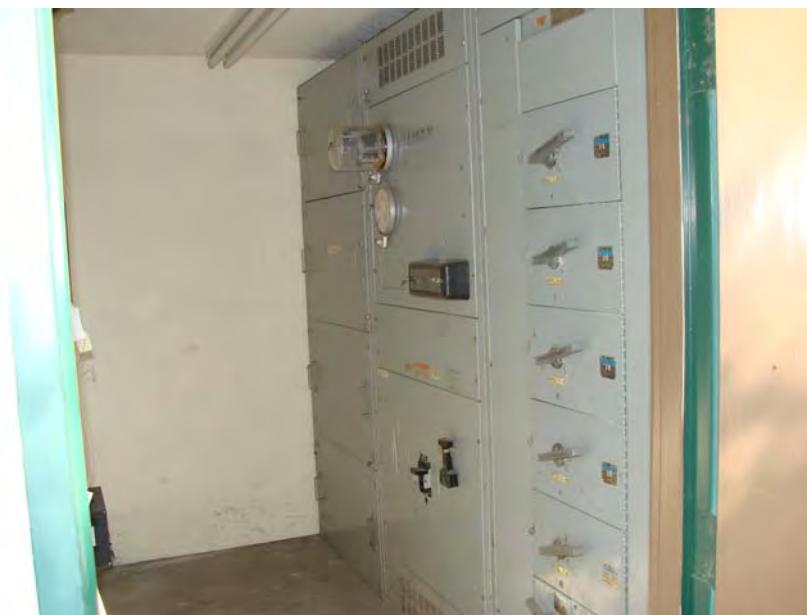
084 P_W: Main electric service - 1000 Amp main panel.

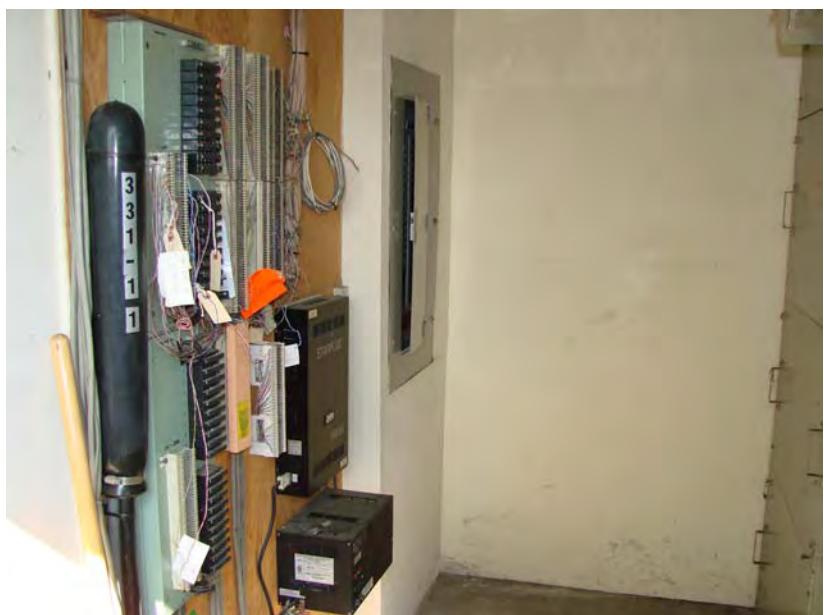
085 P_W: Main telephone patch panel in electrical room.
