PROPERTY CONDITION REPORT OUTLINE

May 2, 2007

The Palms

Prepared for:
No. 1 LTC Operator, Anytown, USA

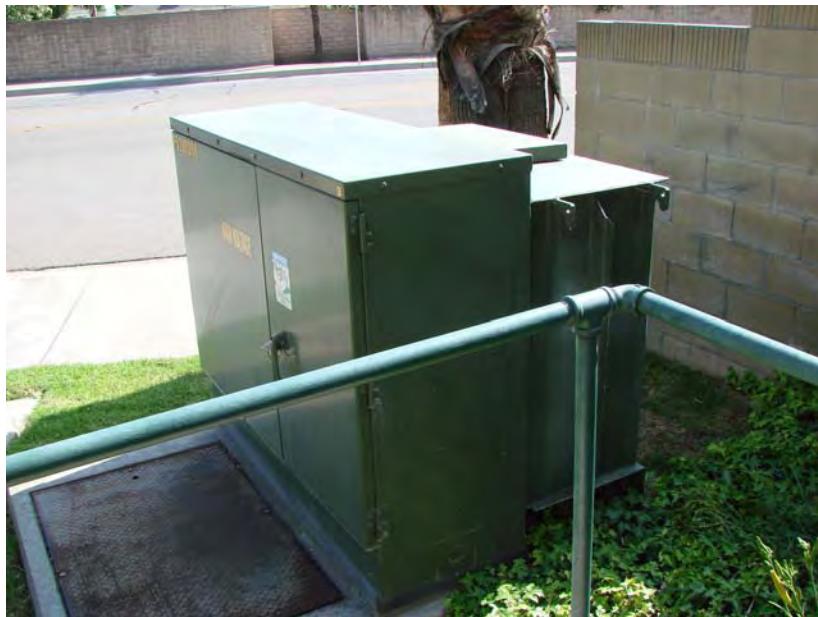
086 P_W: Pad mounted electrical transformer.

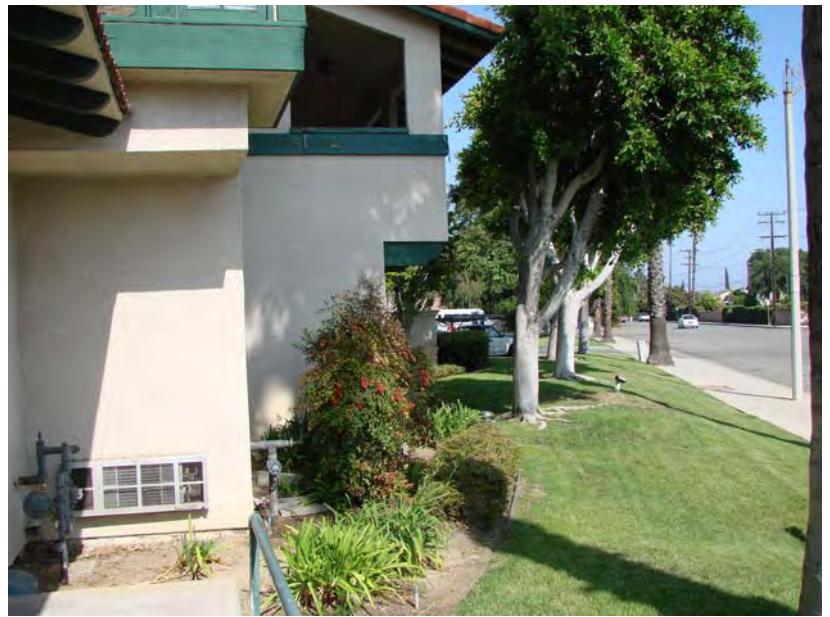
087 P_W: Southwest property line looking east along road frontage.

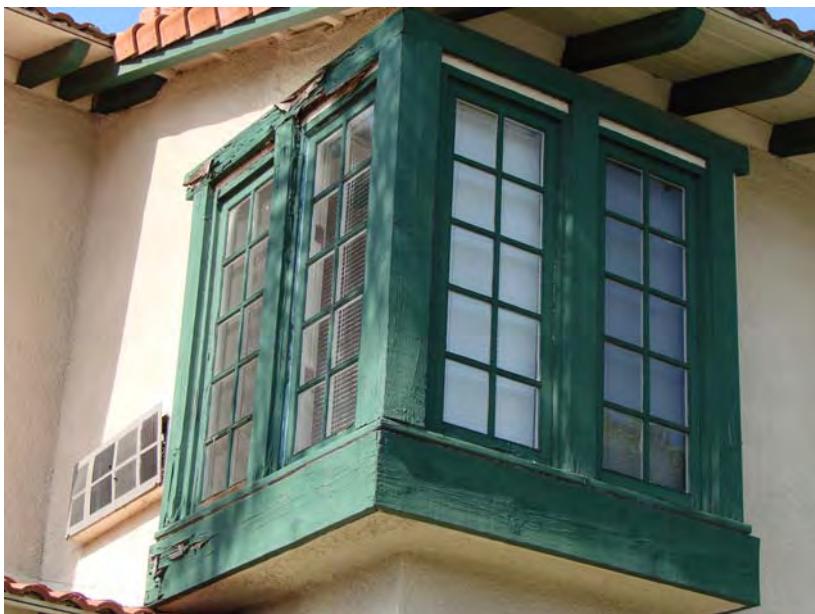
088 P_W: Rotten wood trim on windows.

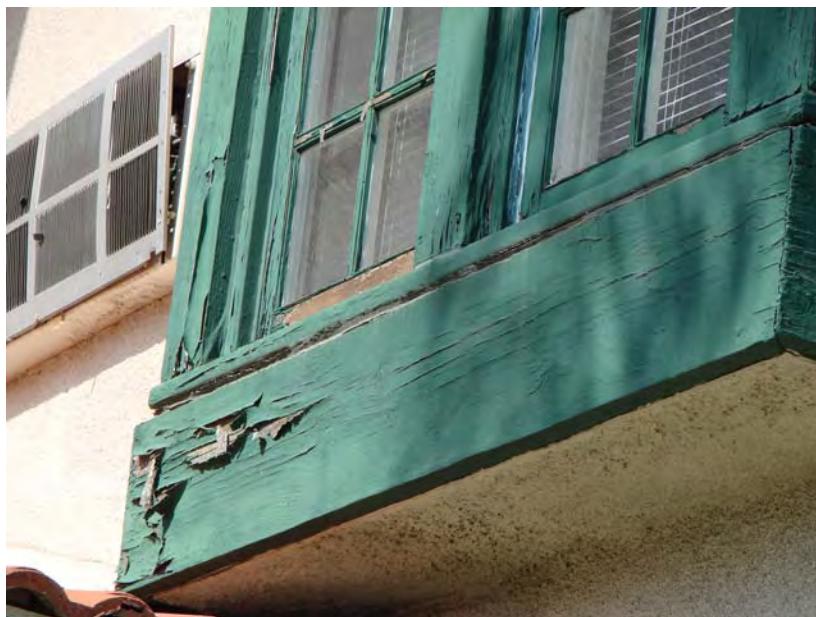
090 P_W: Rotten wood trim on windows.

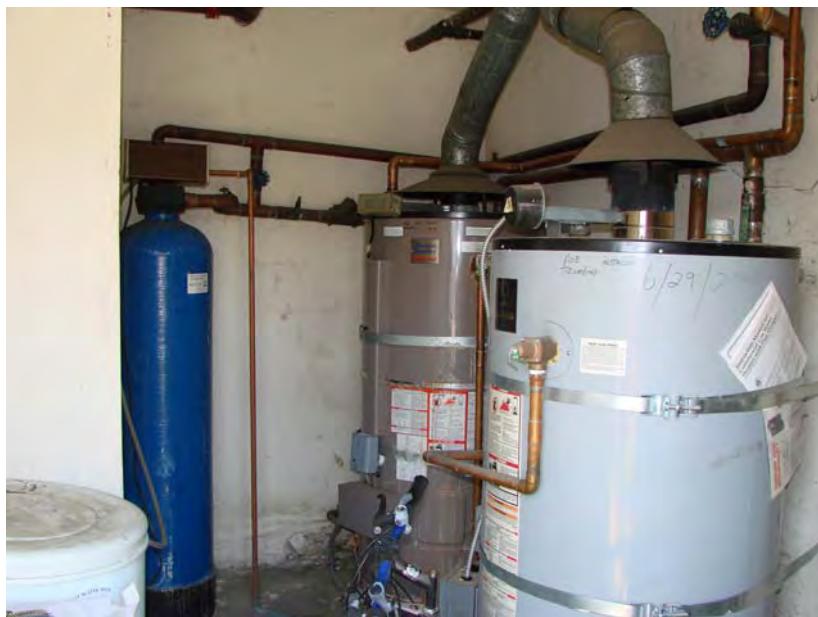
091 P_W: American Standard & State 100-gallon water heaters with water treatment system.

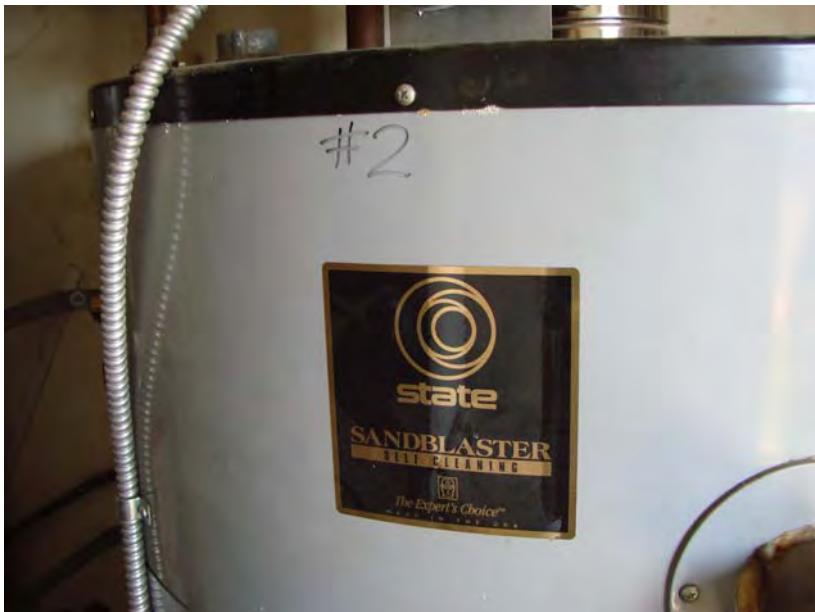
092 P_W: State water heater (#2), 100-gal, 260,000 BTUH.

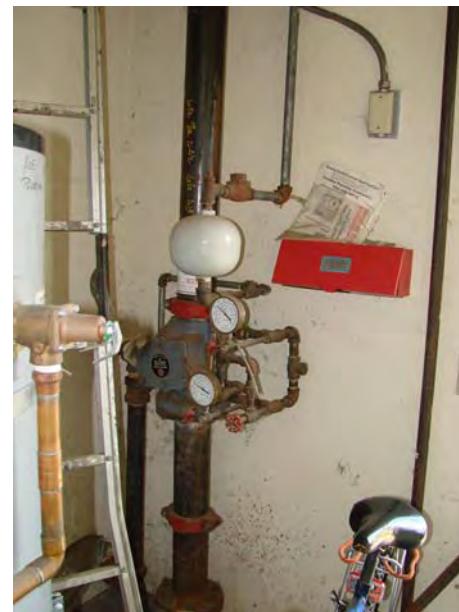
097 P_W: Fire sprinkler riser.

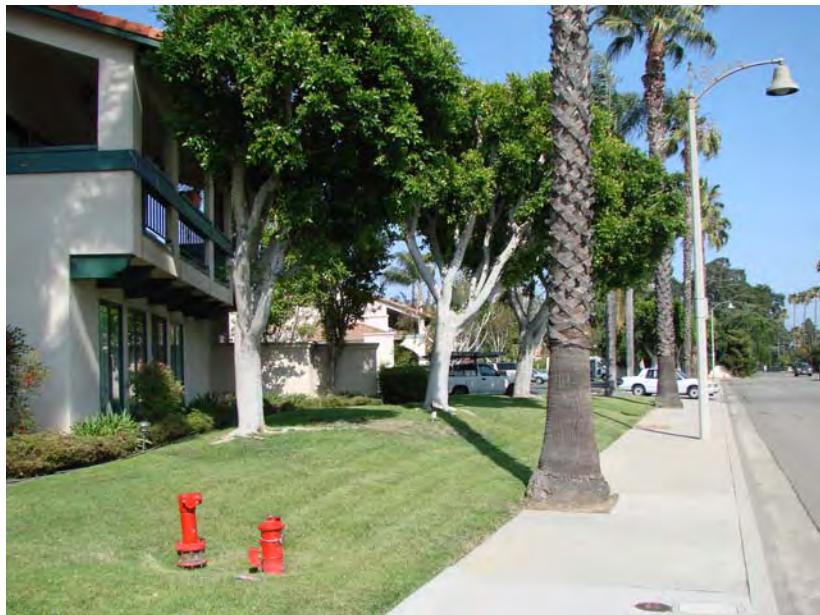
098 P_W: Southwest property line looking east along road frontage. Fire stand pipe.
