# The Palms: Before ~ After Photos

351 East Palm Drive, Anytown, USA 01995

Anytown, USA; July 31, 2009

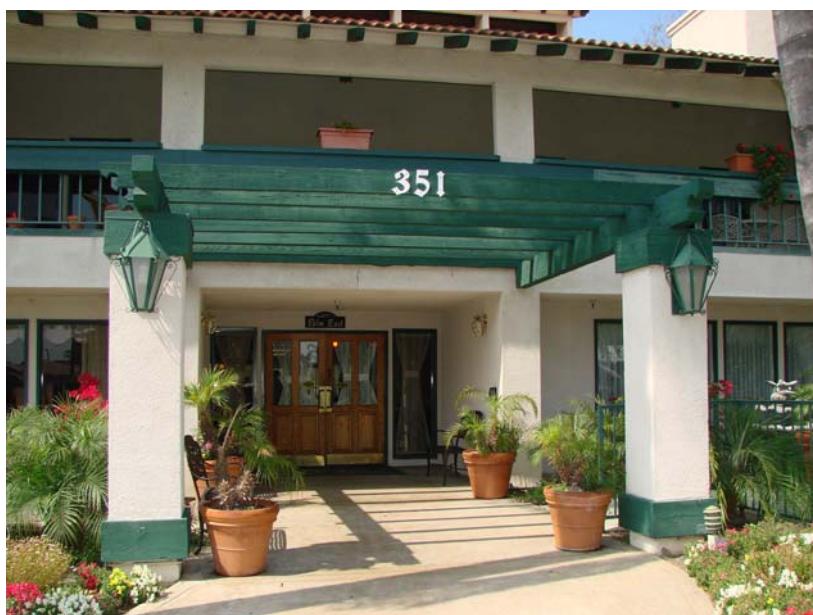
03-2007-05-02\_006 P\_E: Before - Main entrance to Palm East.

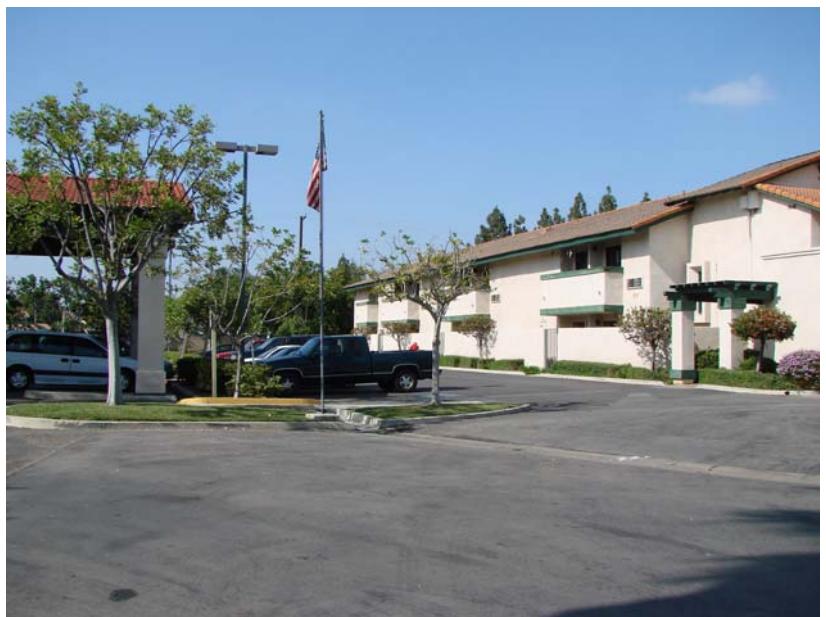
06-2007-05-02\_013 P\_E: Before - West elevation of Palm East (looking north).

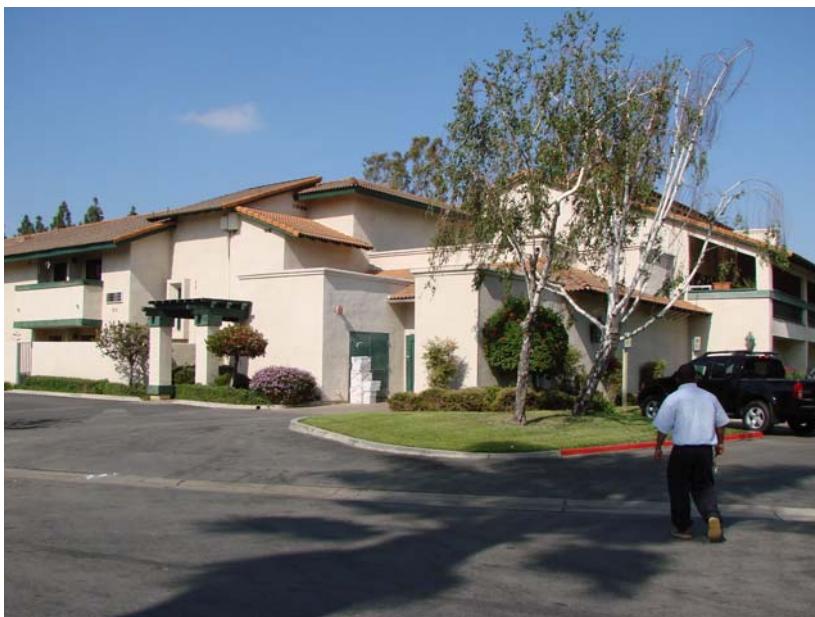
07-2007-05-02\_014 P\_E: Before - Palm East service entrance - water heater room & kitchen delivery area.

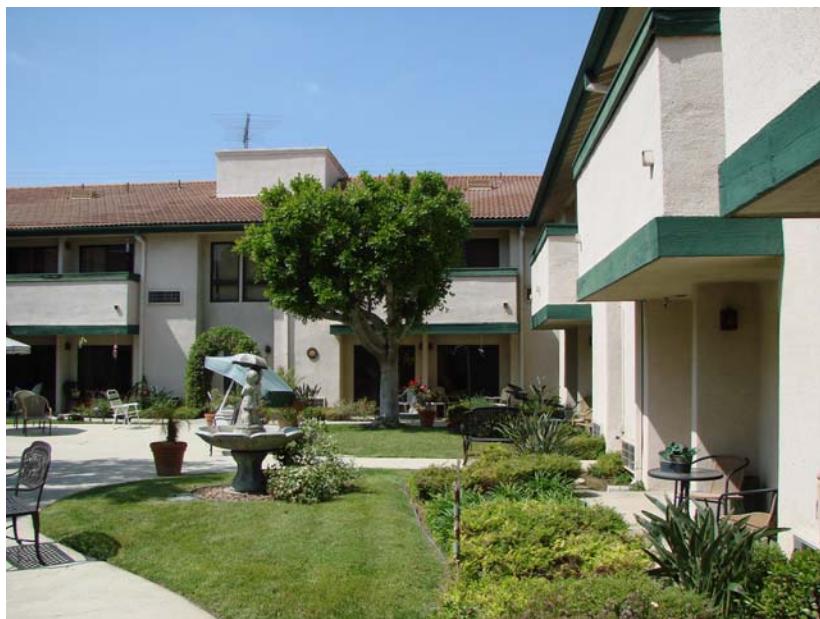
13-2007-05-02\_158 P\_E: Before - Interior courtyard.

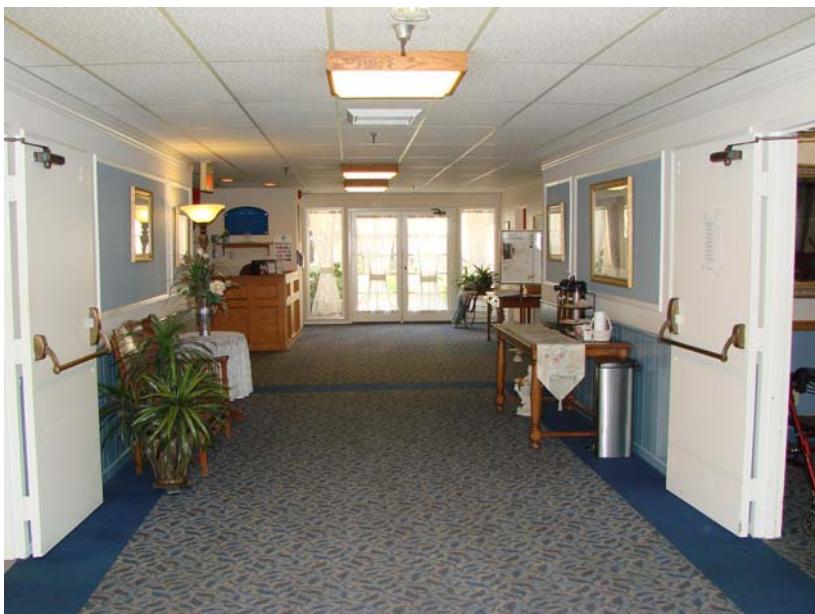
19-2007-05-02\_054 P\_E: Before - Front entry with reception desk and door into courtyard.

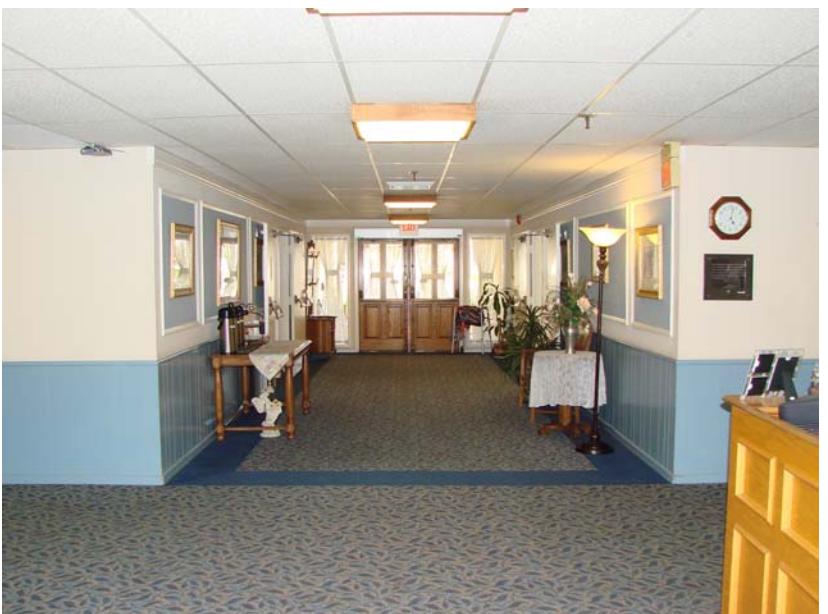
20-2007-05-02\_053 P\_E: Before - Front entry.

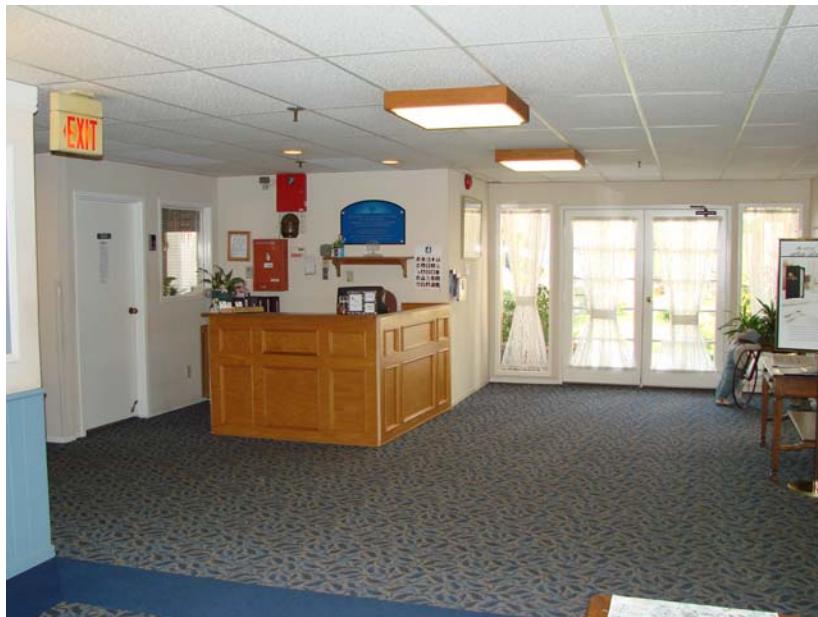
21-2007-05-02\_055 P\_E: Before - Reception desk at Palm East entrance.

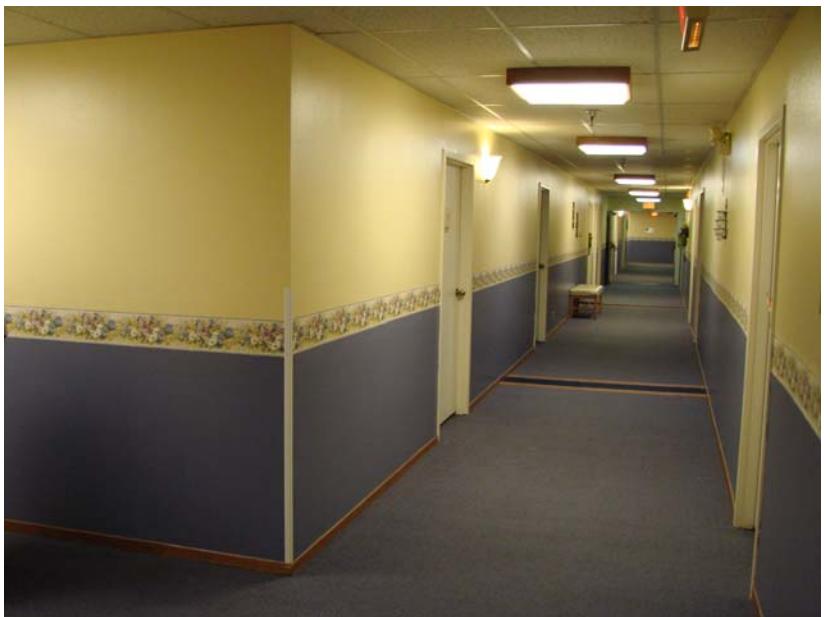
24-2007-05-02\_119 P\_E: Before - 2nd floor West Hall looking south.

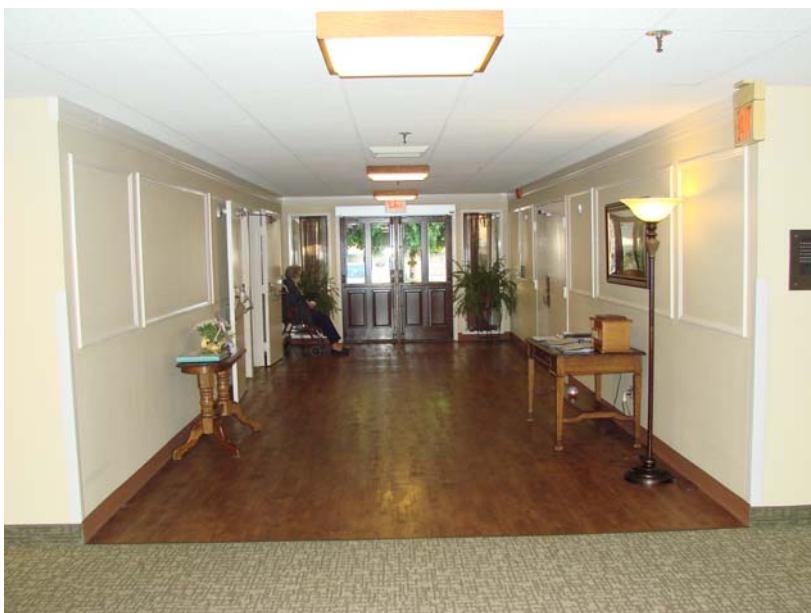
27-2009-07-31\_DSC09270: After - Main entrance & corridors

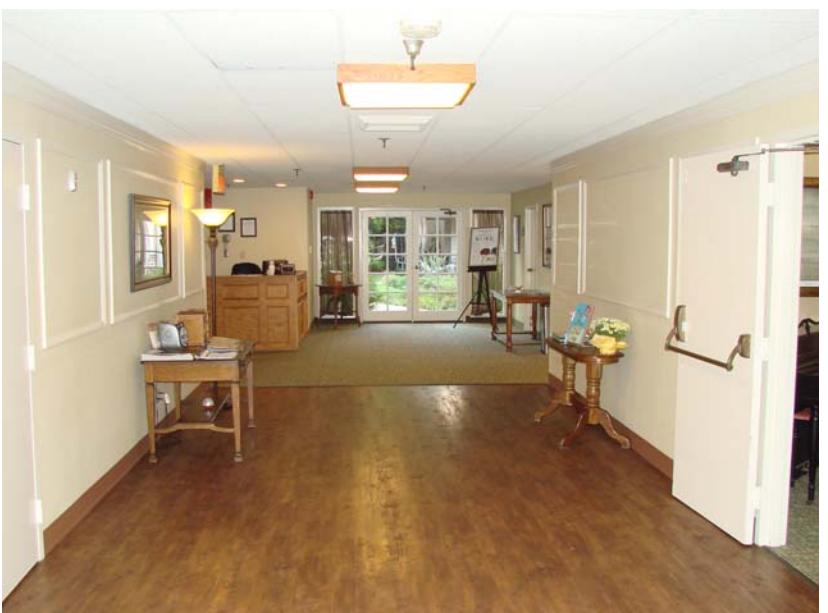
28-2009-07-31\_DSC09271: After - Main entrance & corridors

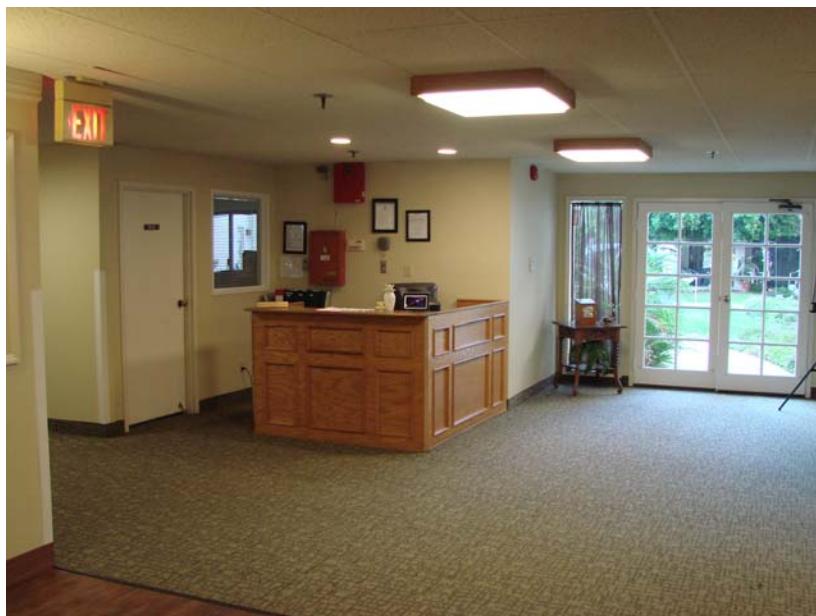
29-2009-07-31\_DSC09274: After - Main entrance & corridors

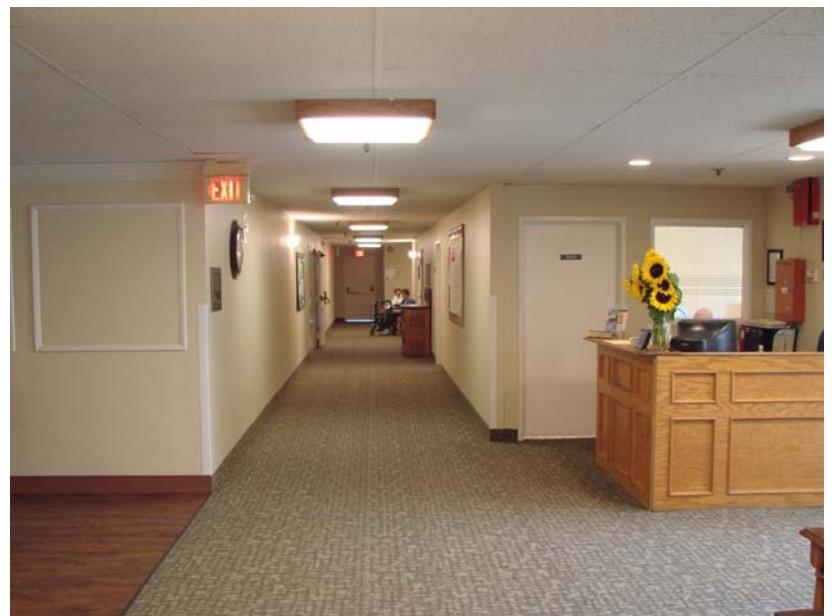
30-2009-04-23\_DSC09302: After - Main entrance & corridors

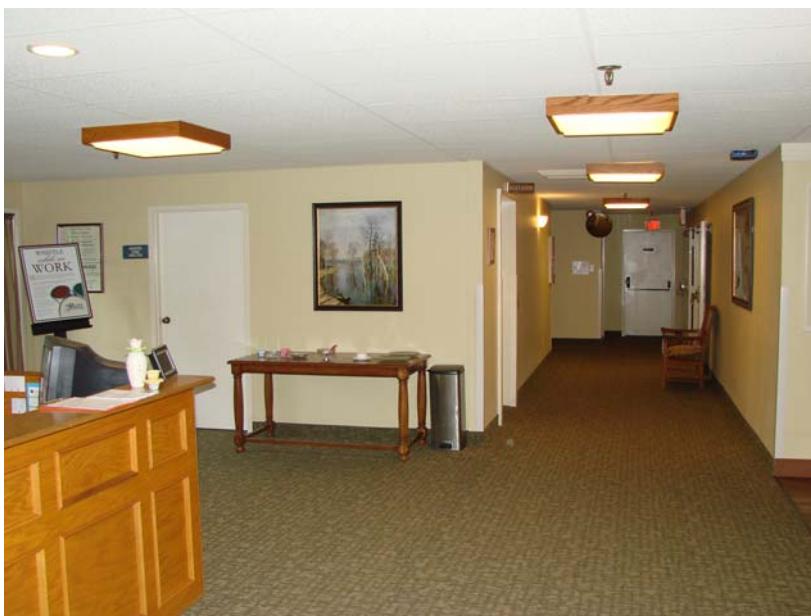
31-2009-07-31\_DSC09278: After - Main entrance & corridors

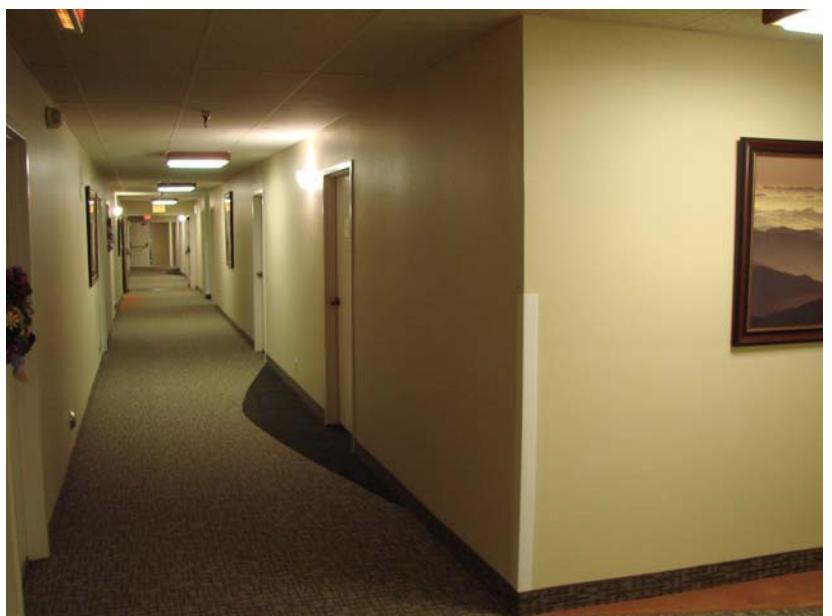
32-2009-07-31\_DSC09325: After - Main entrance & corridors

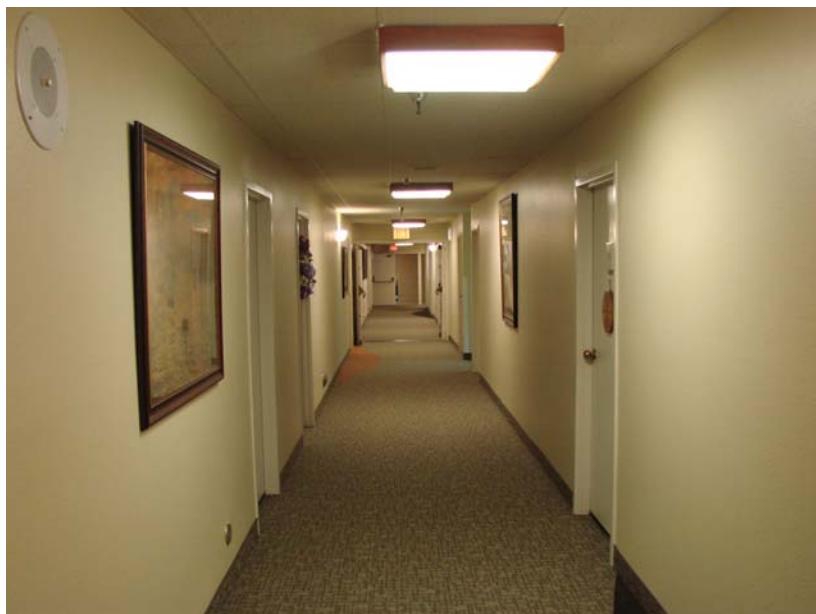
33-2009-07-31\_DSC09327: After - Main entrance & corridors

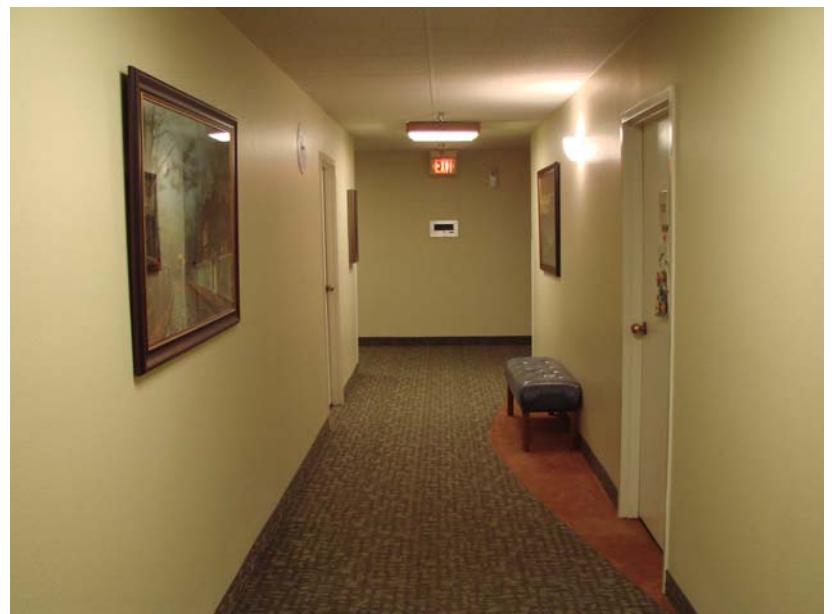
34-2009-07-31\_DSC09323: After - Main entrance & corridors

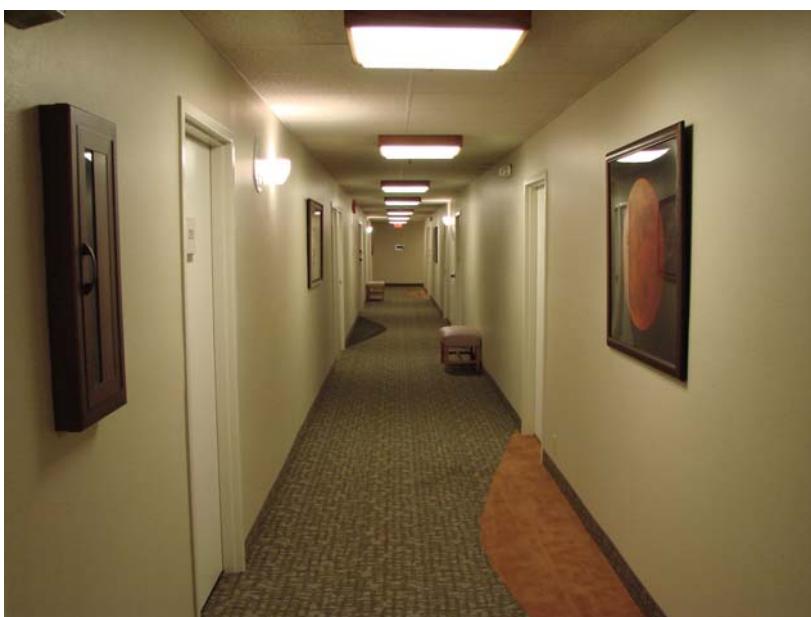
35-2009-07-31\_DSC09376: After - Main entrance & corridors

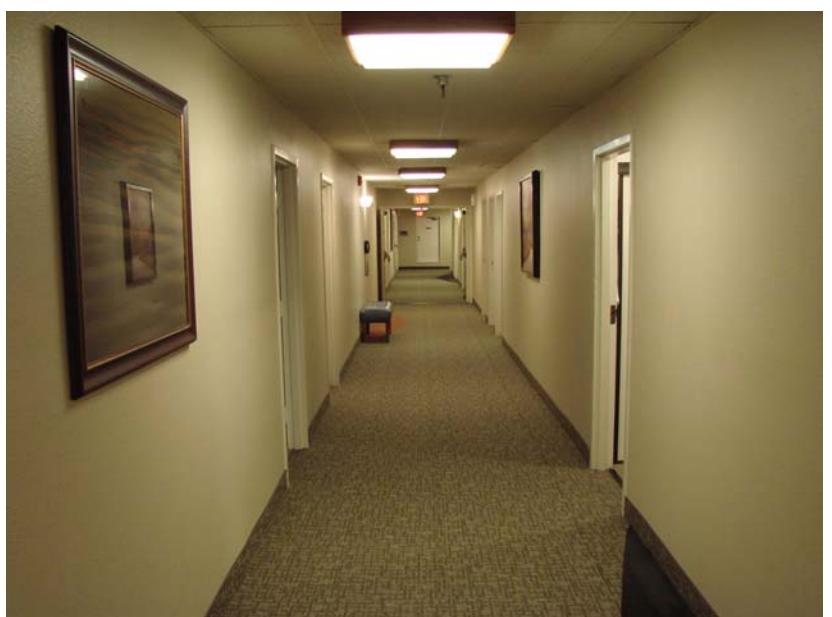
36-2009-07-31\_DSC09384: After - Main entrance & corridors

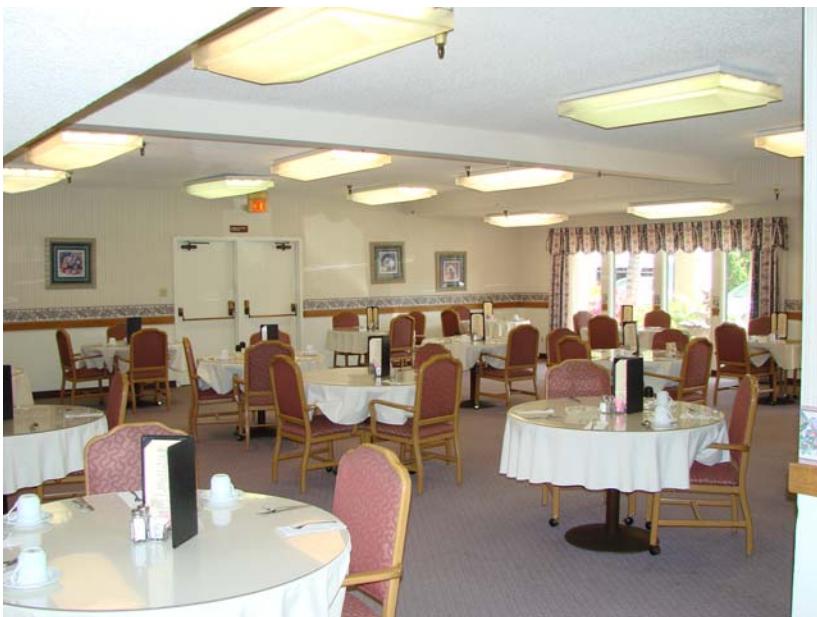
37-2007-05-02\_066 P\_E: Before - Main dining room.

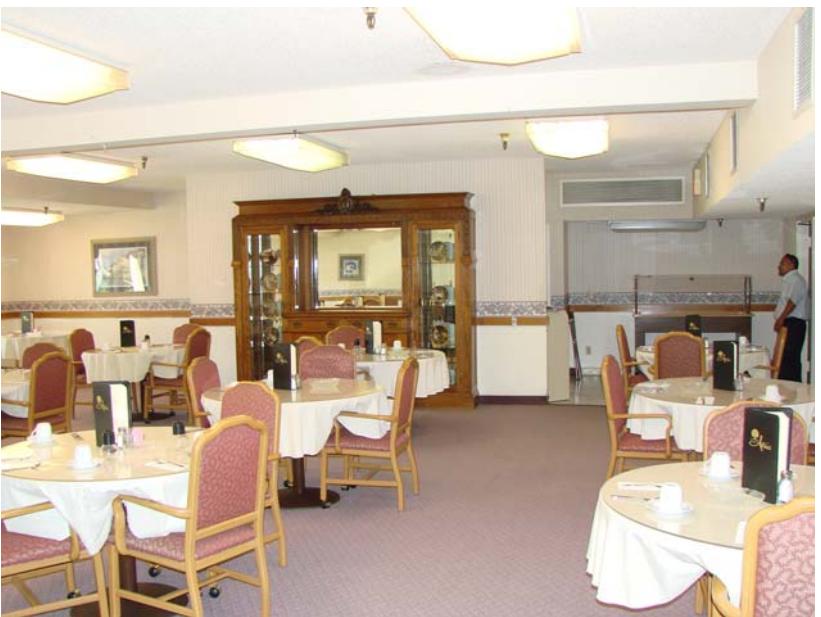
38-2007-05-02\_068 P\_E: Before - Main dining room - screen wall with kitchen access.

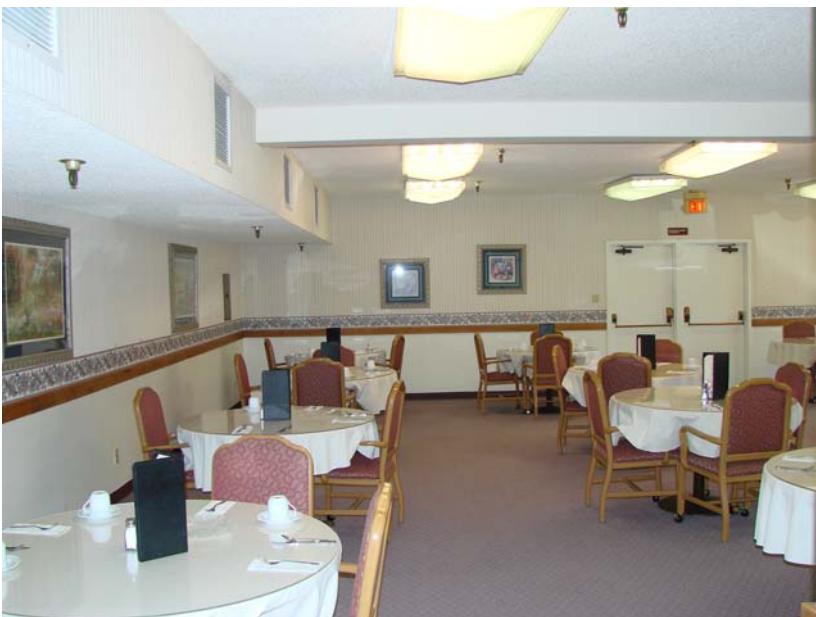
39-2007-05-02\_067 P\_E: Before - Main dining room.

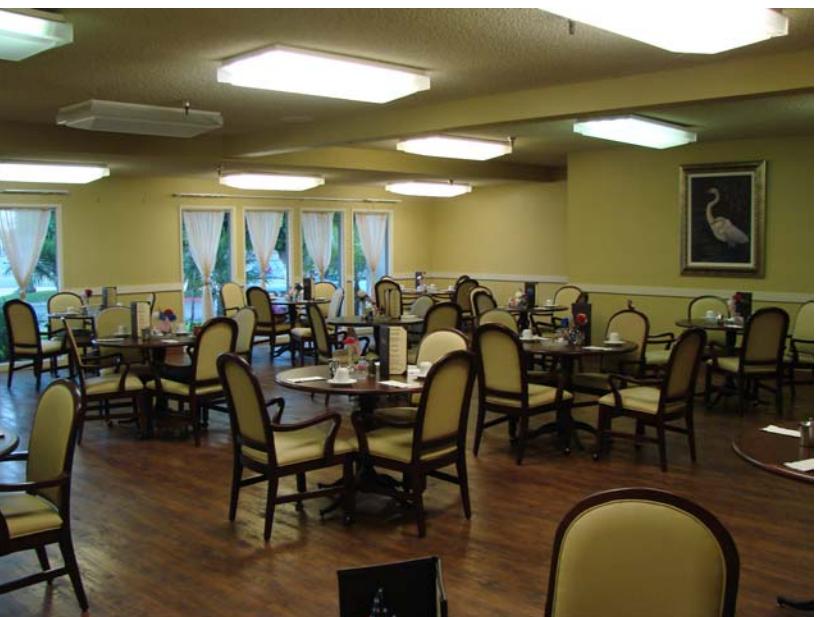
40-2009-07-31\_DSC09306: After - Main dining room

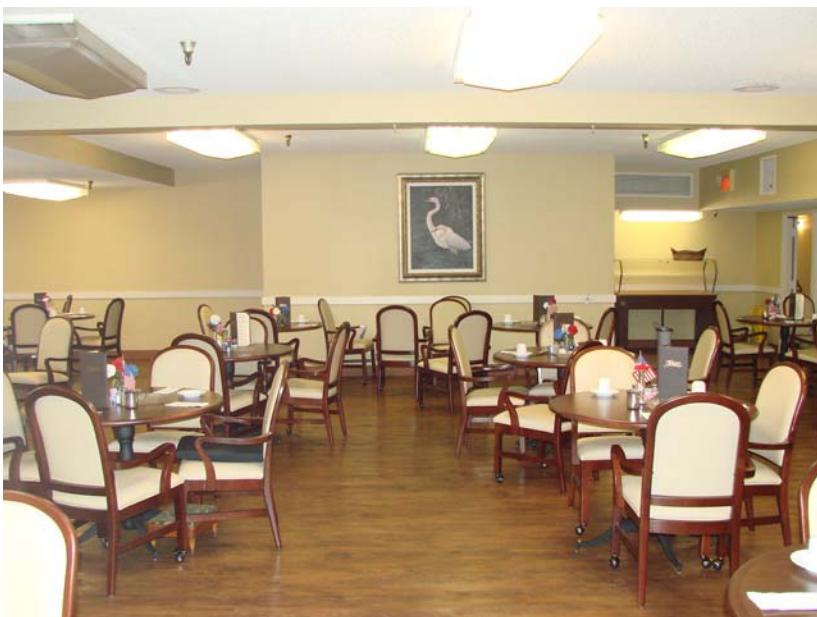
41-2009-07-31\_DSC09295: After - Main dining room

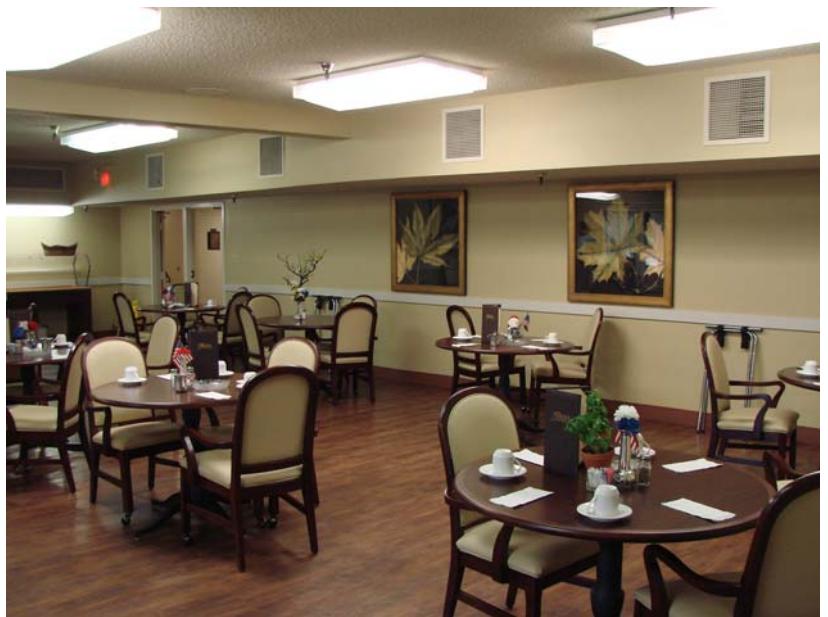
42-2009-07-31\_DSC09298: After - Main dining room

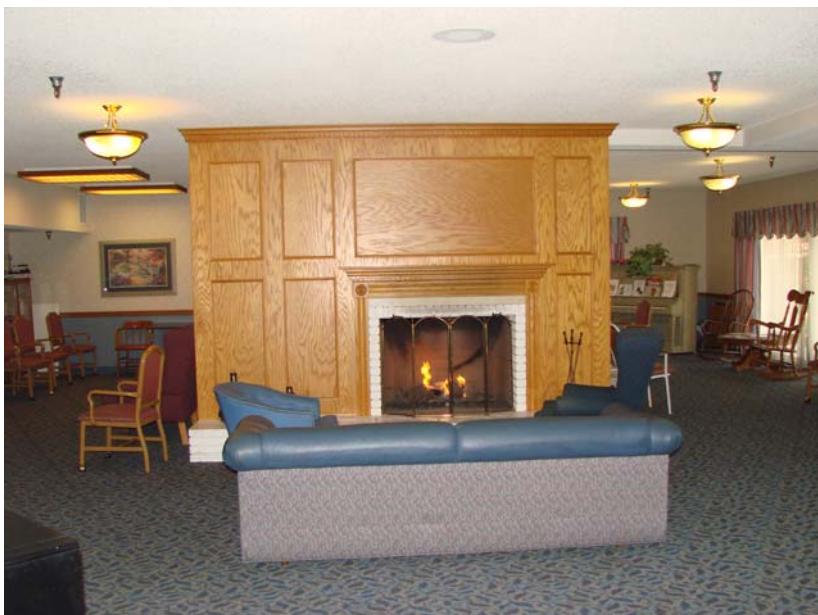
43-2007-05-02\_061 P\_E: Before - Living room.

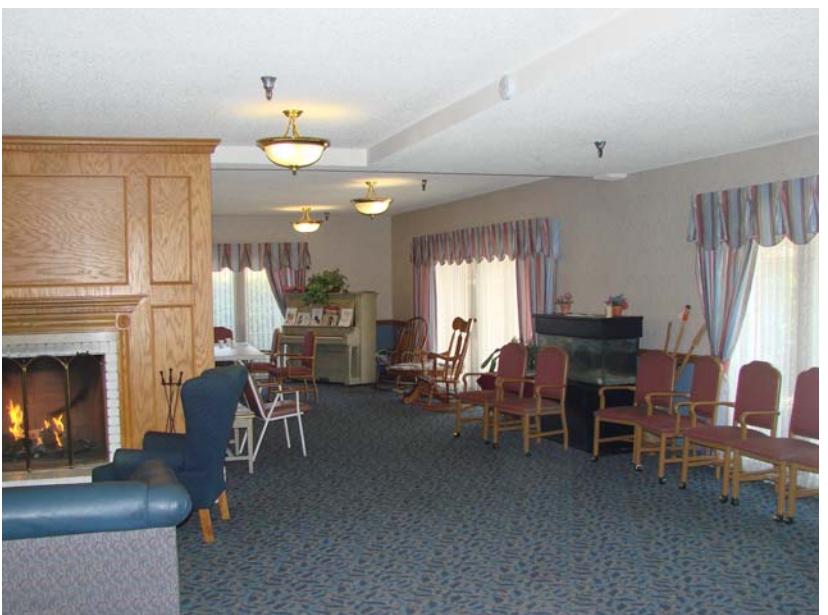
44-2007-05-02\_062 P\_E: Before - Living room.

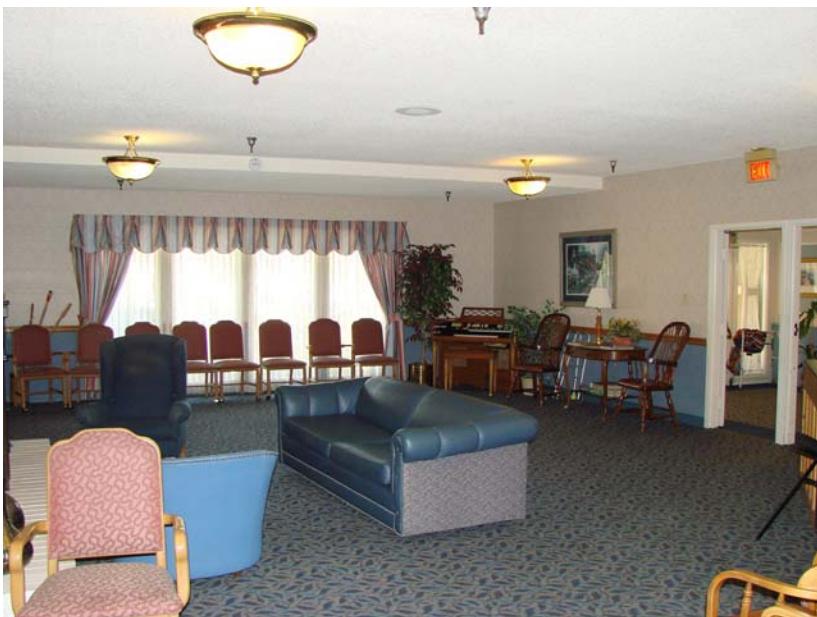
45-2007-05-02\_059 P\_E: Before - Living room.

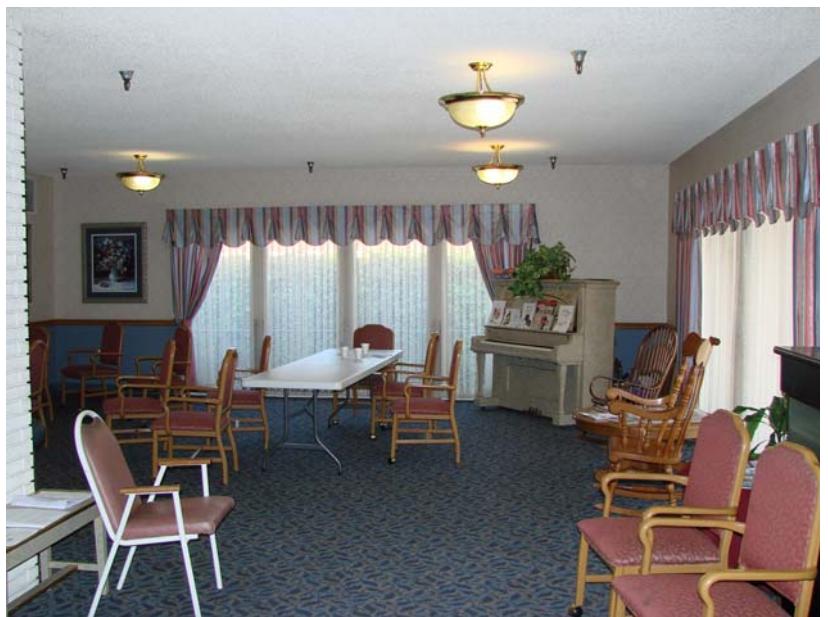
46-2007-05-02\_063 P\_E: Before - Living room.

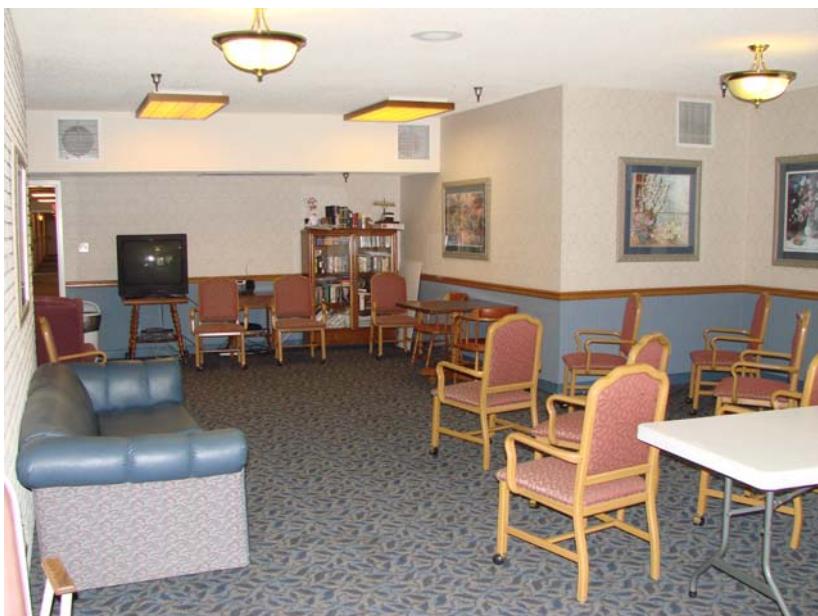
47-2007-05-02\_064 P\_E: Before - Living room.

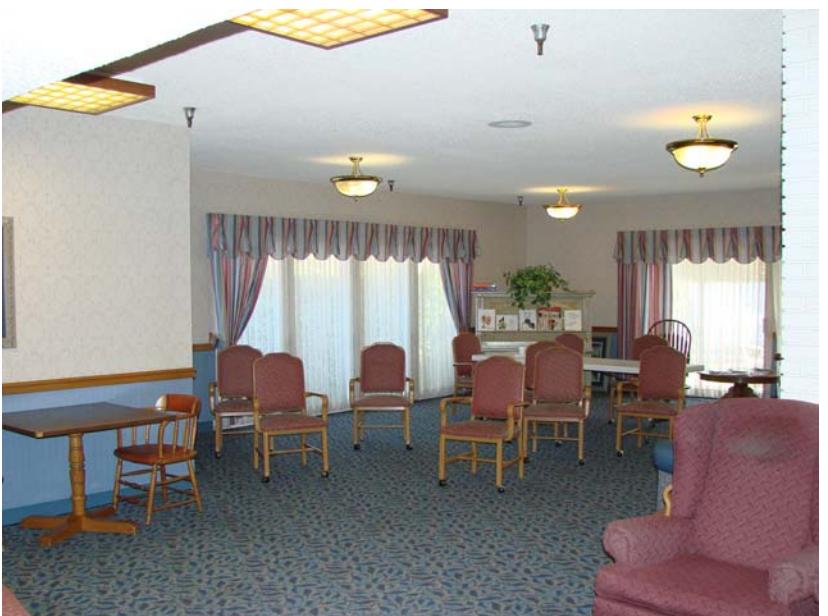
48-2007-05-02\_057 P\_E: Before - Living room.

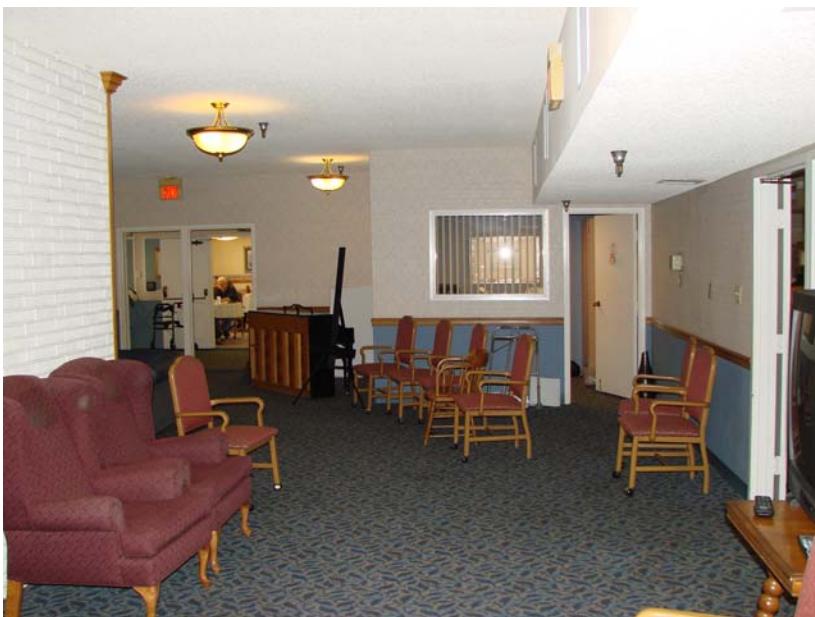
49-2007-05-02\_058 P\_E: Before - Living room.

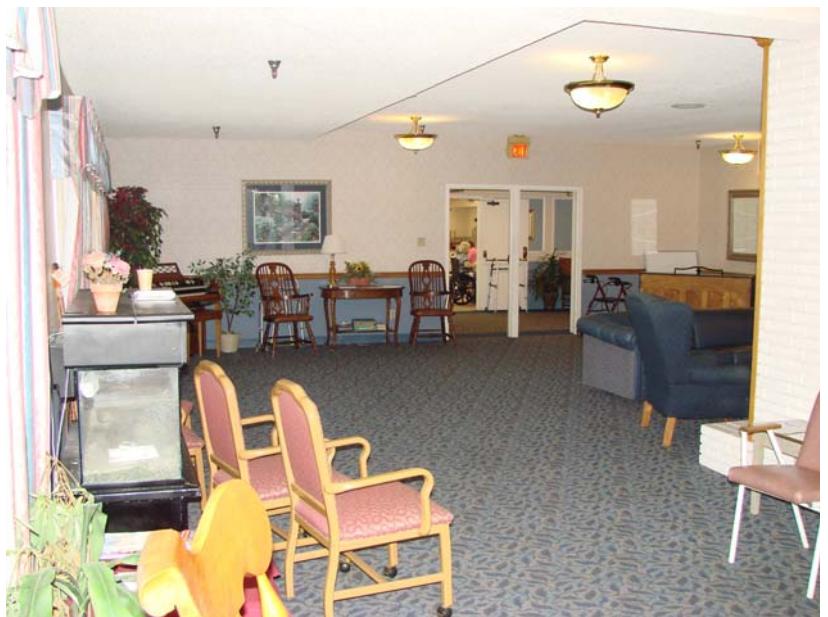
50-2007-05-02\_065 P\_E: Before - Living room.

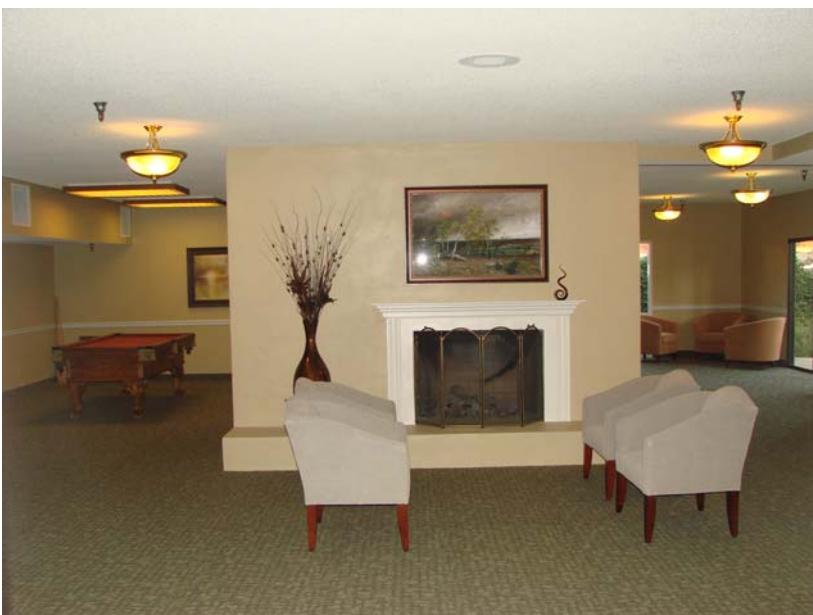
51-2009-07-31\_DSC09250: After - 1st floor living room.

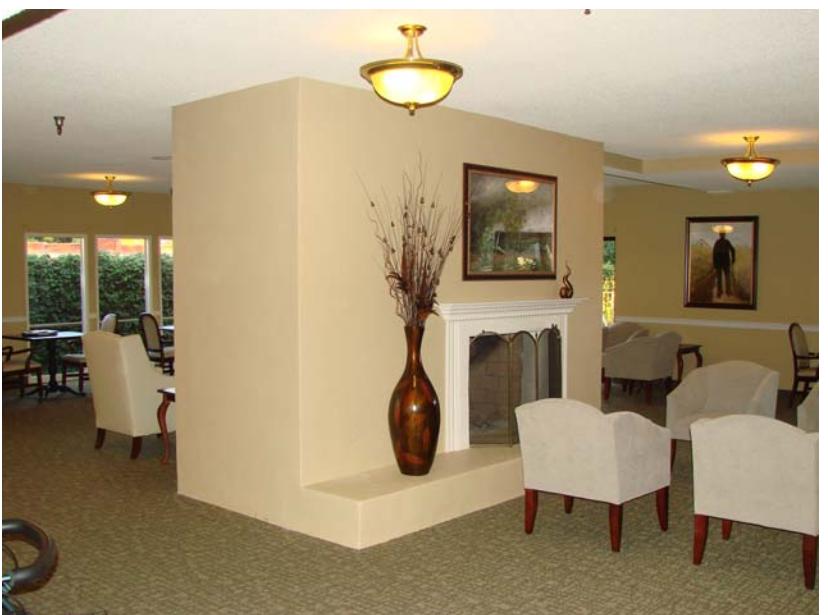
52-2009-07-31\_DSC09256: After - 1st floor living room.

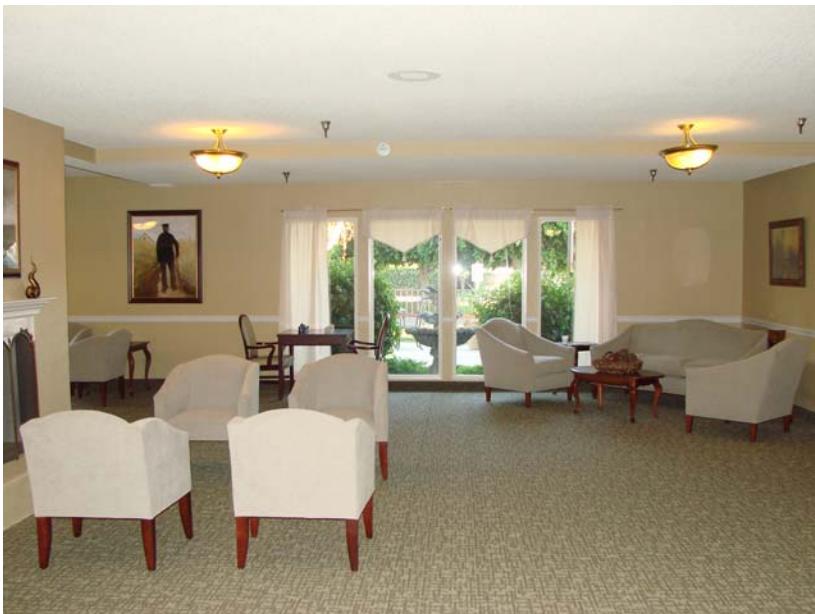
53-2009-07-31\_DSC09253: Before - 1st floor living room.

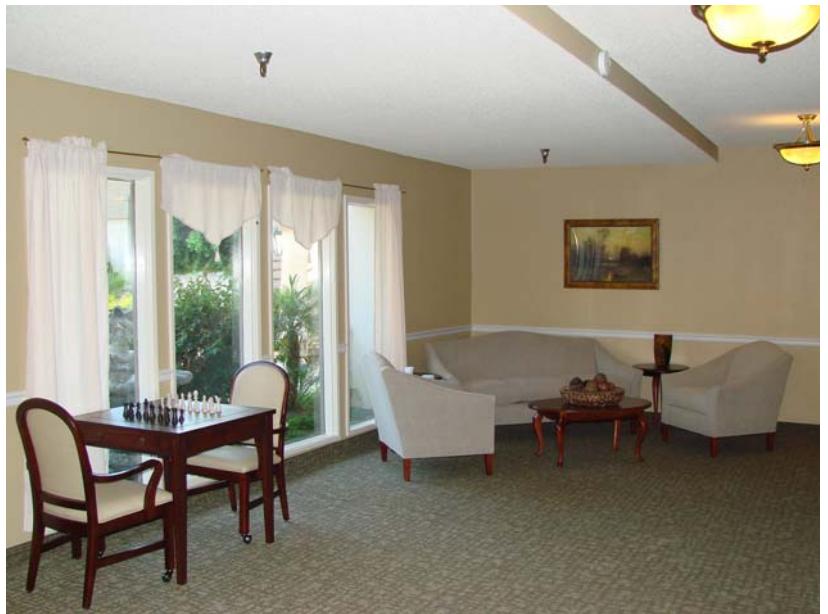
54-2009-07-31\_DSC09237: After - 1st floor living room.

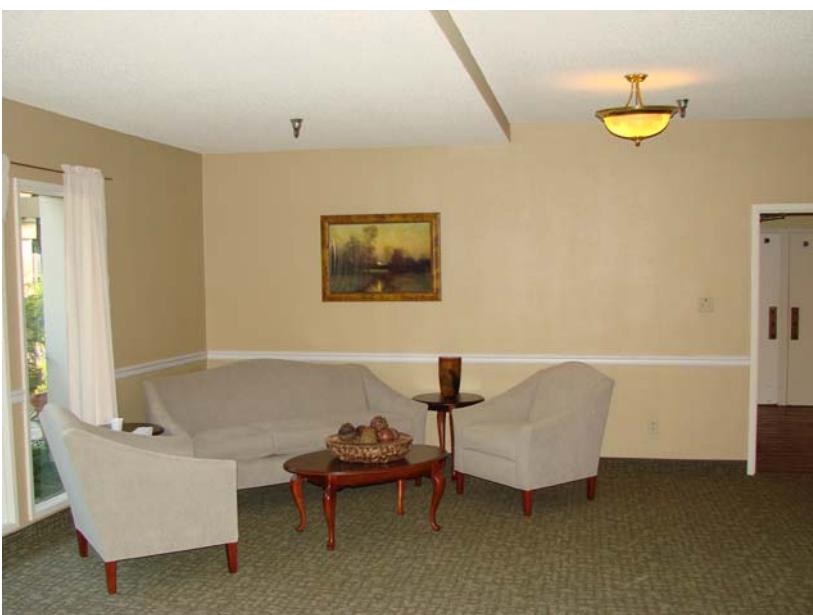
55-2009-07-31\_DSC09242: Before - 1st floor living room.

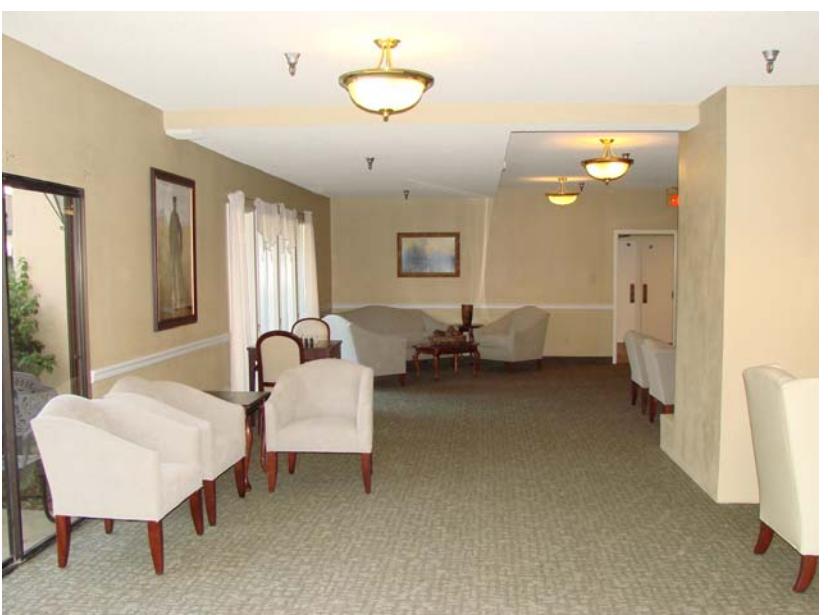
56-2009-07-31\_DSC09223: After - 1st floor living room.

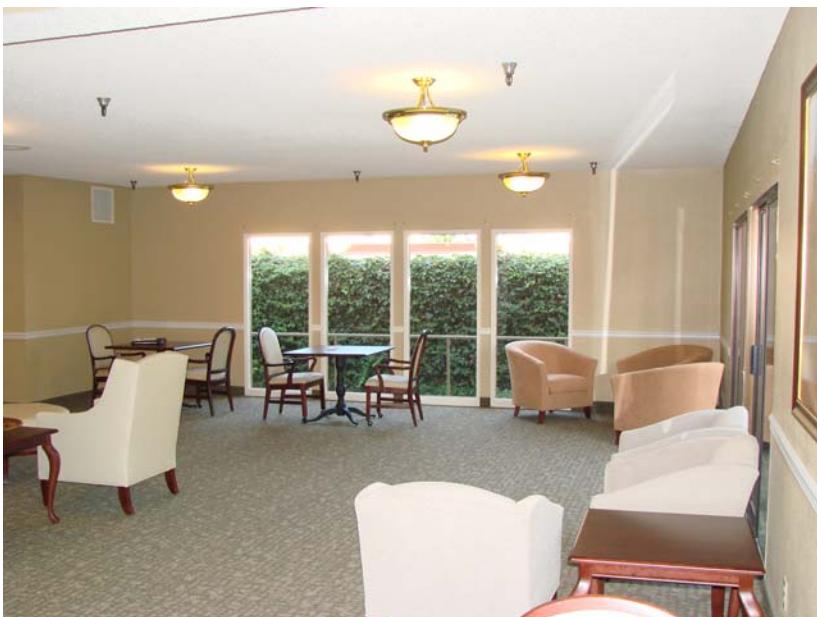
57-2009-07-31\_DSC09241: Before - 1st floor living room.

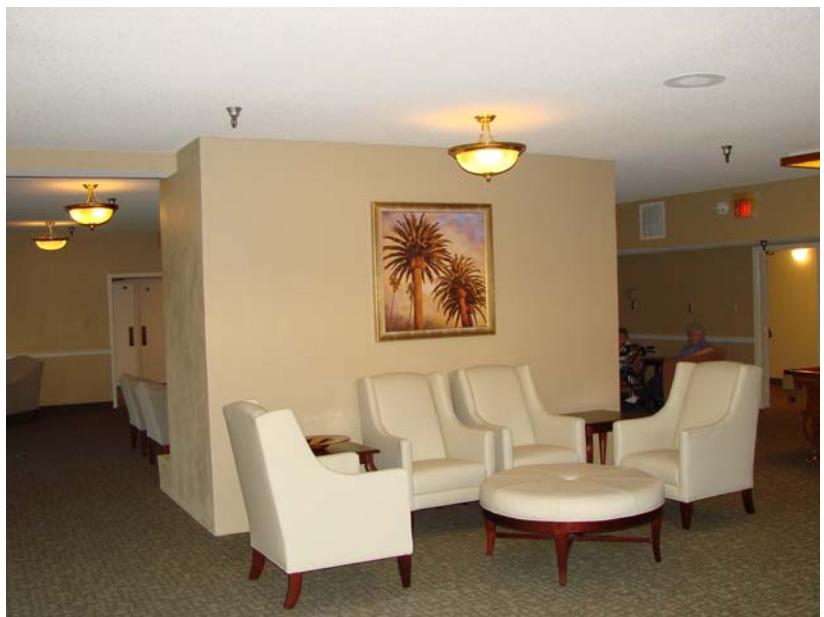
58-2009-07-31\_DSC09224: After - 1st floor living room.

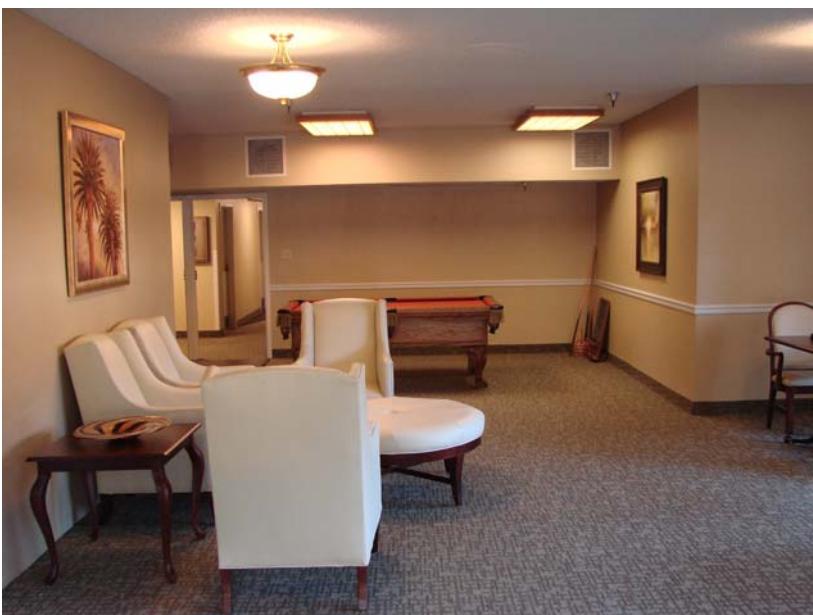
59-2009-07-31\_DSC09229: Before - 1st floor living room.

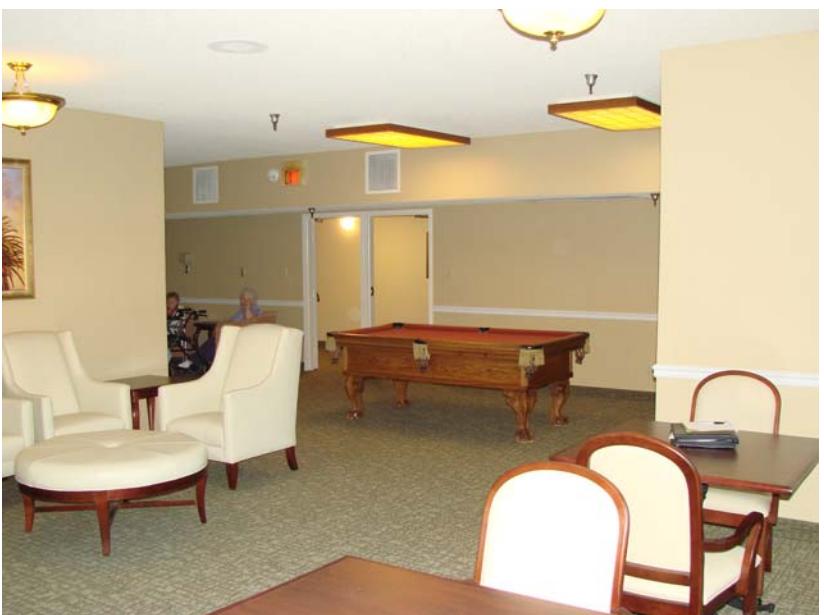
60-2009-07-31\_DSC09227: After - 1st floor living room.

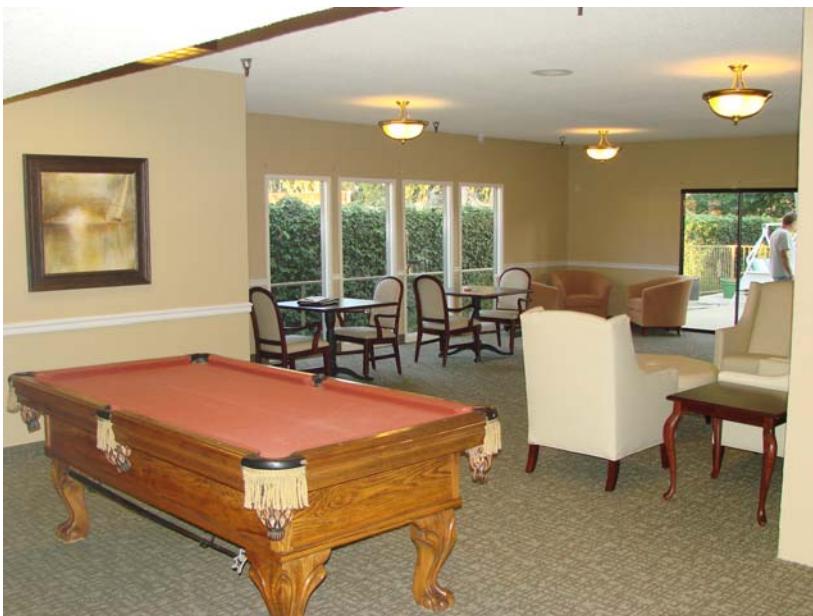
61-2009-07-31\_DSC09267: After - 1st floor living room.

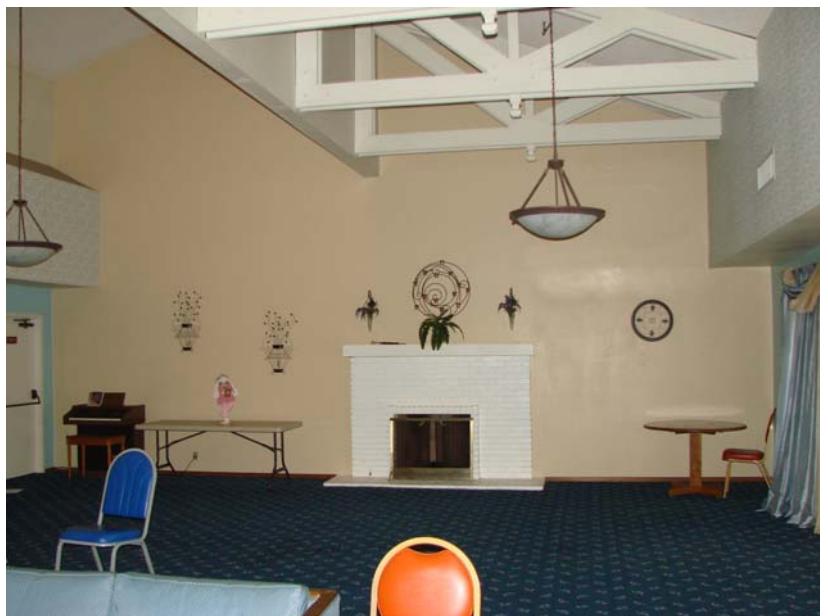
62-2007-05-02\_102 P\_E: Before - 2nd floor TV-Activity room.
