# The Palms: Before ~ After Photos

351 East Palm Drive, Anytown, USA 01995

Anytown, USA; July 31, 2009

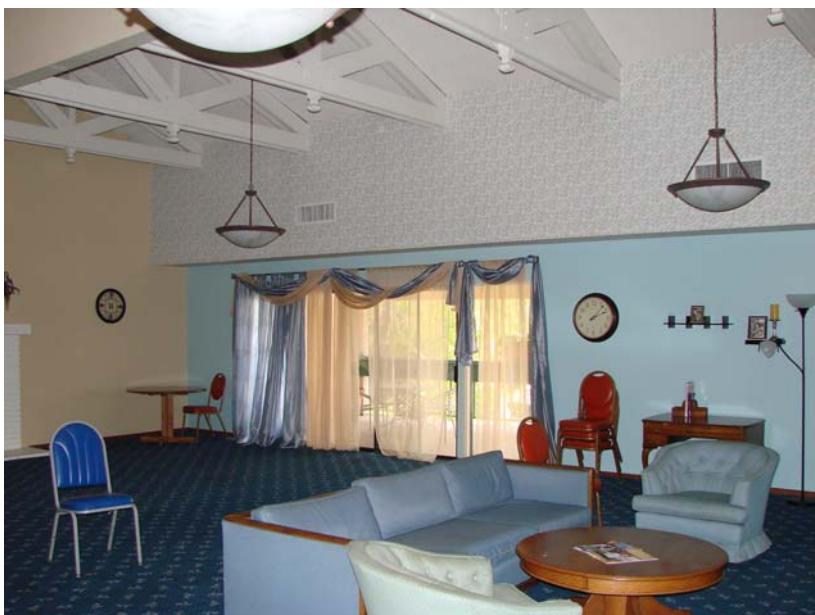
63-2007-05-02\_103 P\_E: Before - 2nd floor TV-Activity room.

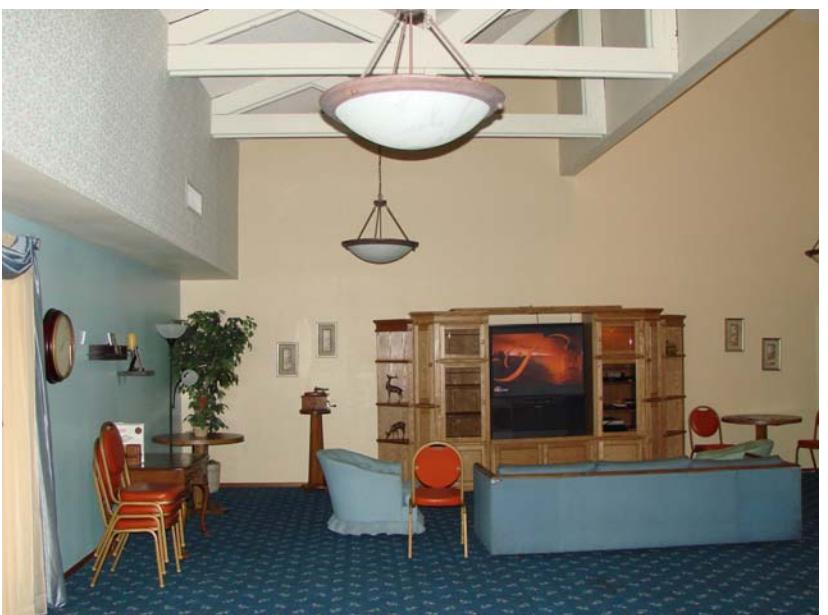
64-2007-05-02\_105 P\_E: Before - 2nd floor TV-Activity room.

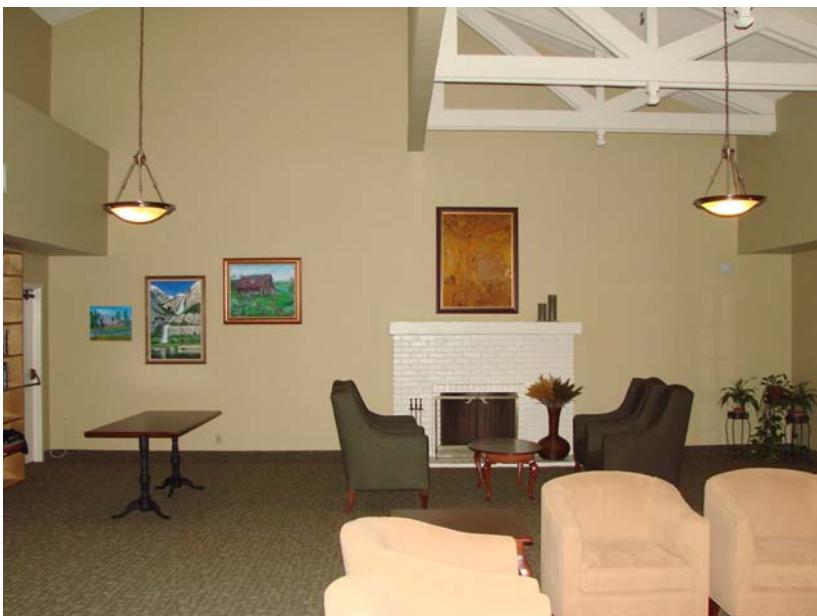
65-2009-07-31\_DSC09490: Before - 2nd floor Library & Movie Room

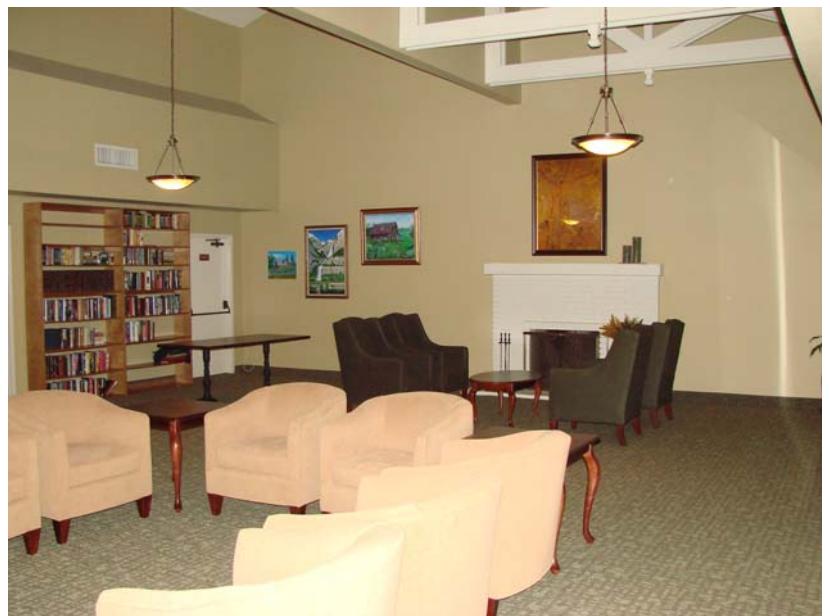
66-2009-07-31\_DSC09509: After - 2nd floor Library & Movie Room

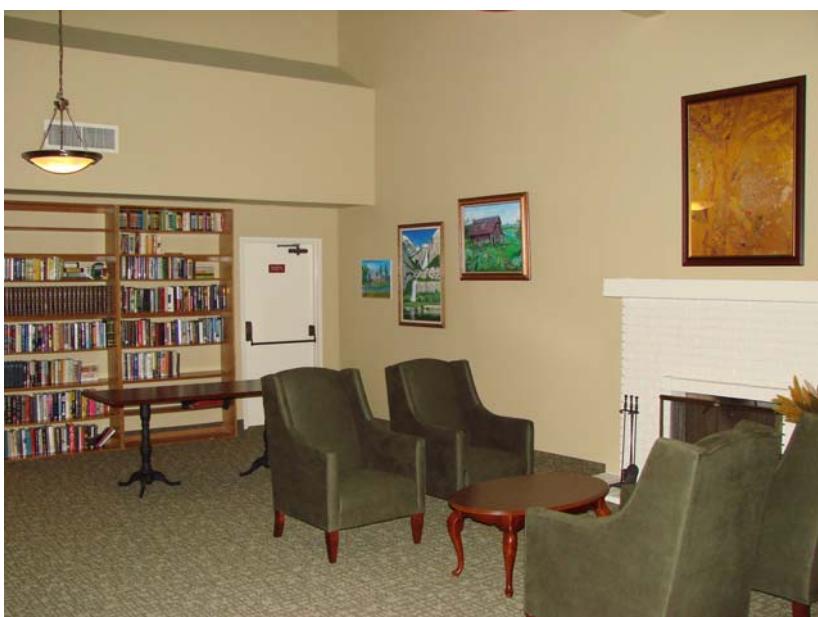
67-2009-07-31\_DSC09494: After - 2nd floor Library & Movie Room

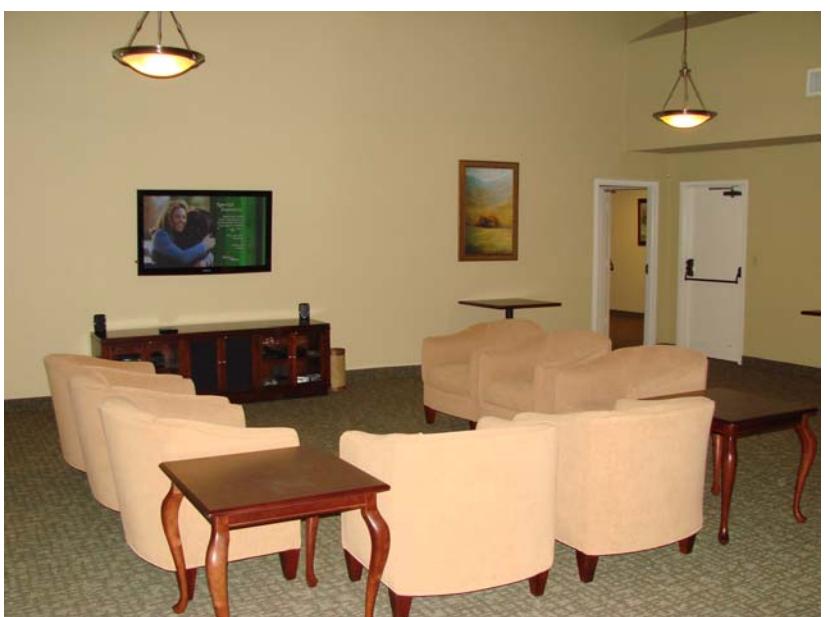
68-2009-07-31\_DSC09497: After - 2nd floor Library & Movie Room

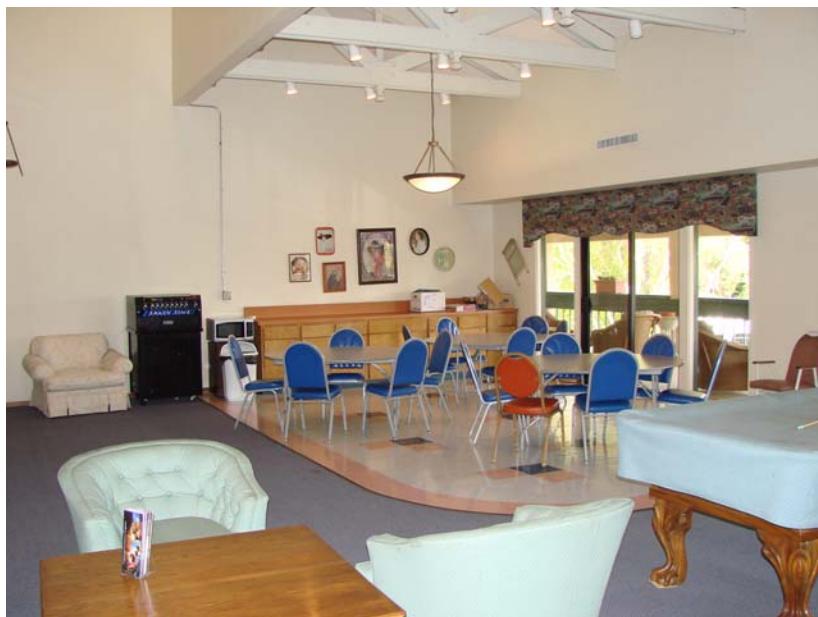
69-2007-05-02\_109 P\_E: Before - 2nd floor game-recreation room.

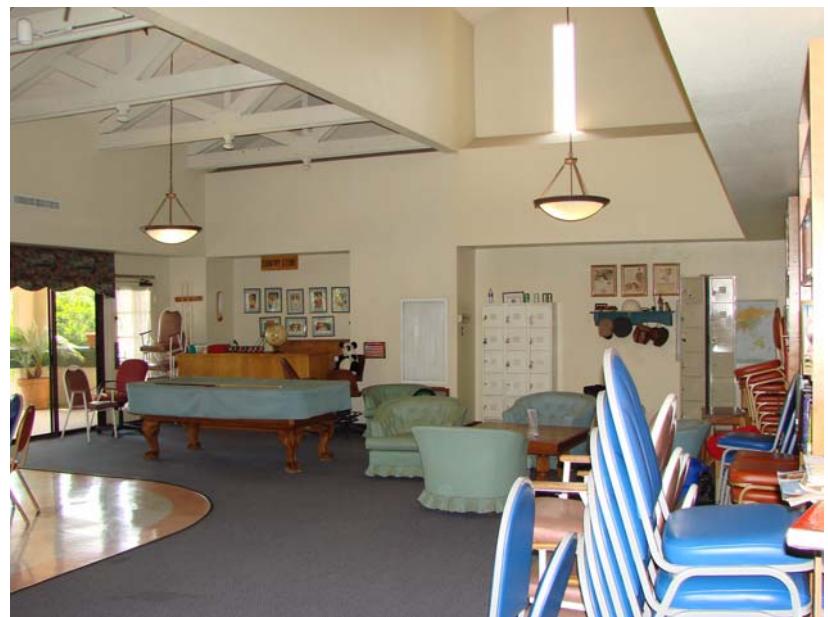
70-2007-05-02\_110 P\_E: Before - 2nd floor game-recreation room.

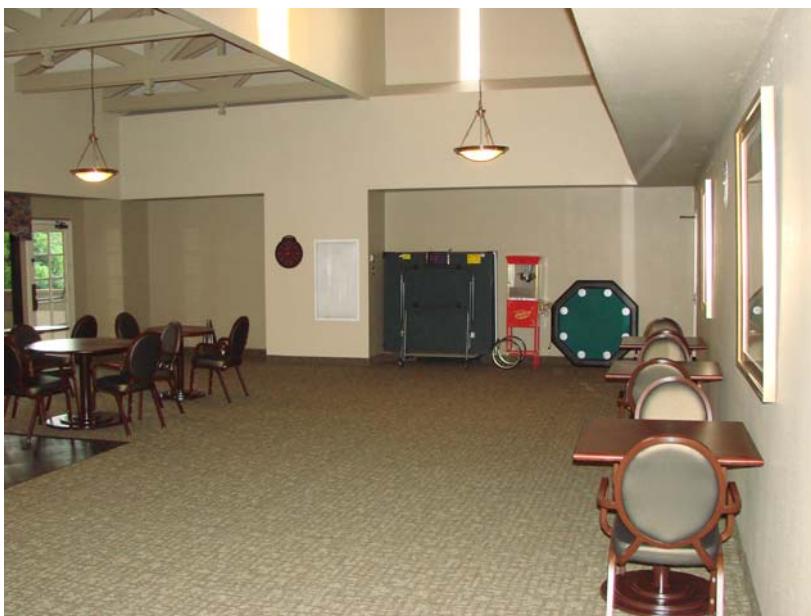
71-2009-07-31\_DSC09343: After - 2nd floor game-recreation room.

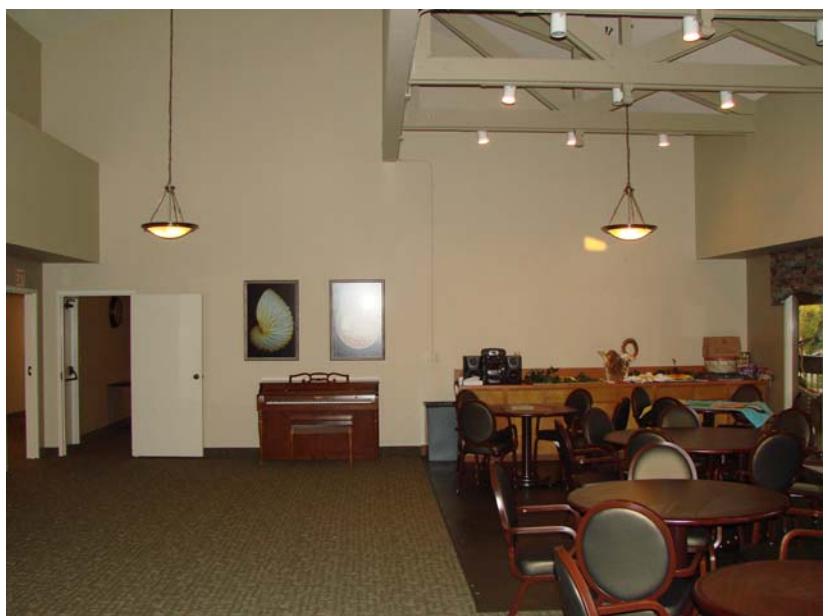
72-2009-07-31\_DSC09350: After - 2nd floor game-recreation room.

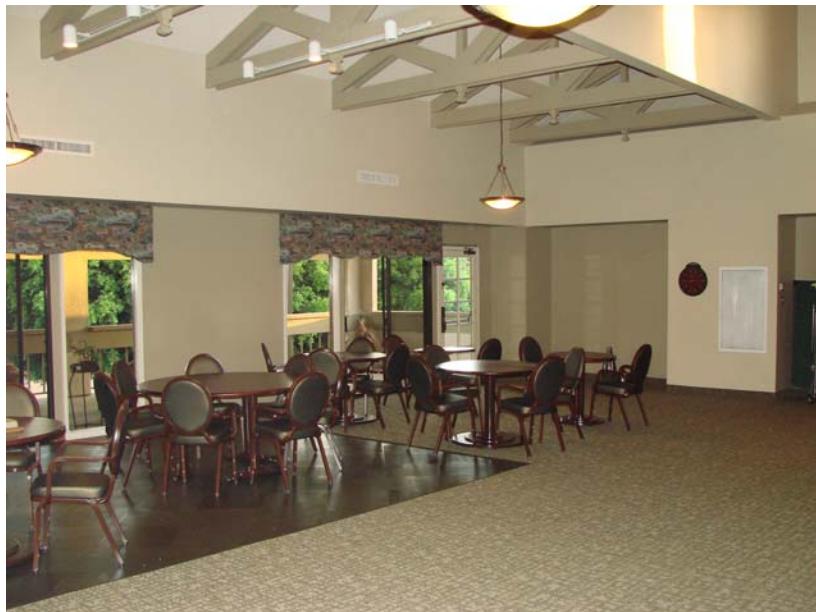
73-2009-07-31\_DSC09345: Before - 2nd floor game-recreation room.

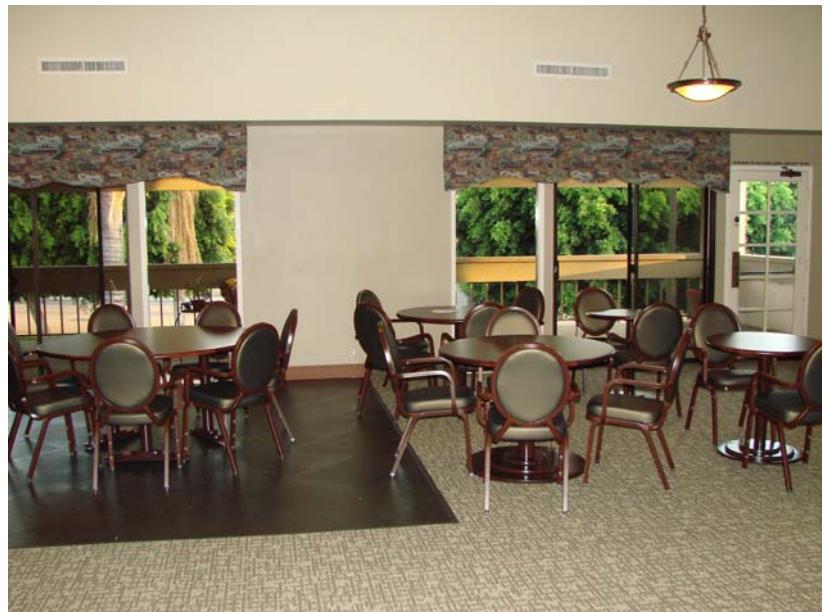
74-2009-07-31\_DSC09349: After - 2nd floor game-recreation room.
