The Palms - PALM EAST
351 East Palm Drive, Anytown, USA 01995
PH 987-654-3210 * FAX 987-654-3211

The Palms - PALM EAST

Anytown, USA; May 2, 2007

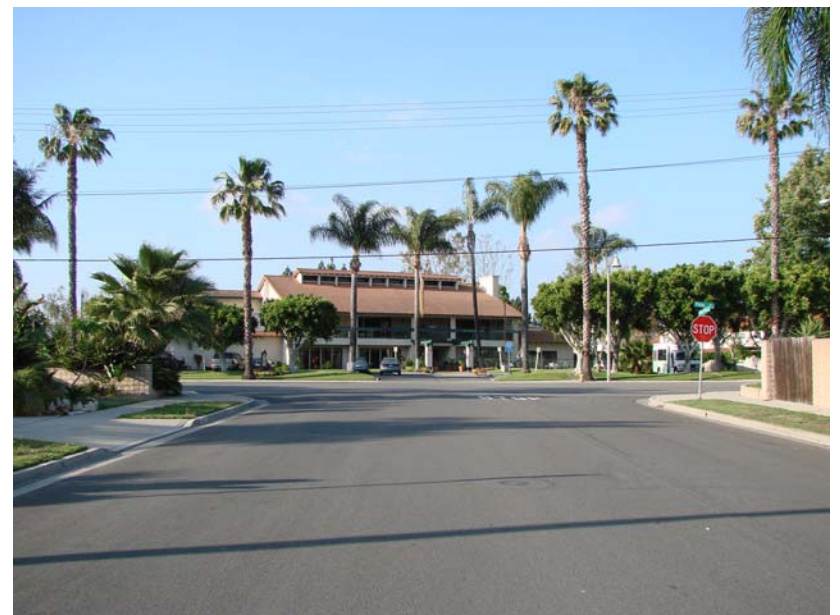
005 P_E: Palm East front (south) elevation.

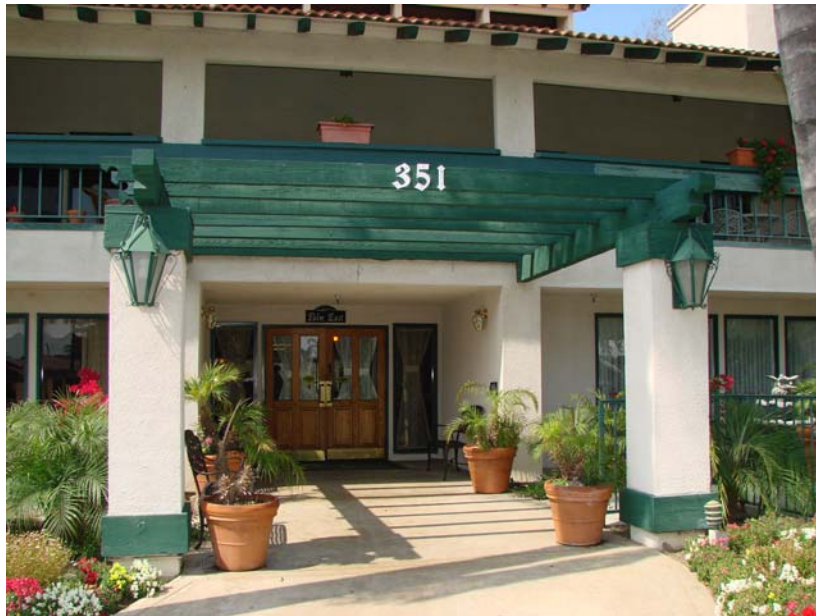
006 P_E: Main entrance to Palm East.

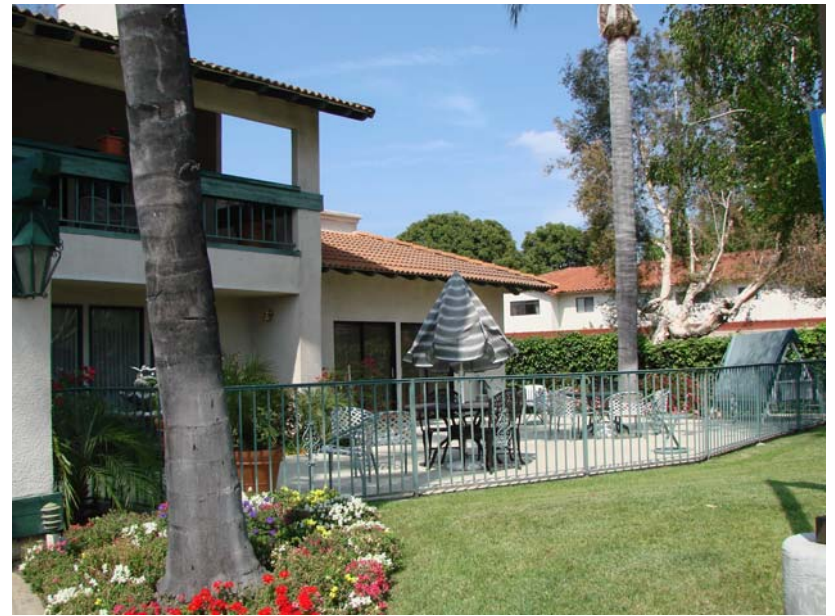
007 P_E: Front patio outside living room.

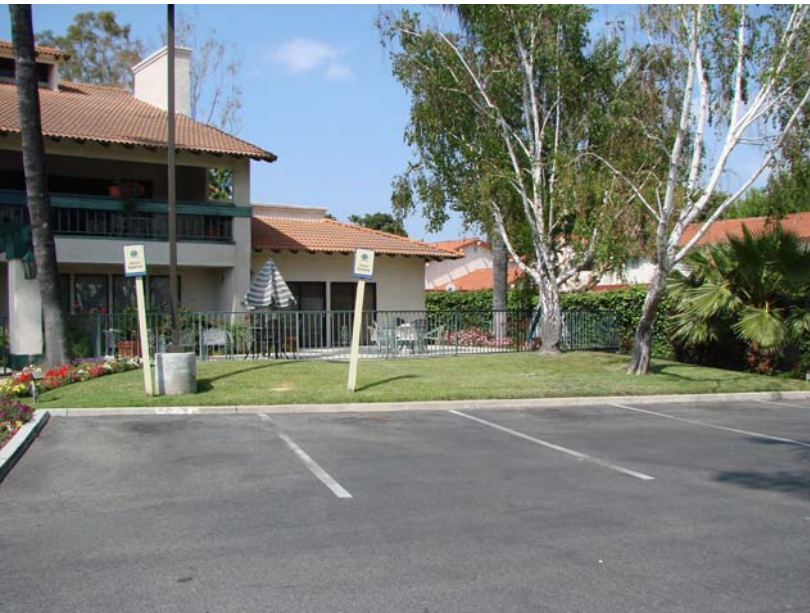
008 P_E: Front patio outside living room.

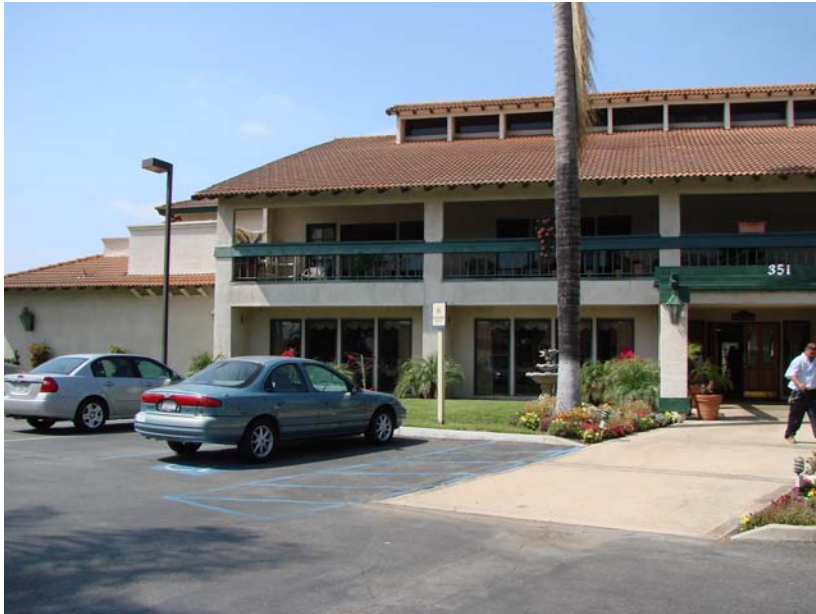
010 P_E: Front (south) elevation.

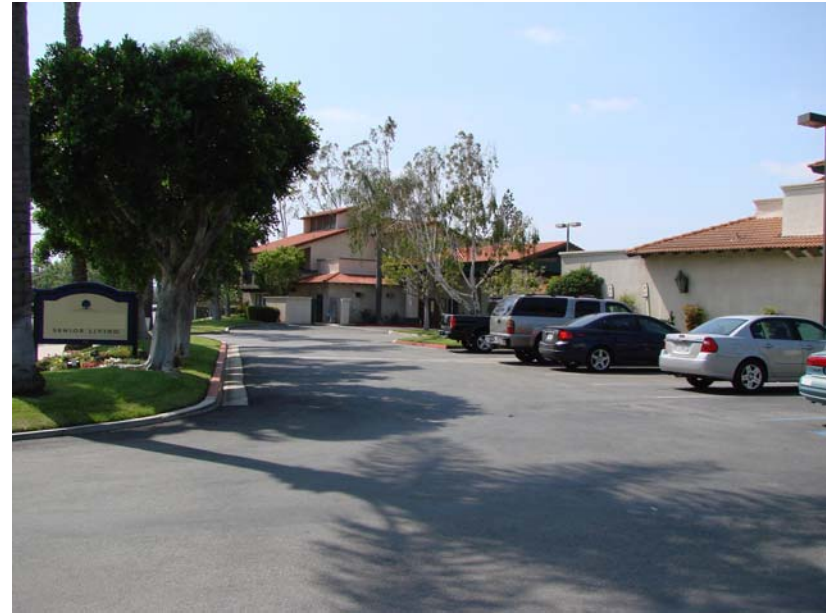
011 P_E: Front parking area looking west to Palm West.

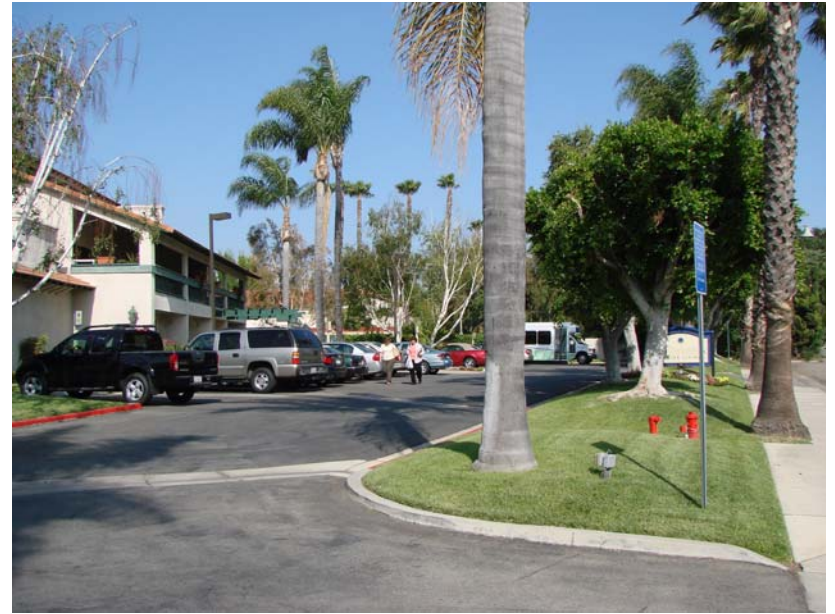
015 P_E: Parking entrance and parking in front of Palm East.

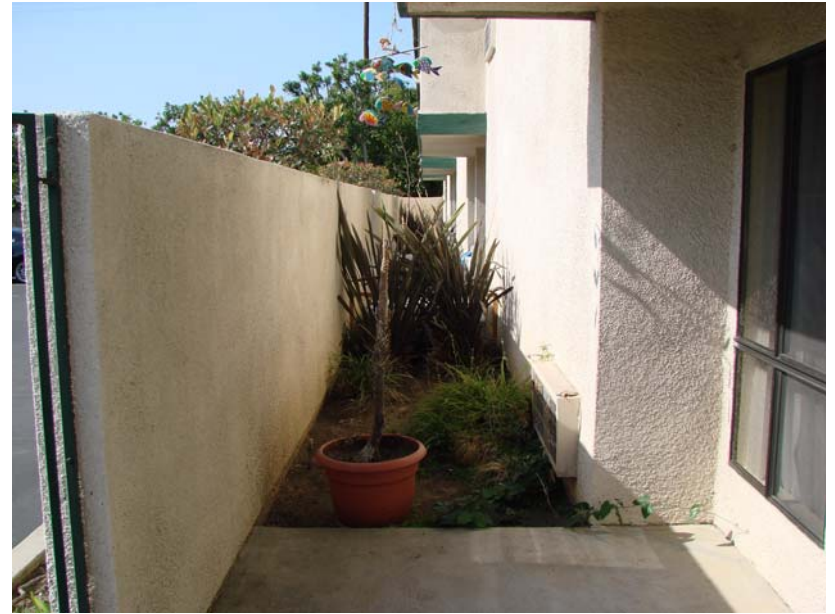
035 P_E: Landscape area on exterior of Palm East west elevation.

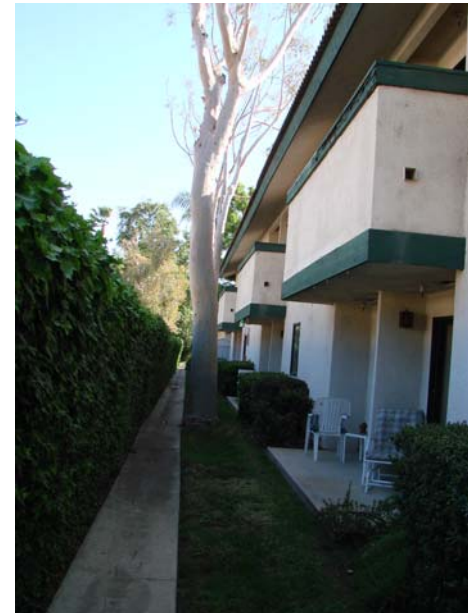
041 P_E: East elevation looking south.

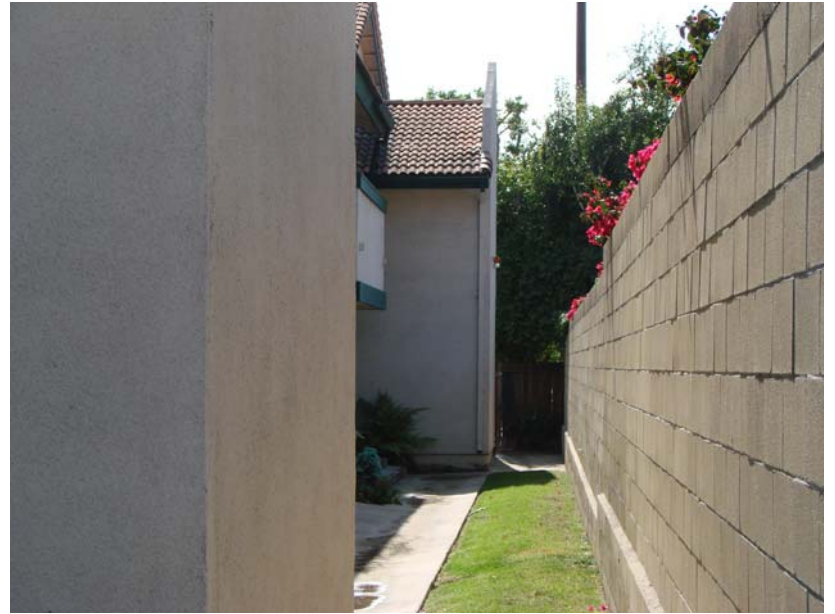
047 P_E: North property line looking west.

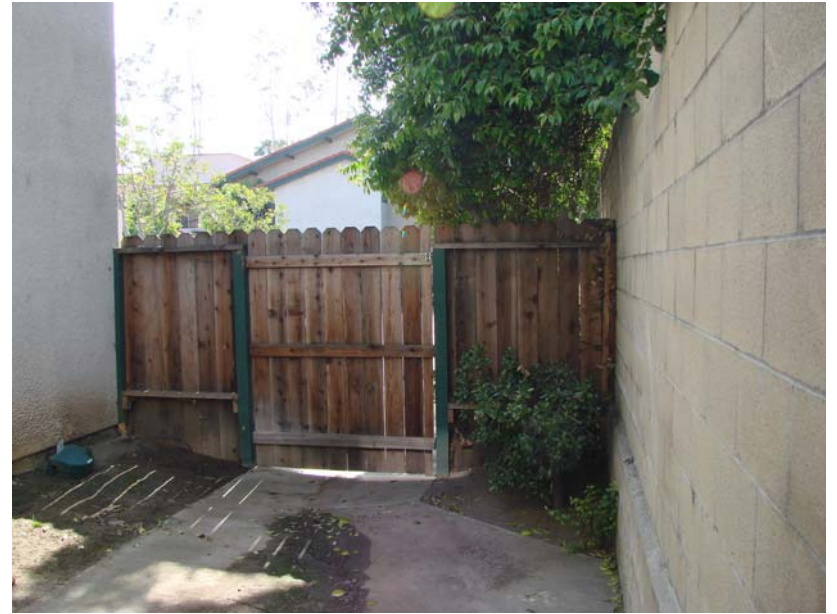
051 P_E: Exit gate to parking lot between Palm East & Palm West.

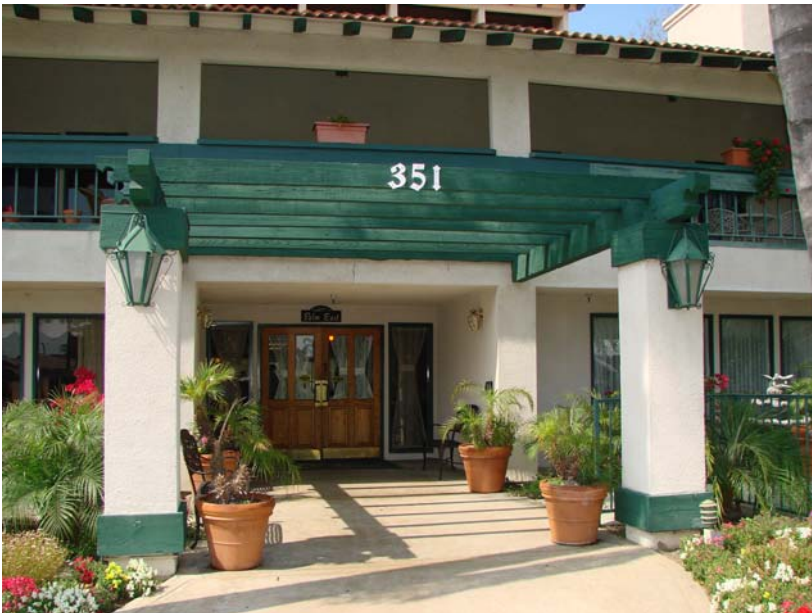
052 P_E: Main entrance to Palm East.

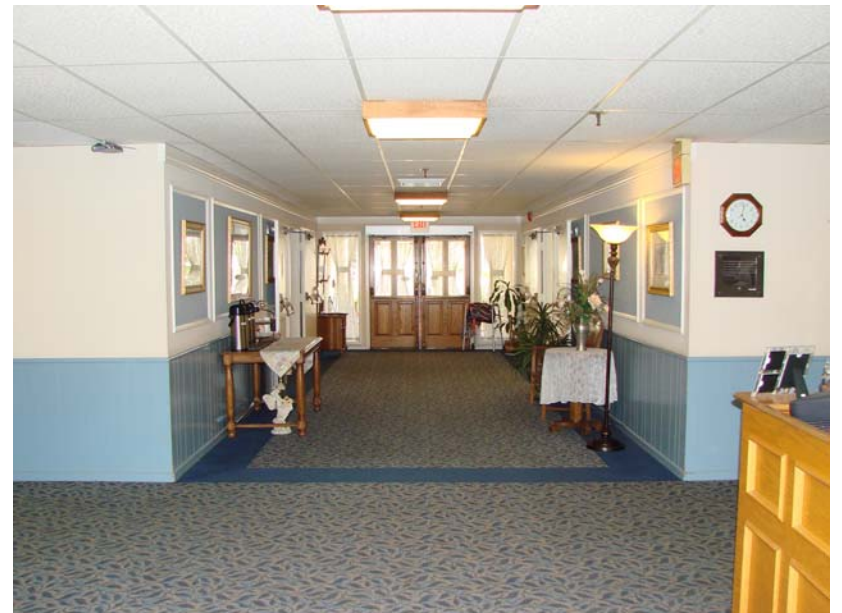
053 P_E: Front entry.

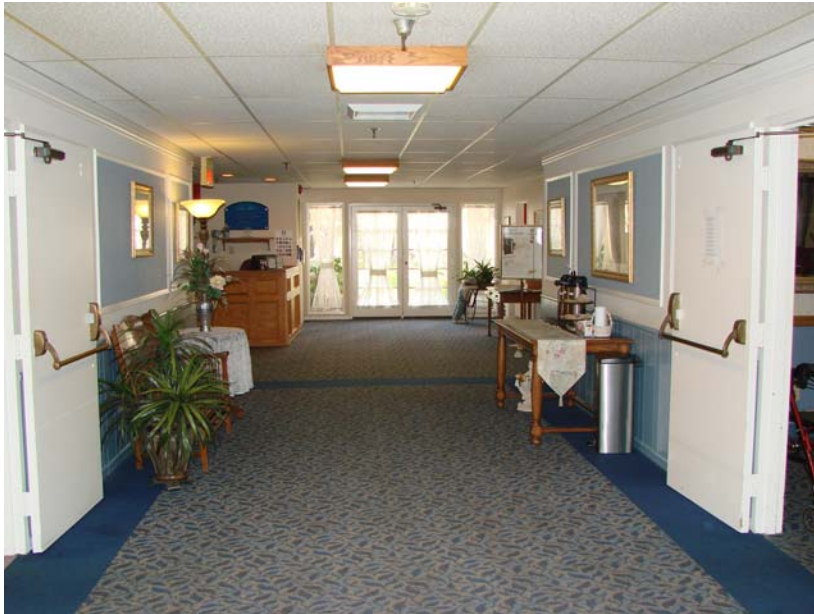
054 P_E: Front entry with reception desk and door into courtyard.

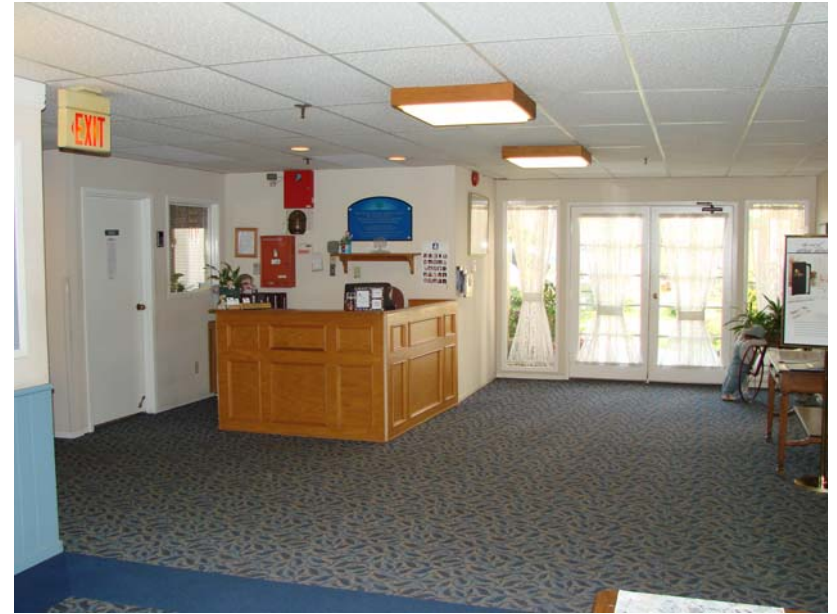
055 P_E: Reception desk at Palm East entrance.

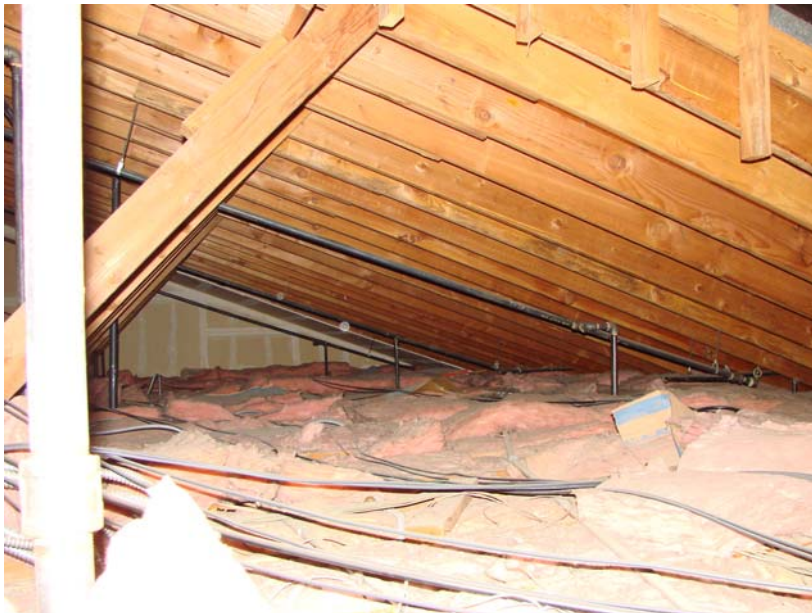
136 P_E: Palm East - typical attic detail.

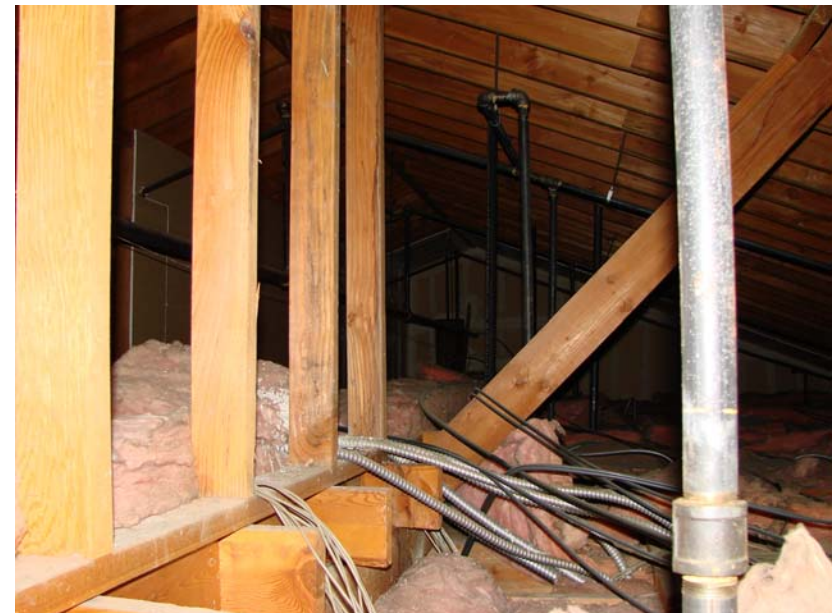
137 P_E: Palm East - typical attic detail.

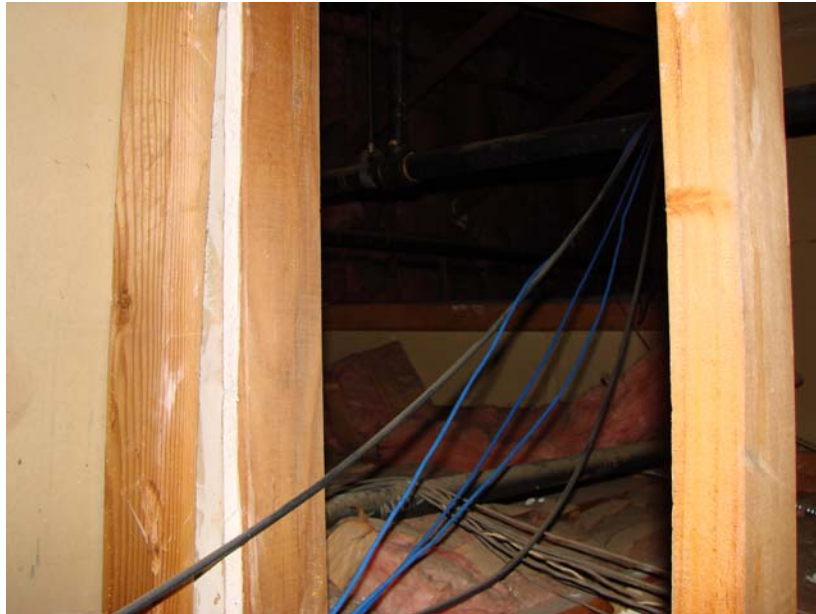
138 P_E: Palm East - typical attic detail.

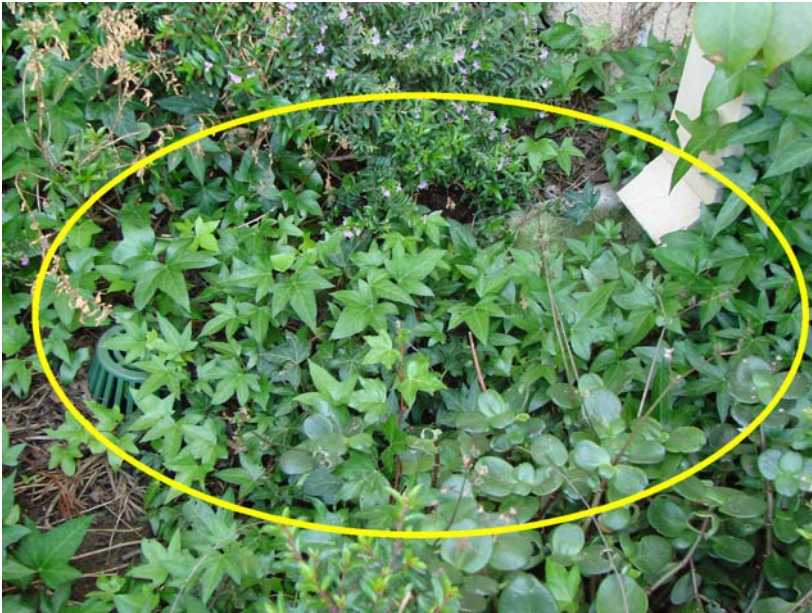
164 P_E: Detail - courtyard gutter surface drains to courtyard area drain.

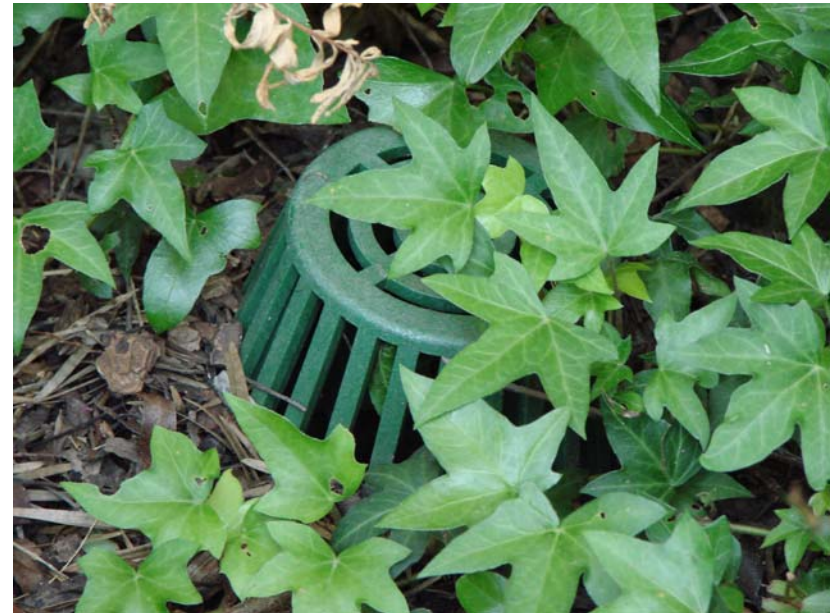
165 P_E: Area drain detail in courtyard.

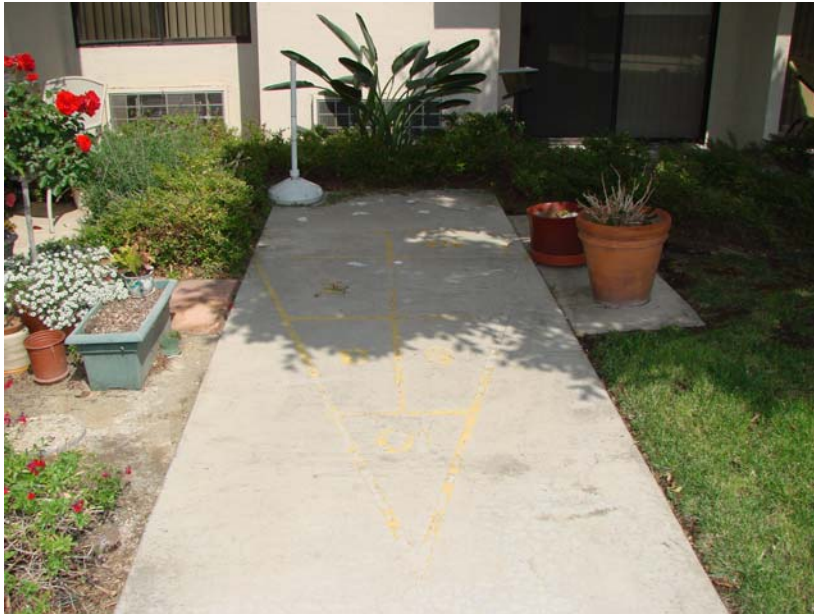
166 P_E: Faded shuffleboard court.

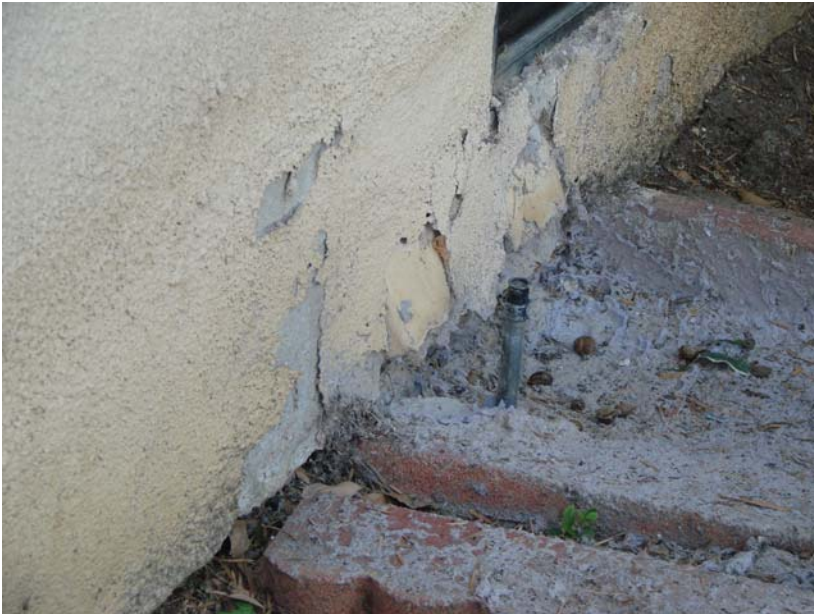
174 P_E: Laundry dryer vents - consider adding a wire cage lint trap.

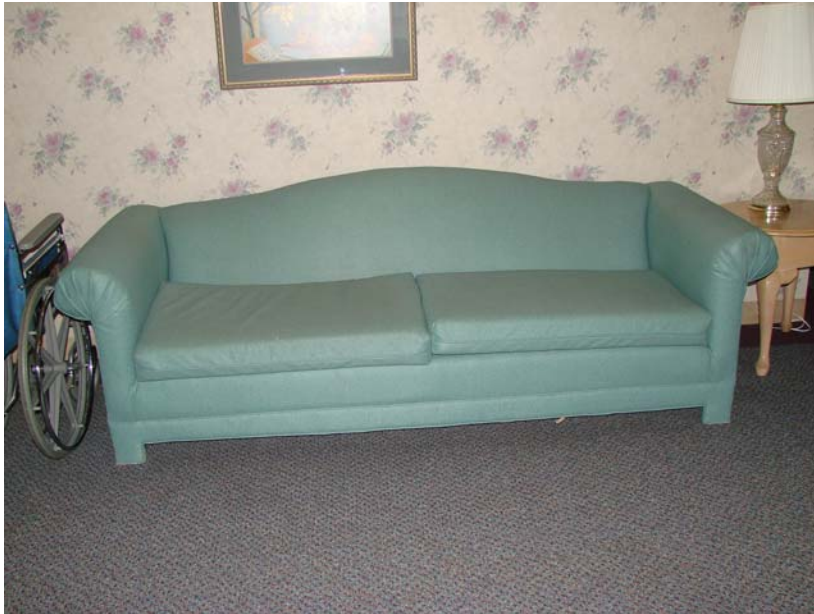
030 P_W: Living room - dated furniture.

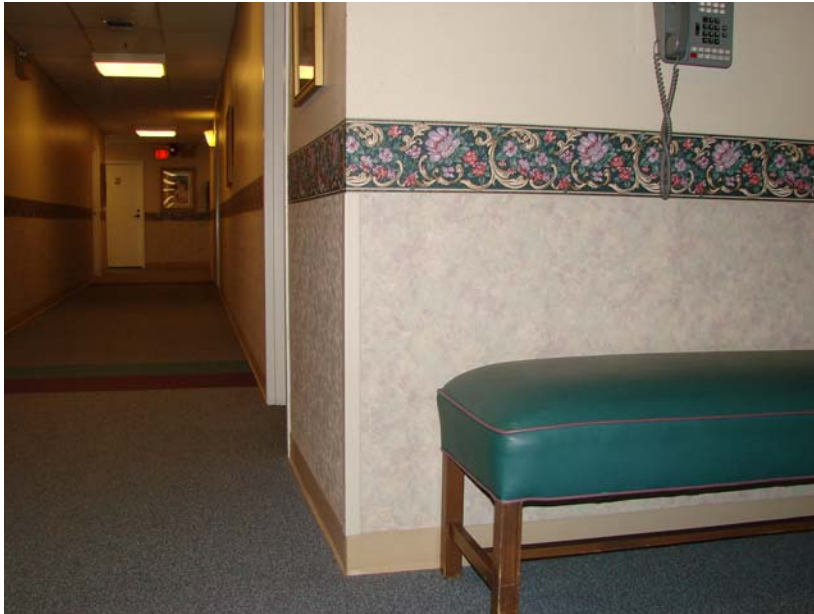
038 P_W: Corridor detail - carpet, rubber base, corner guards, wall covering below border, paint above border to ceiling.

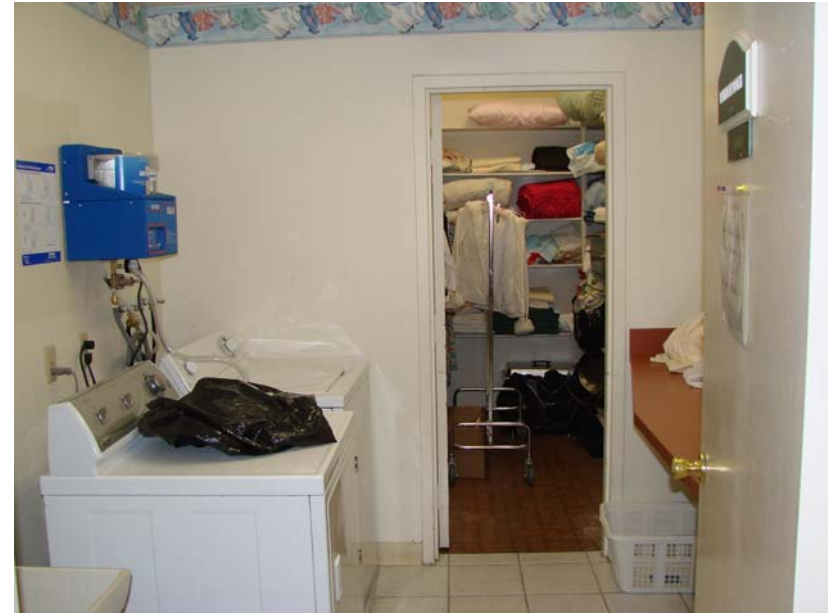
039 P_W: Laundry - single residential washer & dryer.

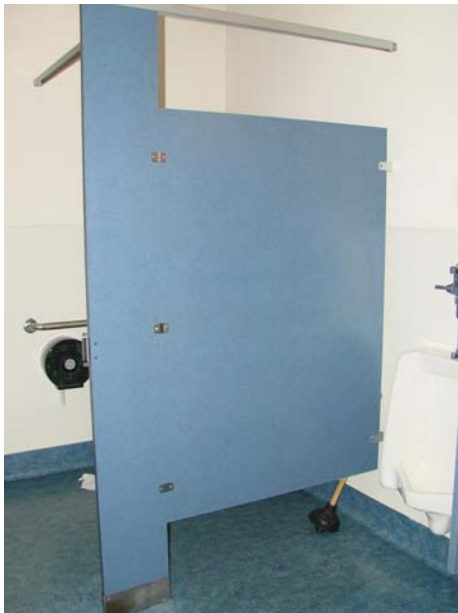
040 P_W: Public restroom.

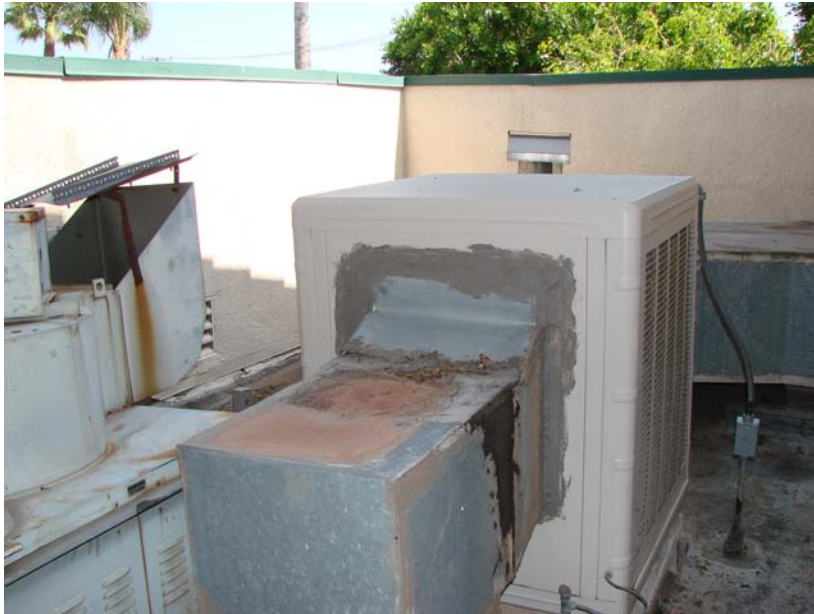
054 P_W: Kitchen swamp cooler in roof well.

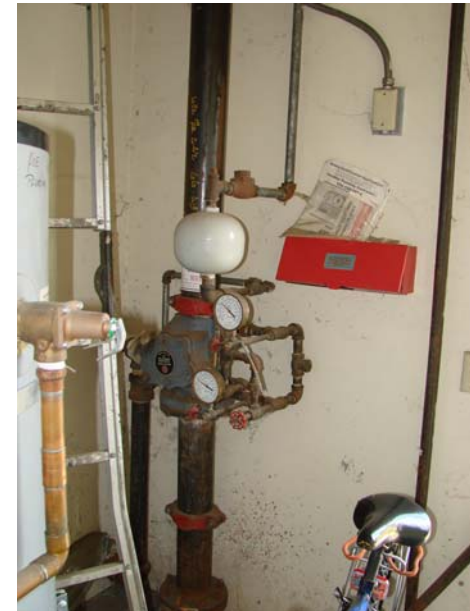
097 P_W: Fire sprinkler riser.
