## The Willows @ Anytown

Anytown, USA; Oct 4, 2006

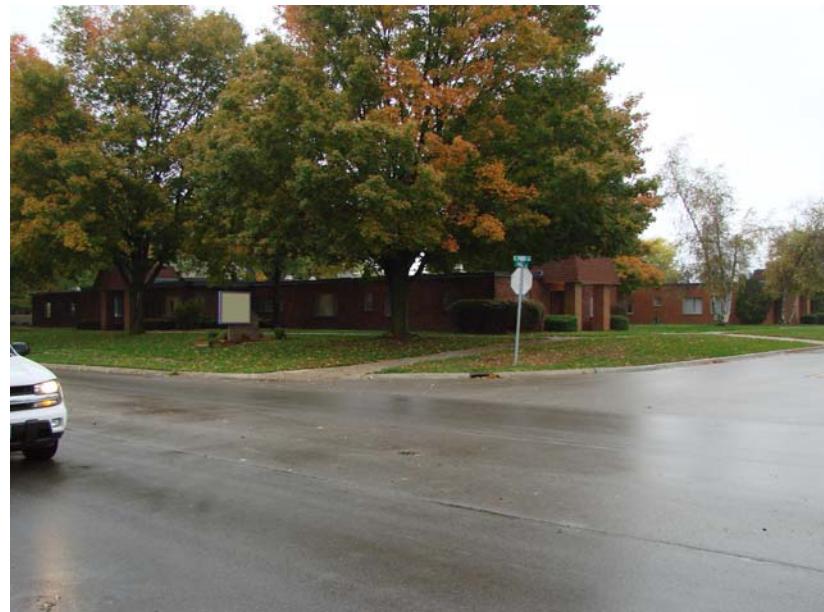
002\_MI\_1: Front (east) elevation - Central Hall, East Hall.

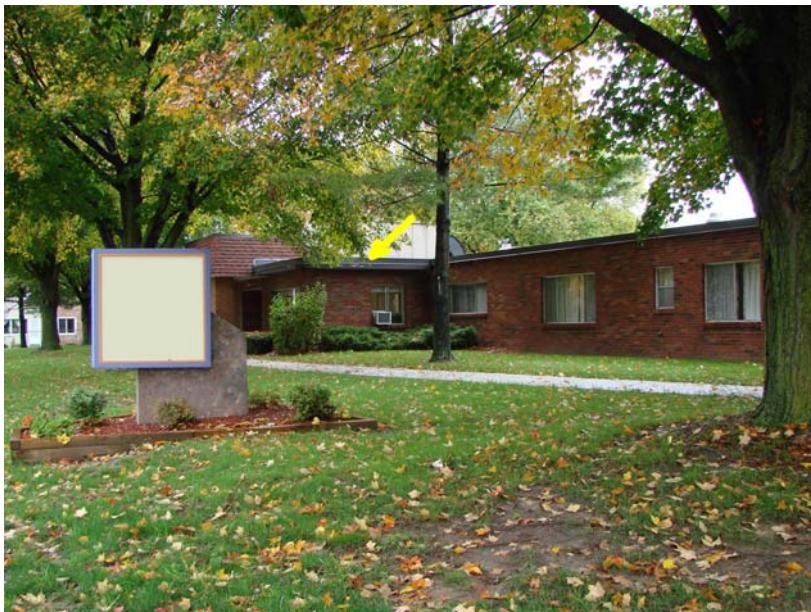
003\_MI\_1: Facility identification sign - southeast property corner.

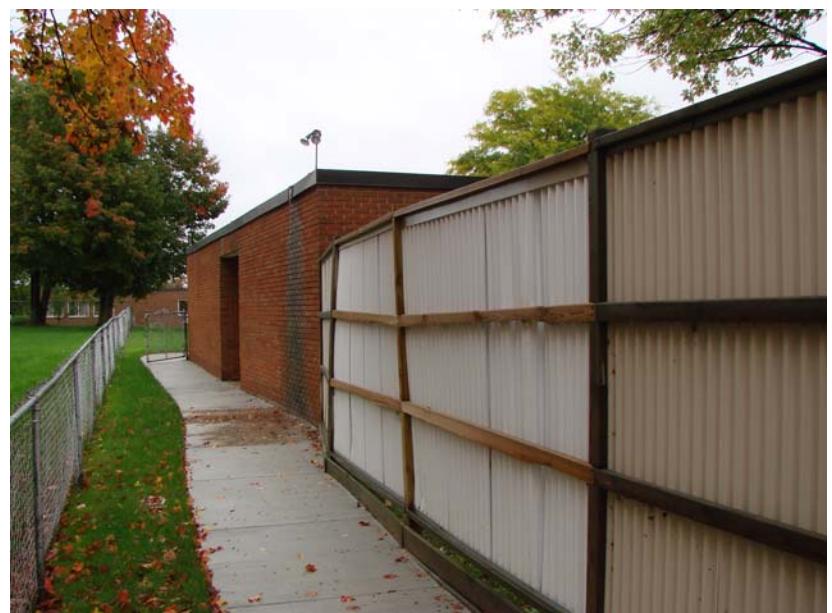
012\_MI\_1: Vinyl fence enclosing courtyard between South 2 and South 1 Halls.

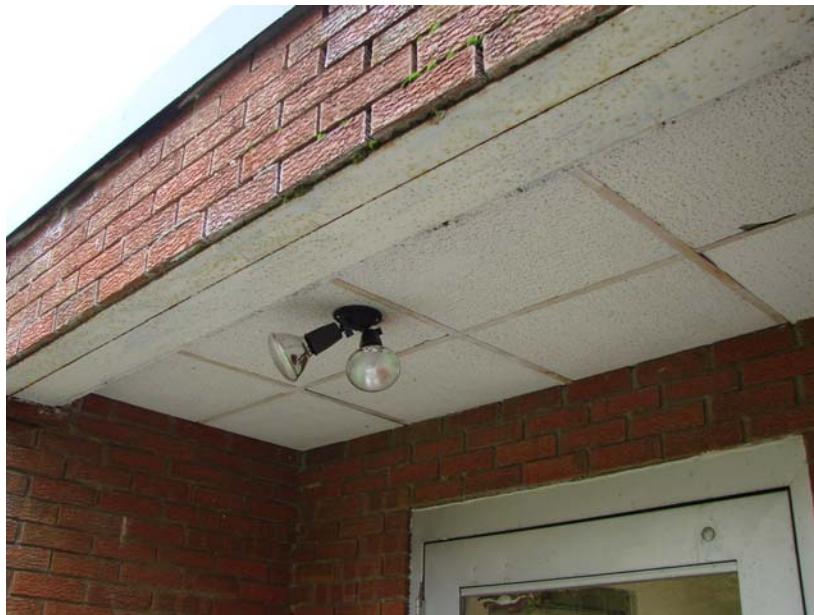
013\_MI\_1: Acoustical grid ceiling at South Hall 1 west exit.

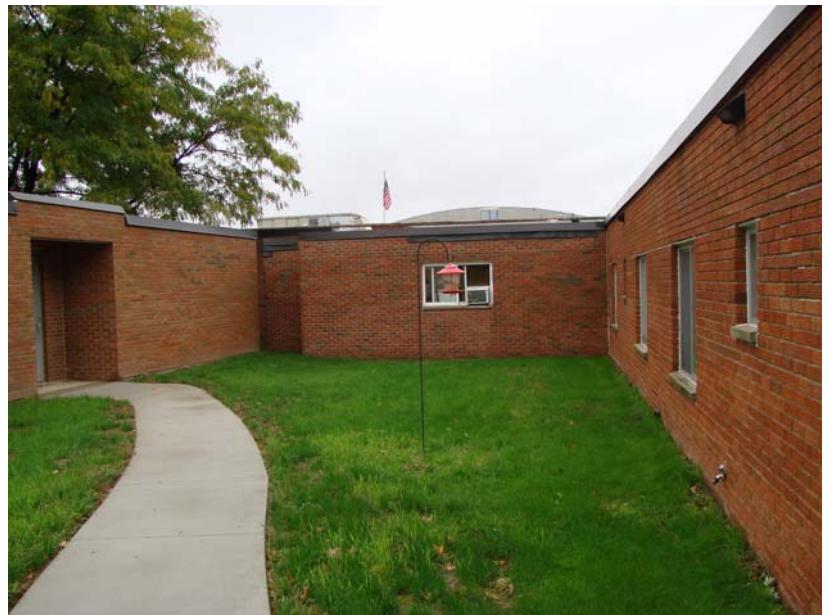
014\_MI\_1: Intersecting- building additions - West Hall (1980's) and South 1 Hall (1960's).

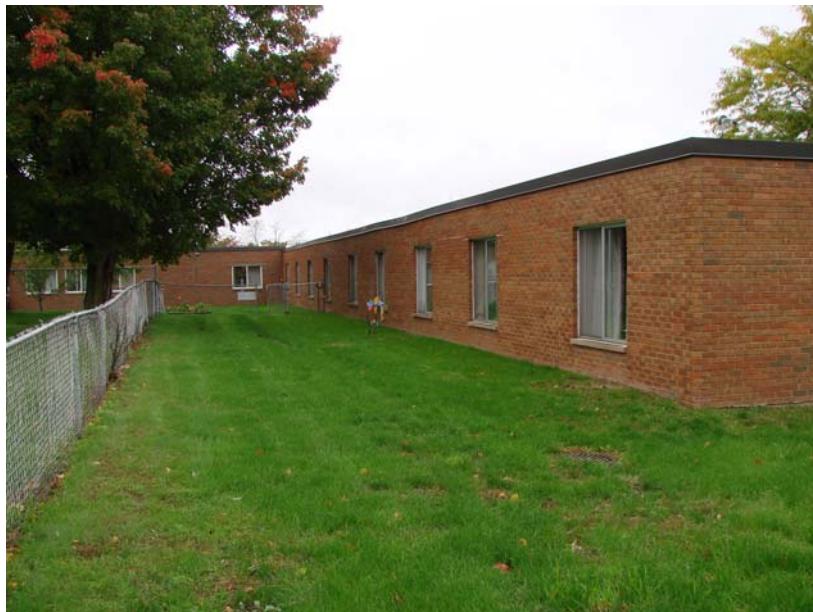
015\_MI\_1: West elevation of West Hall looking north.

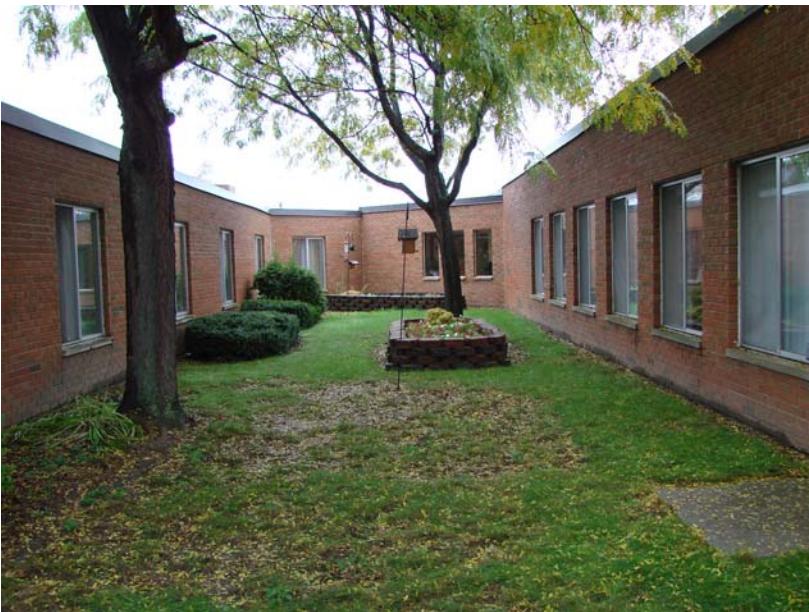
017\_MI\_1: Landscaped area between West Hall (1980s) and Central Hall (1974).

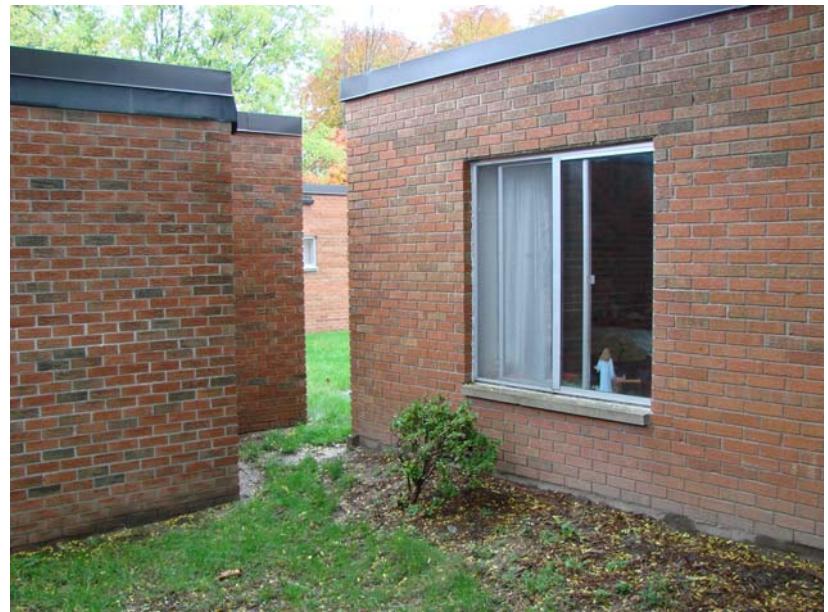
018\_MI\_1: Building configuration - between Central Hall (1974) and West Hall (1980's).

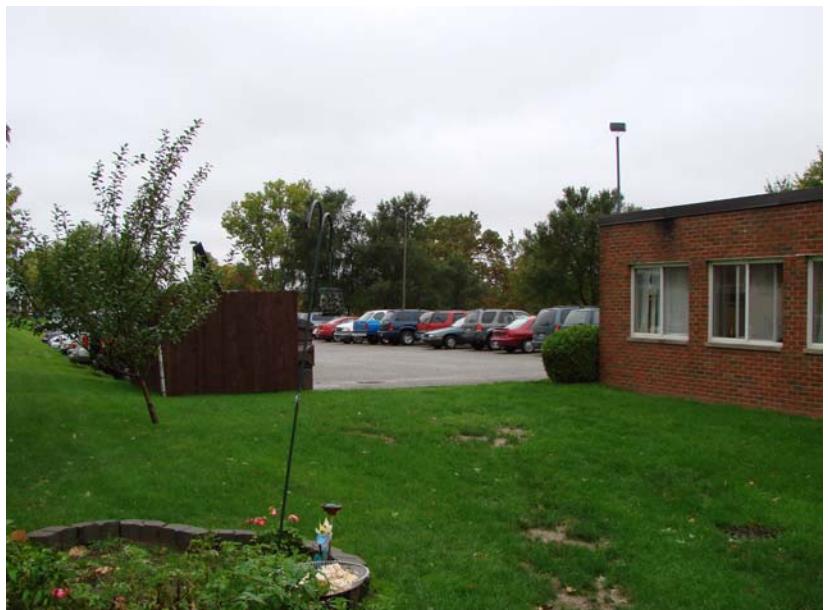
020\_MI\_1: Parking lot behind facility West Hall.

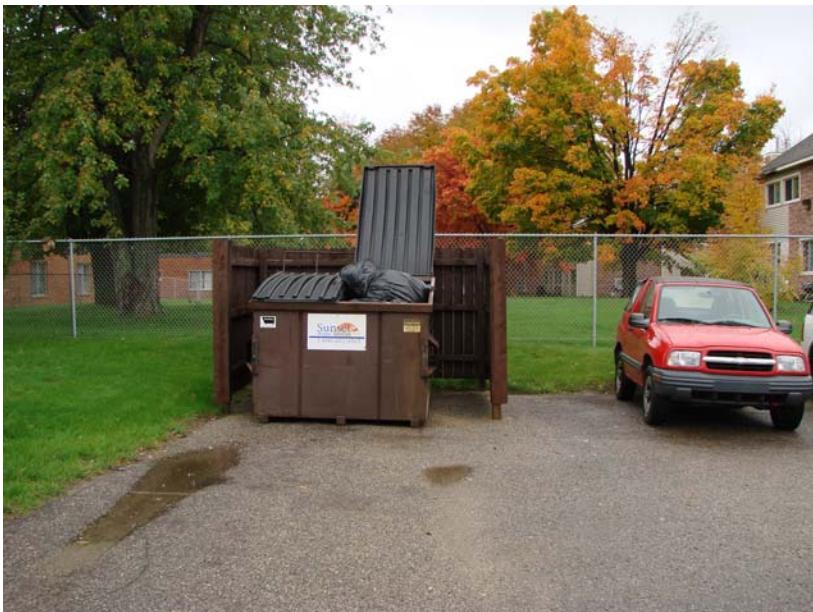
021\_MI\_1: Trash dumpster in west parking lot.

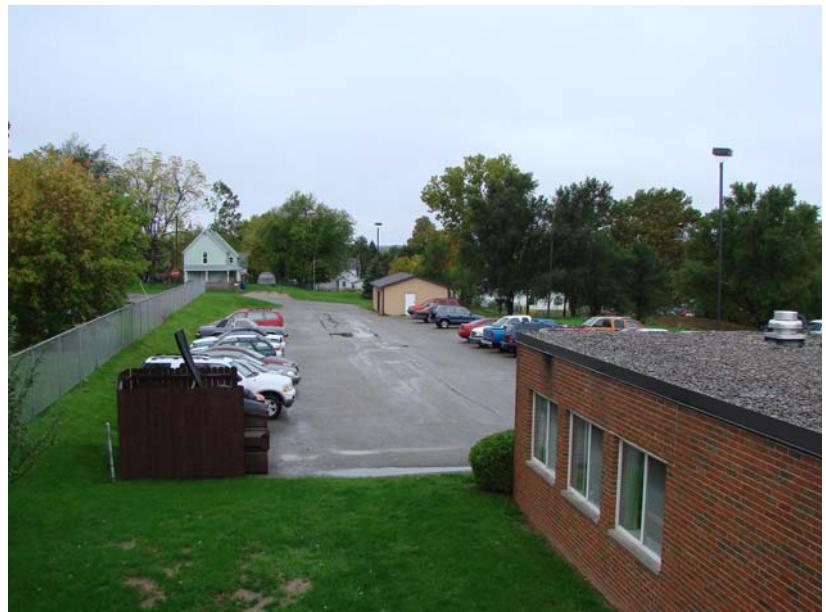
022\_MI\_1: Parking lot - west side of building.

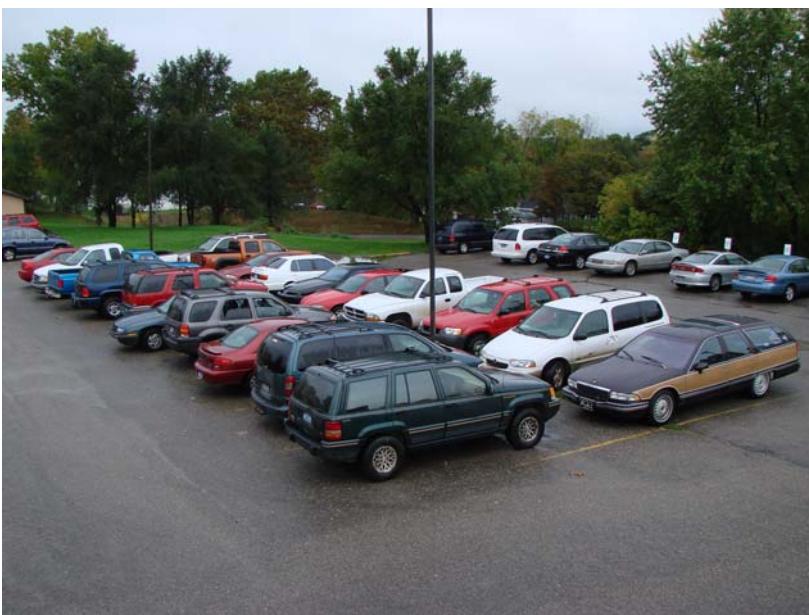
023\_MI\_1: Parking lot - west side of building.

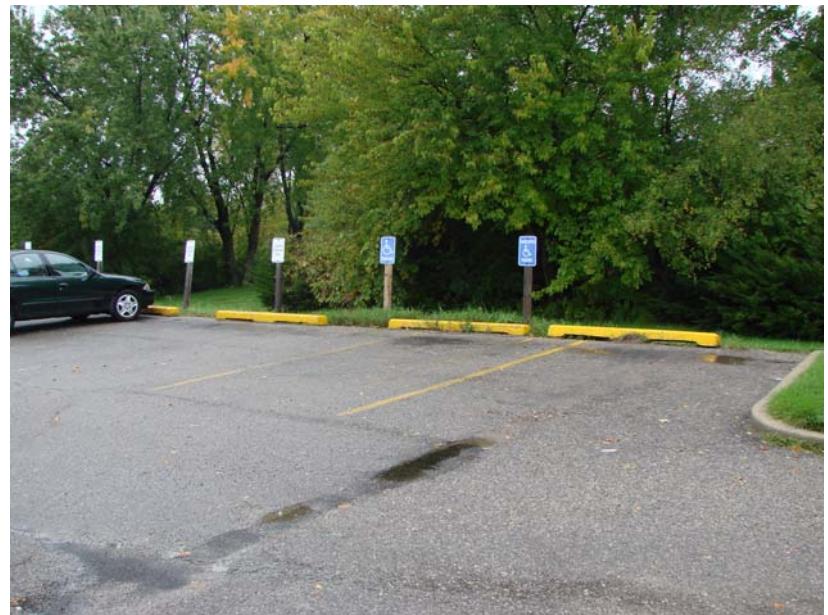
026\_MI\_1: Parking lot detail - asphalt paving needs to be sealed and striped.

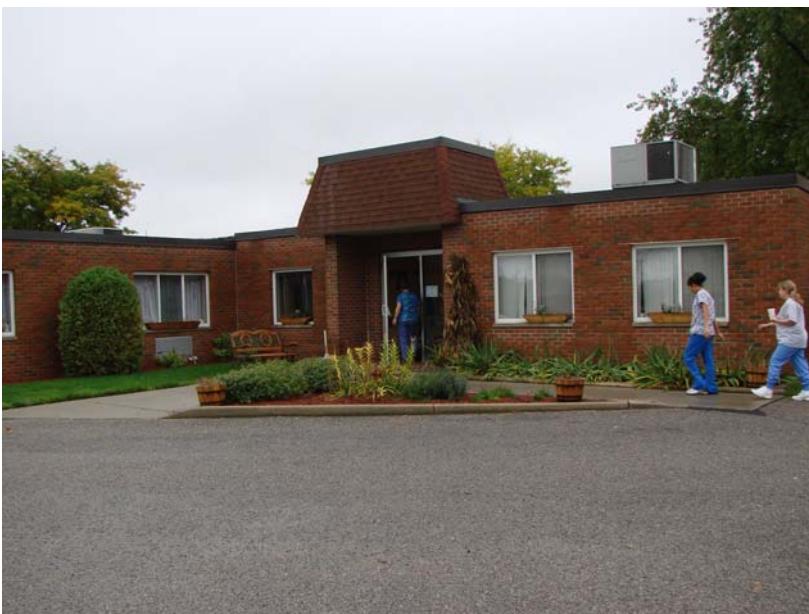
027\_MI\_1: Main facility entrance & outpatient therapy.

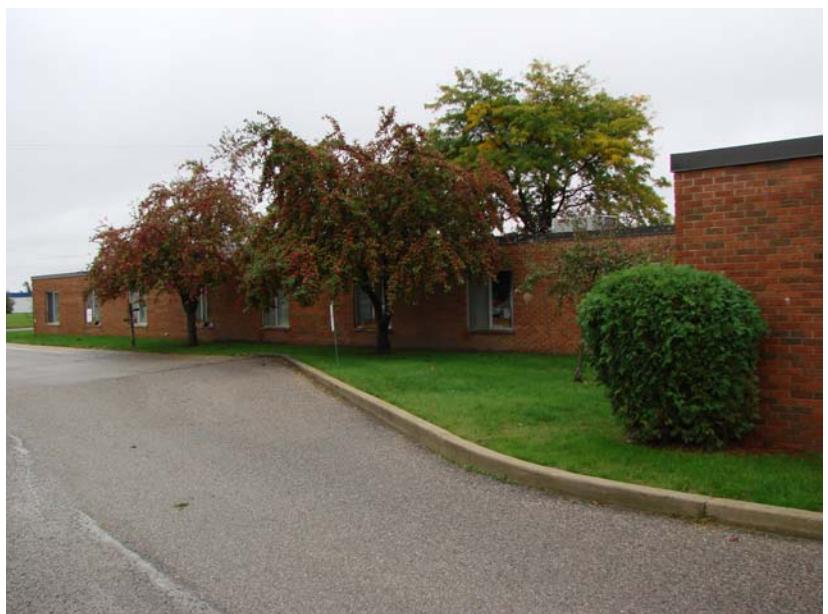
028\_MI\_1: East Hall north elevation looking east.

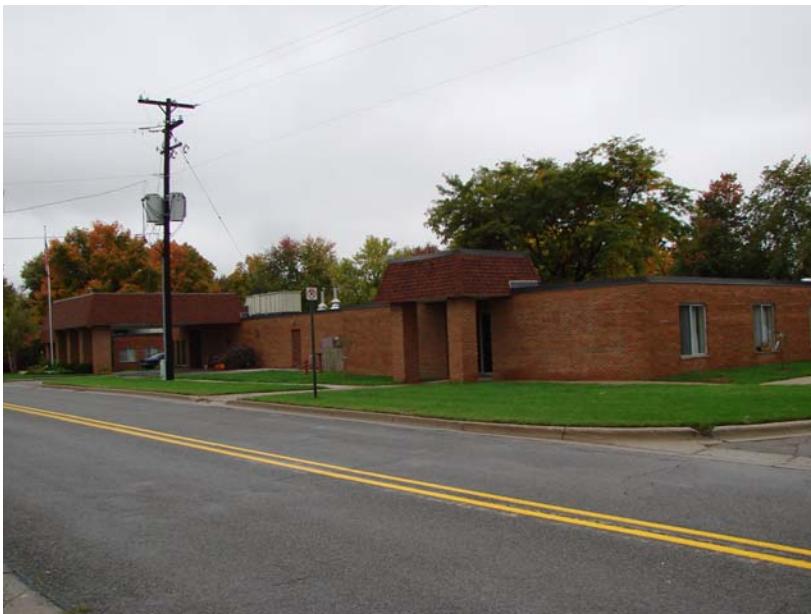
029\_MI\_1: Front east elevation of Central Hall and East Hall.

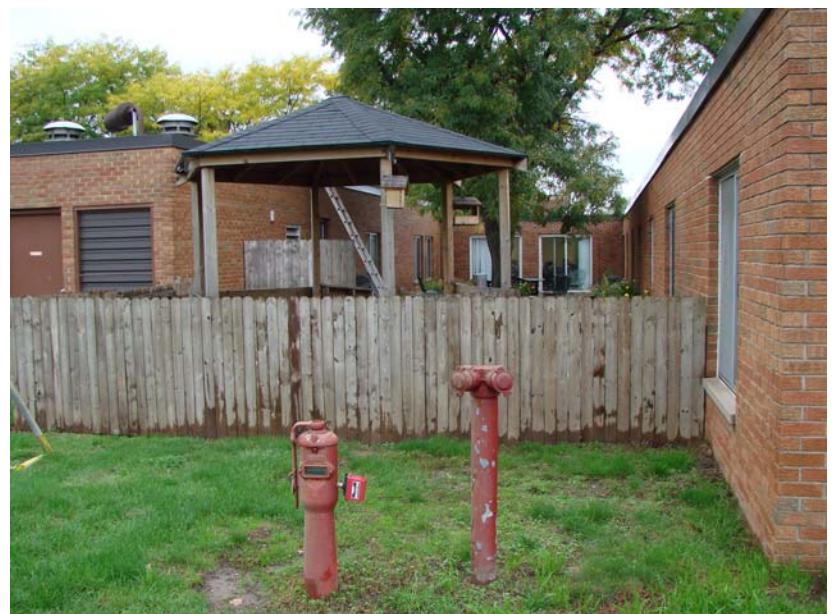
032\_MI\_1: Fire sprinkler connection, courtyard between Central Hall and East Hall.

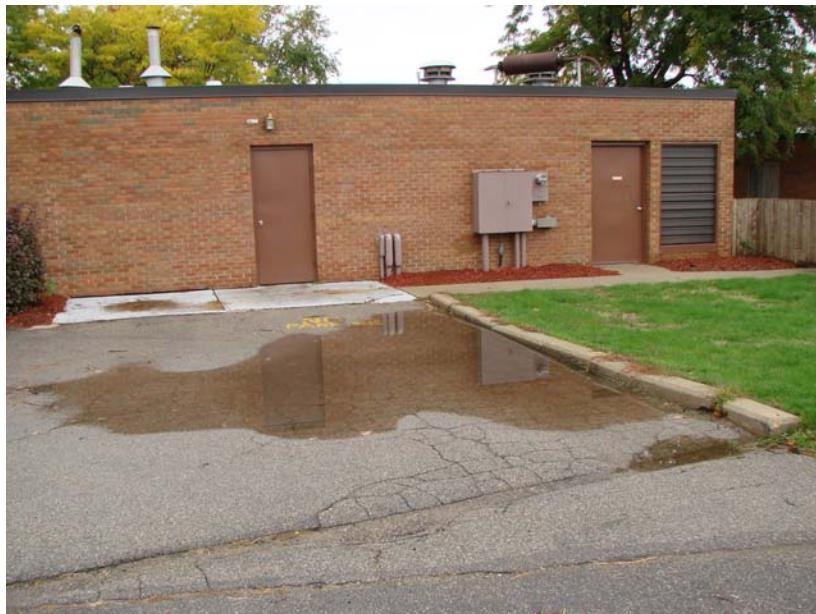
033\_MI\_1: Central Hall - mechanical room doors.

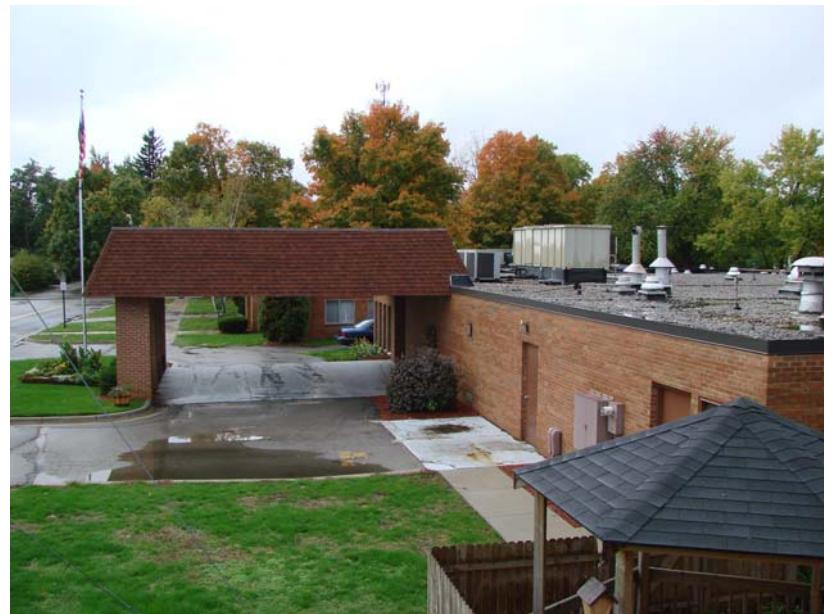
034\_MI\_1: Porte-cochere at Central Hall (administrative offices).

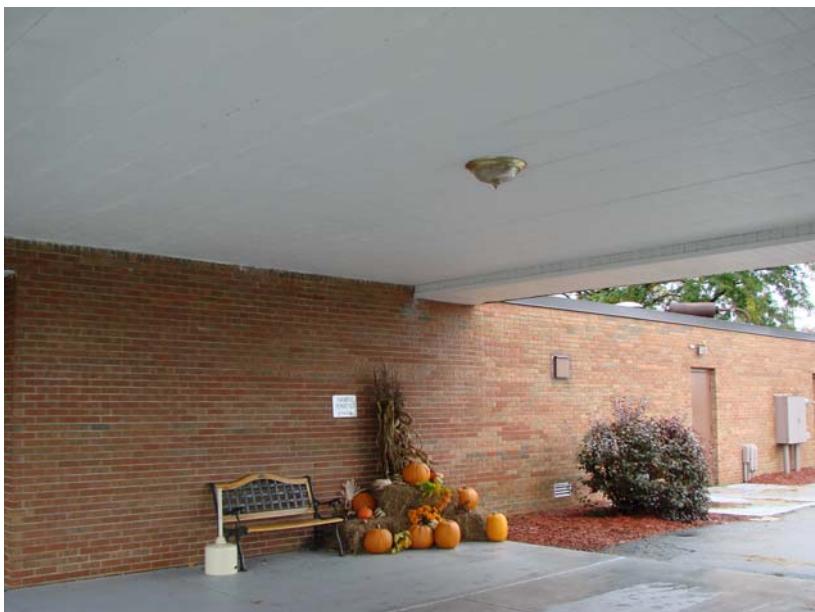
035\_MI\_1: Porte-cochere - pre-cast concrete planks with architectural -docks plank- finish.

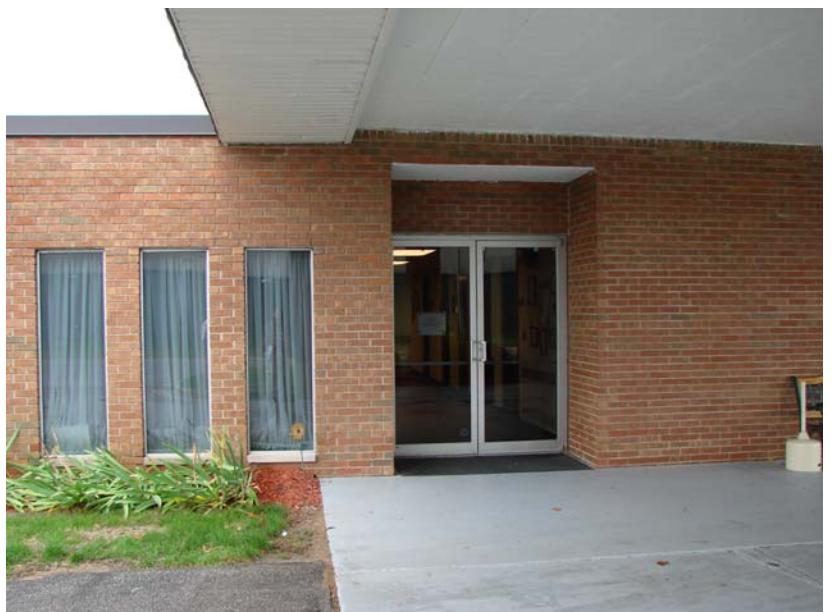
036\_MI\_1: Porte-cochere entrance to Central Hall - administration offices.

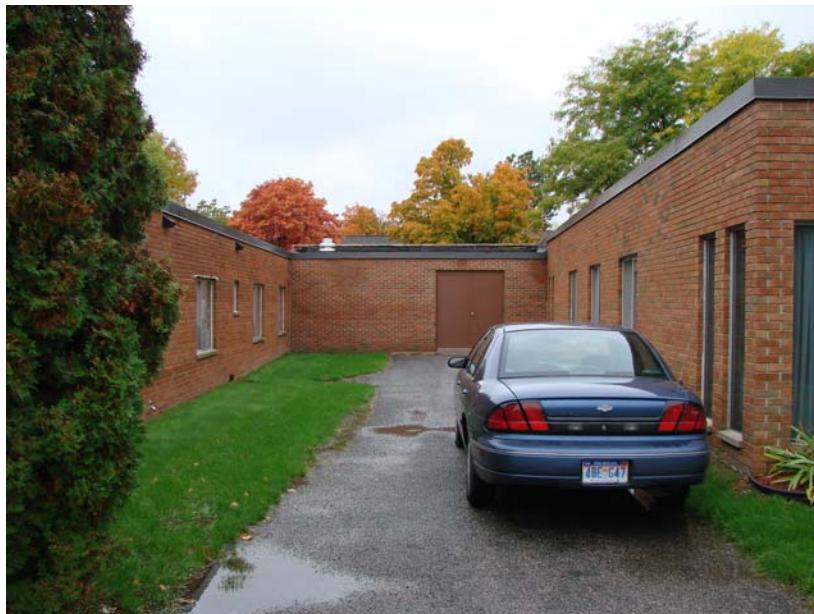
037\_MI\_1: Connection between South 1 (1960s) and Central Halls (1974).

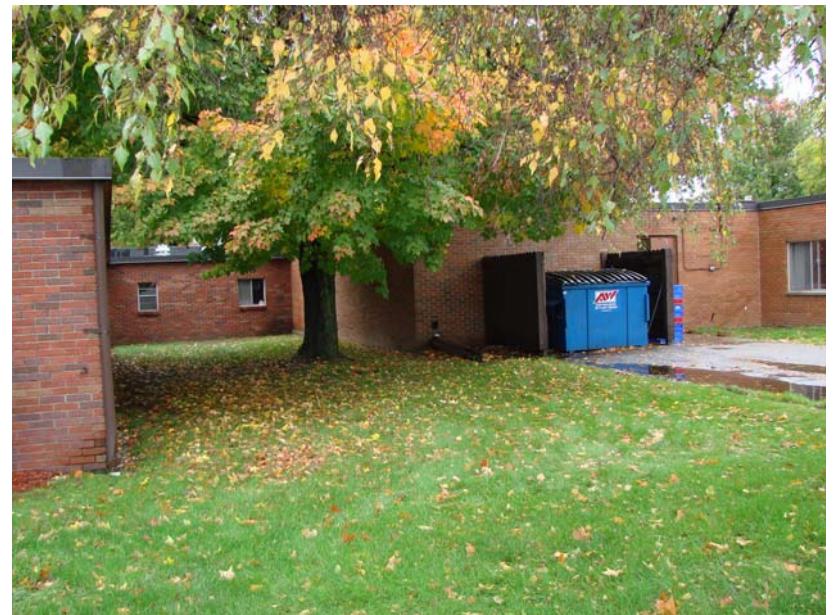
046\_MI\_1: Building connection between South 2 (1950's) and South 1 Halls (1960's).

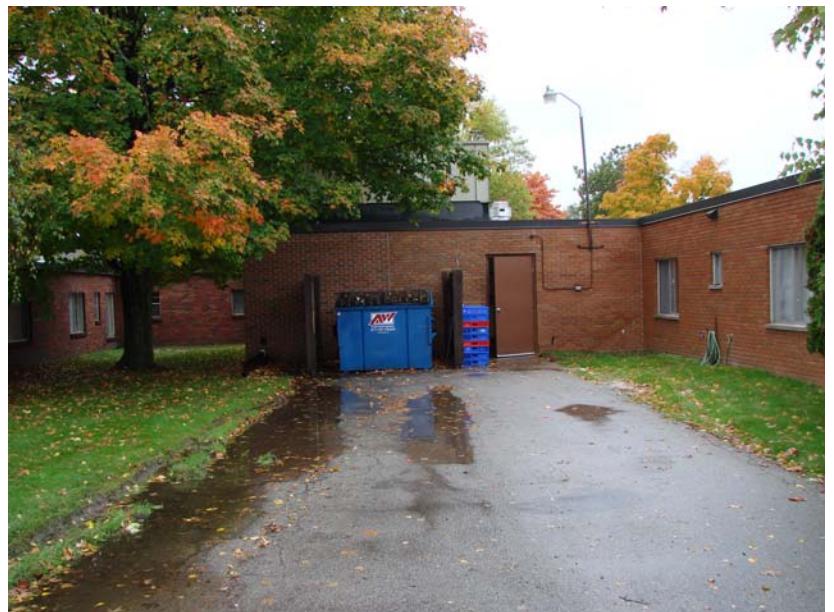
048\_MI\_1: Trash dumpster outside kitchen at South 1 Hall.

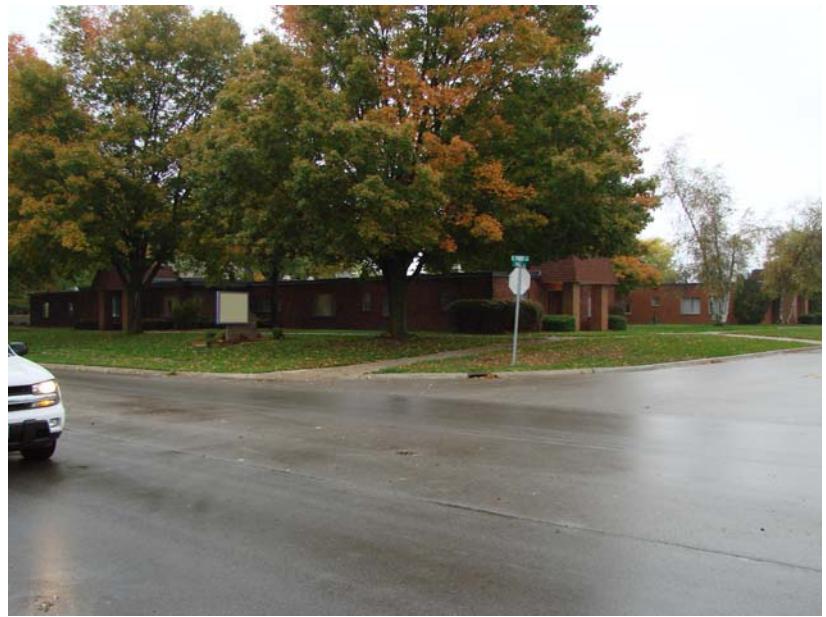
050\_MI\_1: Front (east) elevation - Central Hall, East Hall.

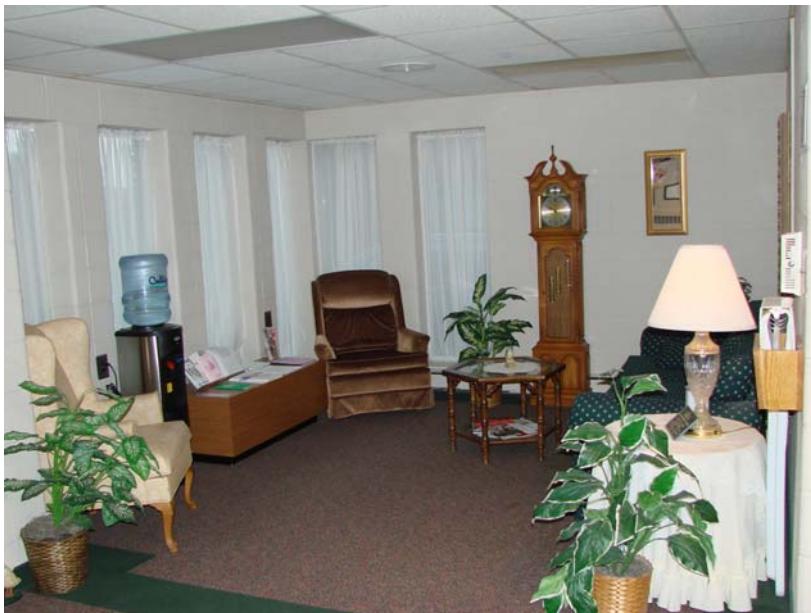
051\_MI\_1: Sitting room adjacent to administration offices.

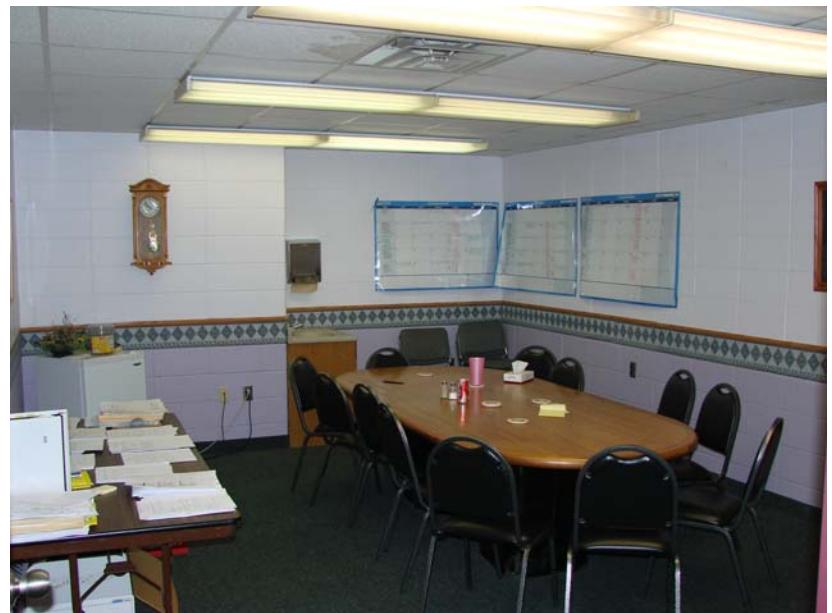
052\_MI\_1: Conference room adjacent to administrative offices.

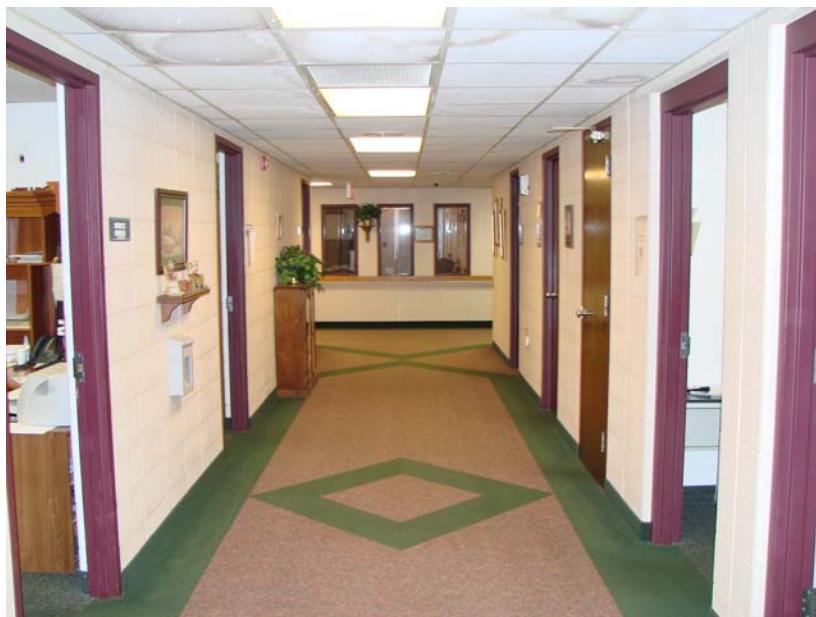
053\_MI\_1: Administrative corridor (original) looking to dining room.

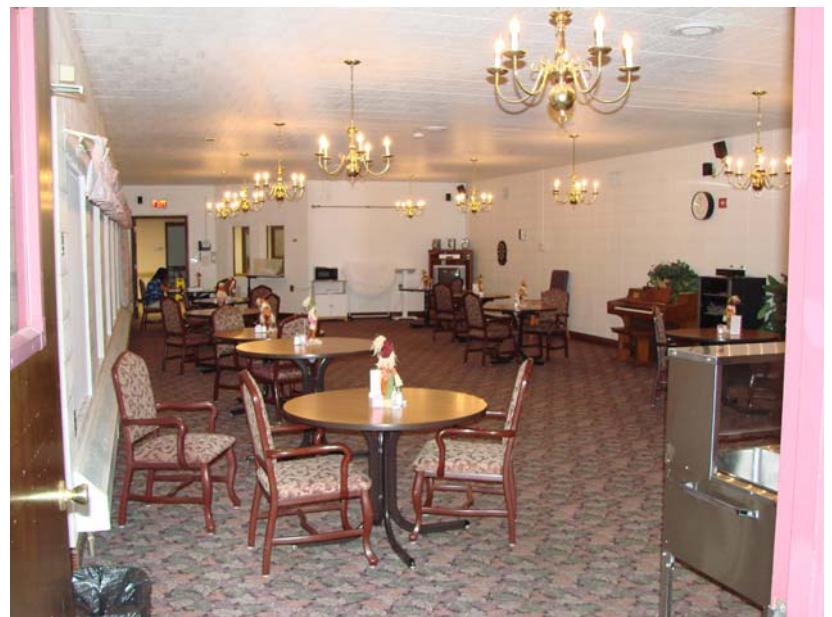
054\_MI\_1: Dining room at west end of Administrative Hall.

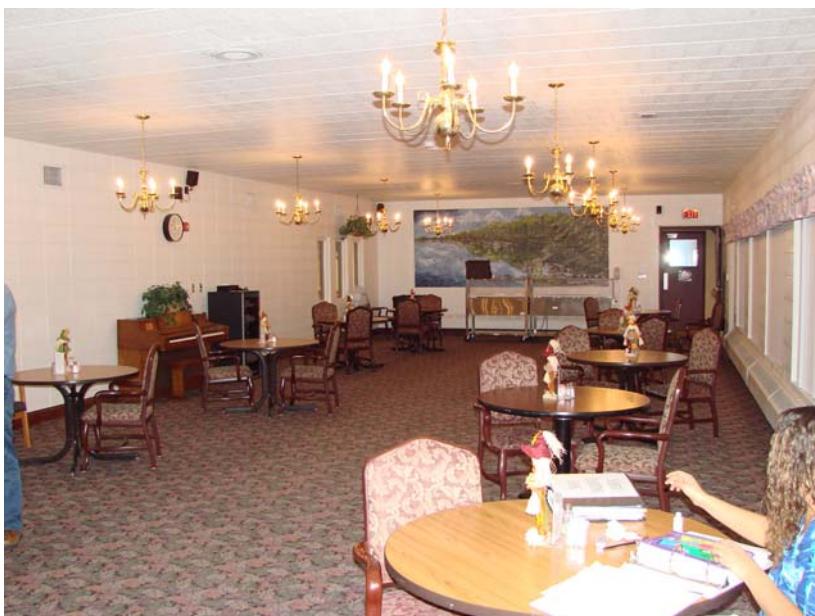
055\_MI\_1: Dining room at west end of Administrative Hall.

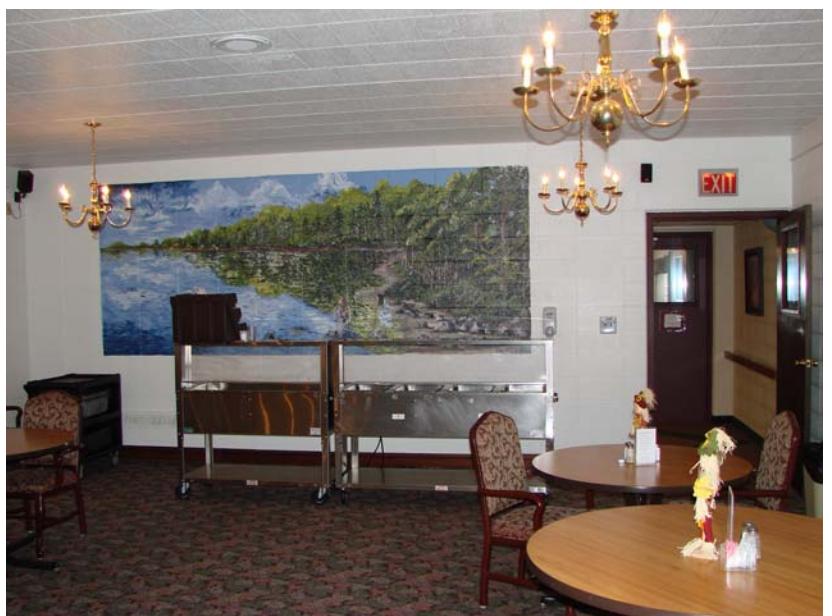
056\_MI\_1: Wal mural at south end of dining room.

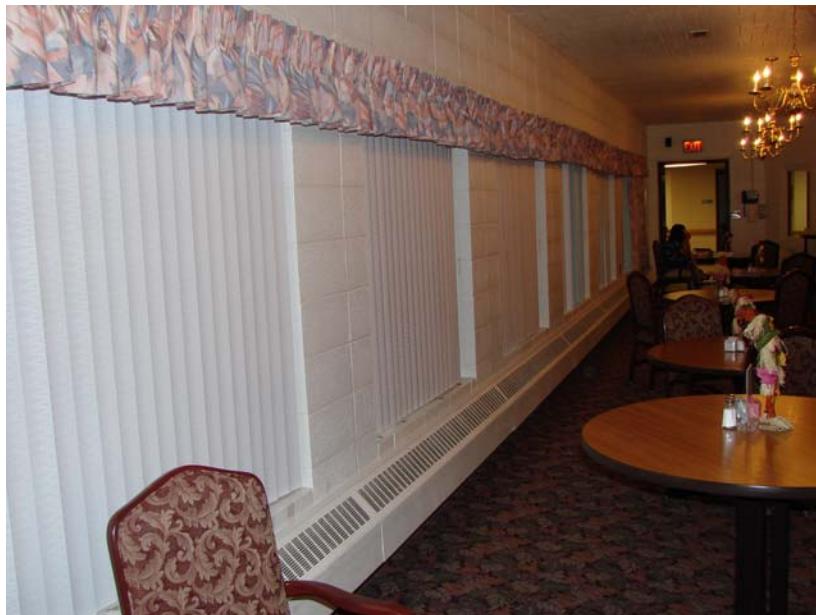
057\_MI\_1: Dining room at west end of Administrative Hall - radiant heating units (water source).

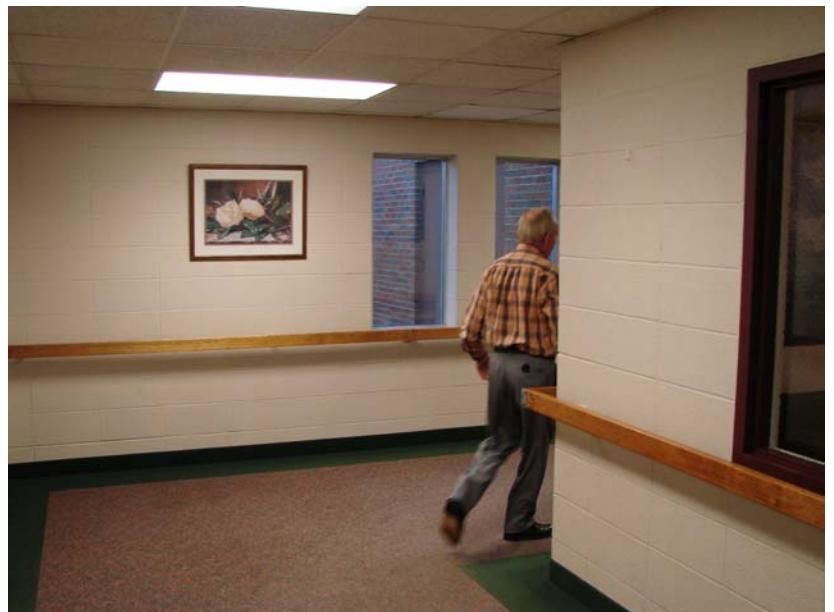
060\_MI\_1: Corridor -jog- to south from administrative corridor - leads to 1950's original building.

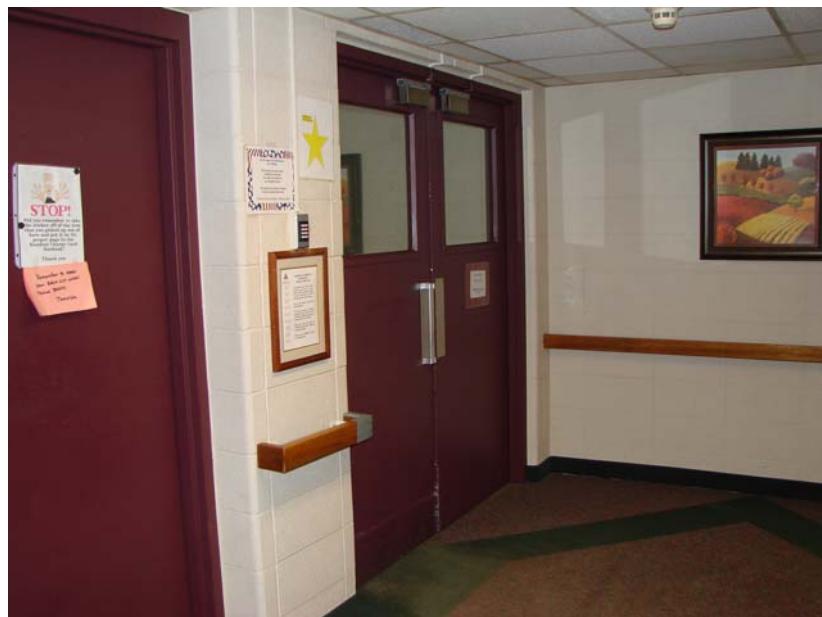
062\_MI\_1: Control doors separating South 1 Hall from center administrative hall.

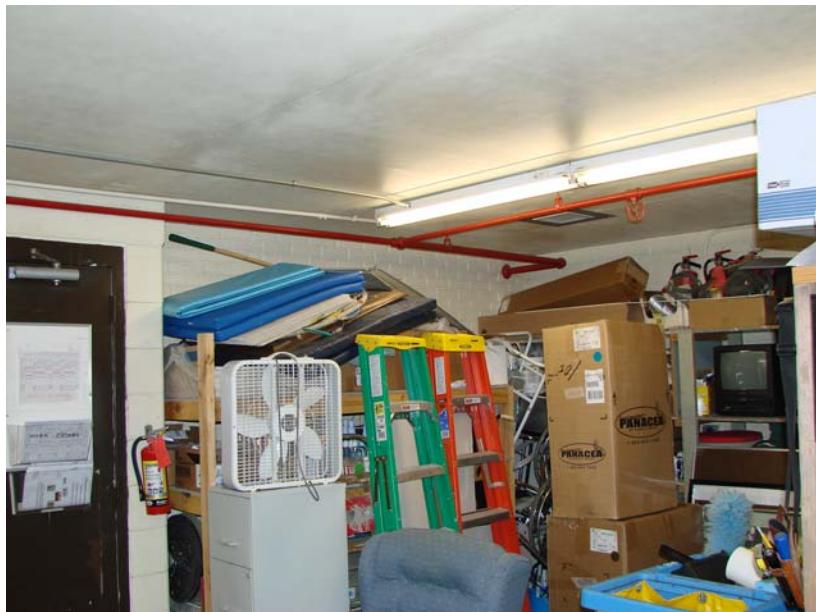
065\_MI\_1: Fire sprinklers in maintenance office. Note facility is only partially sprinkled.

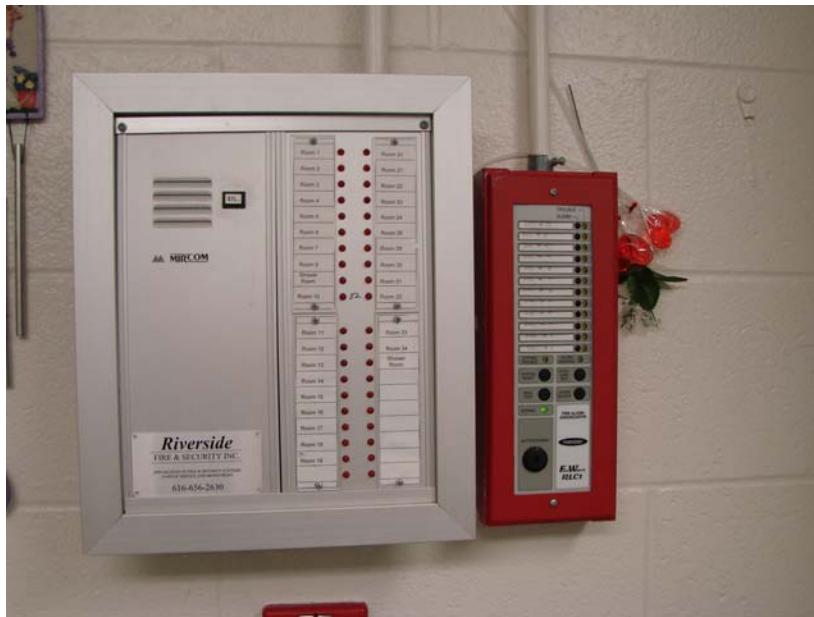
069\_MI\_1: Mircom nurse call, and Fire Watch fire alarm annunciator panels.

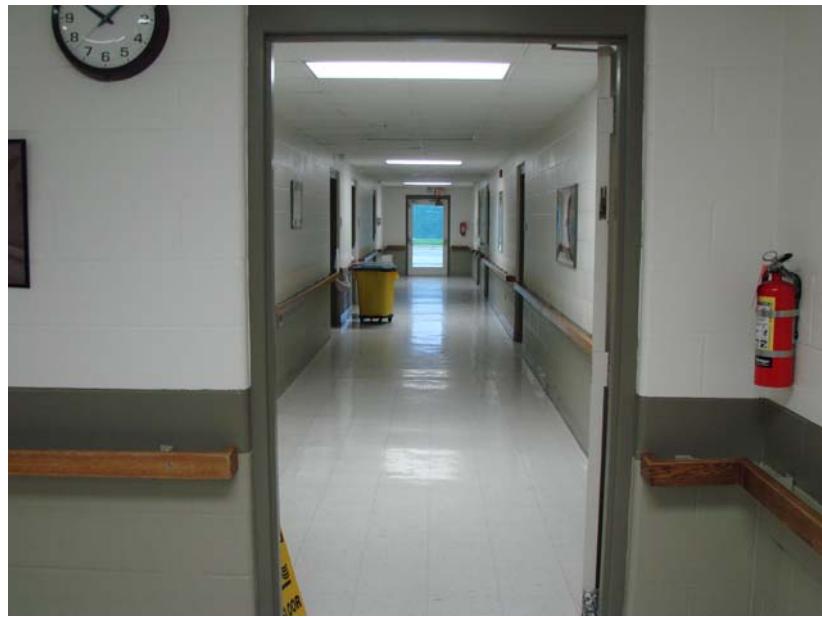
070\_MI\_1: South 1 Hall looking east from nurse station.

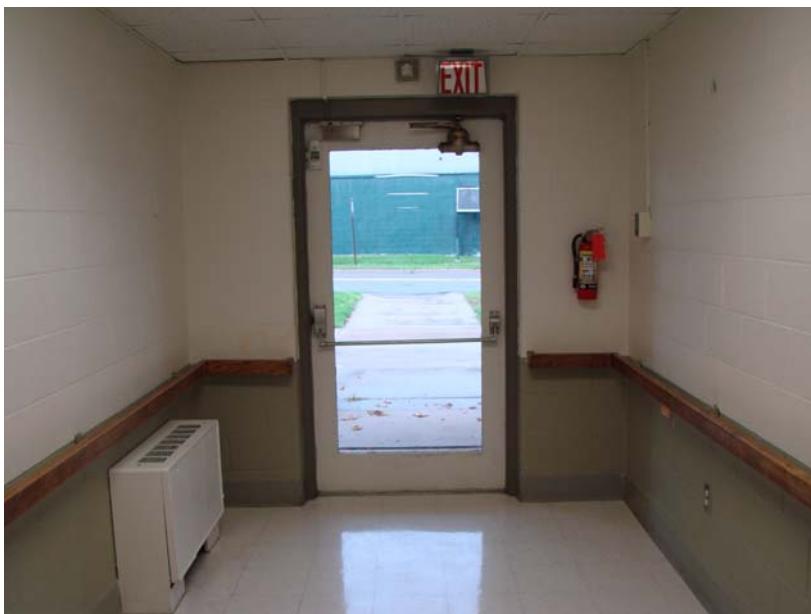
071\_MI\_1: South 1 east corridor exit to Hall street.

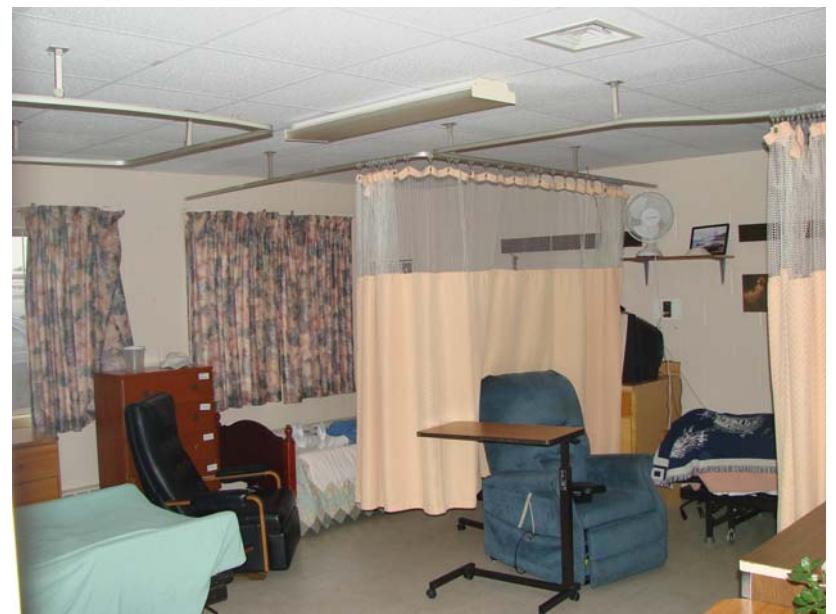
074\_MI\_1: South 1 - 3-bed ward.

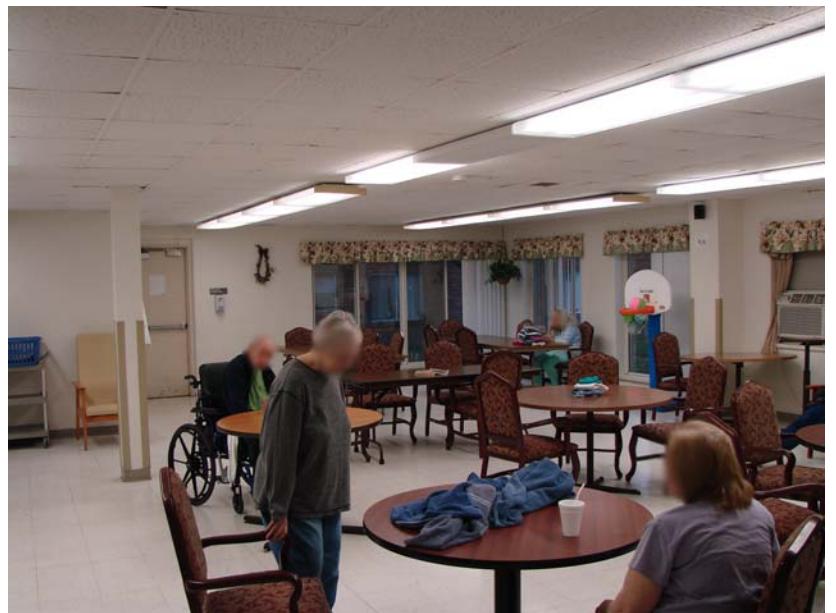
076\_MI\_1: South 1 dining room.

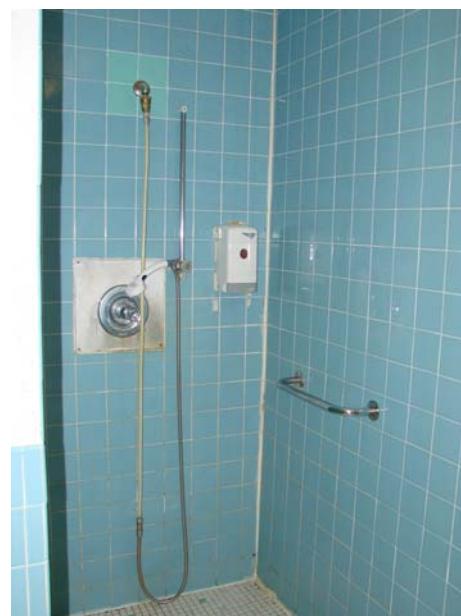
080\_MI\_1: South 1 tub-shower room.

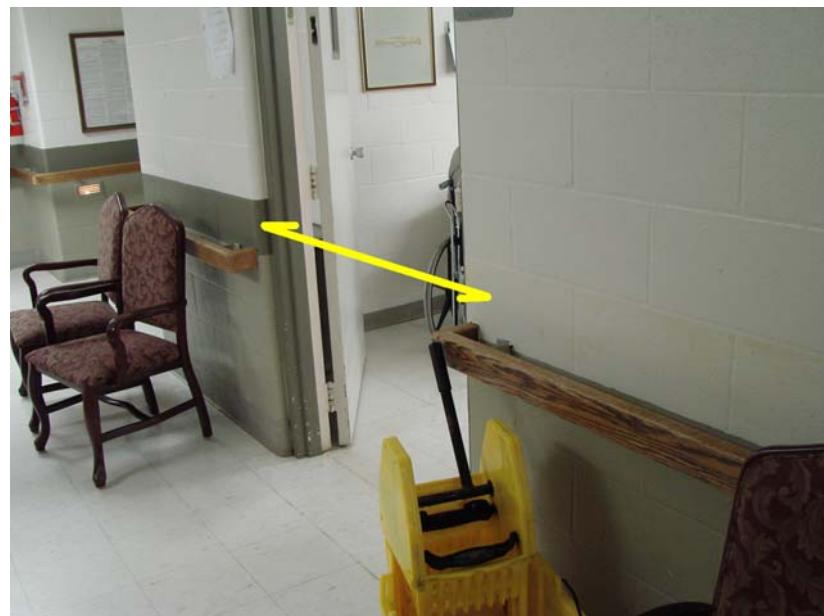
082\_MI\_1: South 1 corridor detail - staff is adding accent band above handrail.

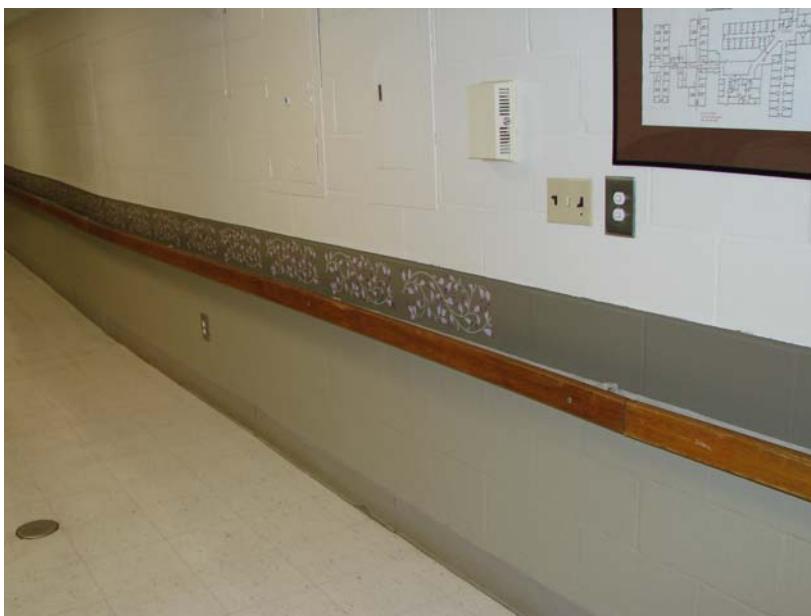
083\_MI\_1: Corridor detail - staff is adding accent band above handrail.

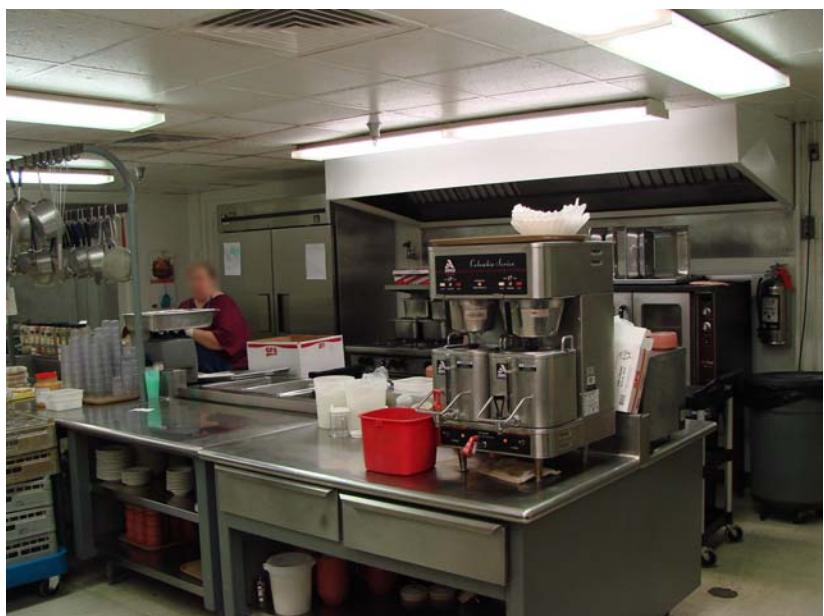
084\_MI\_1: Kitchen - food preparation area.

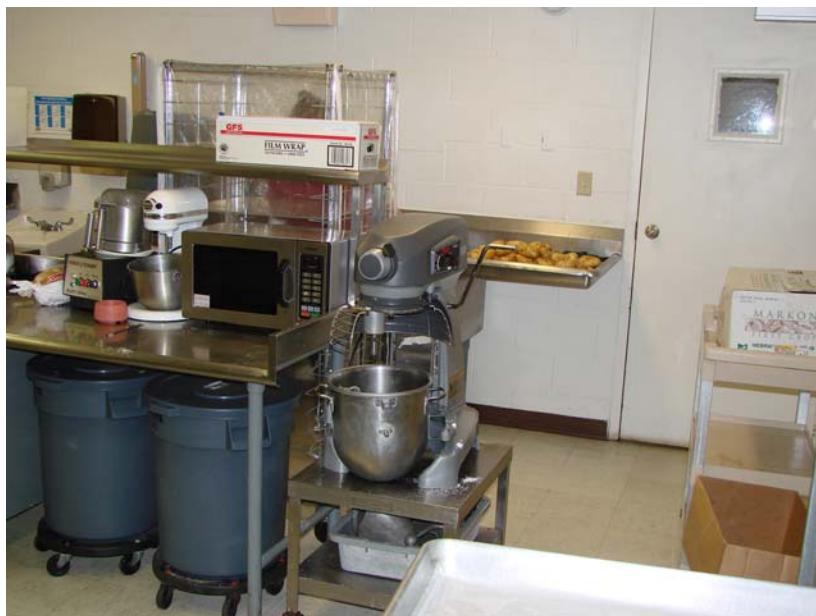
089\_MI\_1: Kitchen - food preparation area - mixer.
