## The Willows @ Anytown

Anytown, USA; Oct 4, 2006

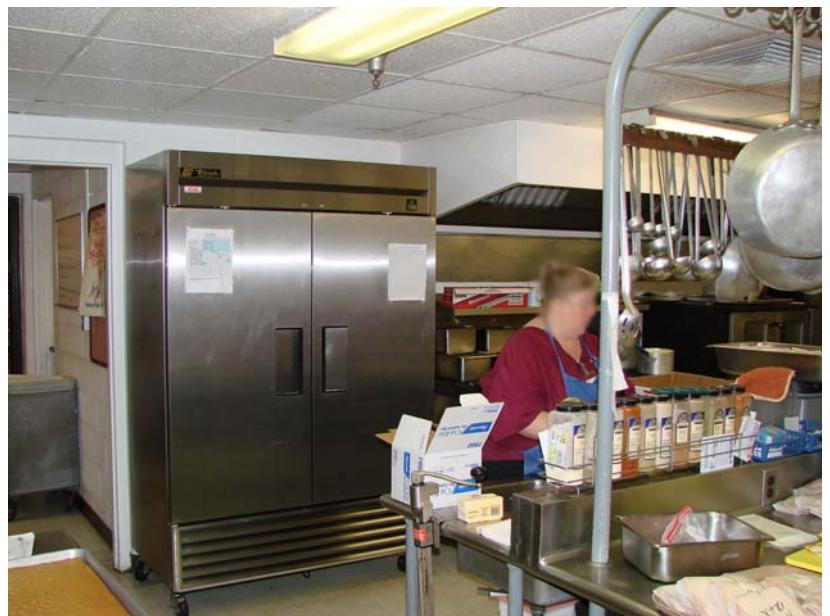
090\_MI\_1: Kitchen - True 2-door reach-in refrigerator.

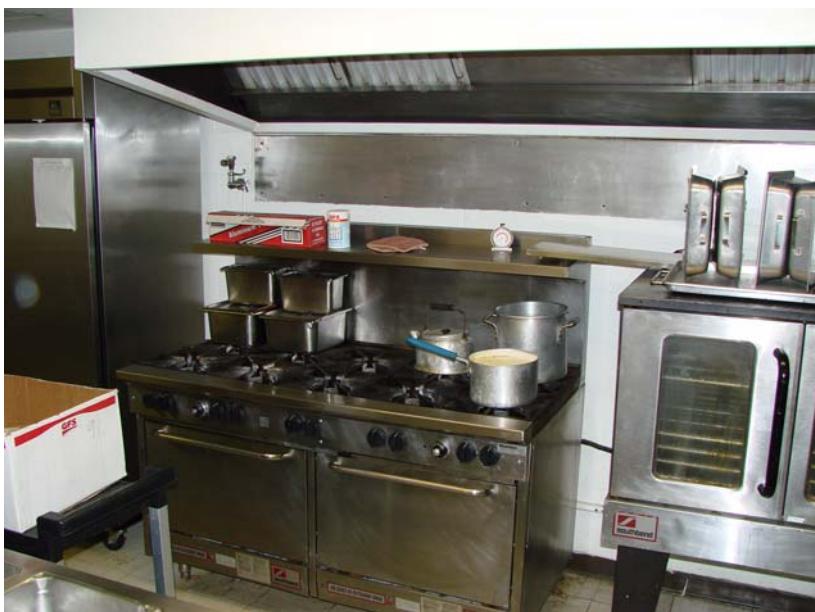
091\_MI\_1: Kitchen - Southbend 10-burner gas stove with double ovens.

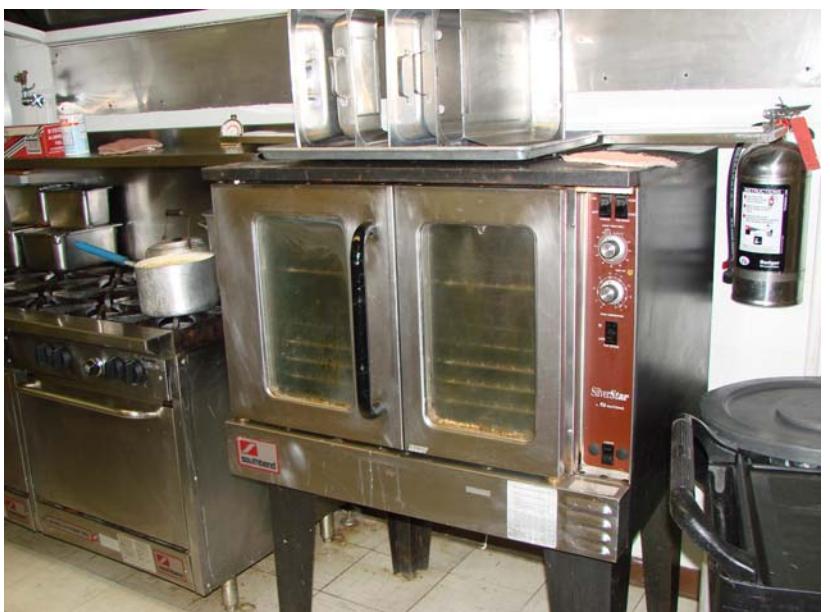
092\_MI\_1: Kitchen - Southbend convection oven.

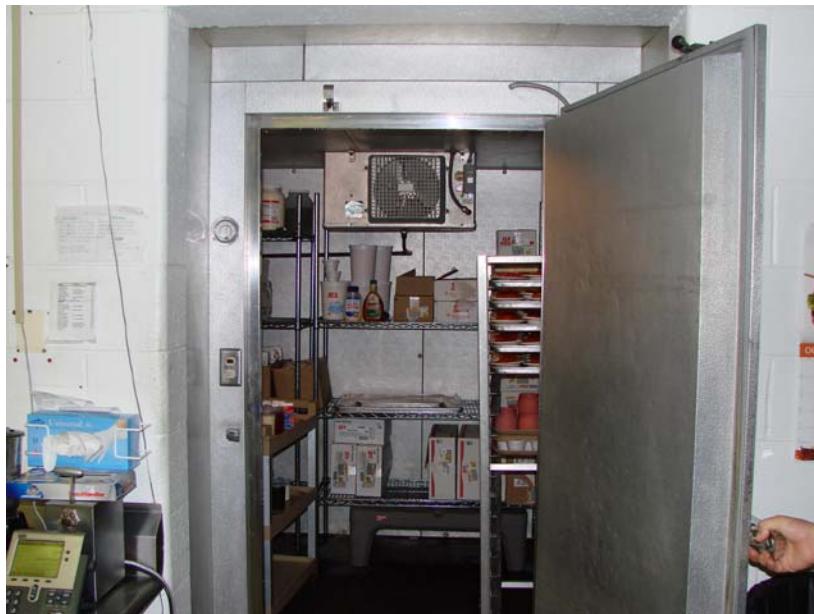
093\_MI\_1: Kitchen - Thermo Kool walk-in cooler.

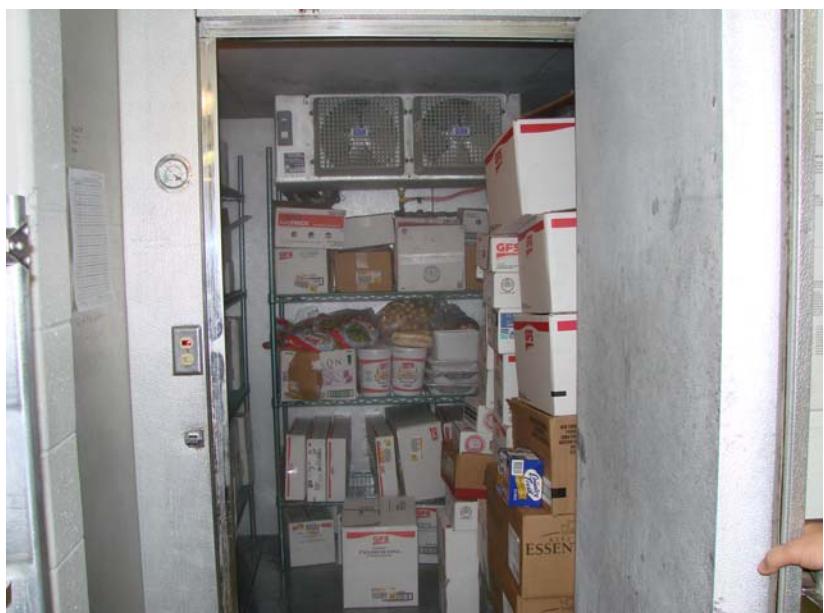
096\_MI\_1: Kitchen - Thermo Kool walk-in freezer.

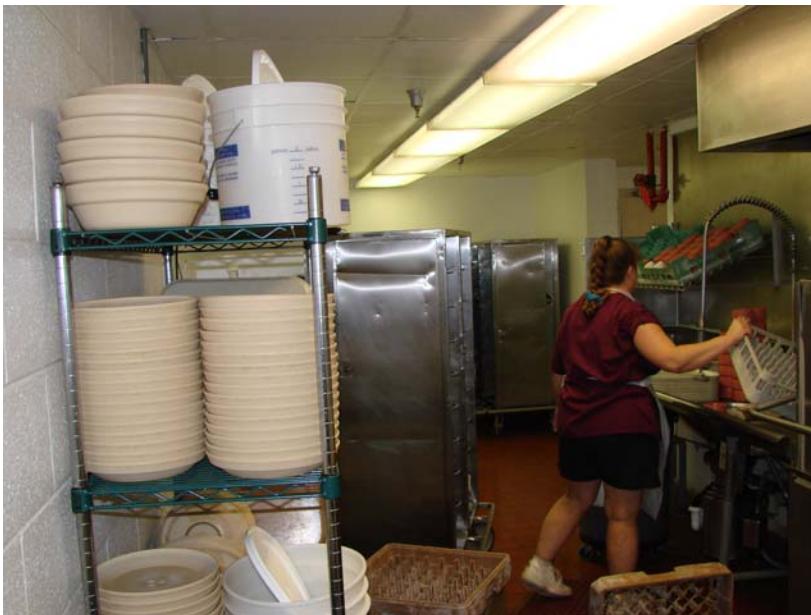
097\_MI\_1: Kitchen - dish washing area, food delivery carts.

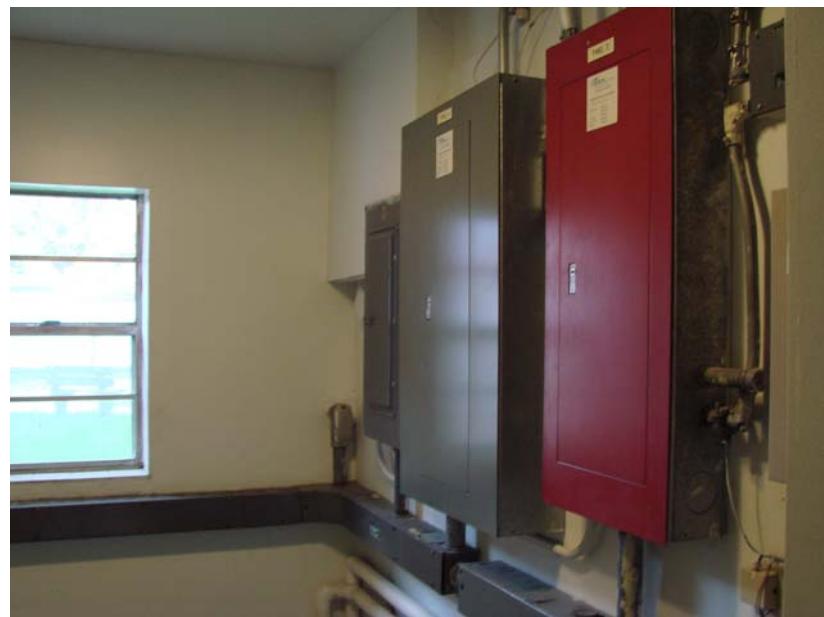
106\_MI\_1: Electrical sub-panels in South 2 Hall.

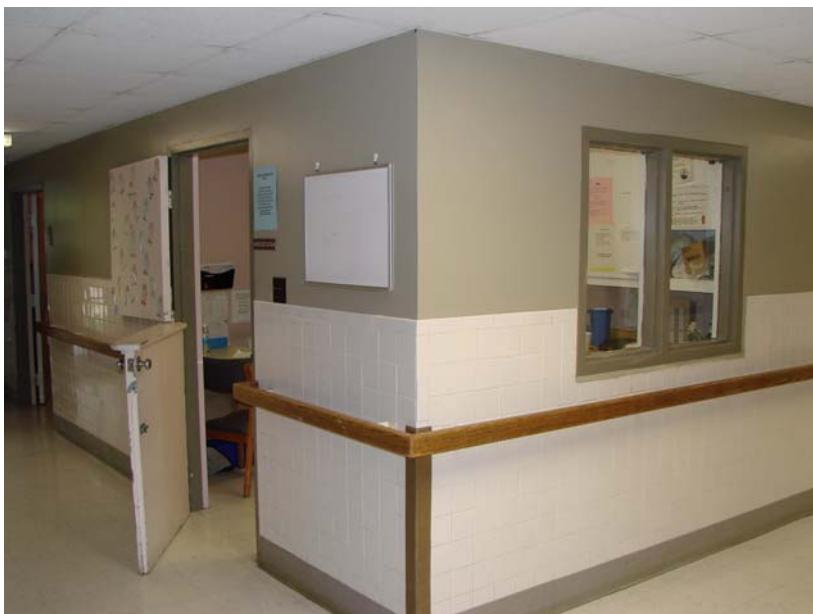
107\_MI\_1: South 2 nurse station.

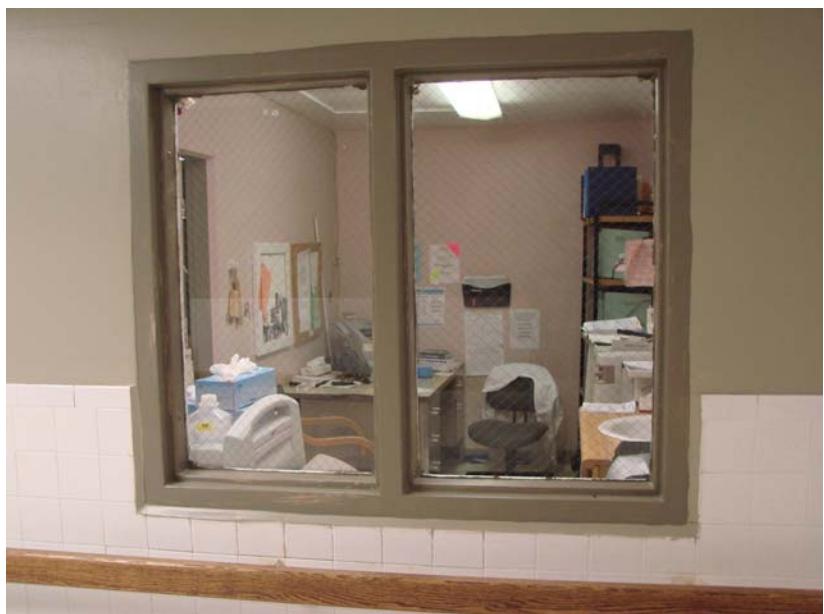
108\_MI\_1: South 2 nurse station.

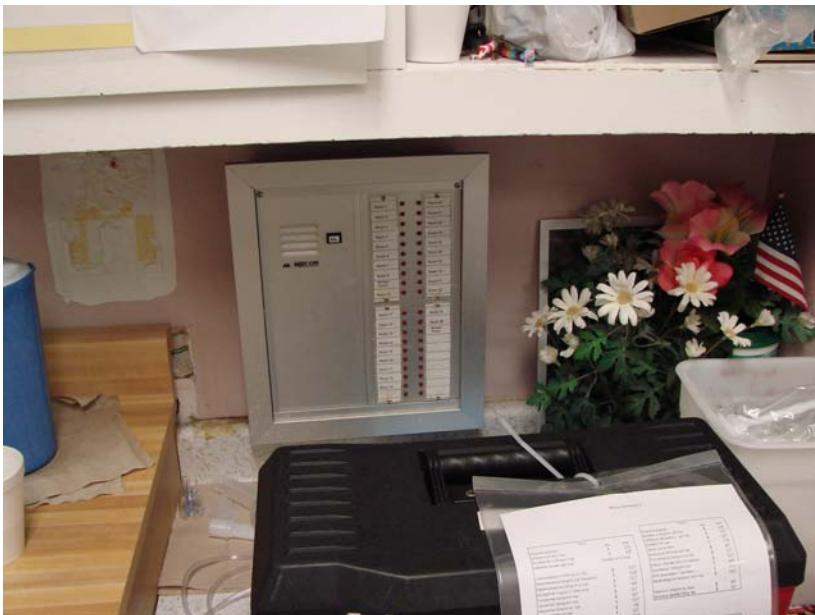
109\_MI\_1: Mircom nurse call annunciator panel.

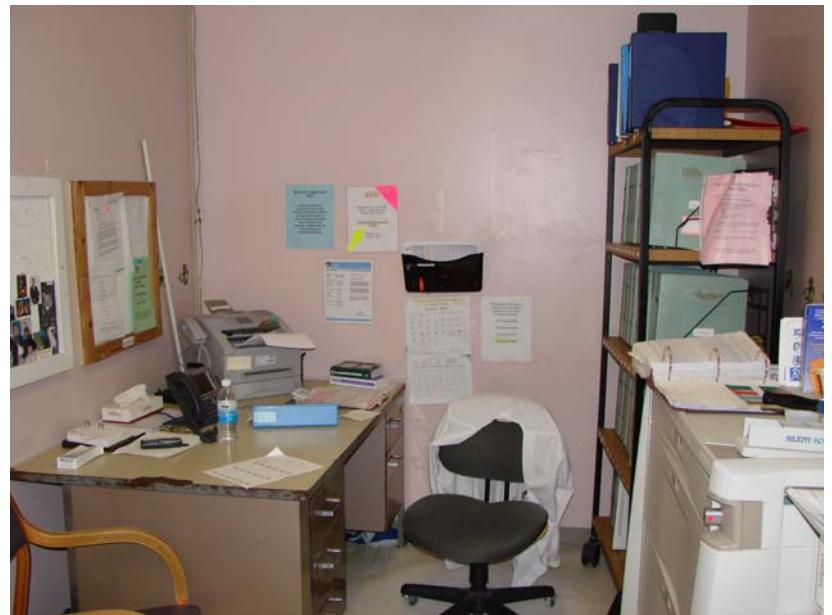
110\_MI\_1: South 2 nurse station.

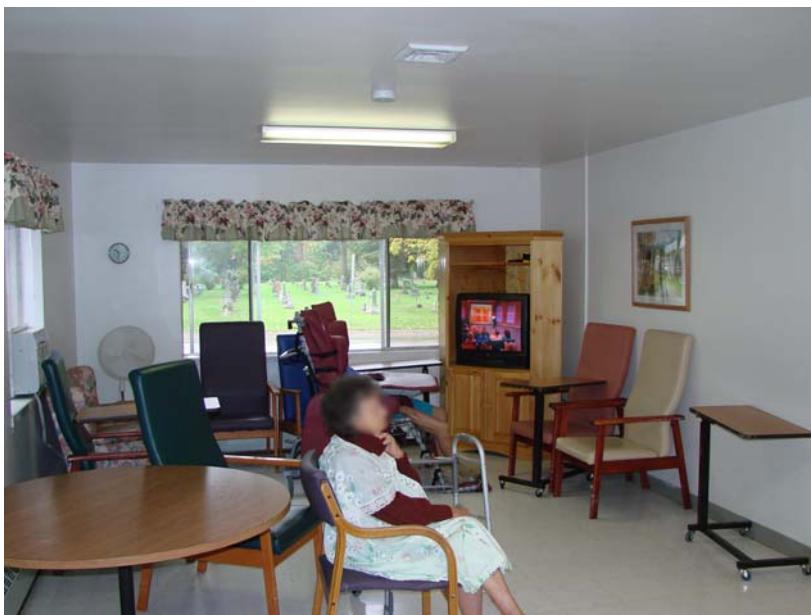
111\_MI\_1: South 2 day room.

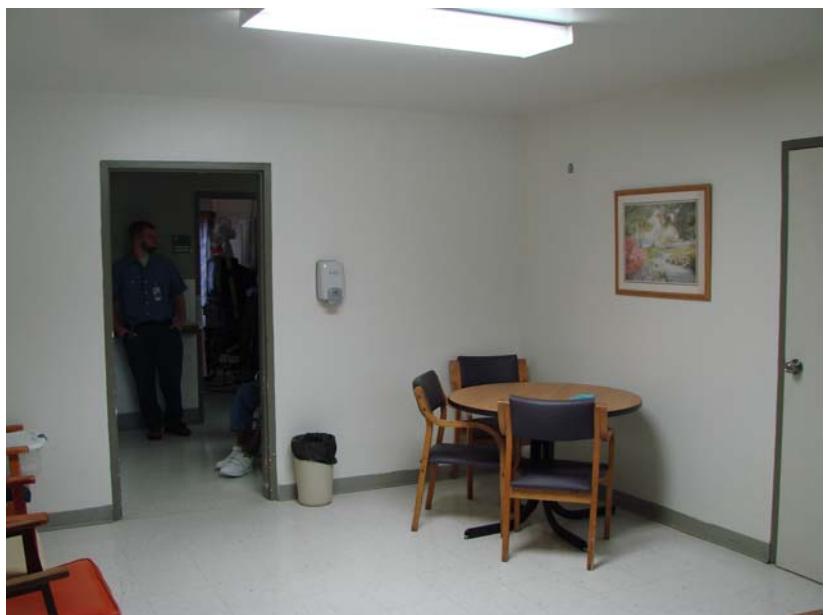
112\_MI\_1: South 2 day room.

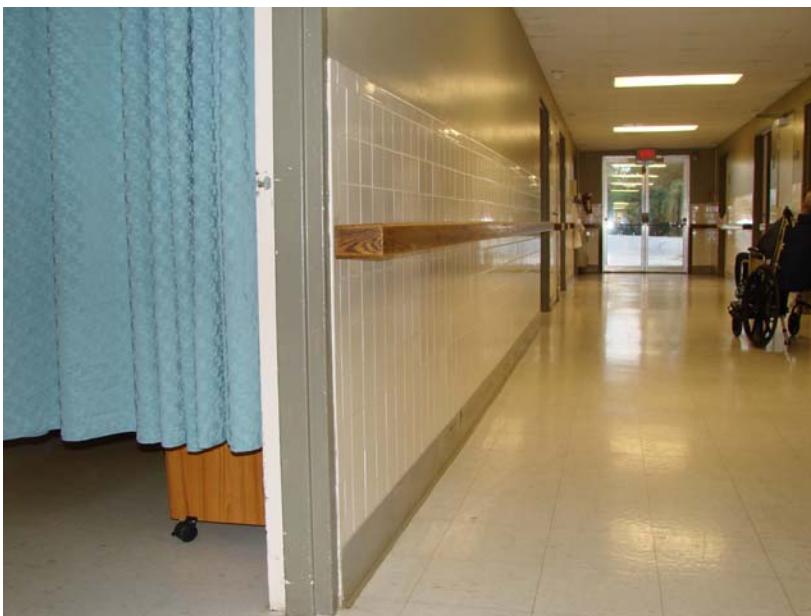
117\_MI\_1: South 2 Hall corridor detail - VCT floor, vinyl base, ceramic tile wainscot, wood handrail, painted wall (skim coat over CMU block wall), acoustic

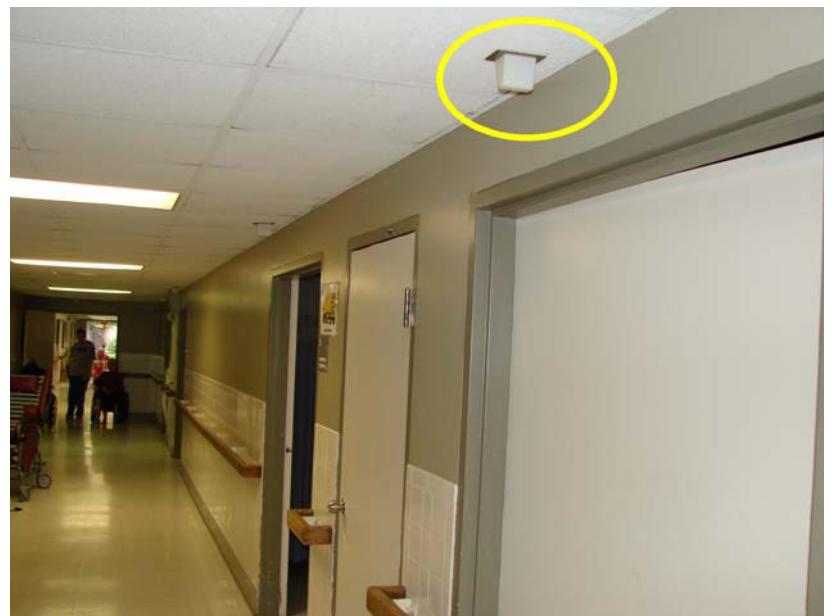
118\_MI\_1: South 2 corridor detail - nurse call lights in ceiling.

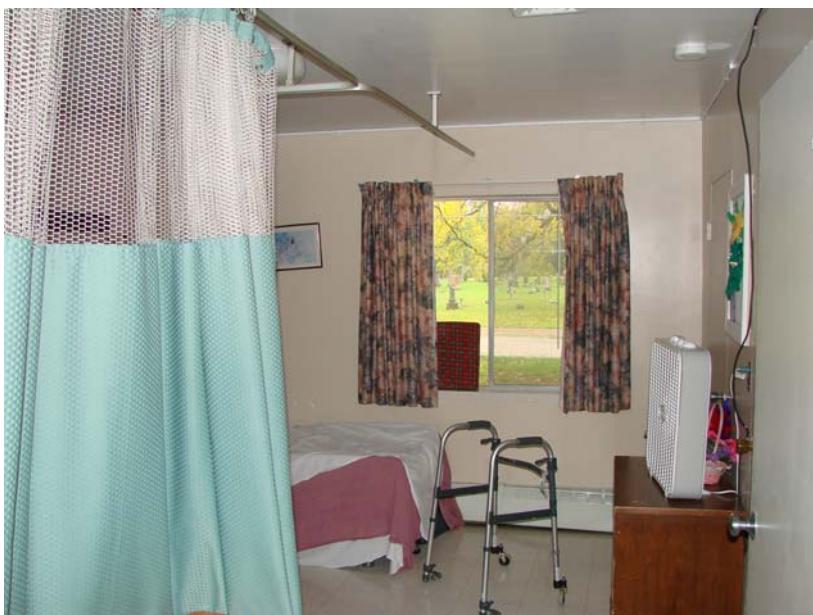
119\_MI\_1: South 2 Hall semi-private room.

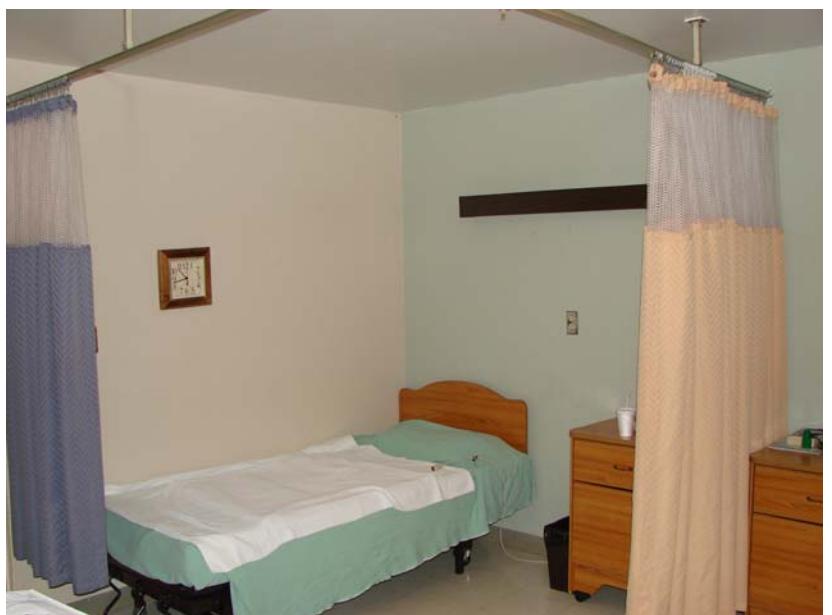
120\_MI\_1: South 2 semi-private resident room.

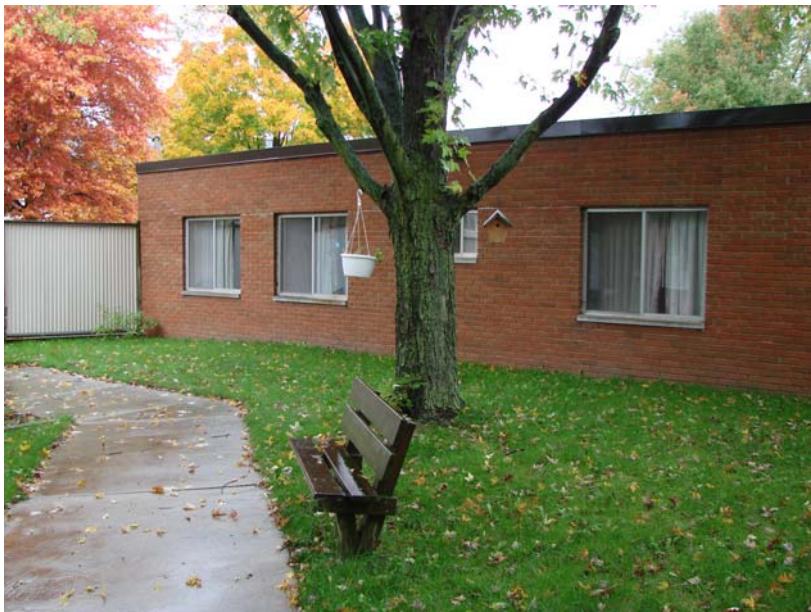
127\_MI\_1: Courtyard between west wings of South 1 and South 2 Halls.

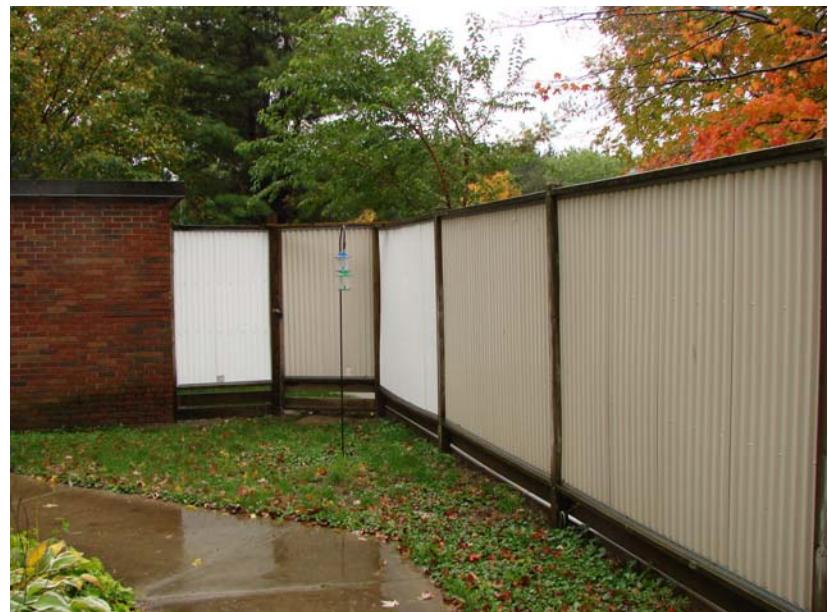
128\_MI\_1: Courtyard between west wings of South 1 and South 2 Halls.

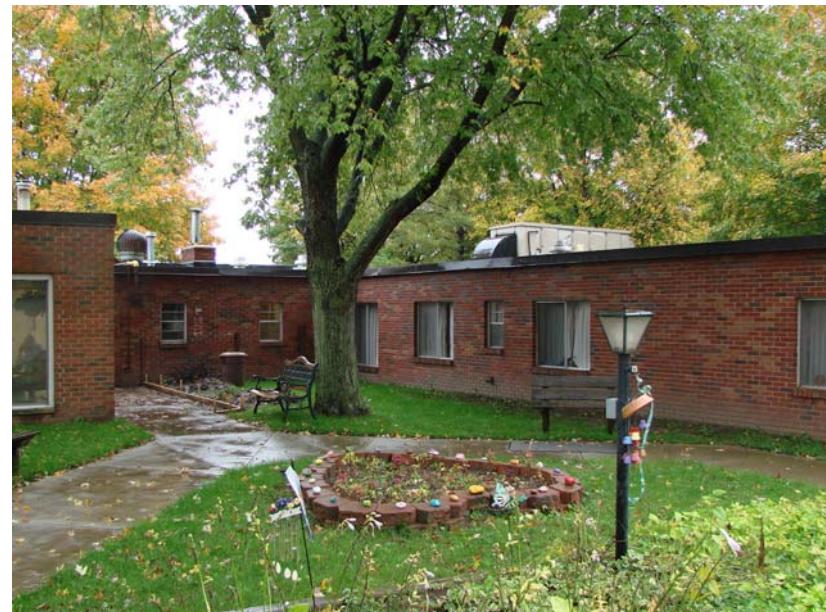
130\_MI\_1: Courtyard between west wings of South 1 and South 2 Halls.

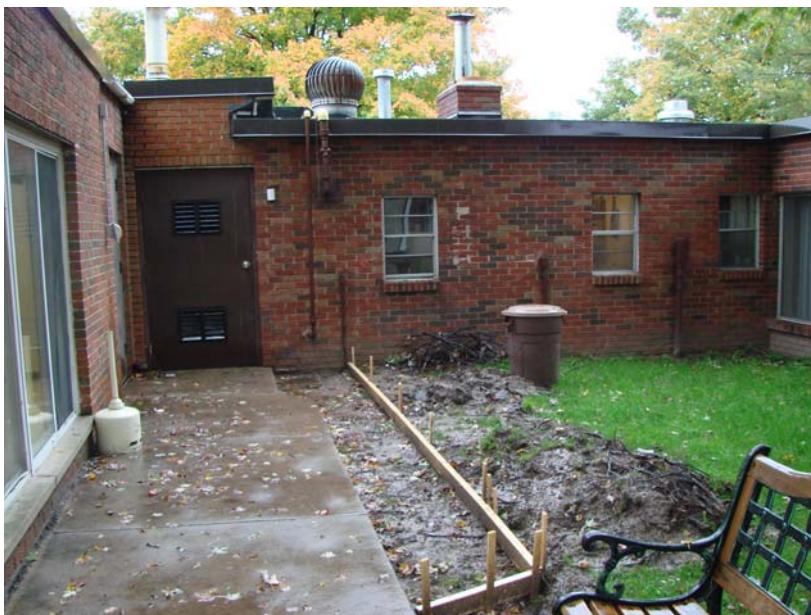
131\_MI\_1: Form boards - staff in widening sidewalk to boiler room.

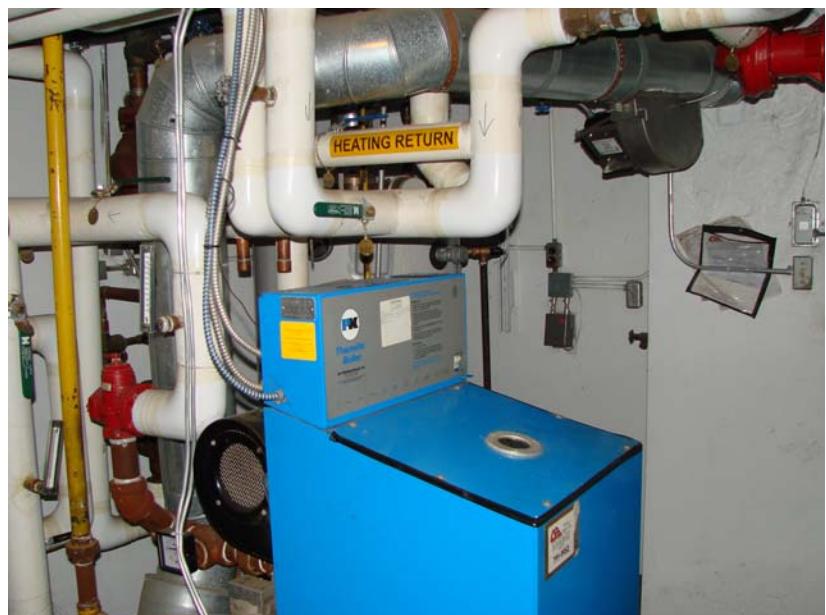
132\_MI\_1: South 2 Hall boiler room. Patterson-Kelly boiler, 700,000 BTUH (1998).

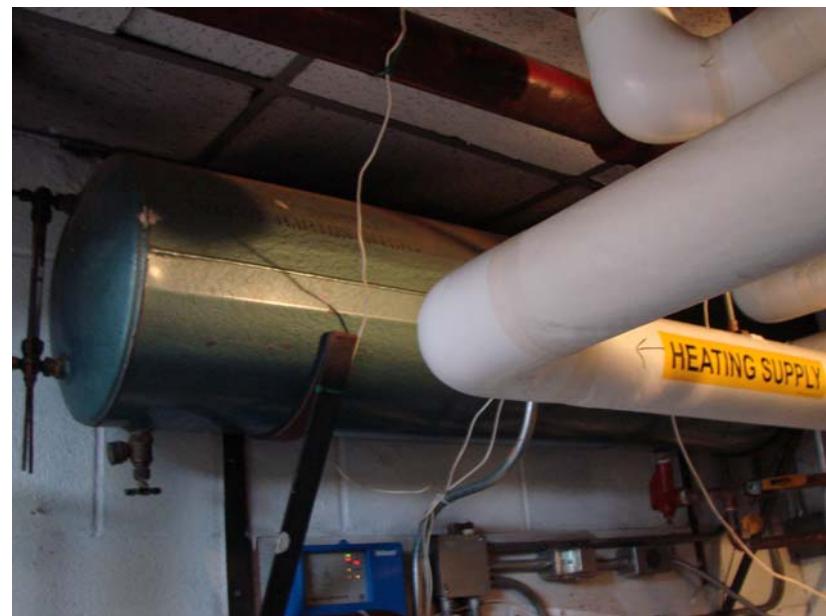
134\_MI\_1: Expansion tank (heating hot water).

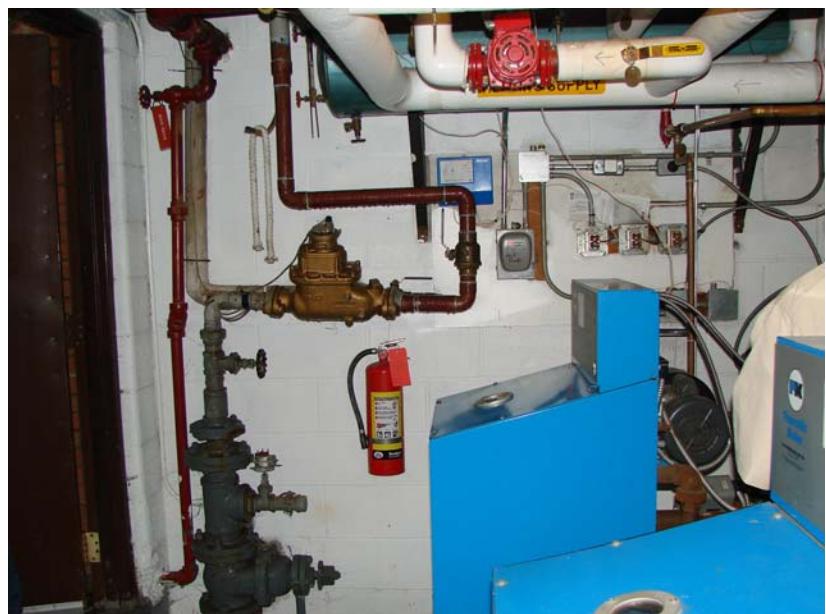
136\_MI\_1: Fire sprinkler riser (facility is only partially sprinkled).

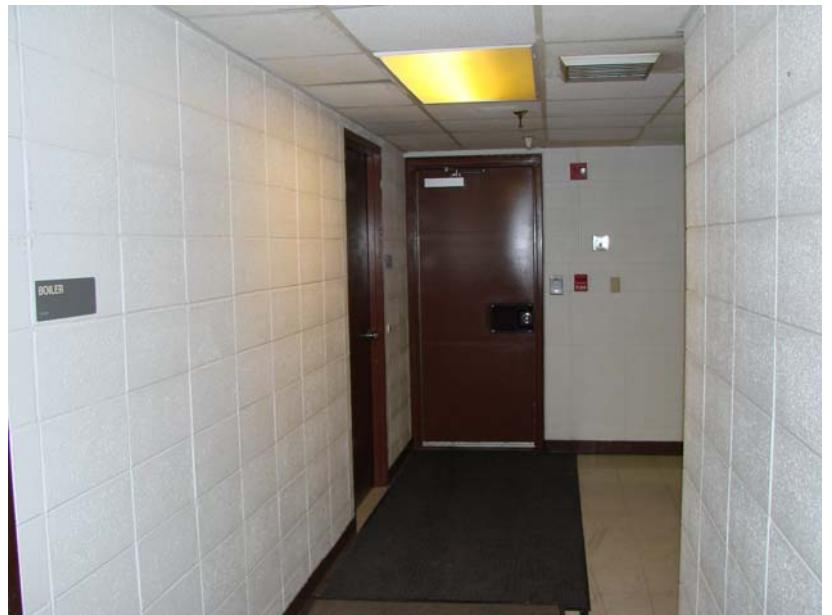
138\_MI\_1: Service corridor - central wing.

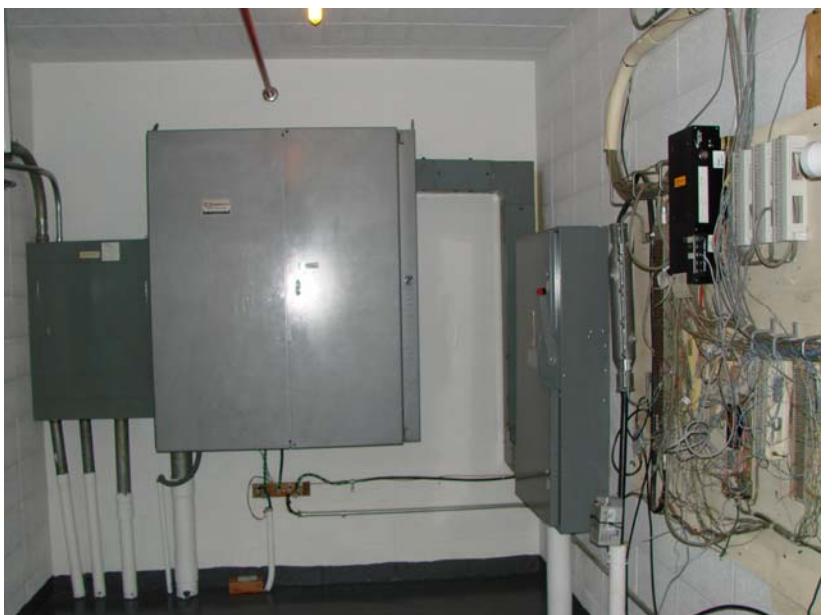
140\_MI\_1: Electrical room - 600 Amp main service, telephone patch panels.

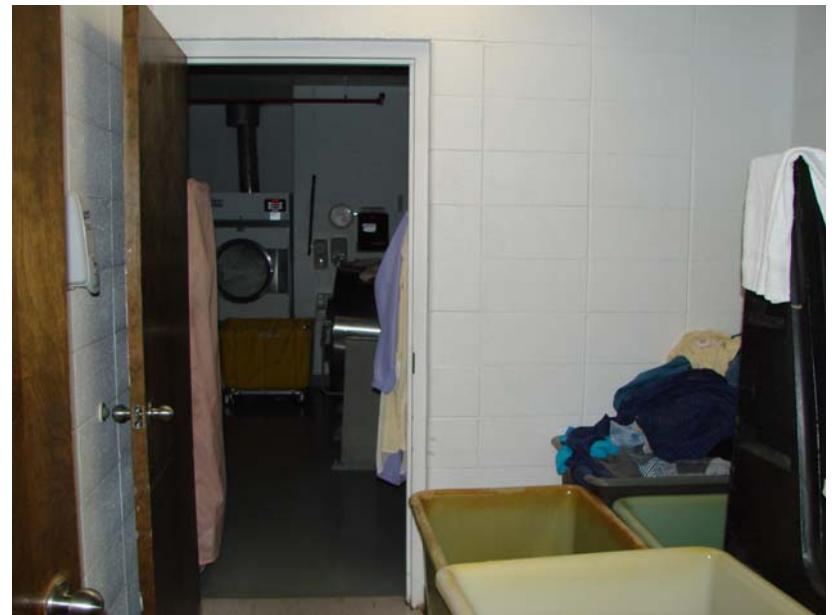
142\_MI\_1: Laundry - soiled linen room.

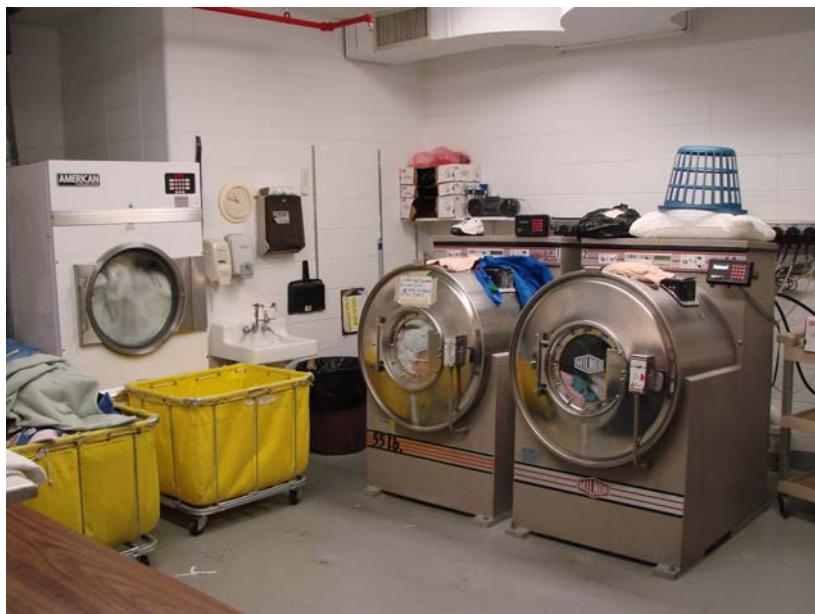
143\_MI\_1: Laundry - 55# Milnor washers (6-yrs); 55# American dryer (15+ yrs).

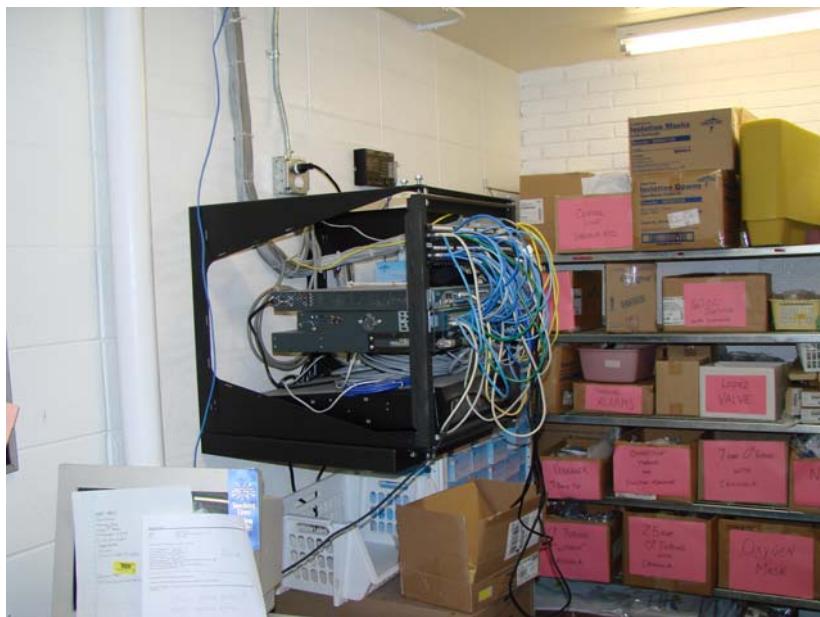
150\_MI\_1: Digital phone equipment in storage room.

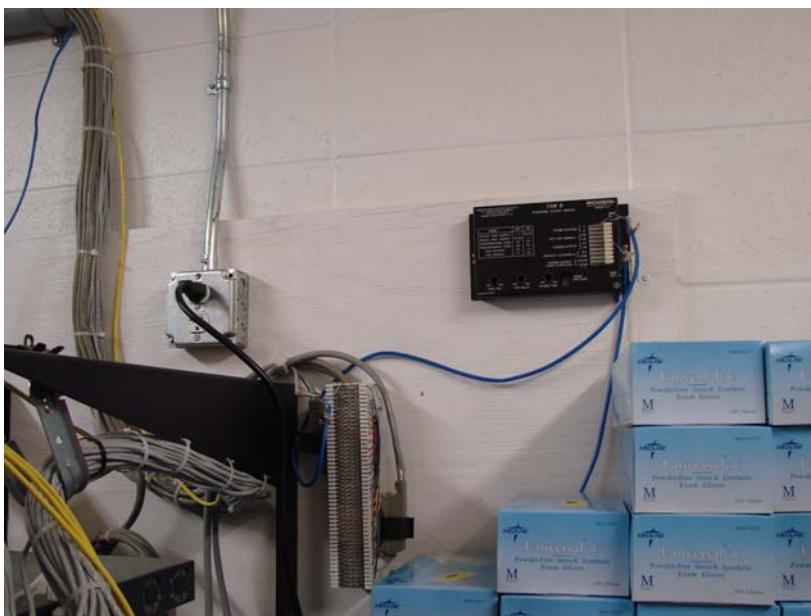
151\_MI\_1: Telephone patch panel in storage room.

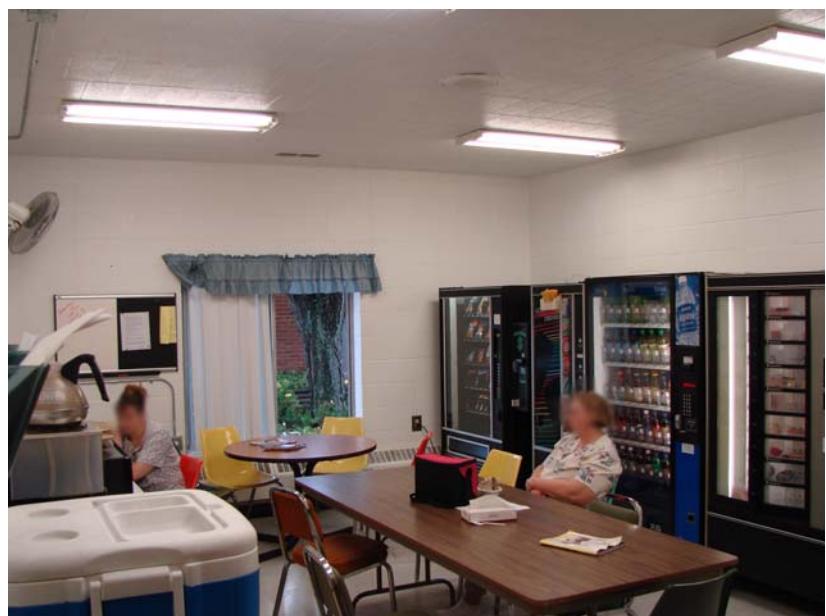
152\_MI\_1: Staff lounge-break room.

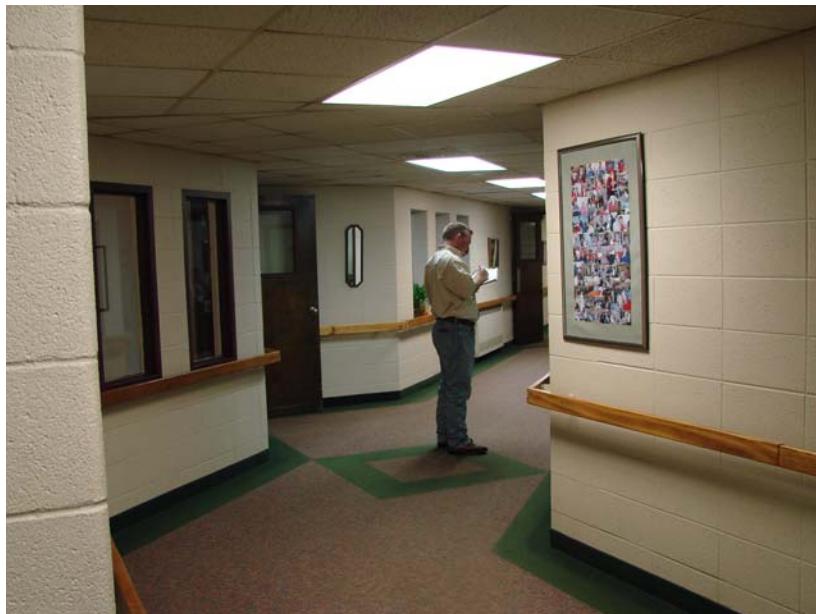
153\_MI\_1: Transition from Central Hall to East Hall.

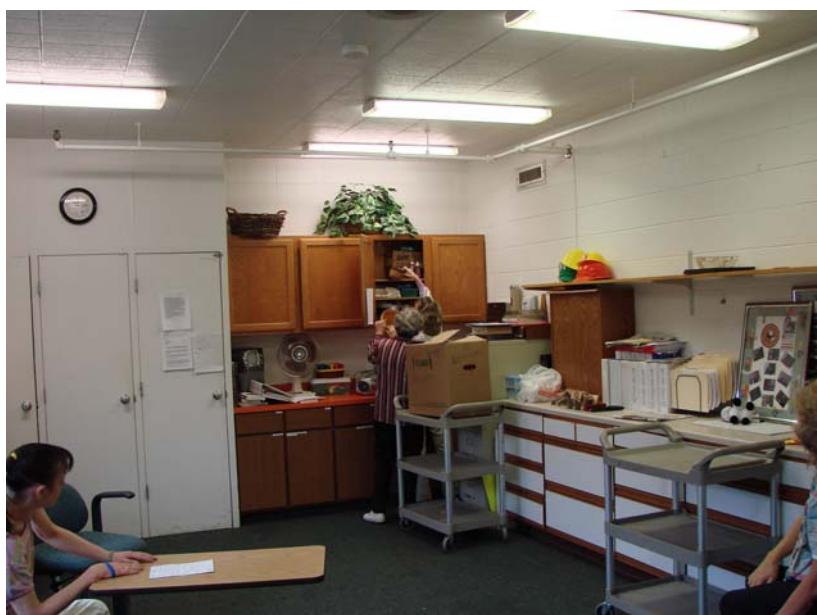
155\_MI\_1: Activity room.

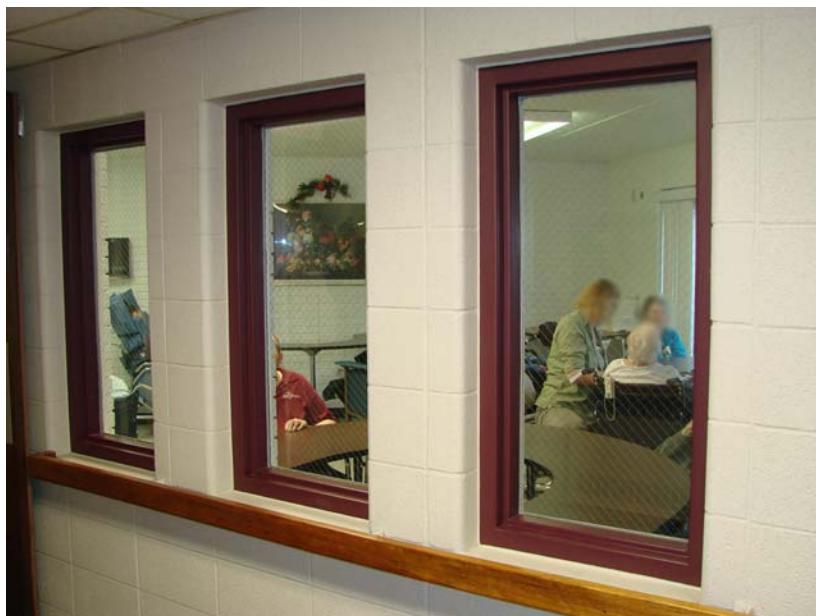
157\_MI\_1: Restorative dining - East Hall.

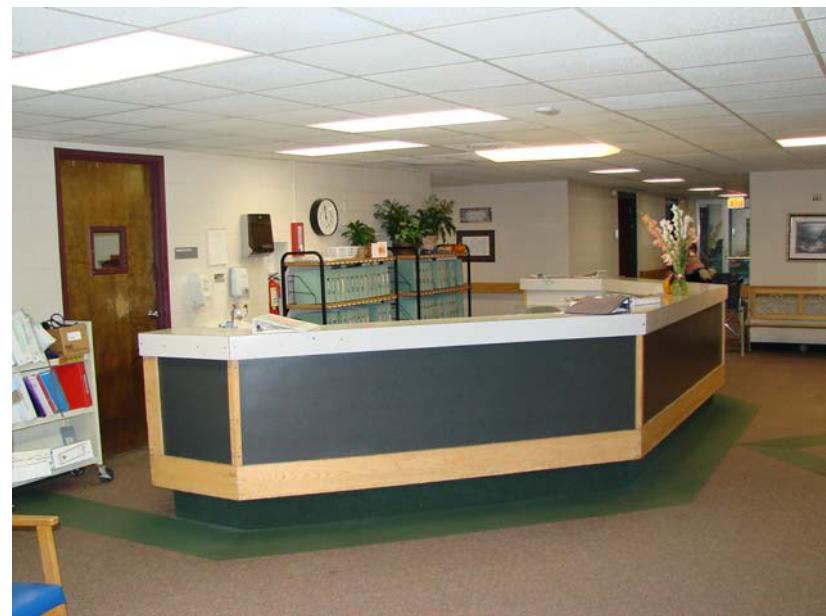
158\_MI\_1: West-East Hall nurse station.

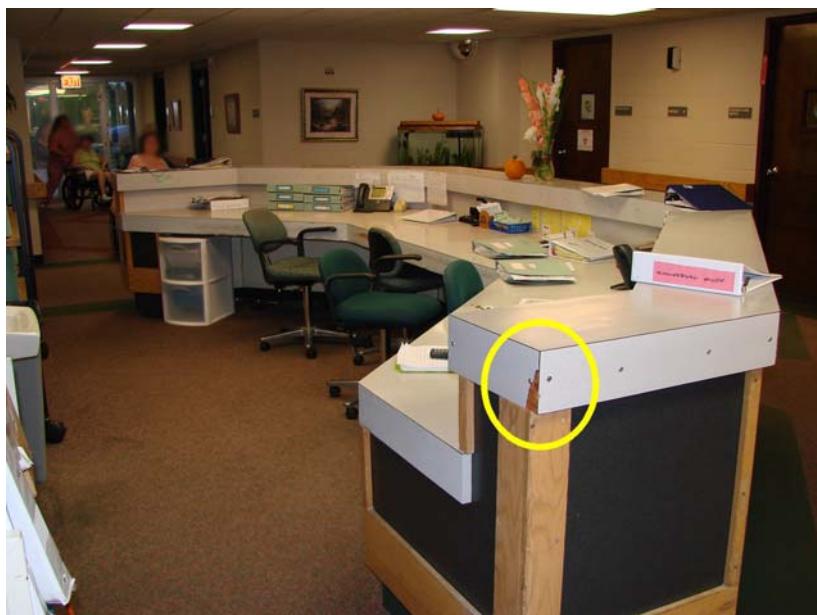
159\_MI\_1: West-East Hall nurse station.

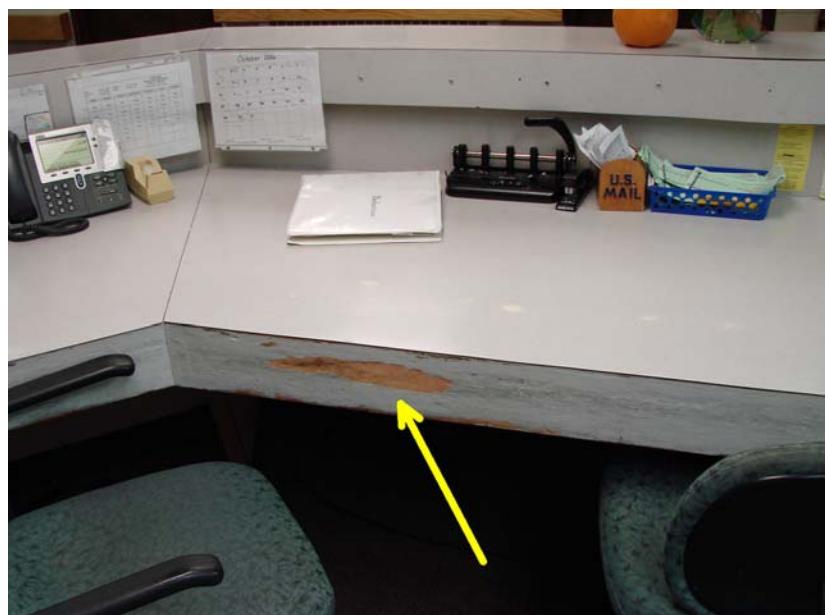
160\_MI\_1: Nurse station detail - counter top needs maintenance.

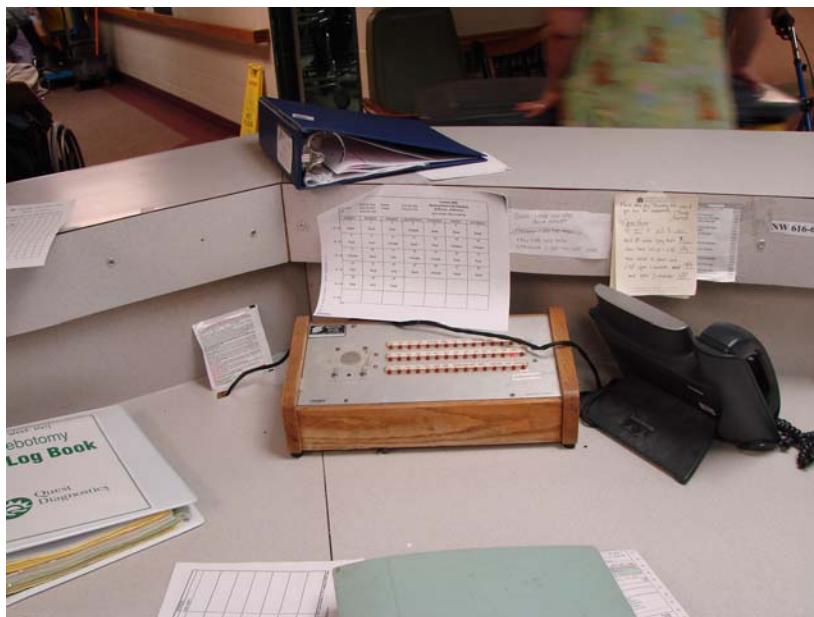
161\_MI\_1: Cornell nurse call annunciator panel at nurse station.

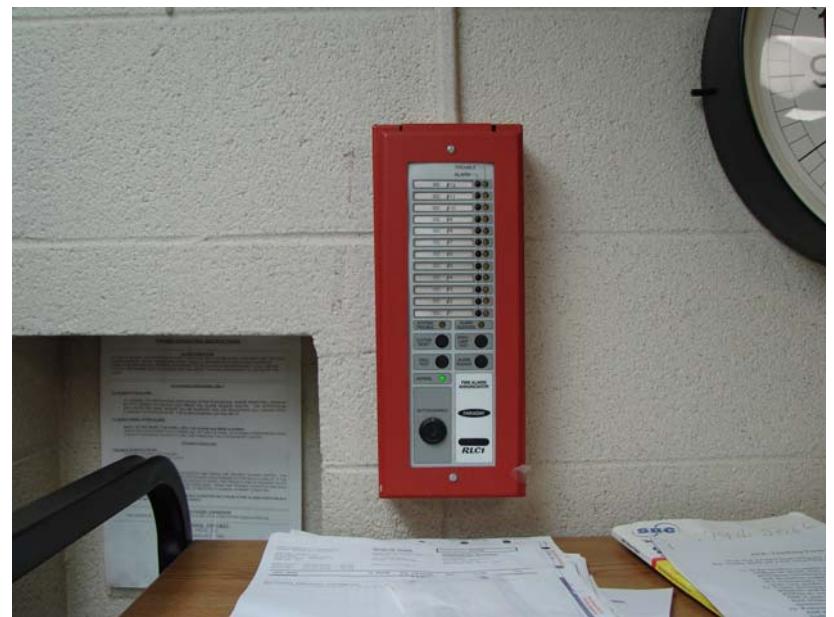
162\_MI\_1: Faraday fire alarm annunciator at nurse station.

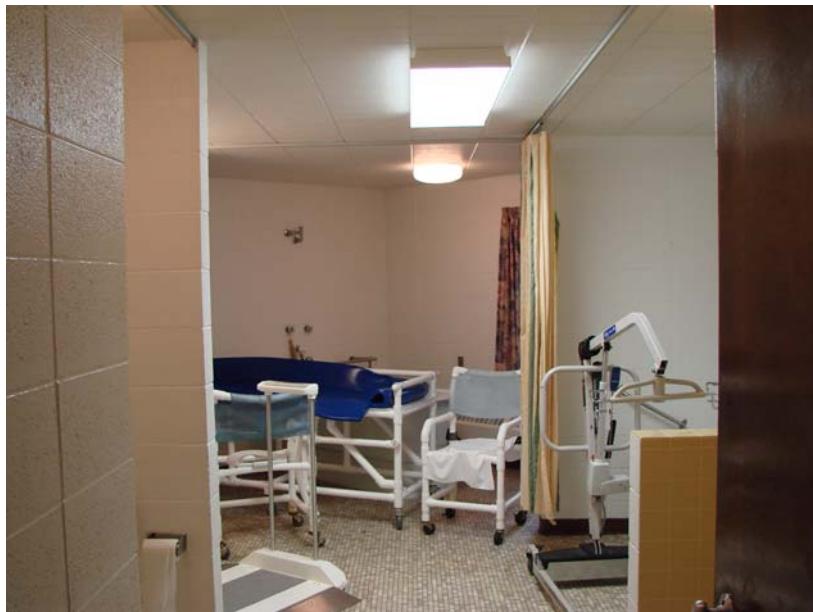
167\_MI\_1: West Hall tub-shower room.

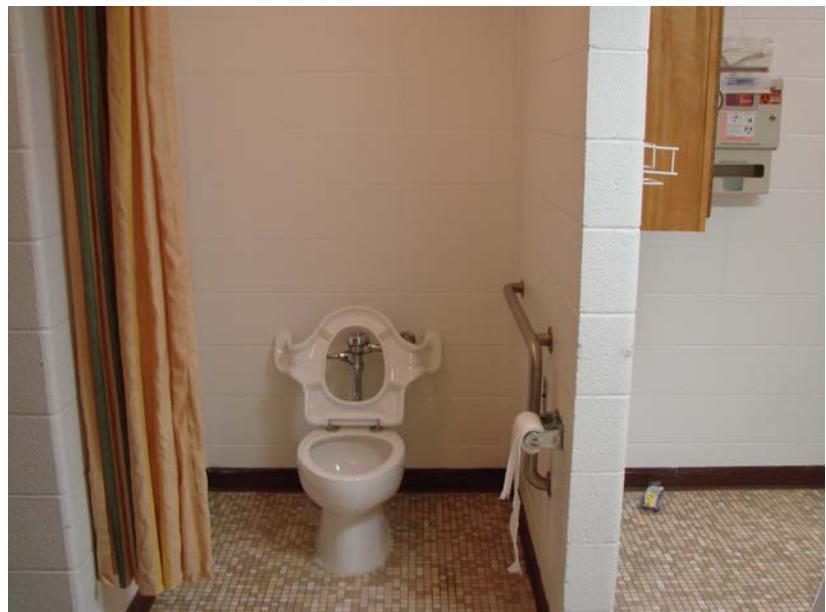
168\_MI\_1: West Hall tub-shower room.

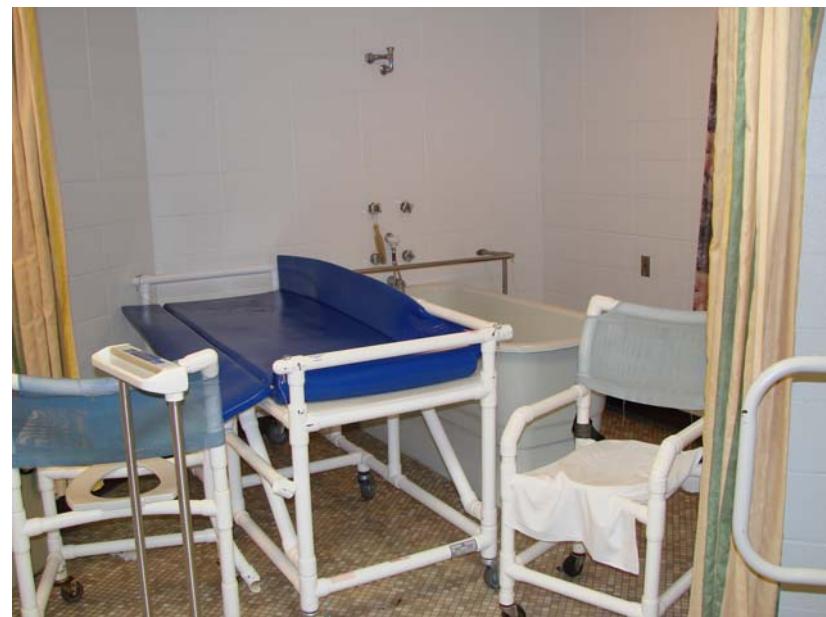
170\_MI\_1: West Hall tub-shower room.

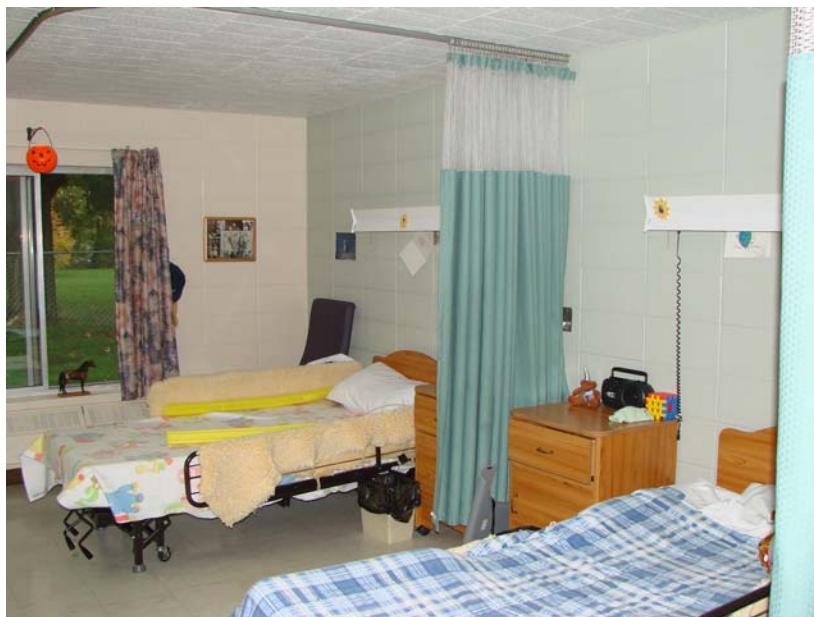
173\_MI\_1: West Hall semi-private resident room.

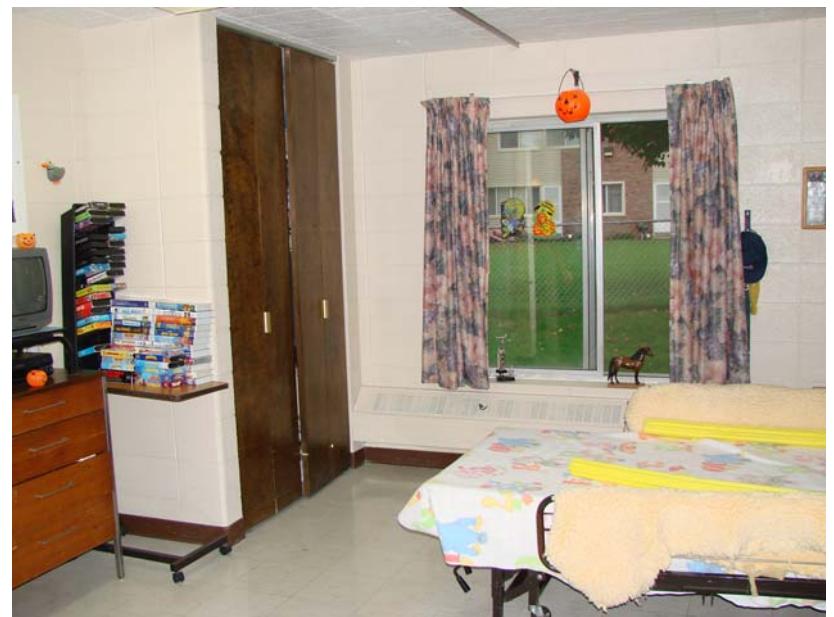
174\_MI\_1: West Hall semi-private resident room - built-in wardrobes.
