## The Willows @ Anytown

Anytown, USA; Oct 4, 2006

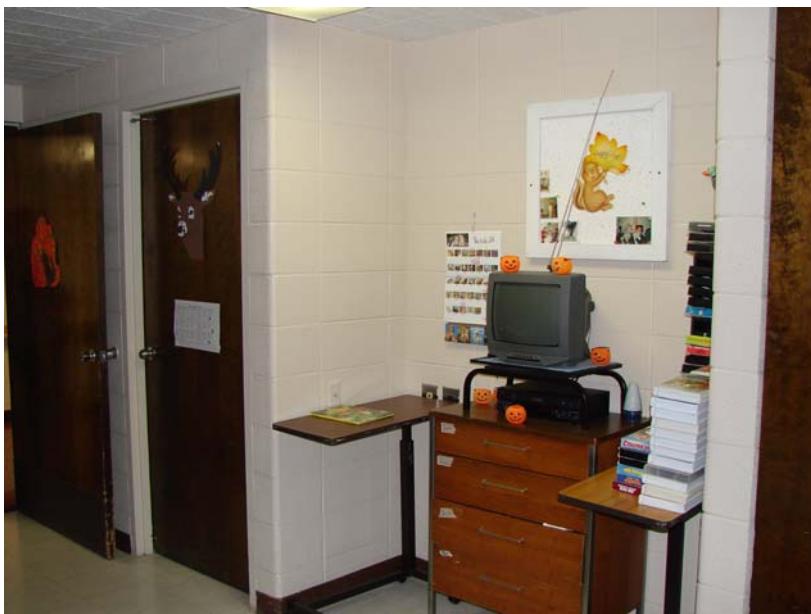
175\_MI\_1: West Hall semi-private resident room.

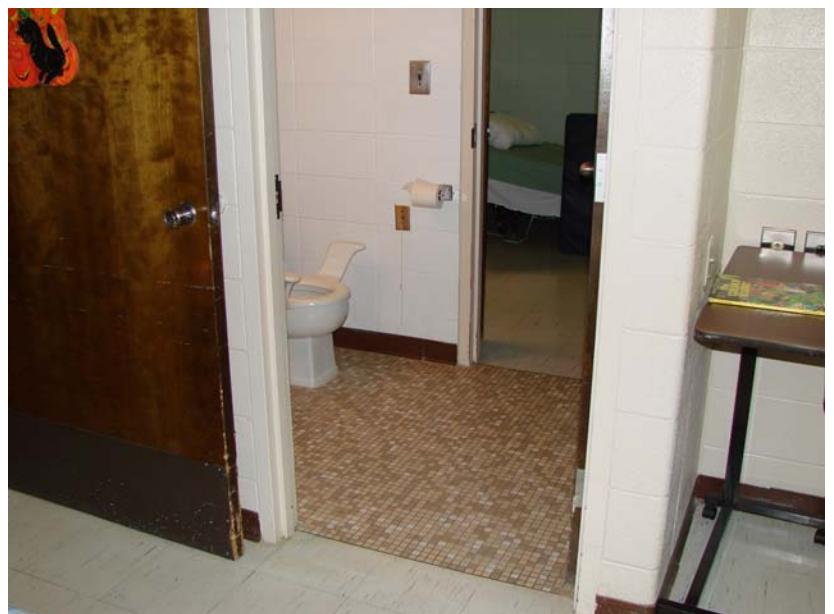
176\_MI\_1: Shared toilet & sink between resident rooms.

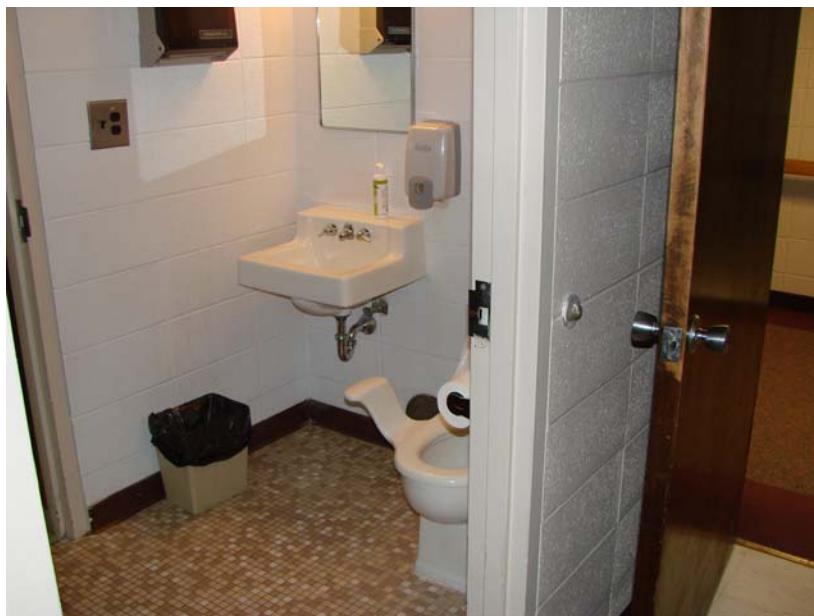
177\_MI\_1: Shared toilet & sink between resident rooms.

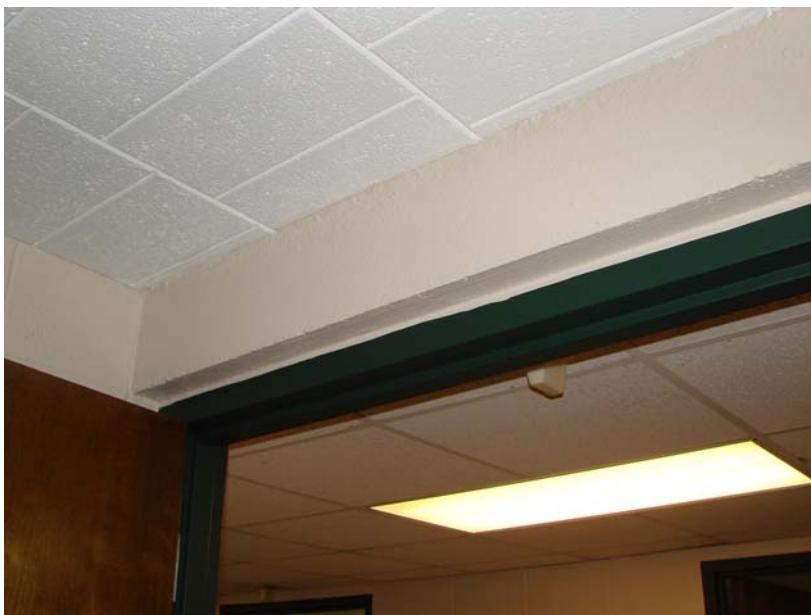
179\_MI\_1: Ceiling detail - exposed concrete plank ceiling in resident rooms, dropped acoustical grid ceiling in corridor.

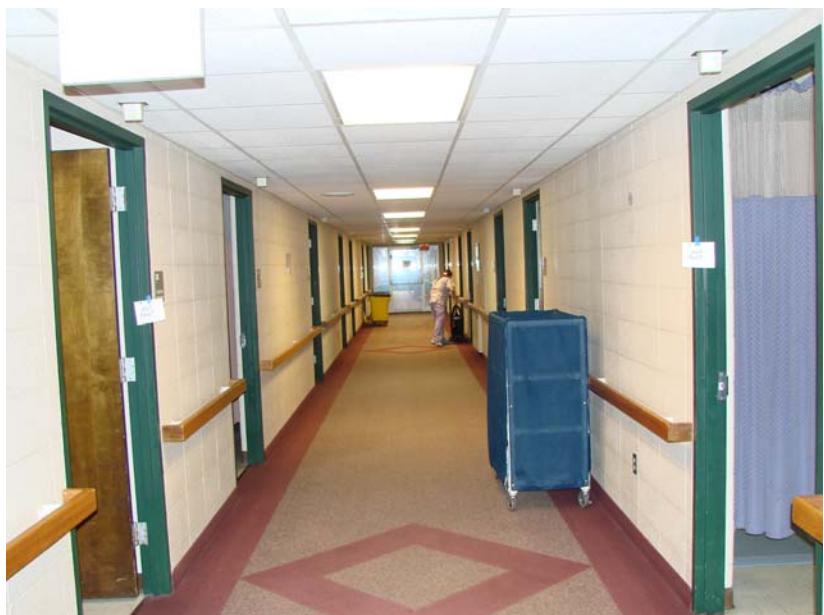
180\_MI\_1: East Hall looking east.

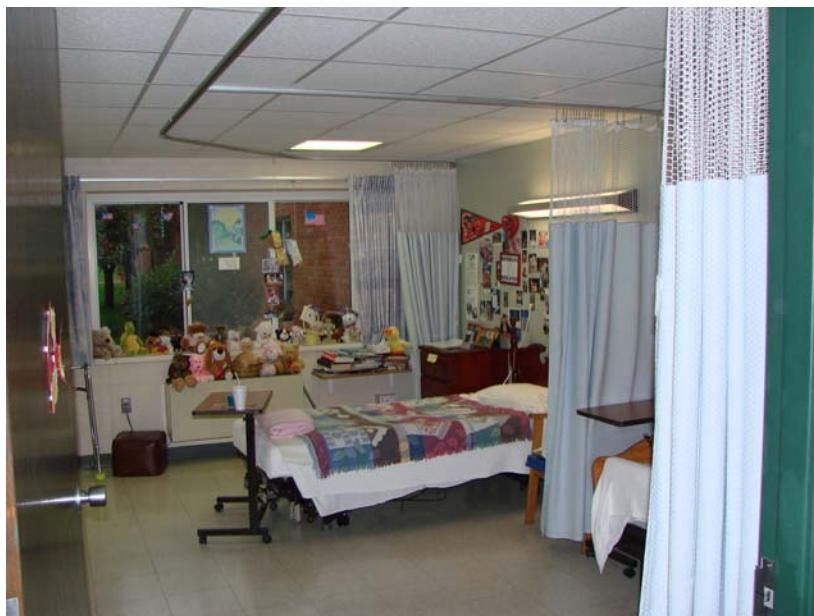
181\_MI\_1: East Wing semi-private room

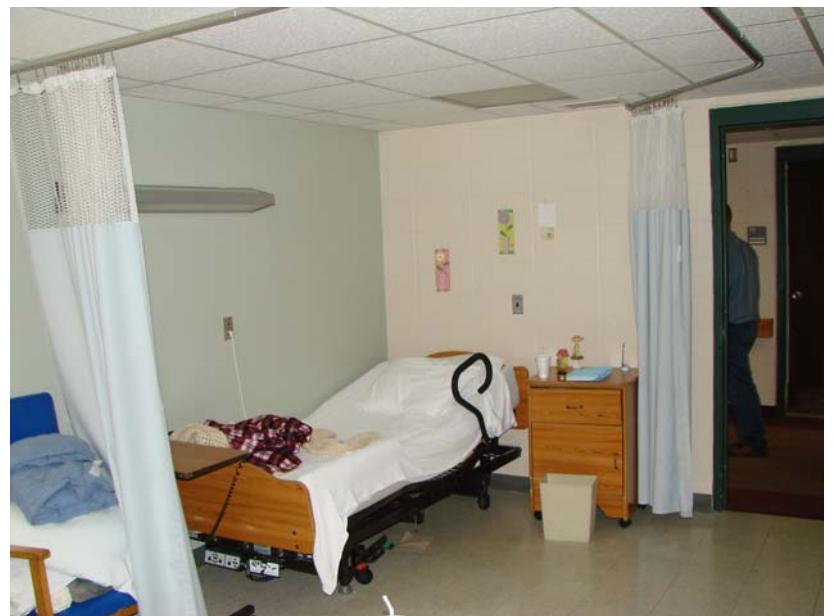
182\_MI\_1: East Wing semi-private room

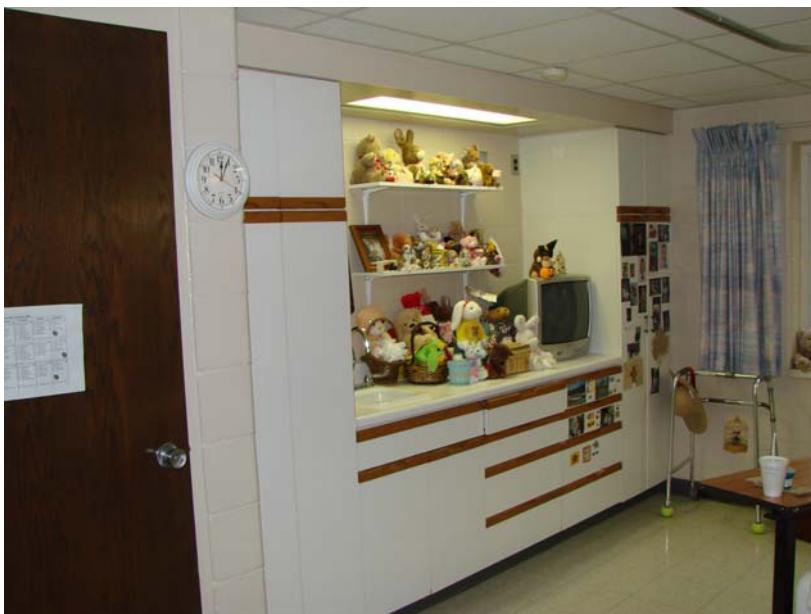
183\_MI\_1: East Wing semi-private room - built-in wardrobes.

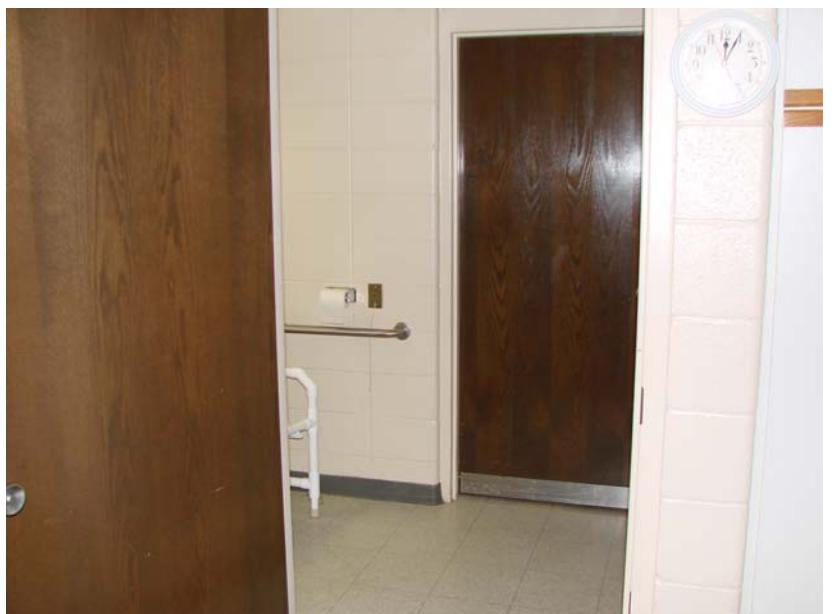
184\_MI\_1: Shared toilet & sink between resident rooms.

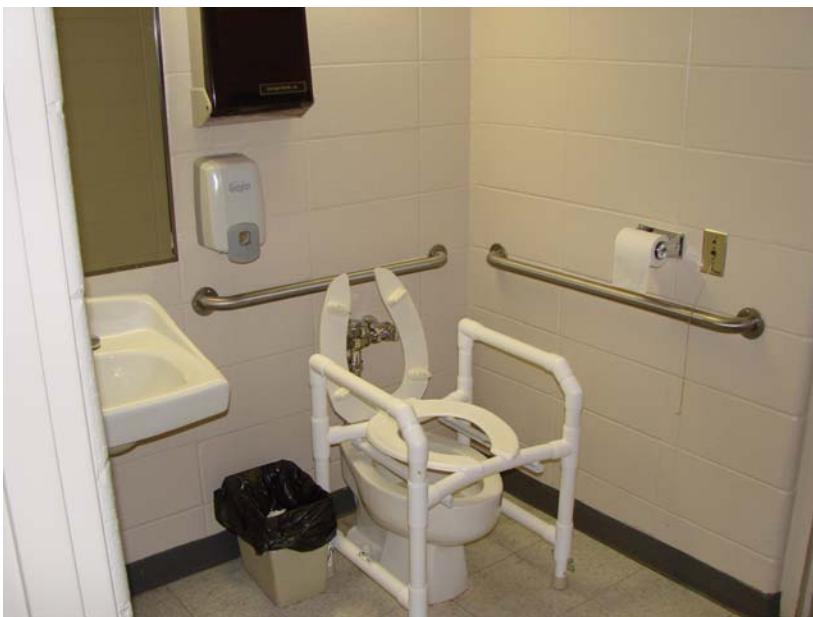
185\_MI\_1: Shared toilet & sink between resident rooms.

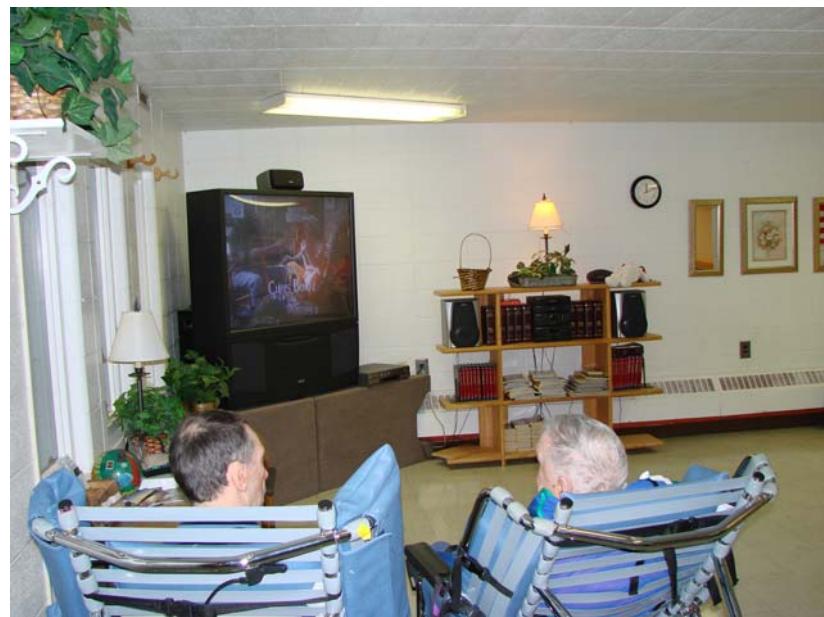
186\_MI\_1: East Hall day room.

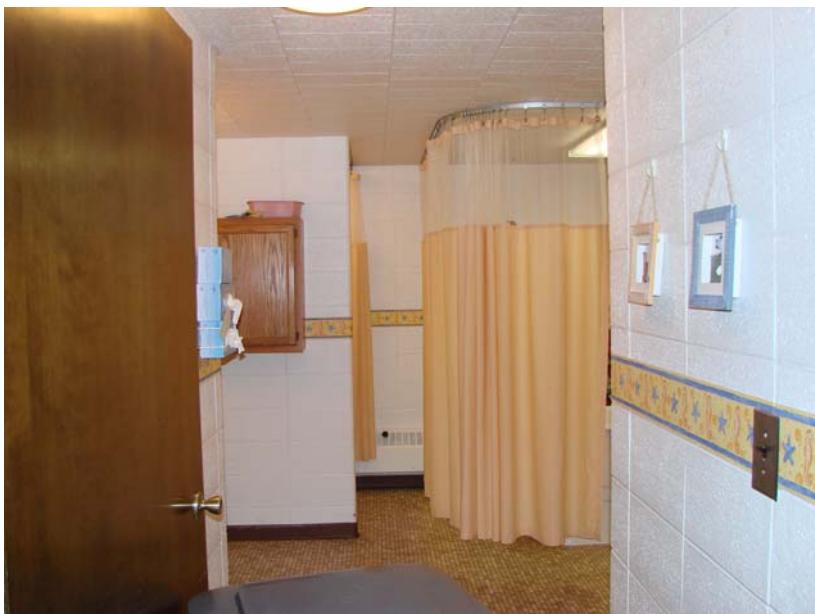
187\_MI\_1: East Hall tub-shower room.

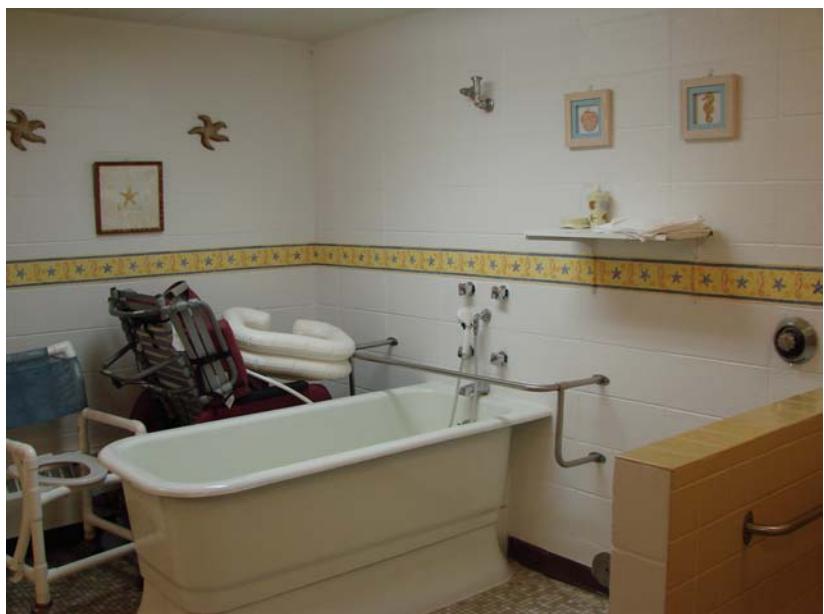
188\_MI\_1: East Hall tub-shower room.

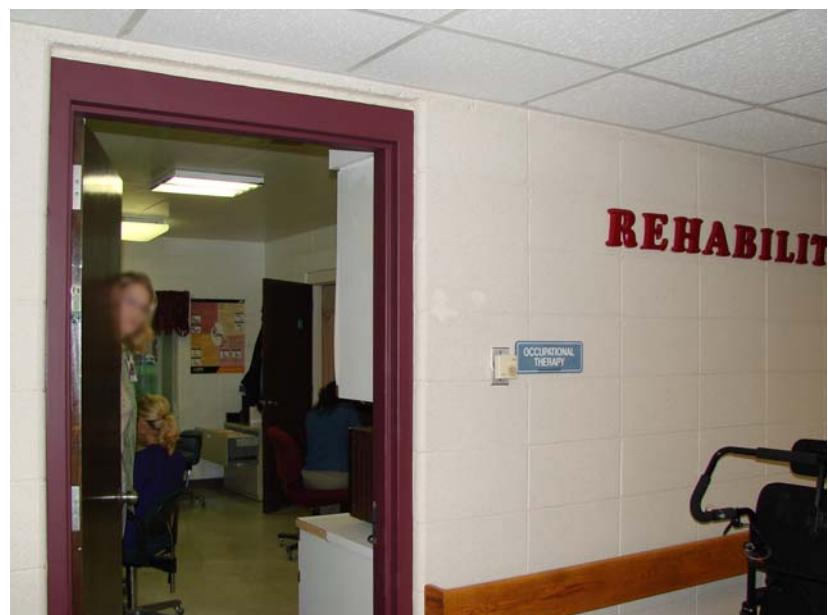
192\_MI\_1: Physical therapy office.

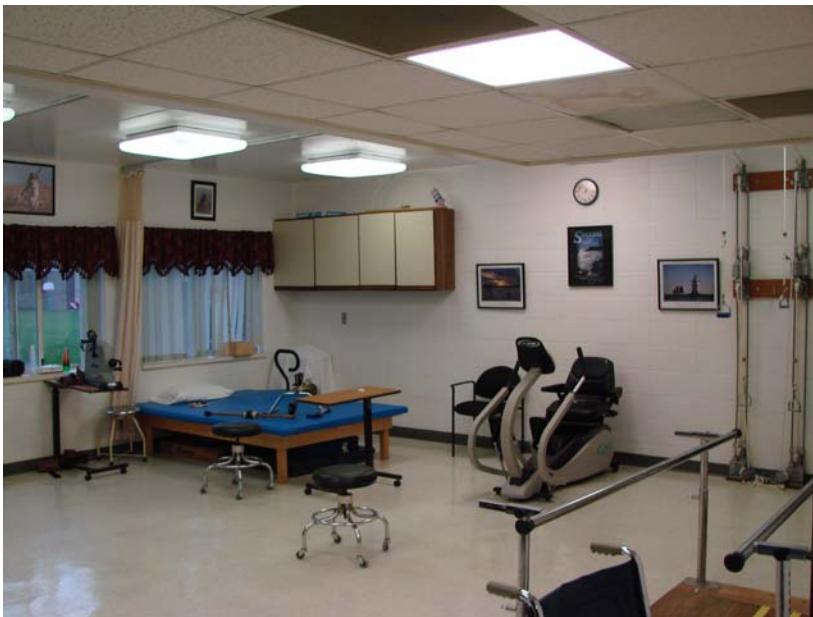
193\_MI\_1: Physical therapy,

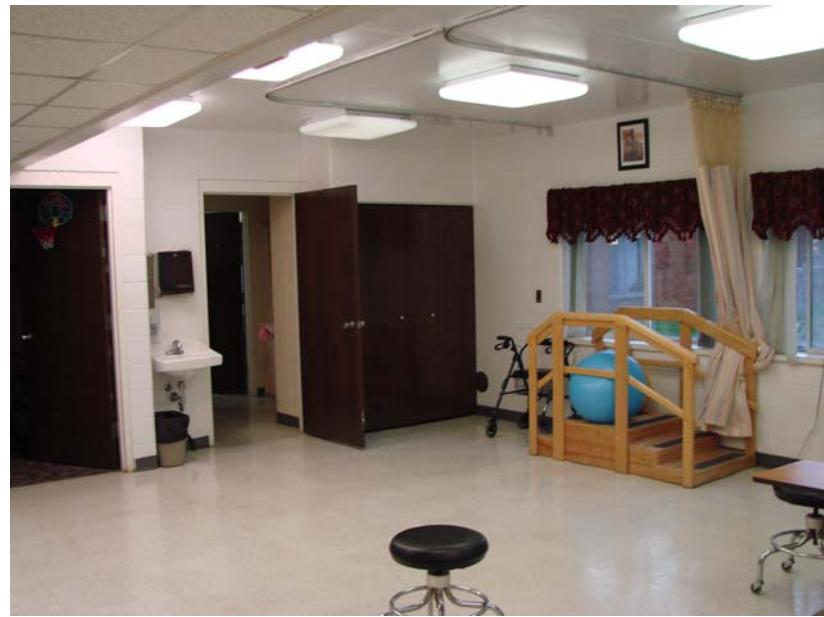
194\_MI\_1: Physical therapy,

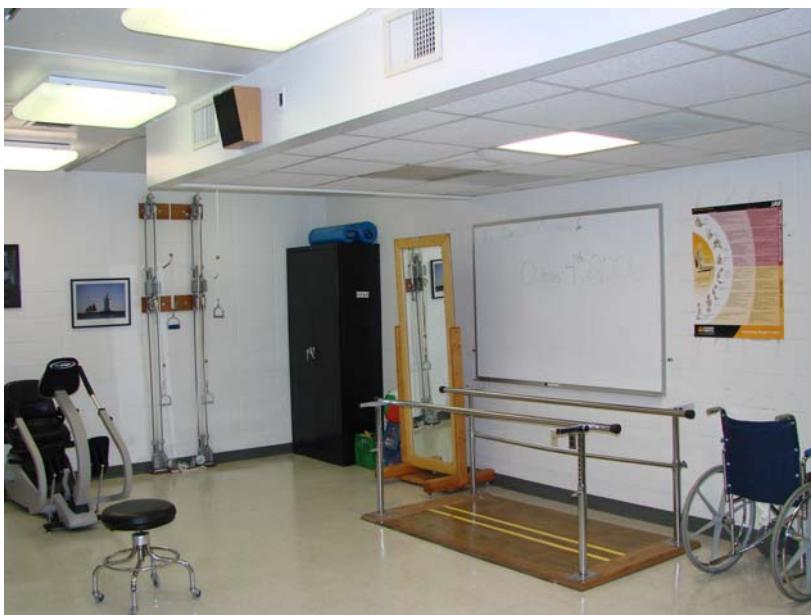
195\_MI\_1: Physical therapy,

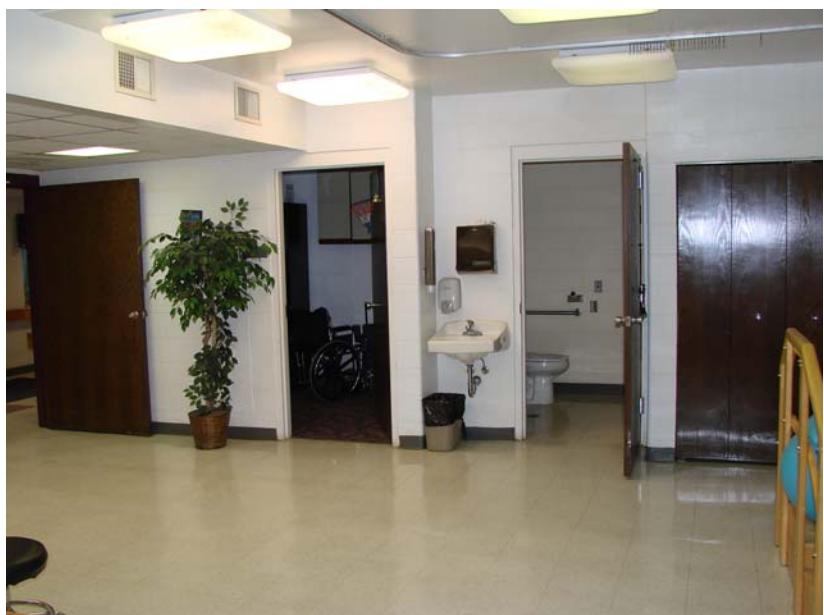
196\_MI\_1: Physical therapy,

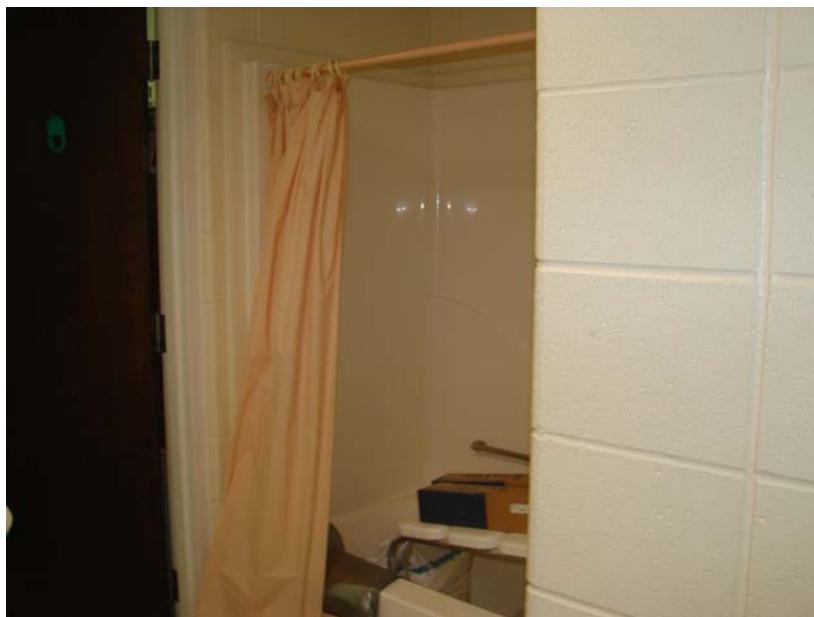
197\_MI\_1: Training bathroom in physical therapy.

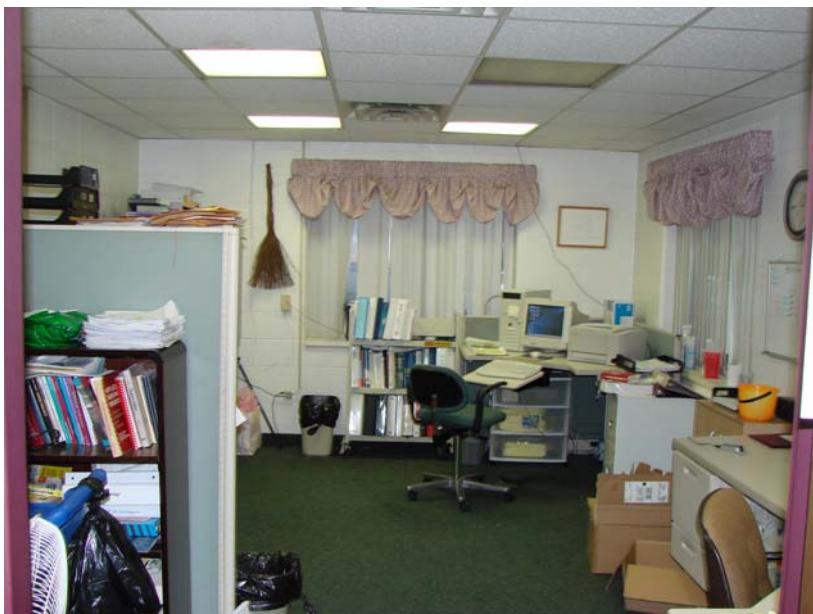
199\_MI\_1: Physical therapy office.

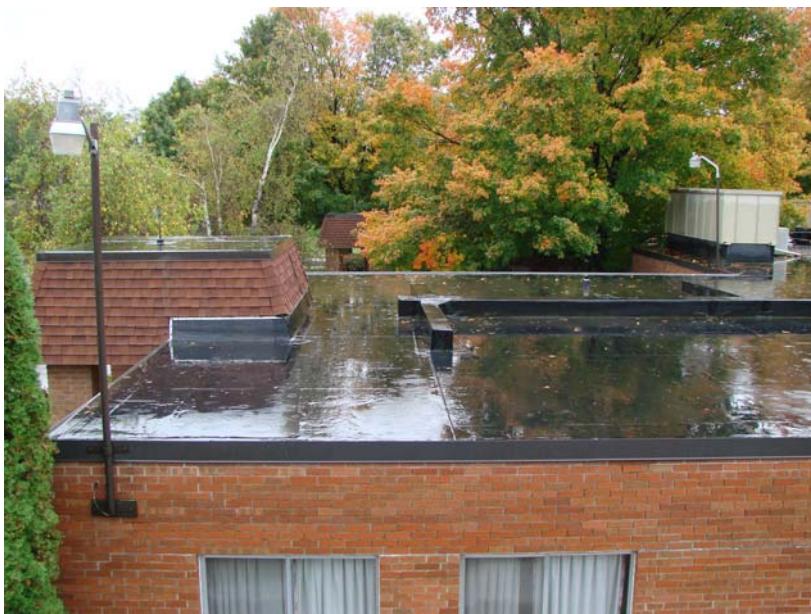
207\_MI\_1: South Hall 1 roof.

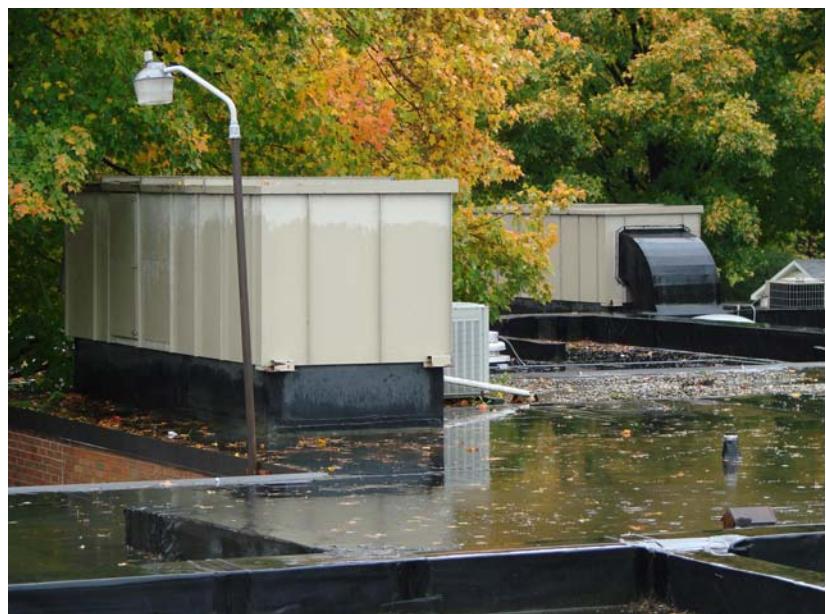
208\_MI\_1: Air conditioners on South 1 Hall roof.

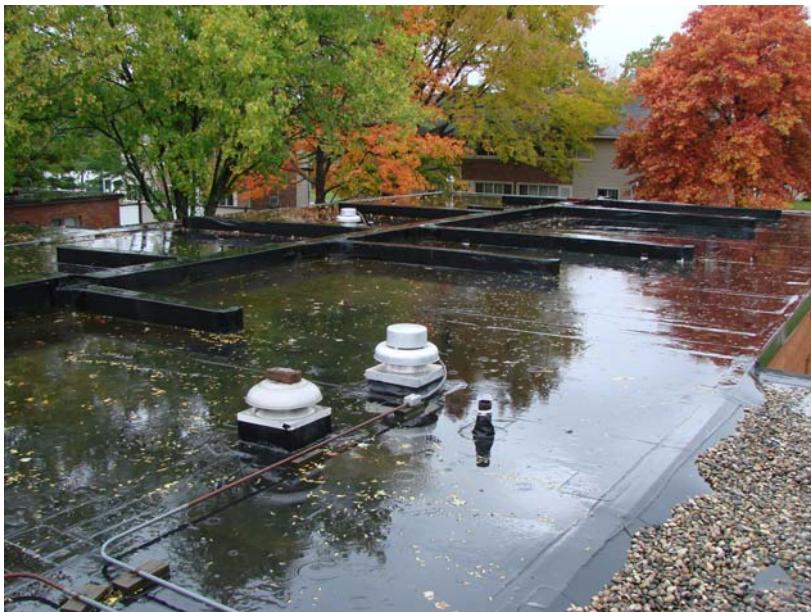
211\_MI\_1: South 1 Hall roof looking west.

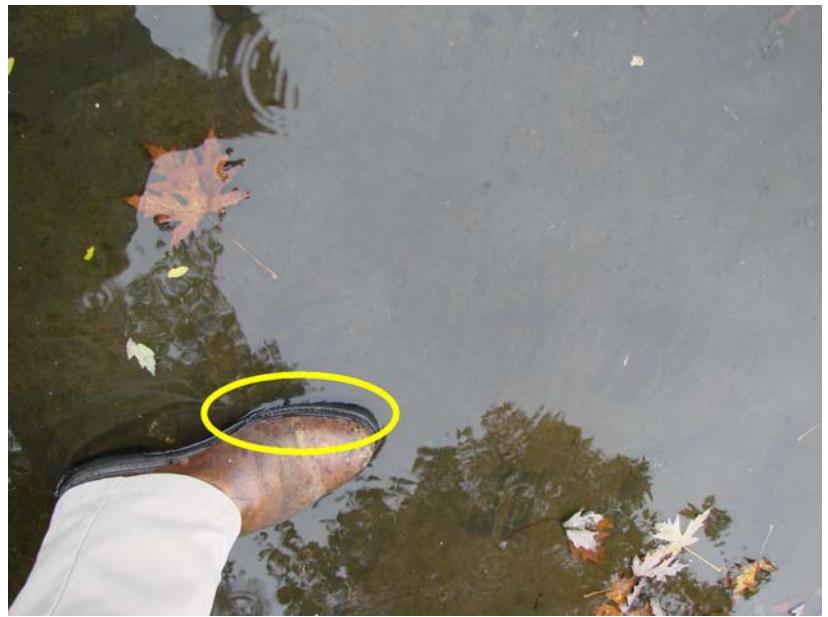
214\_MI\_1: Water ponding detail - approx 3-4- deep.

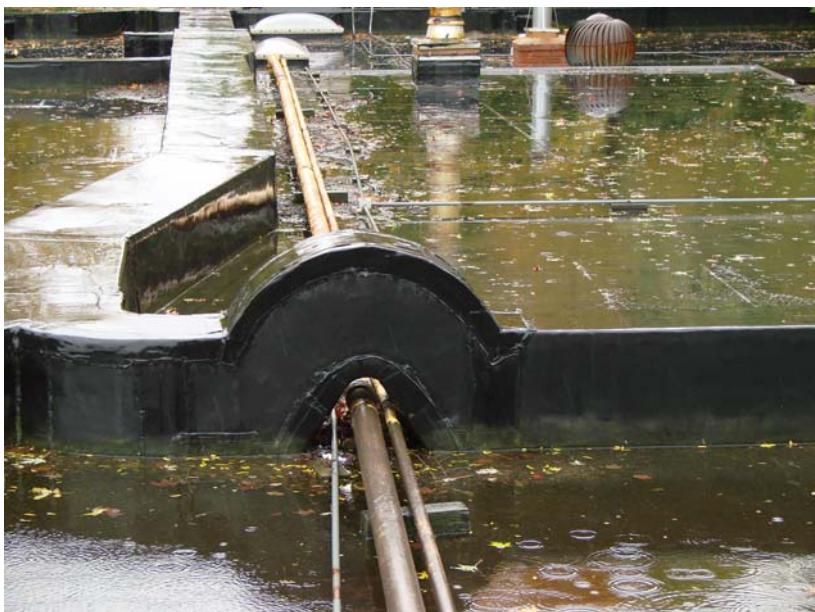
219\_MI\_1: South Hall 1 detail - HVAC duct arched over conduit pipe.

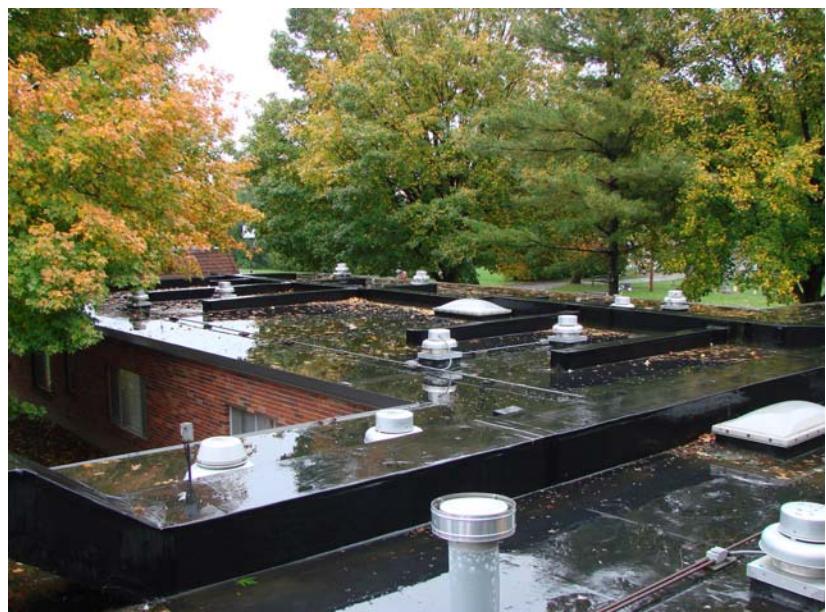
220\_MI\_1: South 2 Hall roof looking east.

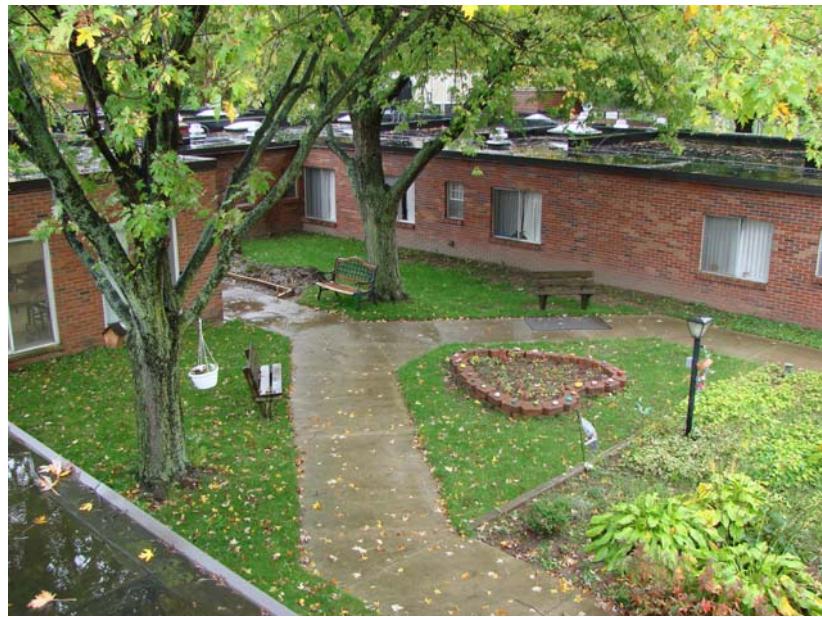
222\_MI\_1: Courtyard between South 1 and South 2 Halls.

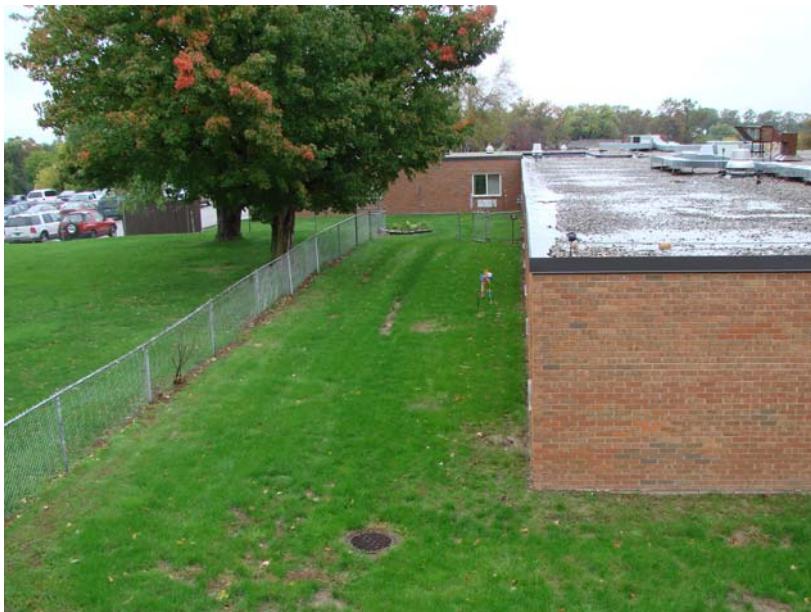
223\_MI\_1: West Hall looking north.

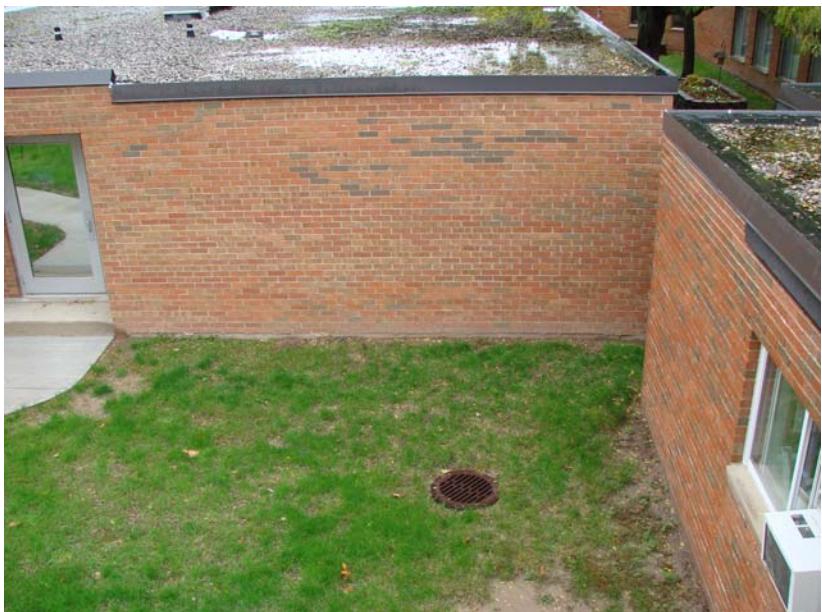
224\_MI\_1: Area drain at south end of West Hall.

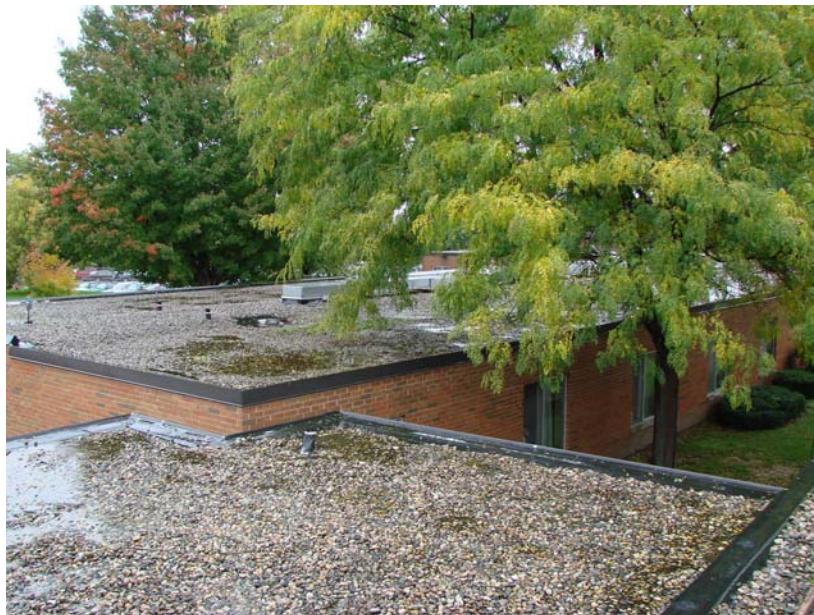
225\_MI\_1: West Hall roof looking north.

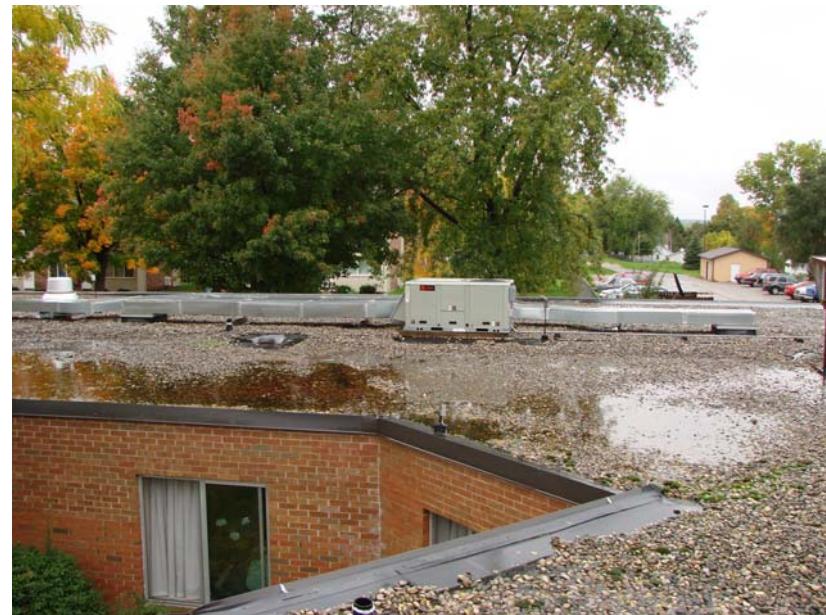
226\_MI\_1: West hall roof looking west to parking lot.

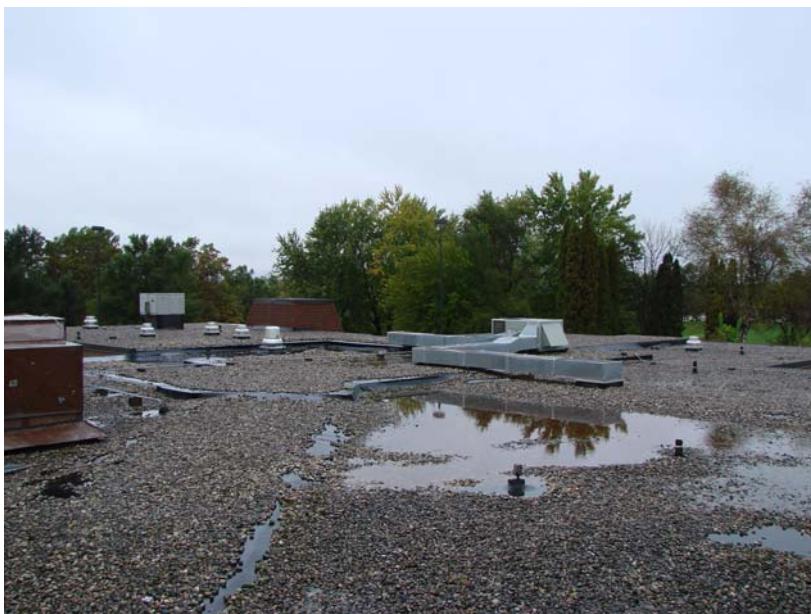
227\_MI\_1: East Hall roof.

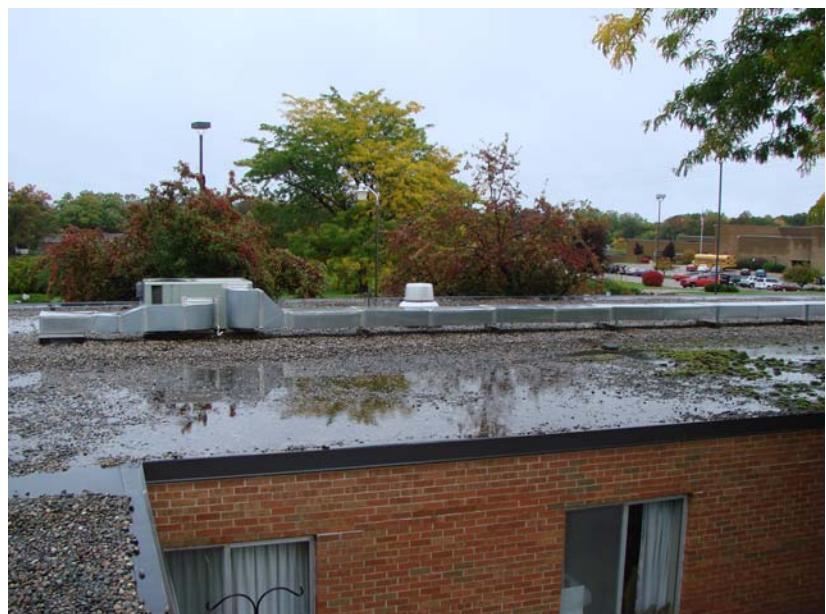
228\_MI\_1: East Hall roof.

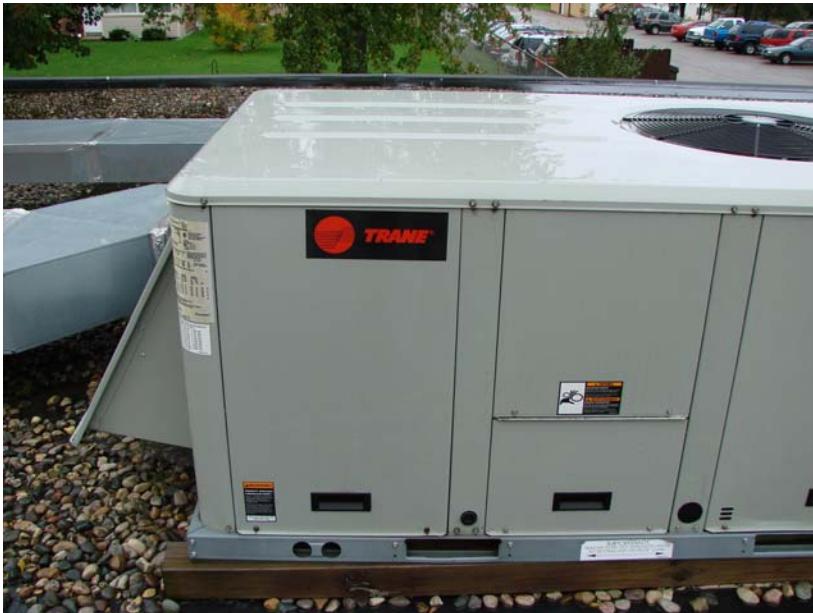
229\_MI\_1: Trane air conditioner on West Hall roof.

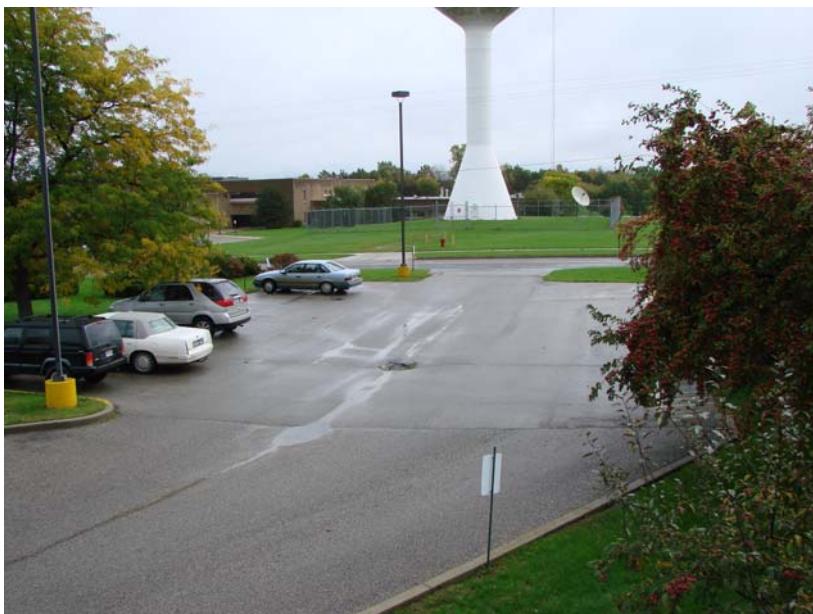
231\_MI\_1: Parking lot entrance from Hall Street.

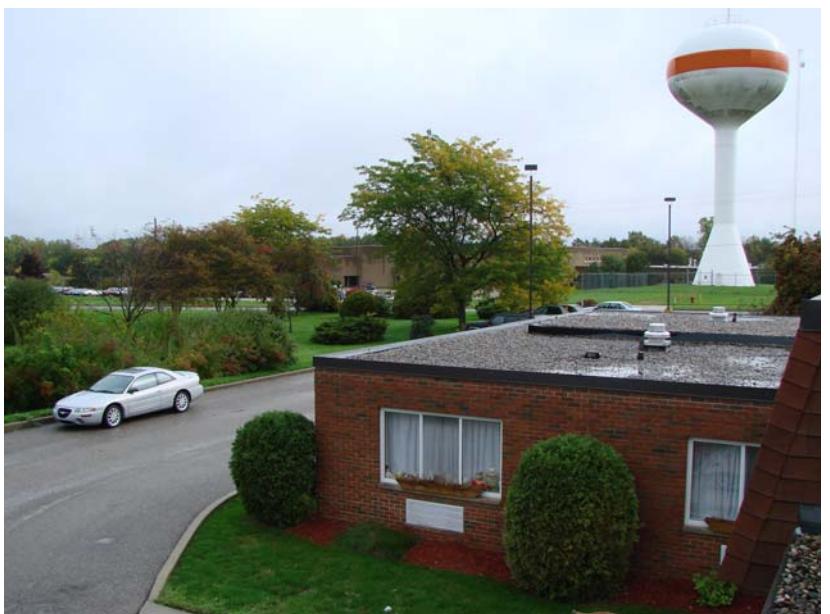
232\_MI\_1: Service drive around East Hall to west parking lot.

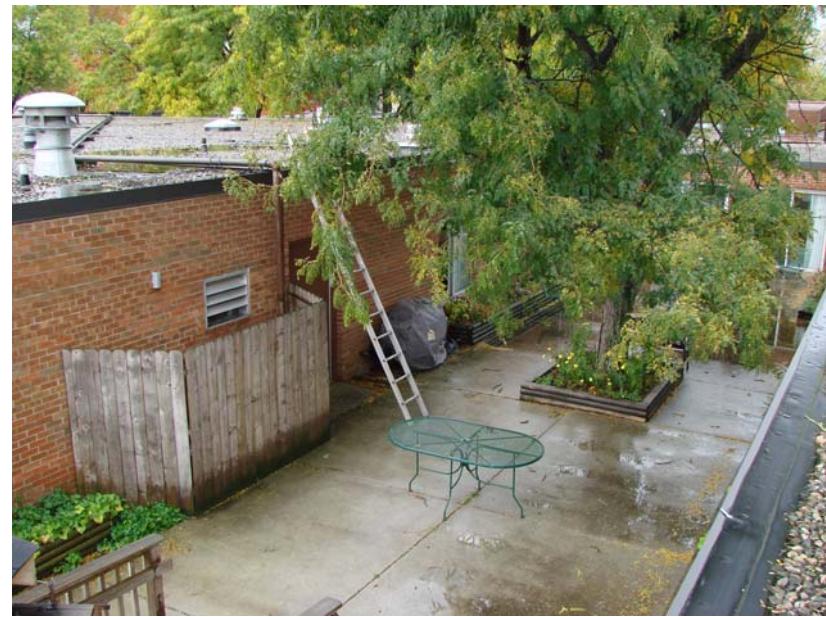
234\_MI\_1: Courtyard between East Hall and Central Hall.

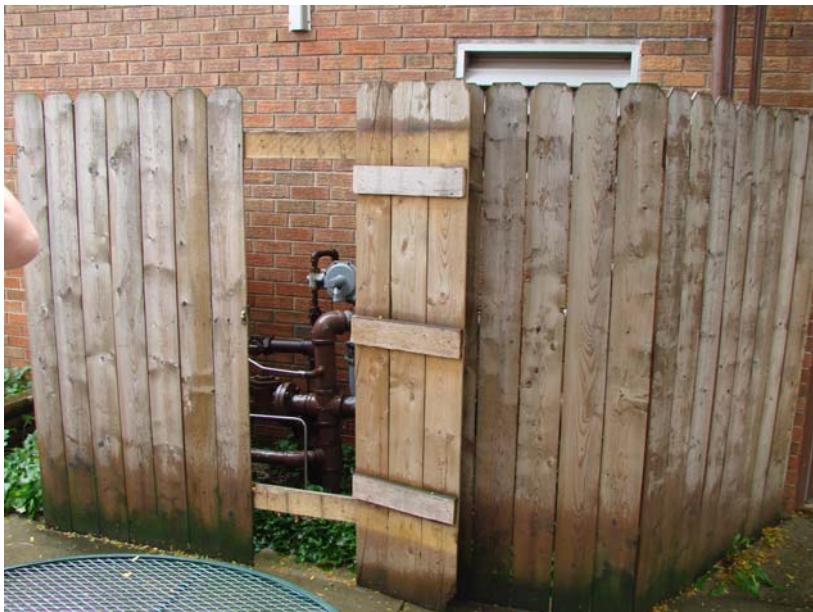
235\_MI\_1: Privacy fence around main gas service.
