PROPERTY CONDITION REPORT

The Willows @ Anytown

414 East Street ♦ Anytown, USA 01995

Client: No.1 LTC Operator

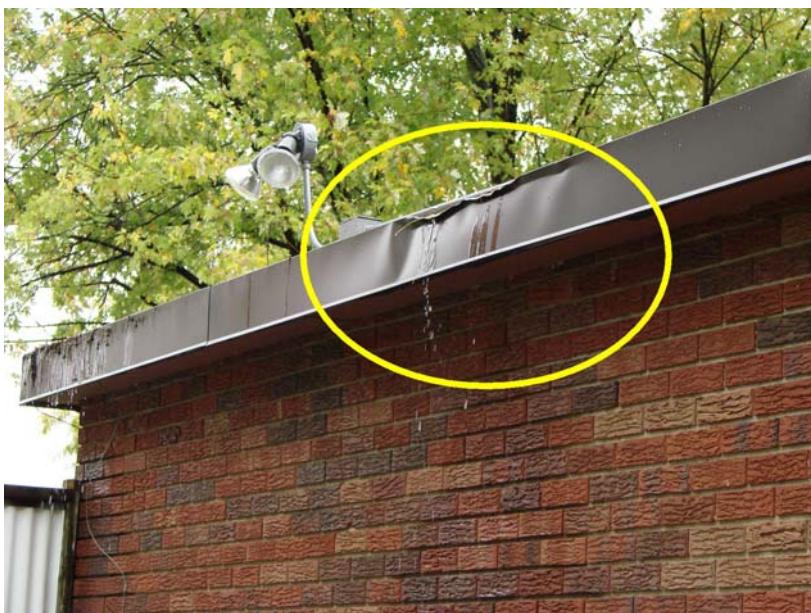
011_MI_1: Water running off edge of roof due to poor roof drainage.

The facility is partially covered by a flat, 60-mil EPDM rubber membrane Firestone roof that is in average condition with several reported leaks and needs to be patched. The other areas of the facility are covered with a ballasted roof that has several leaks and needs near term replacement. Due to a central air conditioning system being installed in recent years, the roof has several areas of advanced ponding. This is caused by improper duct installation on the rooftop. The ductwork needs to be lifted and set on roof curbs to ensure proper drainage to the roof drains (201, 202, 204-207, 209-221, 225-230).

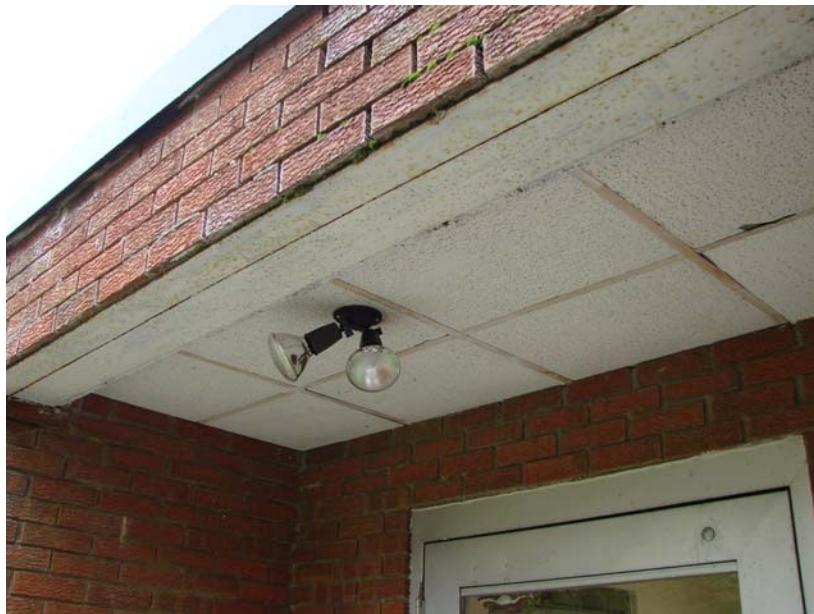
013_MI_1: Acoustical grid ceiling at South Hall 1 west exit.

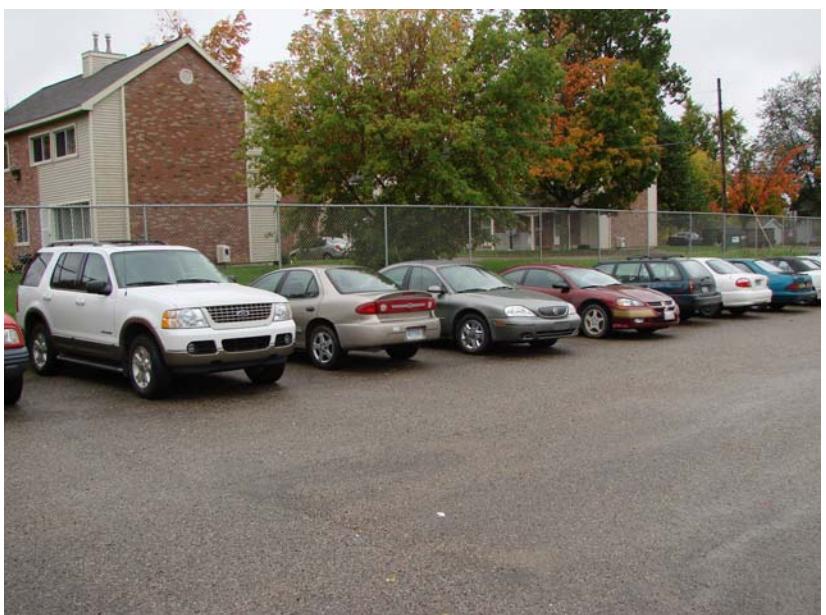
Parking was adequate during the survey visit with 71 asphalt-paved parking stalls and 3 additional handicap-parking stalls. The paved parking is in average overall condition with several areas of advanced deterioration. The asphalt paving has several cracks that should be maintained and the entire paved area should be sealed and restriped (022-026). Exterior lighting appears to be adequate in the parking area and no comments were made by staff that would indicate insufficient parking lot or exterior lighting (025).

024_MI_1: Parking lot detail - asphalt paving needs to be sealed and striped.

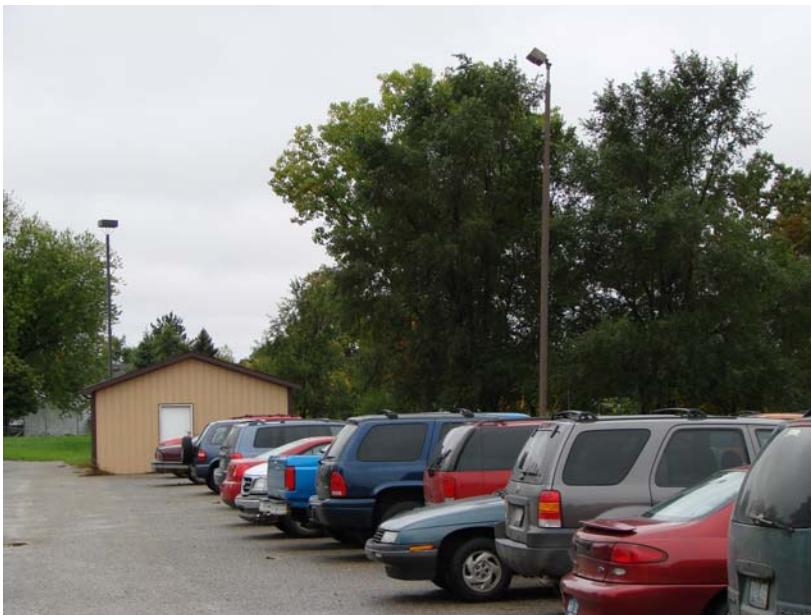
025_MI_1: Storage building at rear of parking lot, note parking lot lighting.

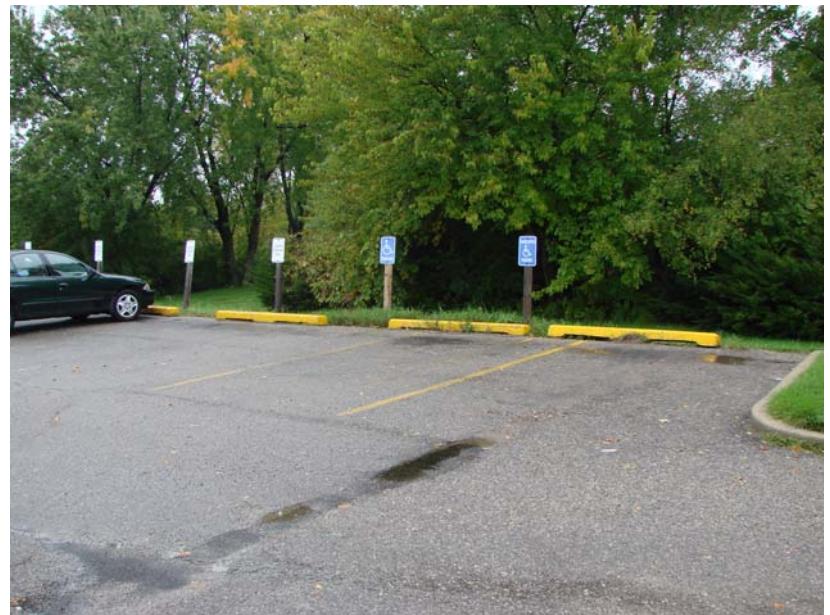
026_MI_1: Parking lot detail - asphalt paving needs to be sealed and striped.

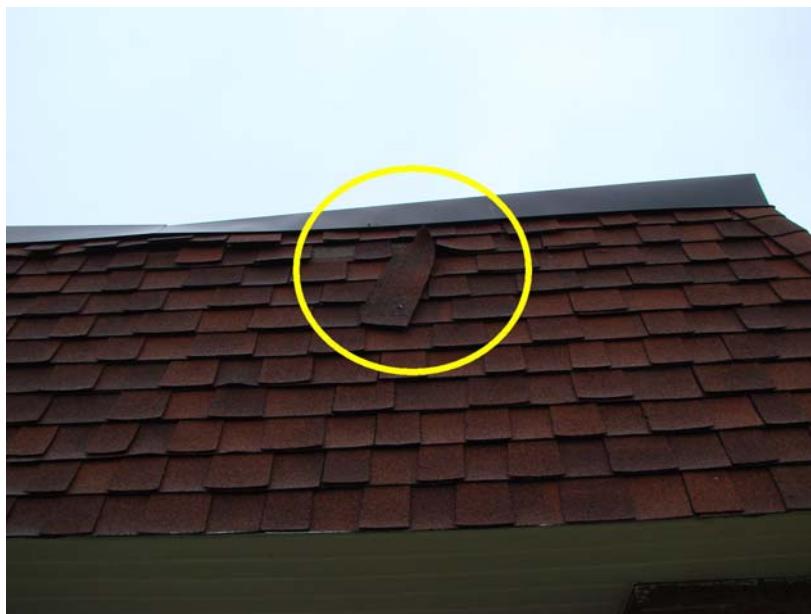
031_MI_1: Lose shingle at parapet wall above East Hall exit.

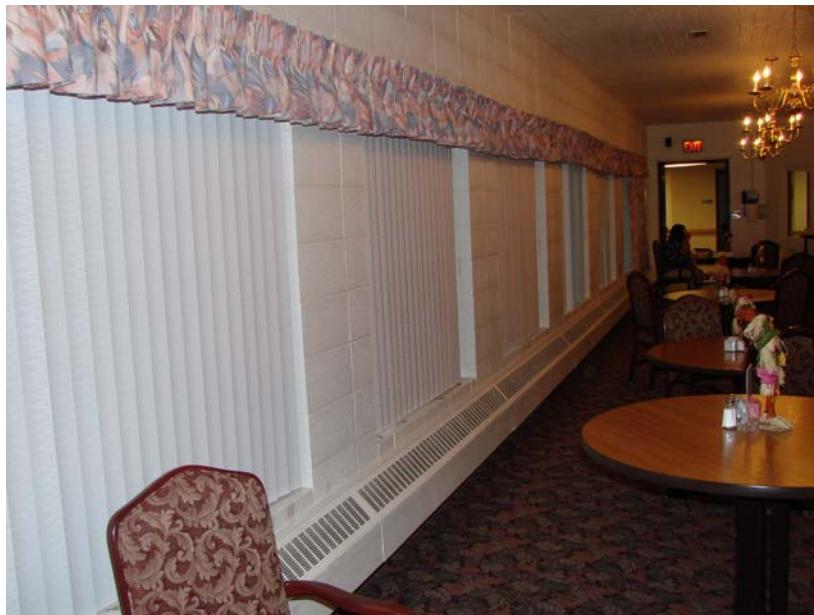
057_MI_1: Dining room at west end of Administrative Hall - radiant heating units (water source).

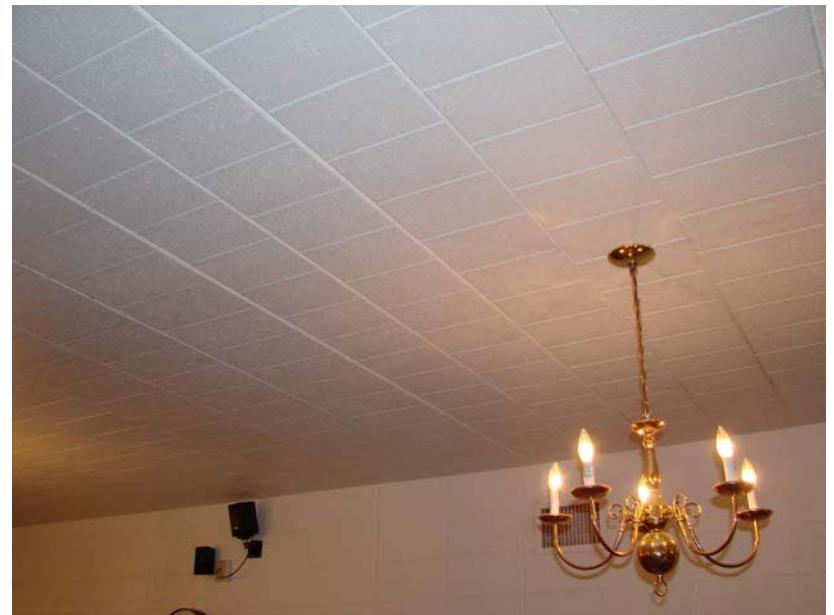
058_MI_1: Ceiling detail - pre-cast concrete plank ceiling with architectural -dock plank- finish.

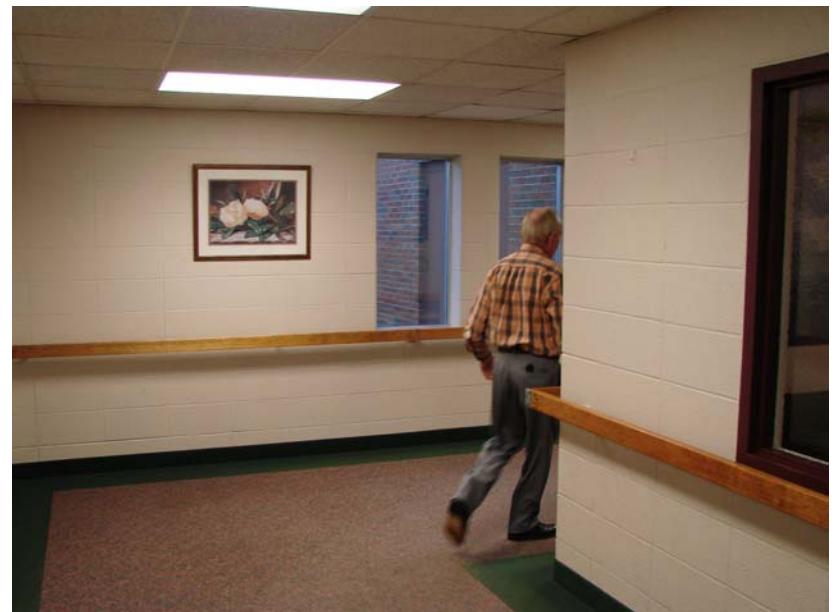
060_MI_1: Corridor -jog- to south from administrative corridor - leads to 1950's original building.

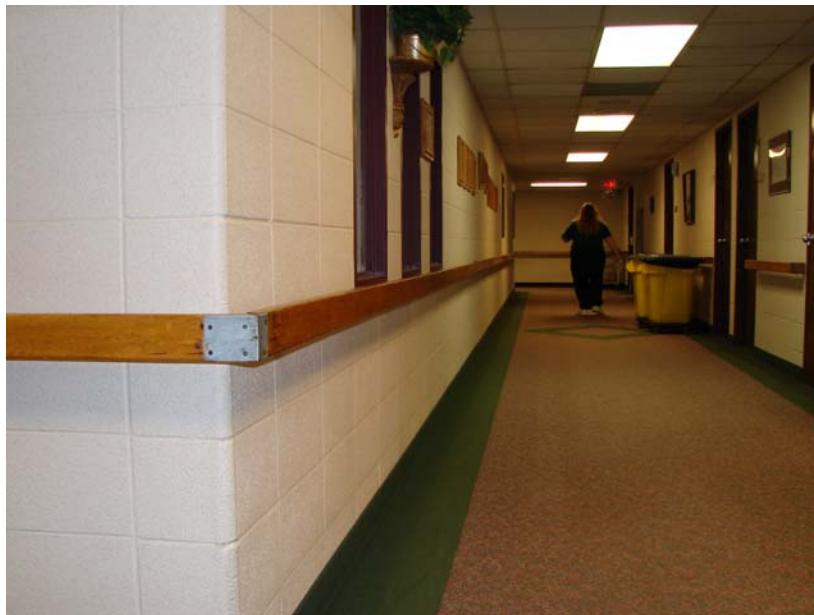
061_MI_1: Corridor detail, Administrative Hall, carpet, carpet base, painted CMU block wall, acoustical grid ceiling.

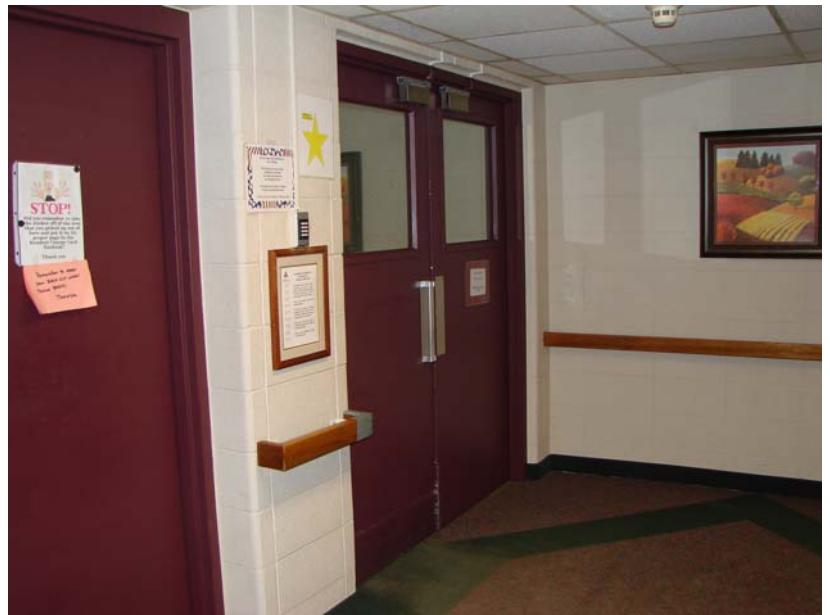
062_MI_1: Control doors separating South 1 Hall from center administrative hall.

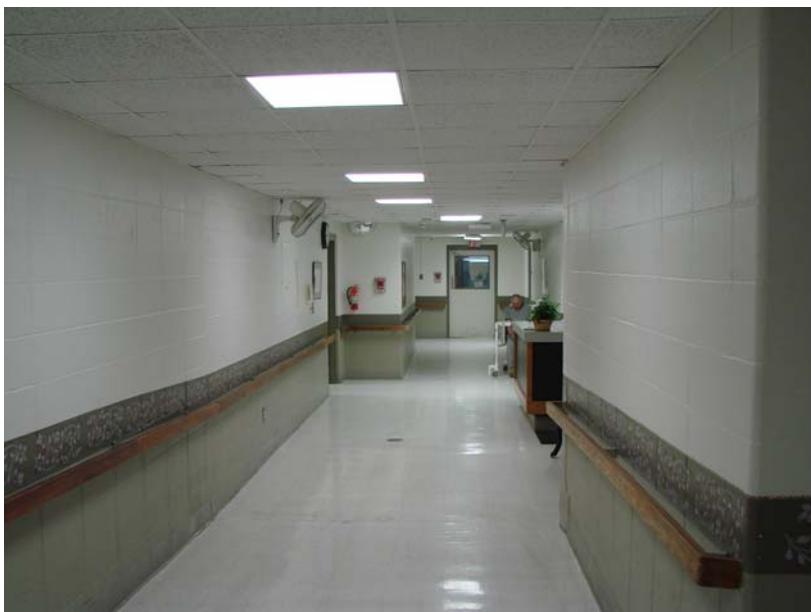
063_MI_1: South 1 Hall - 2nd addition (1960s).

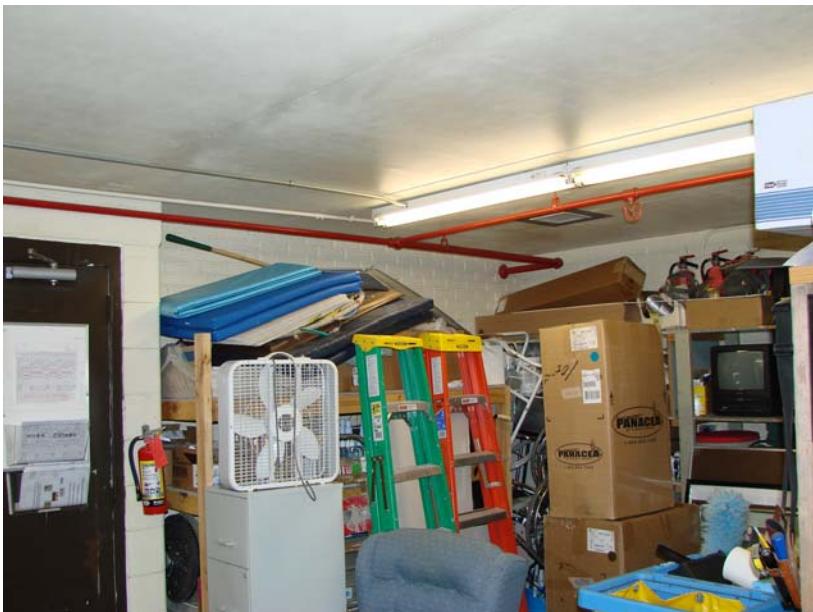
065_MI_1: Fire sprinklers in maintenance office. Note facility is only partially sprinkled.

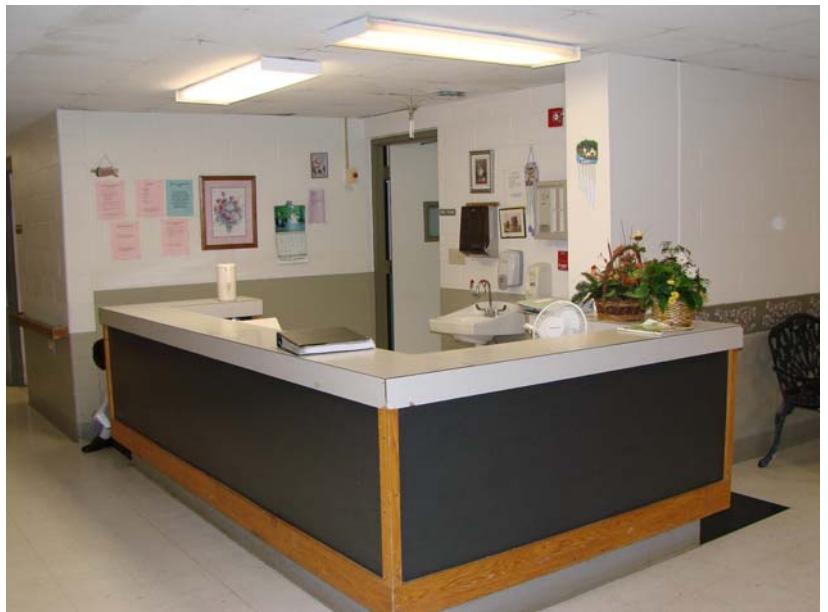
066_MI_1: South 1 nurse station.

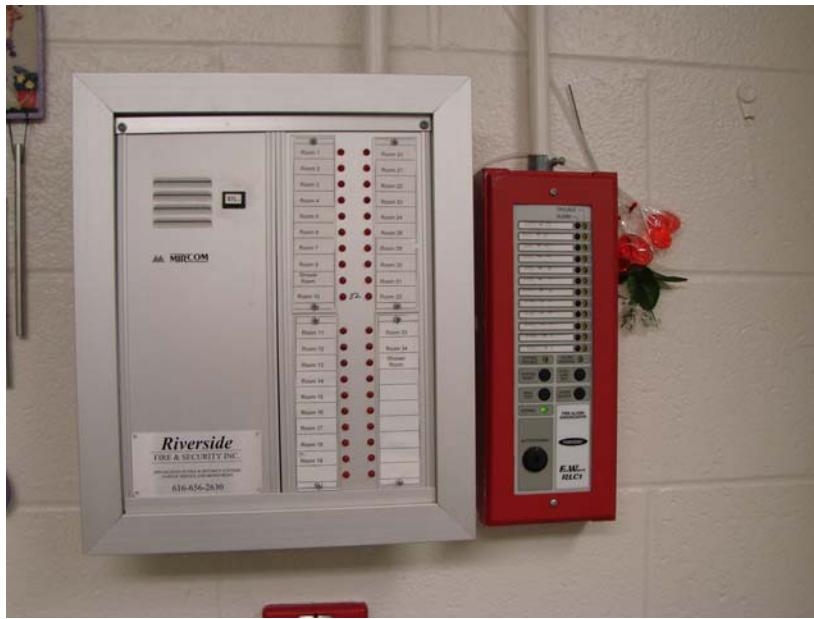
069_MI_1: Mircom nurse call, and Fire Watch fire alarm annunciator panels.

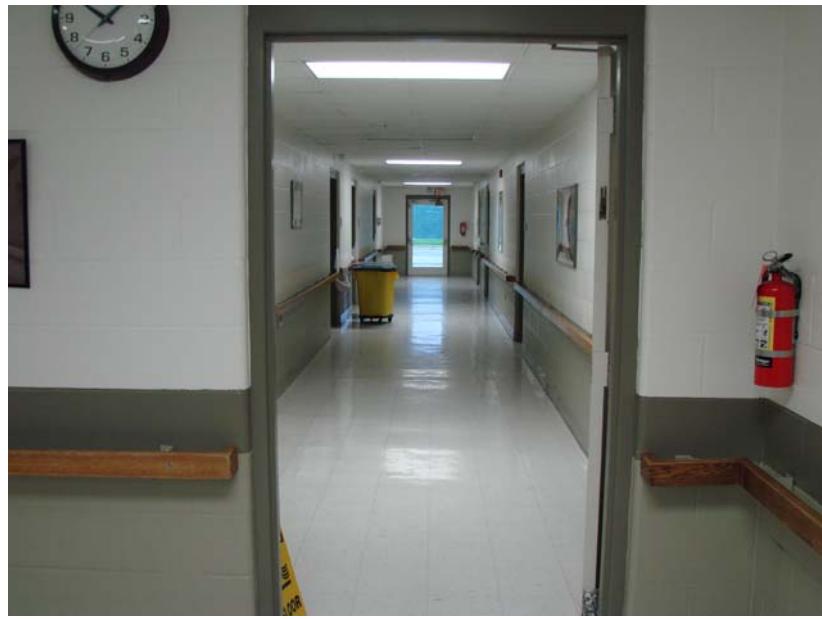
70.	South 1 Hall looking east from nurse station.
71.	South 1 east corridor exit to Hall Street.
72.	Detail - wall base coming loose at doorframe.
73.	South 1 - 3-bed ward.

070_MI_1: South 1 Hall looking east from nurse station.

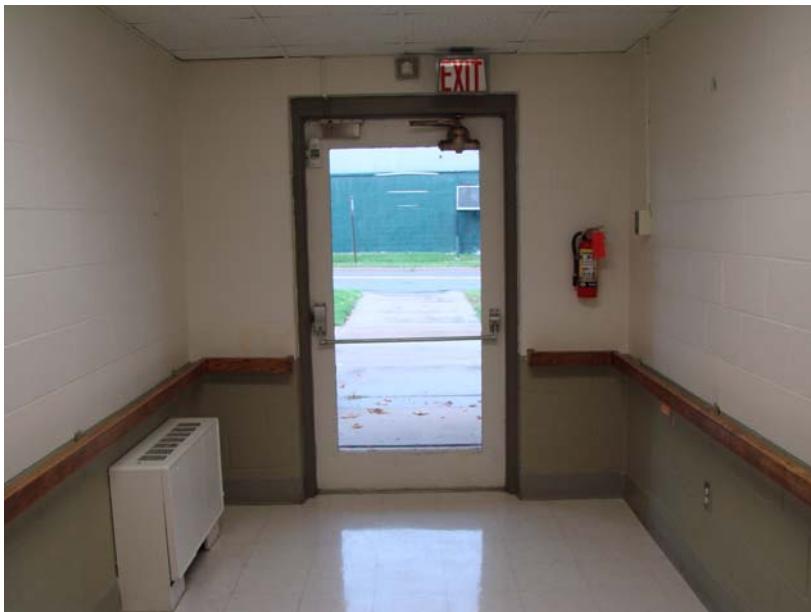
071_MI_1: South 1 east corridor exit to Hall street.

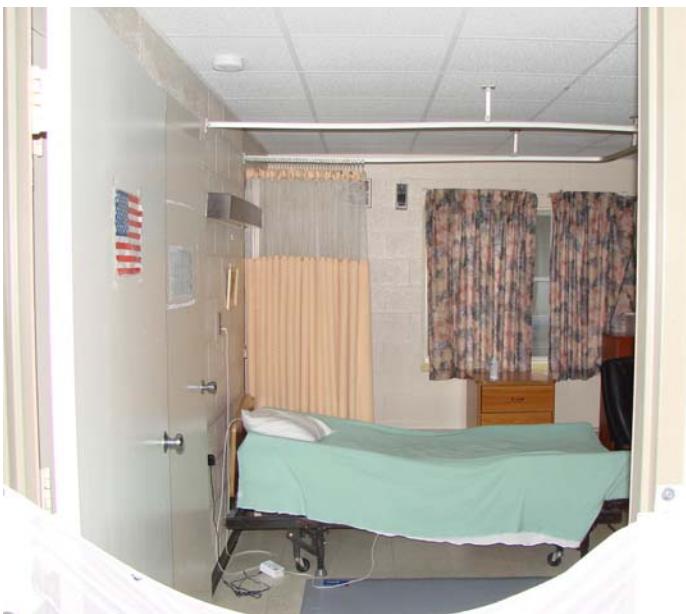
073_MI_1: South 1 - 3-bed ward.

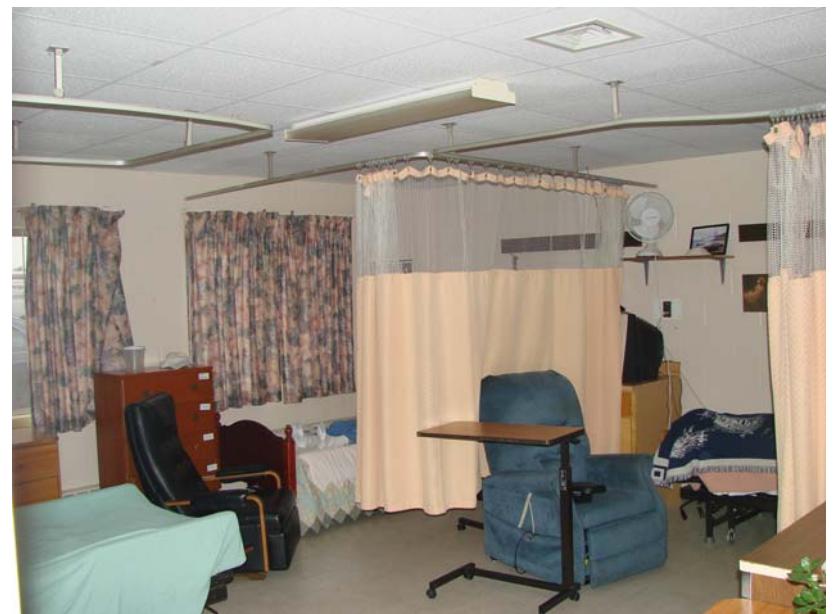
074_MI_1: South 1 - 3-bed ward.

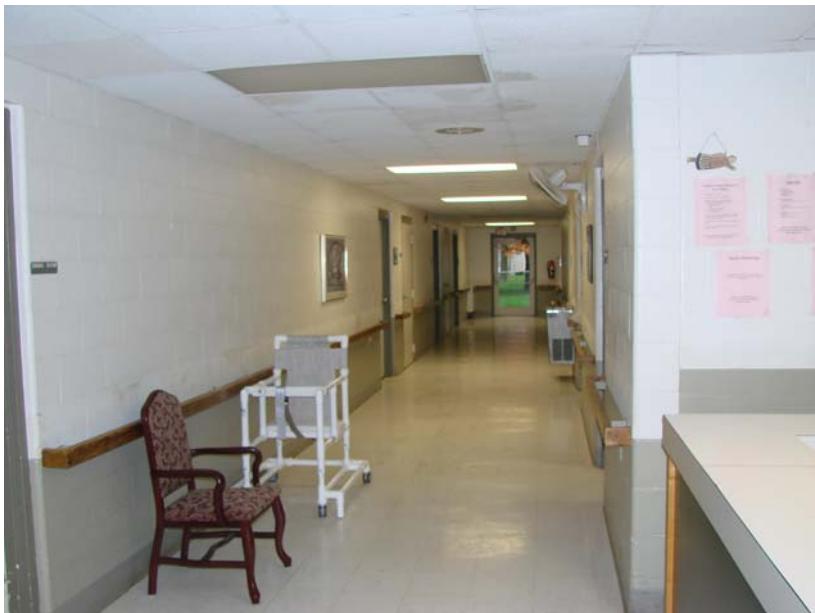
075_MI_1: South 1 Hall looking west from nurse station - note finishes include VCT floor, vinyl base, painted CMU block wall, wood handrail, acoustical grid

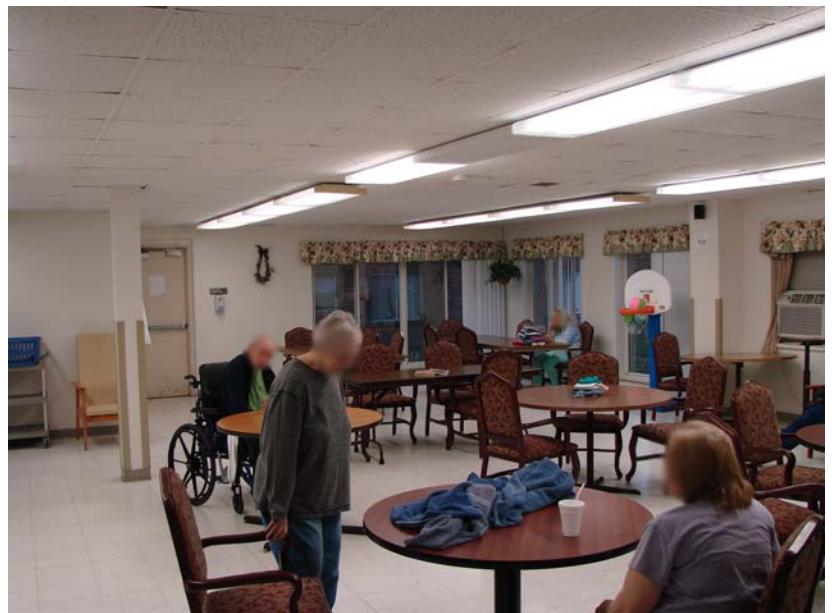
076_MI_1: South 1 dining room.

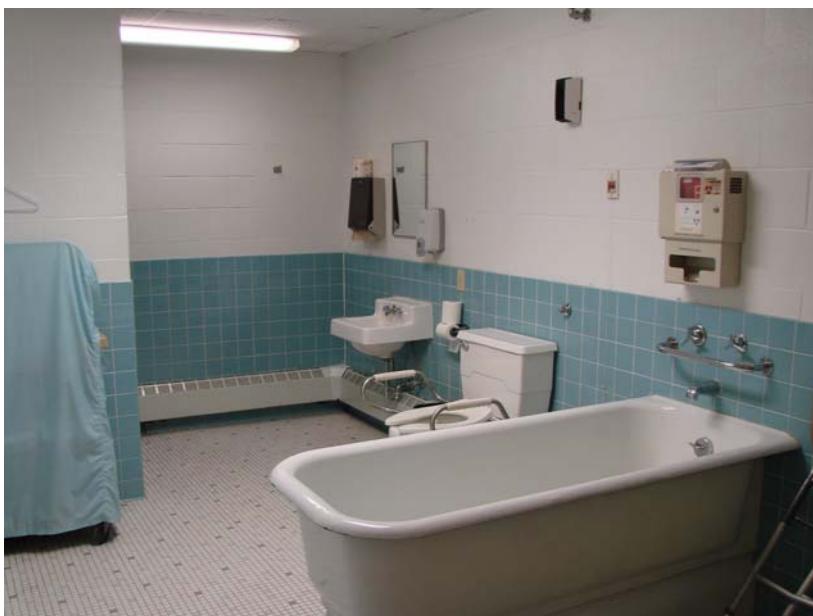
079_MI_1: South 1 tub-shower room - residential style tub.

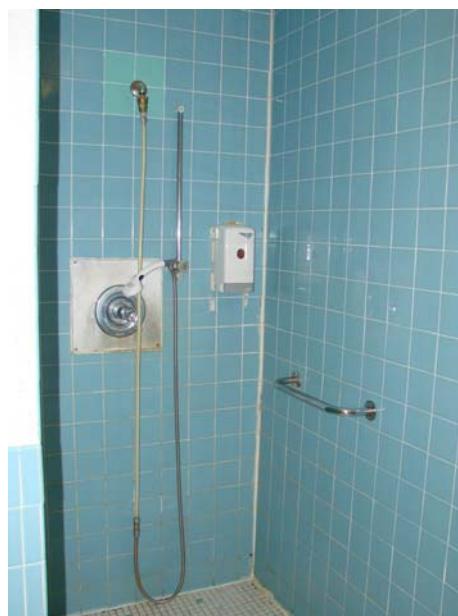
080_MI_1: South 1 tub-shower room.

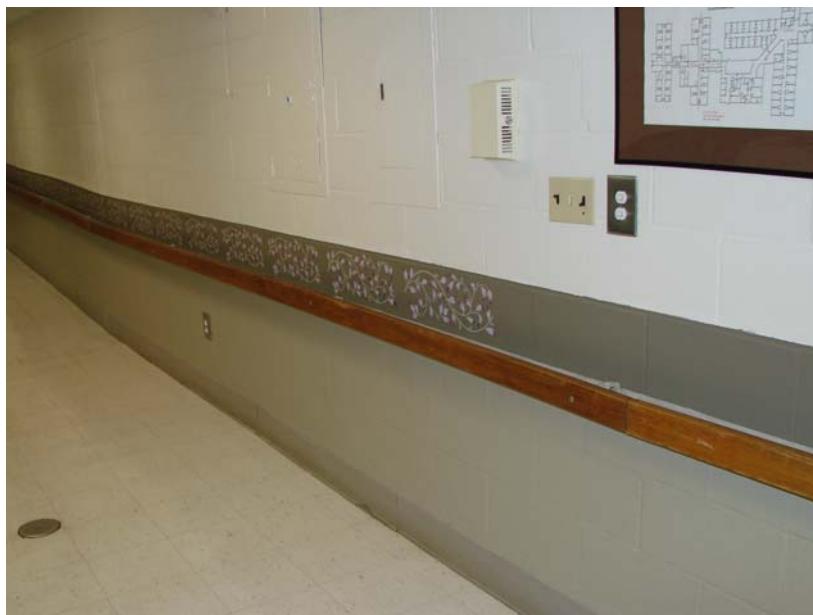
083_MI_1: Corridor detail - staff is adding accent band above handrail.

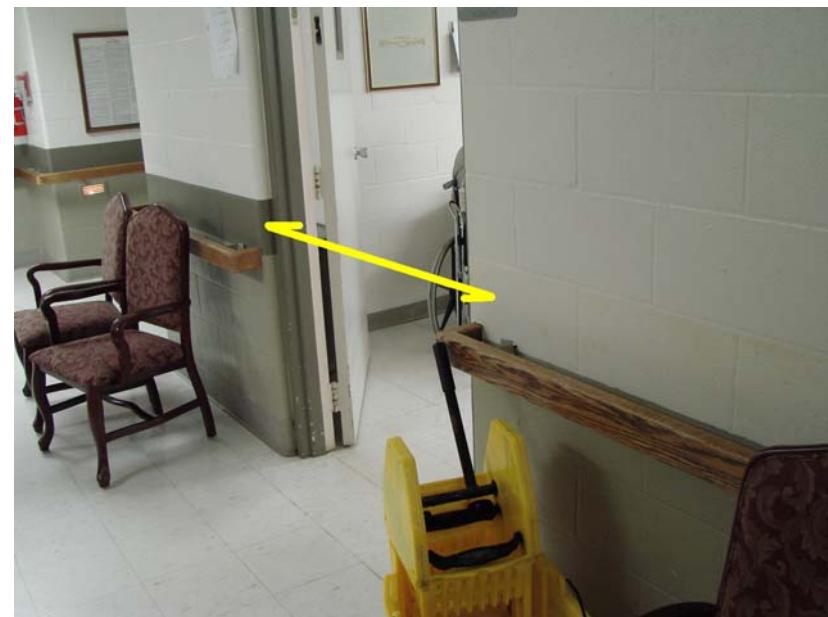
082_MI_1: South 1 corridor detail - staff is adding accent band above handrail.

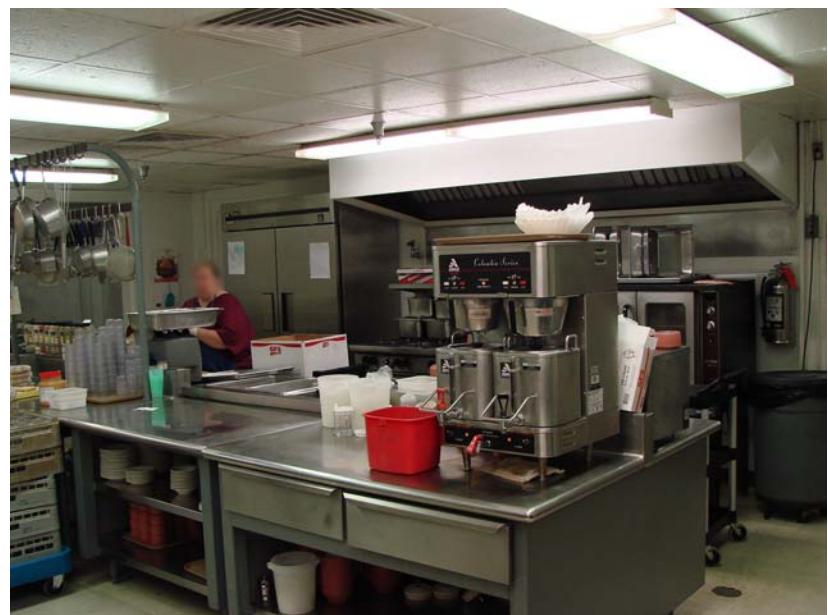
084_MI_1: Kitchen - food preparation area.

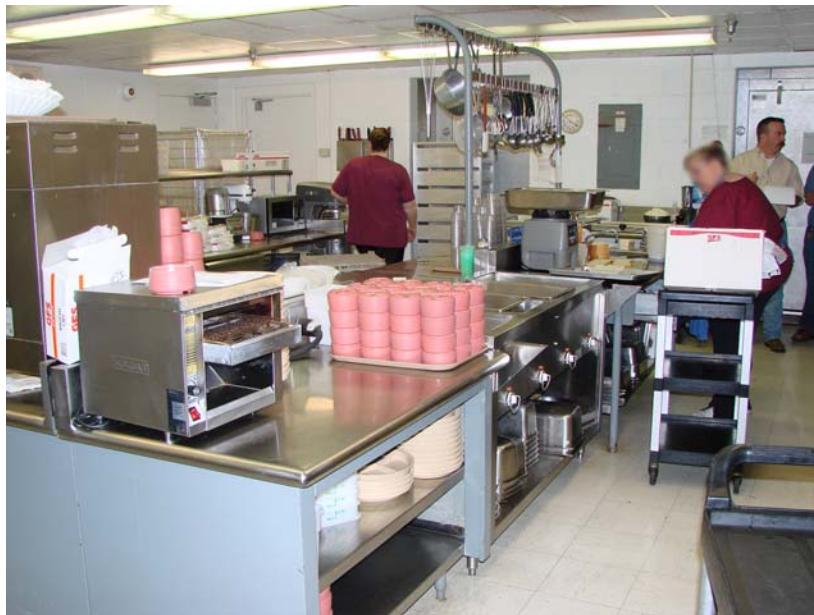
085_MI_1: Kitchen - food serving area - steam table.

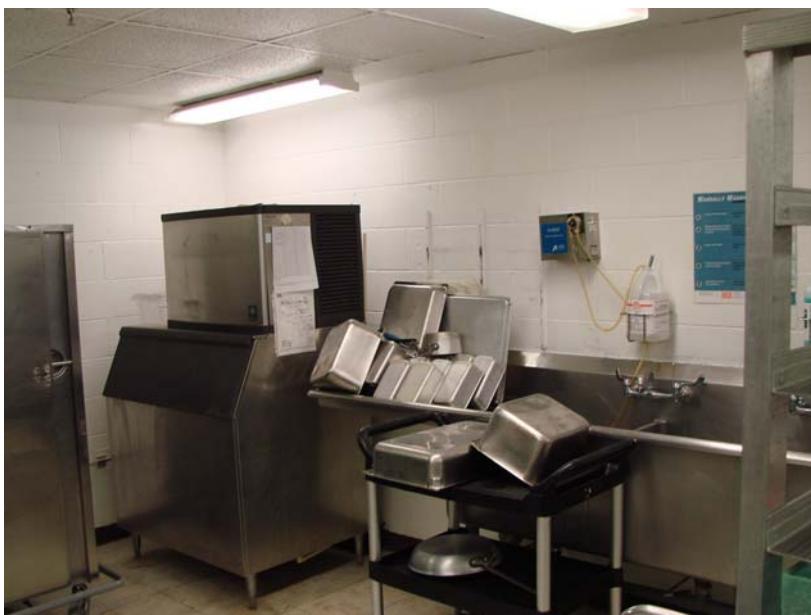
087_MI_1: Kitchen - ice machine, wash-rinse sink.

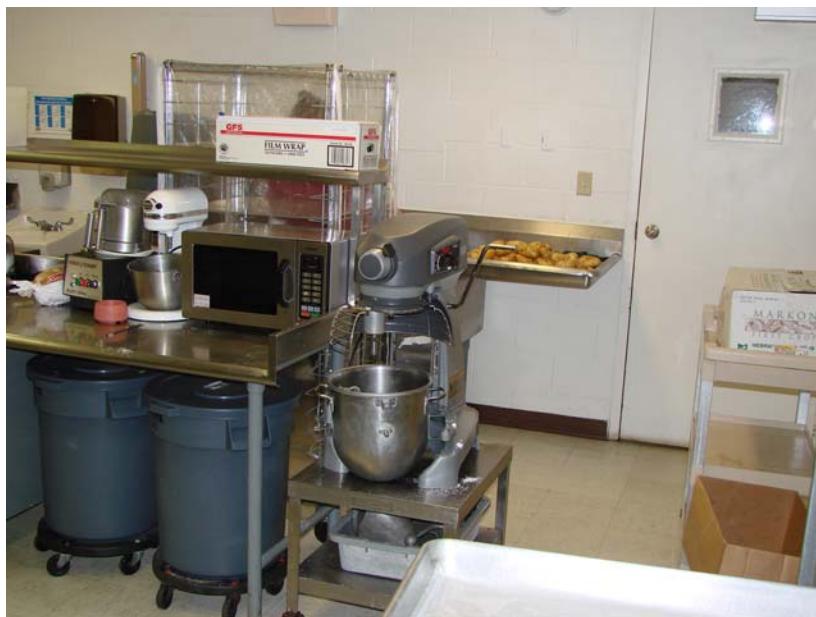
089_MI_1: Kitchen - food preparation area - mixer.

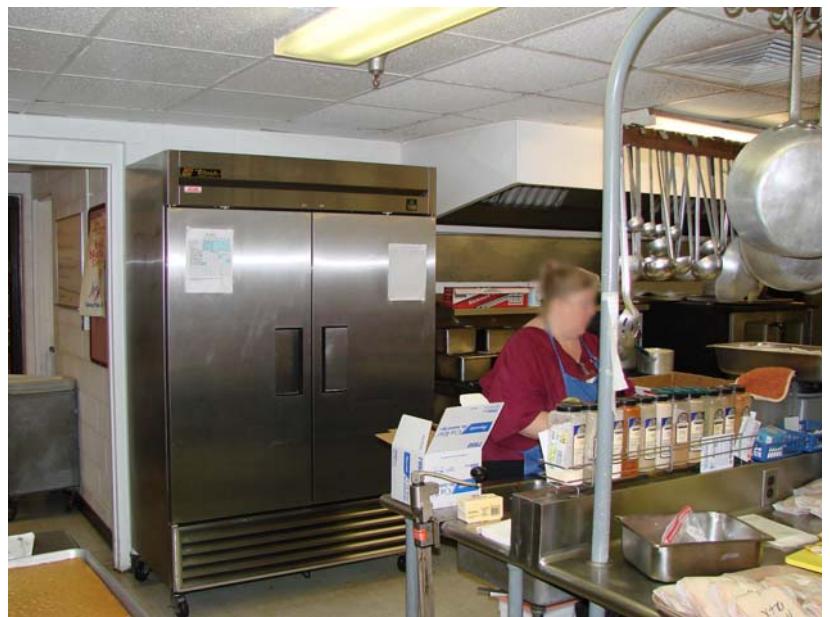
090_MI_1: Kitchen - True 2-door reach-in refrigerator.

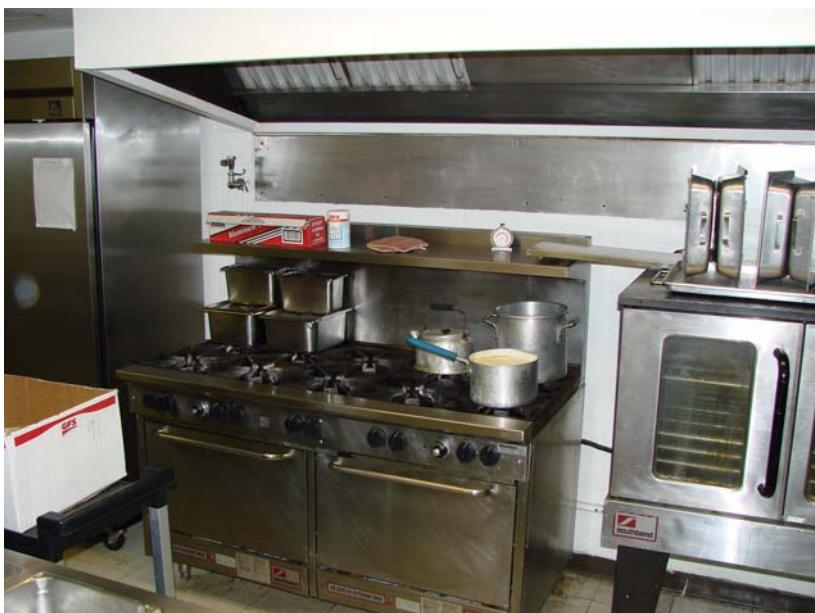
091_MI_1: Kitchen - Southbend 10-burner gas stove with double ovens.

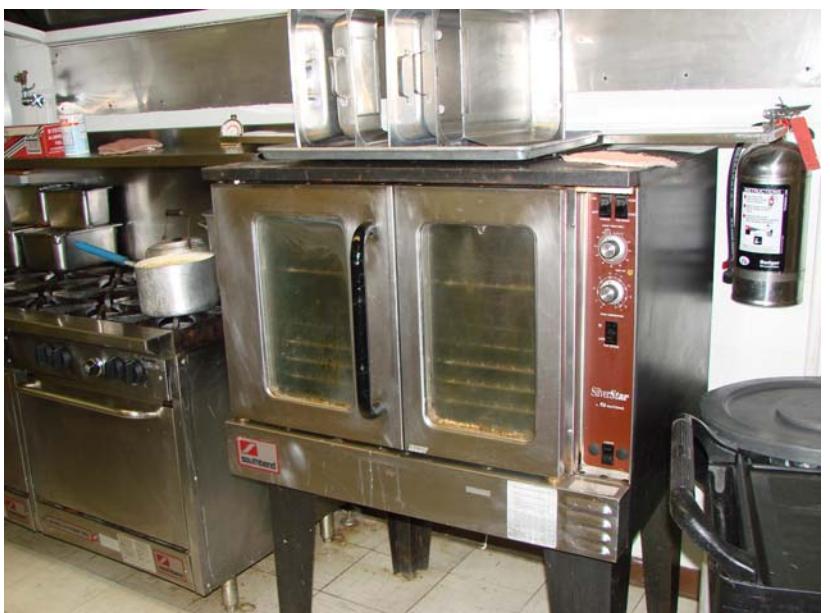
092_MI_1: Kitchen - Southbend convection oven.

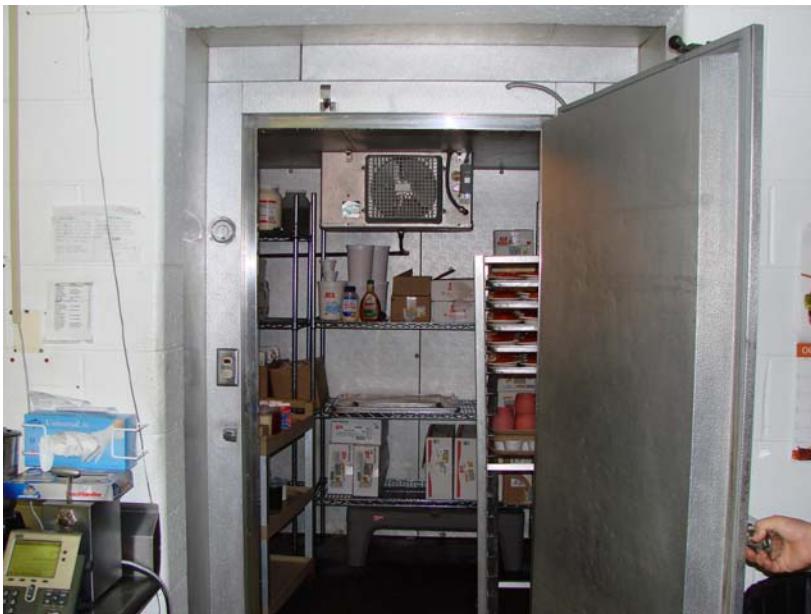
093_MI_1: Kitchen - Thermo Kool walk-in cooler.

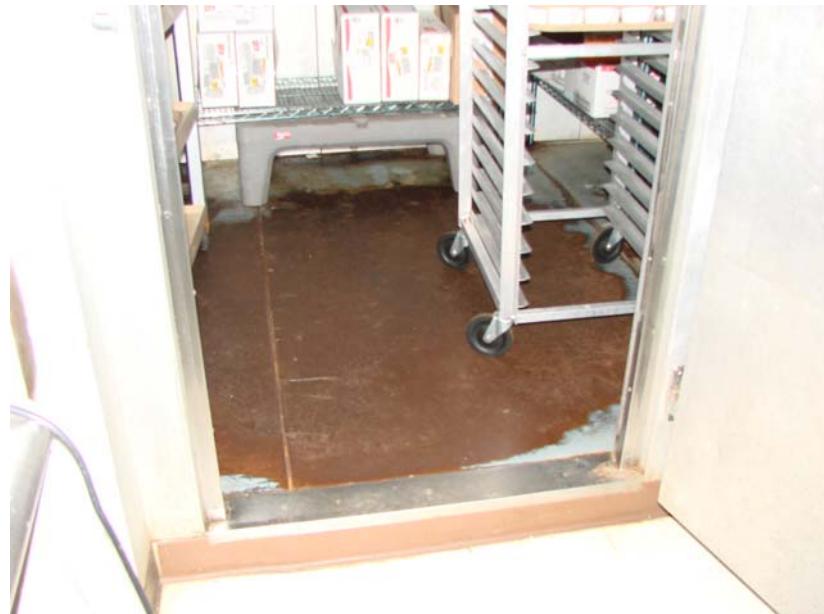
094_MI_1: Walk-in cooler floor detail.

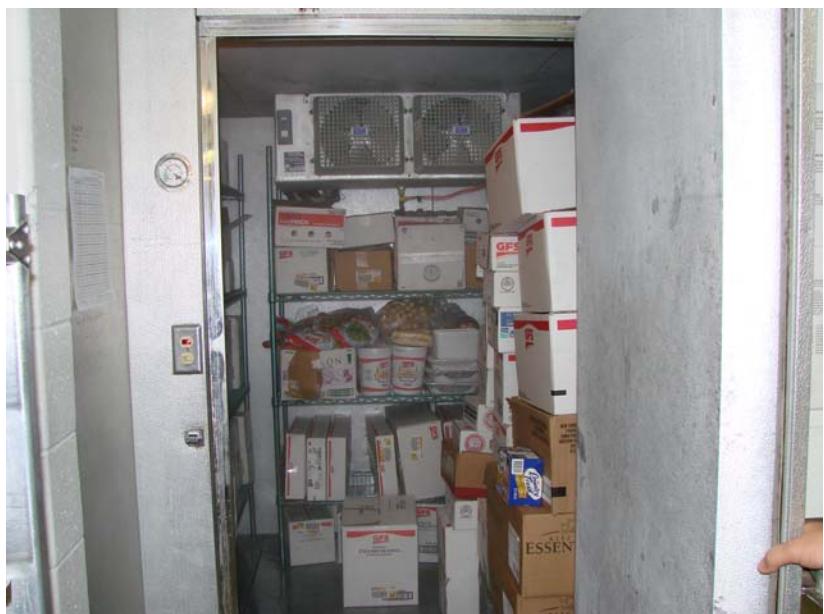
096_MI_1: Kitchen - Thermo Kool walk-in freezer.

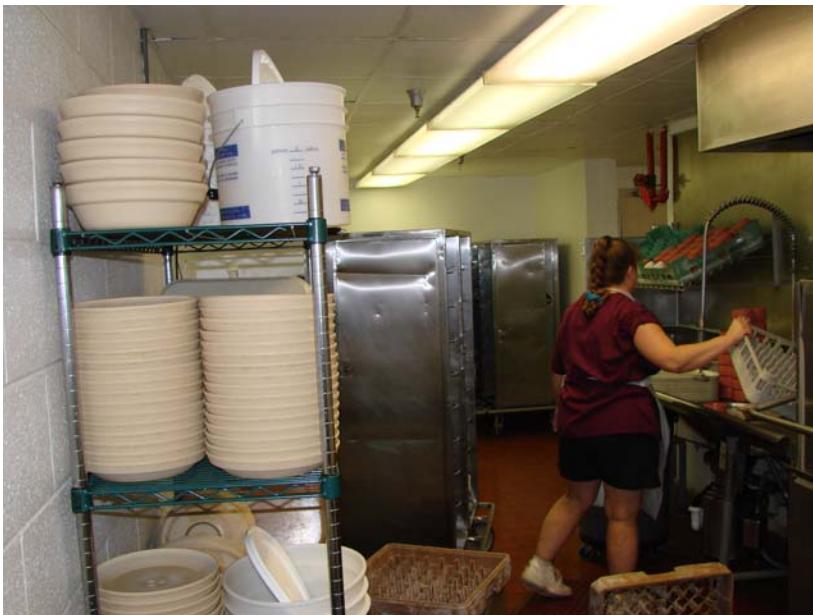
097_MI_1: Kitchen - dish washing area, food delivery carts.

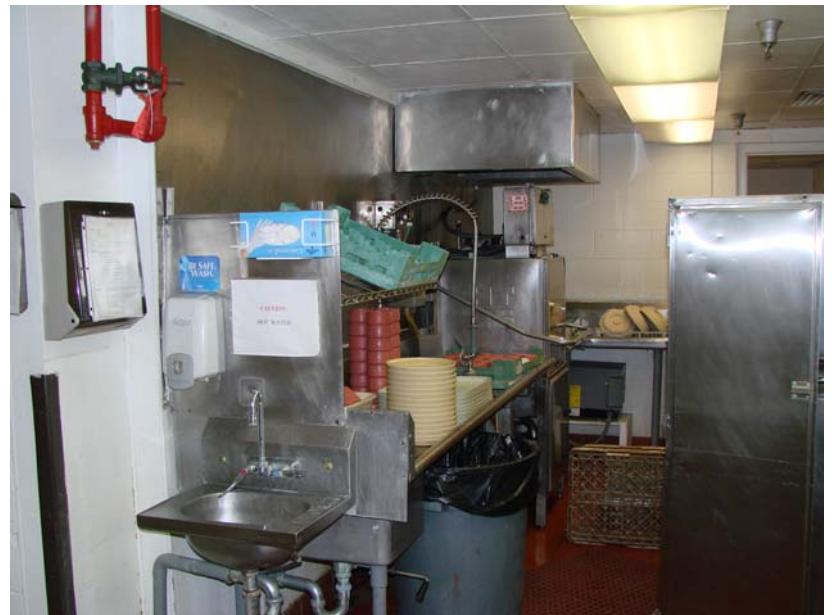
098_MI_1: Kitchen - dishwashing equipment.

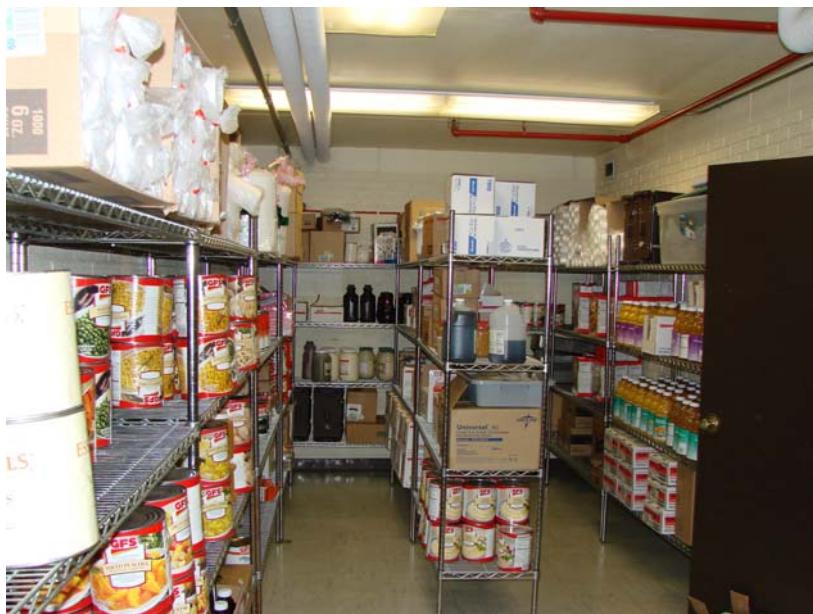
099_MI_1: Kitchen - dry storage.

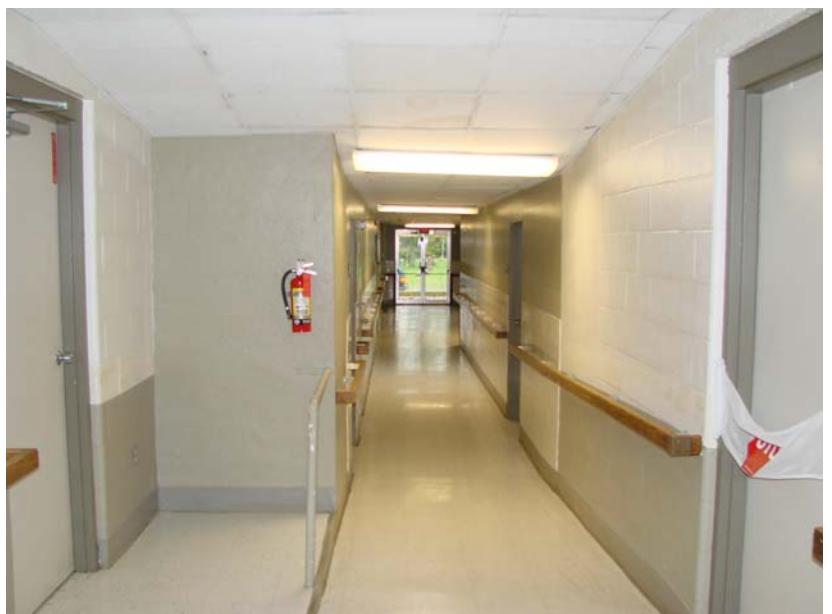
100_MI_1: Narrow connecting corridor from South 1 Hall to South 2 Hall.

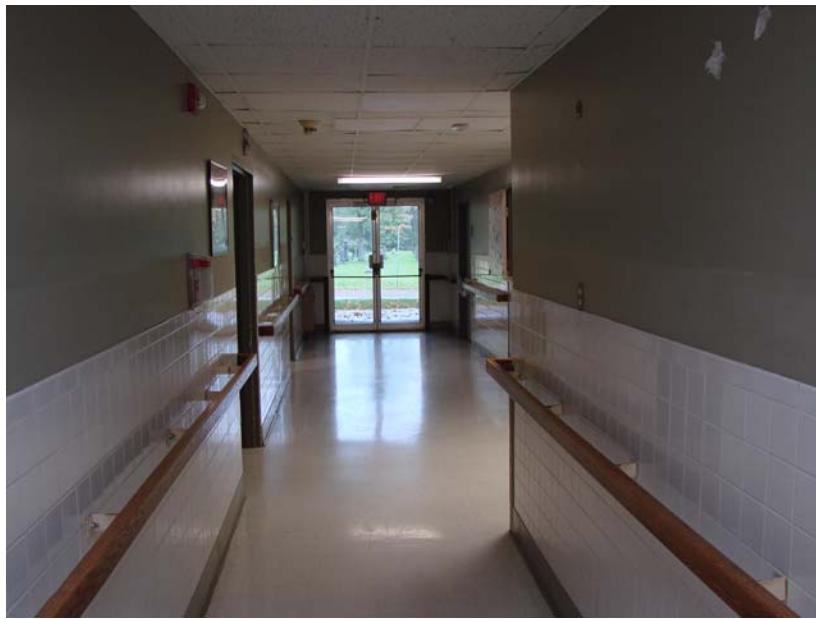
101_MI_1: South 2 Hall looking south - note ceramic tile wainscot on corridor walls.

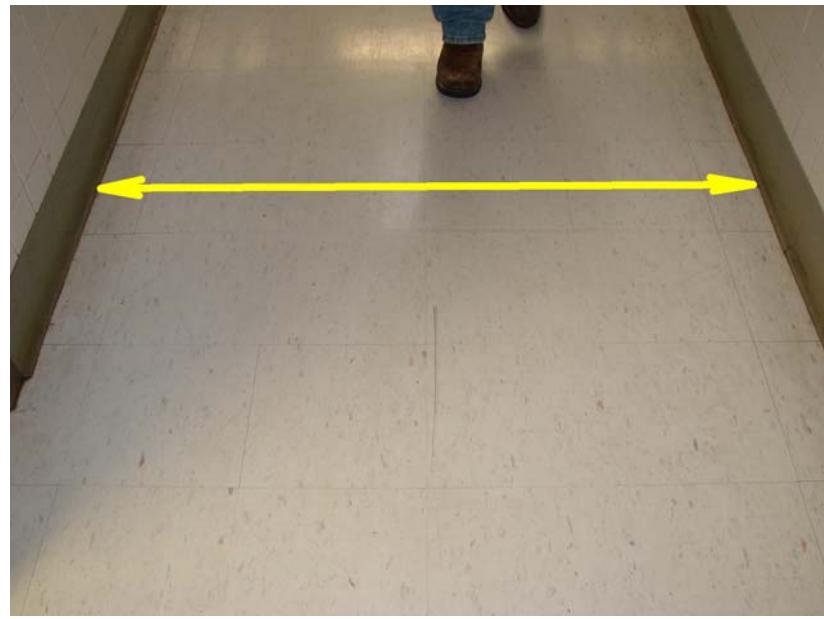
102_MI_1: Detail - approximately 4'-6- corridor width.

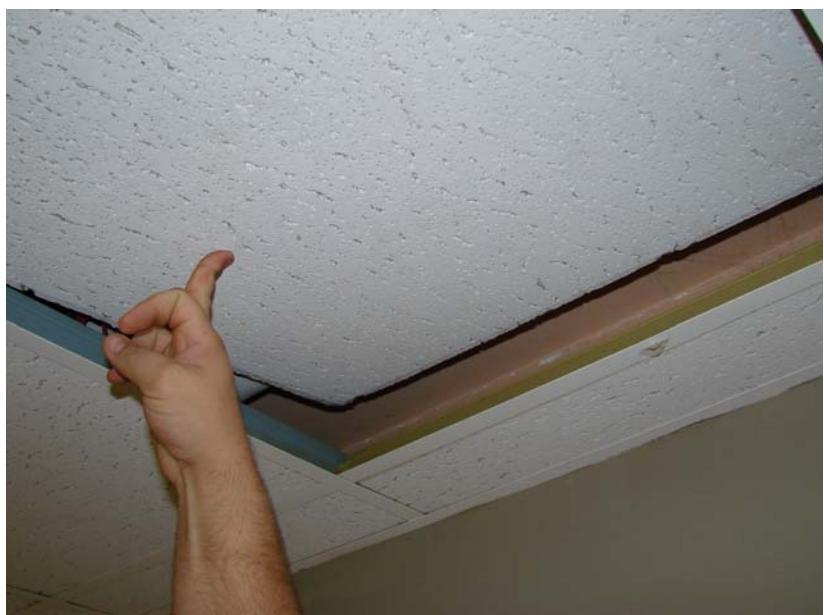
104_MI_1: Ceiling detail - minimal space above corridor ceiling grid.

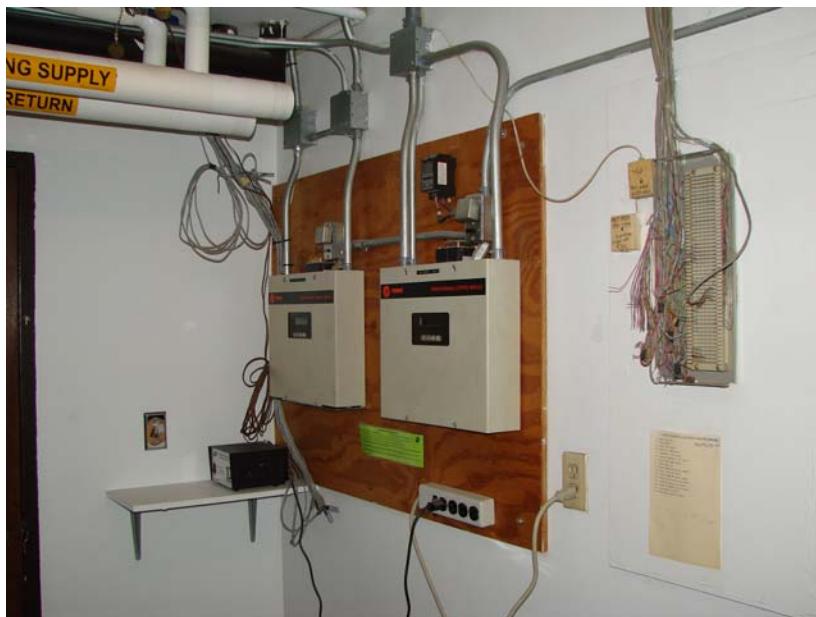
105_MI_1: Trane electronic HVAC controls.

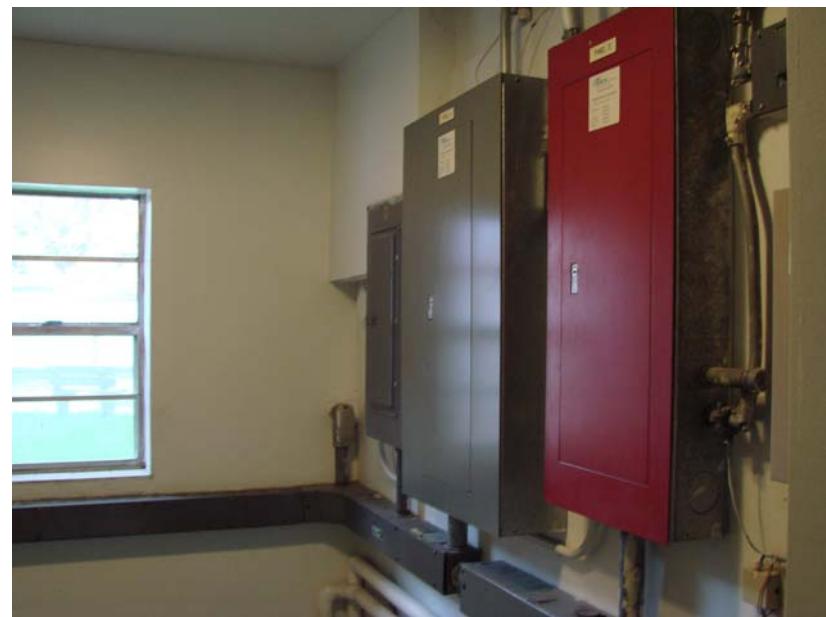
106_MI_1: Electrical sub-panels in South 2 Hall.
