PROPERTY CONDITION REPORT

The Willows @ Anytown

414 East Street ♦ Anytown, USA 01995

Client: No.1 LTC Operator

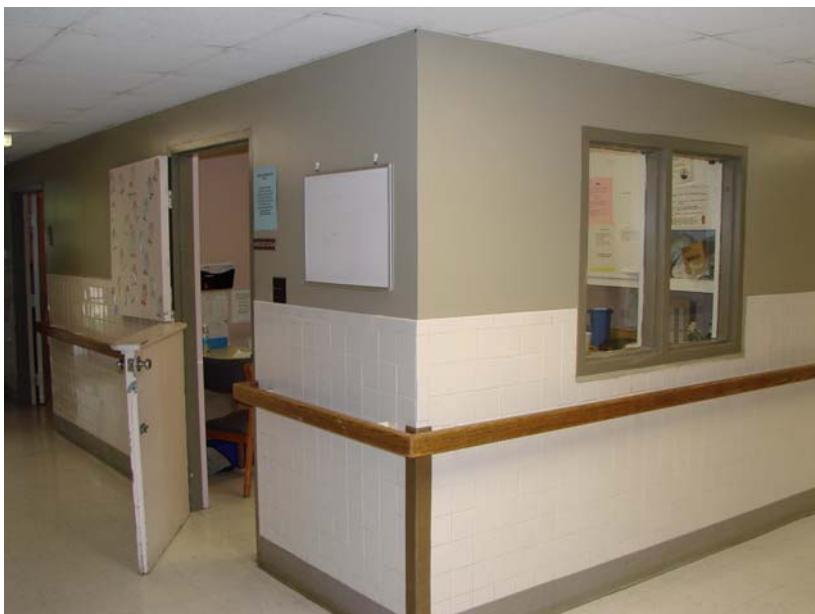
107_MI_1: South 2 nurse station.

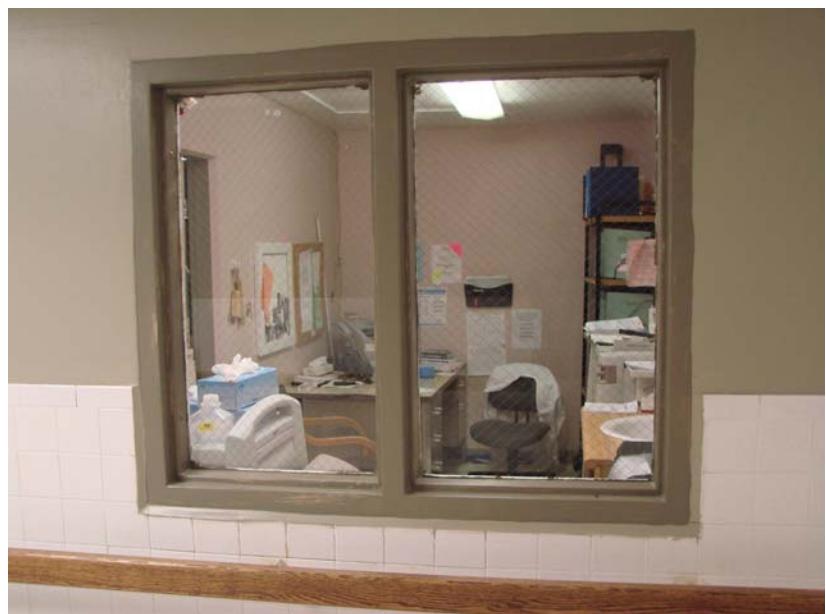
108_MI_1: South 2 nurse station.

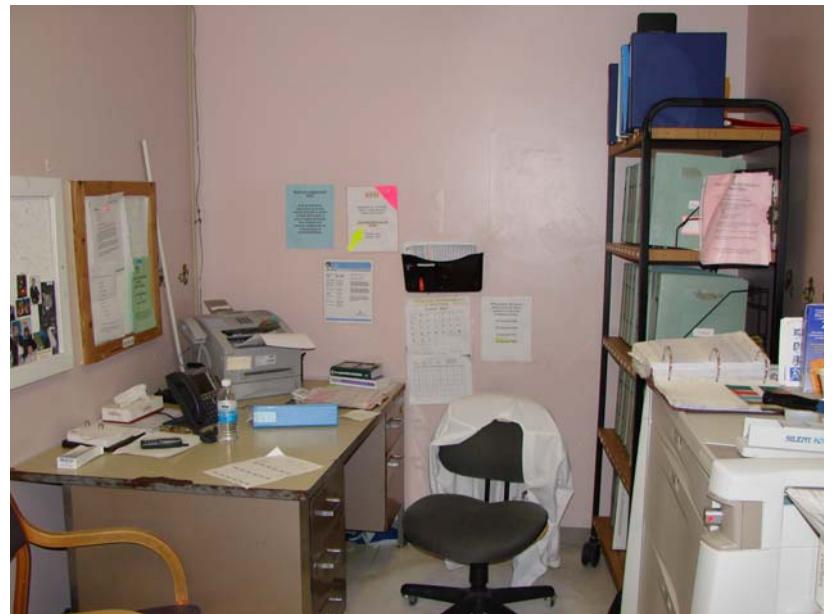
110_MI_1: South 2 nurse station.

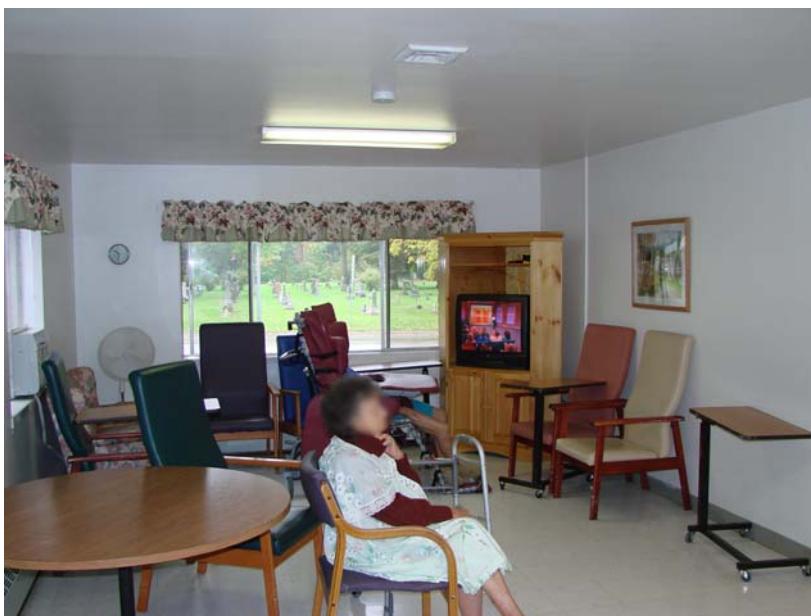
111_MI_1: South 2 day room.

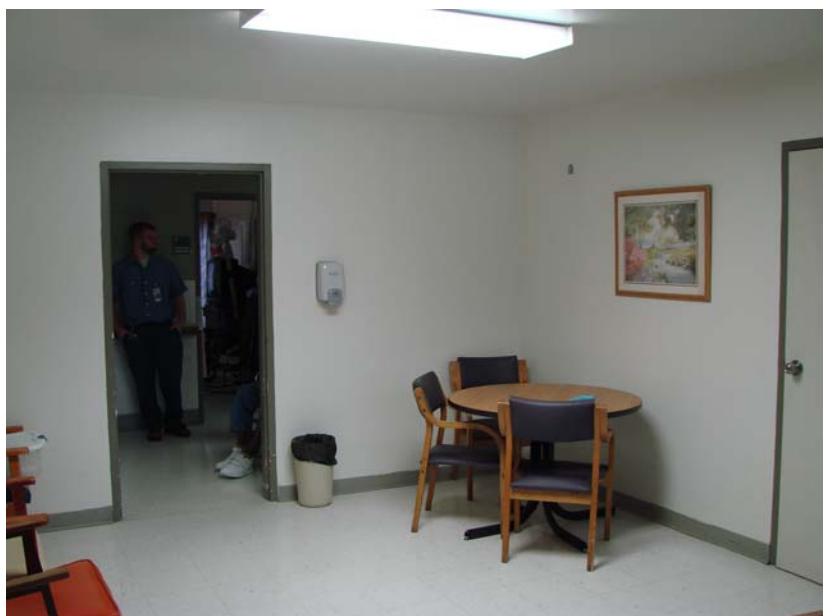
112_MI_1: South 2 day room.

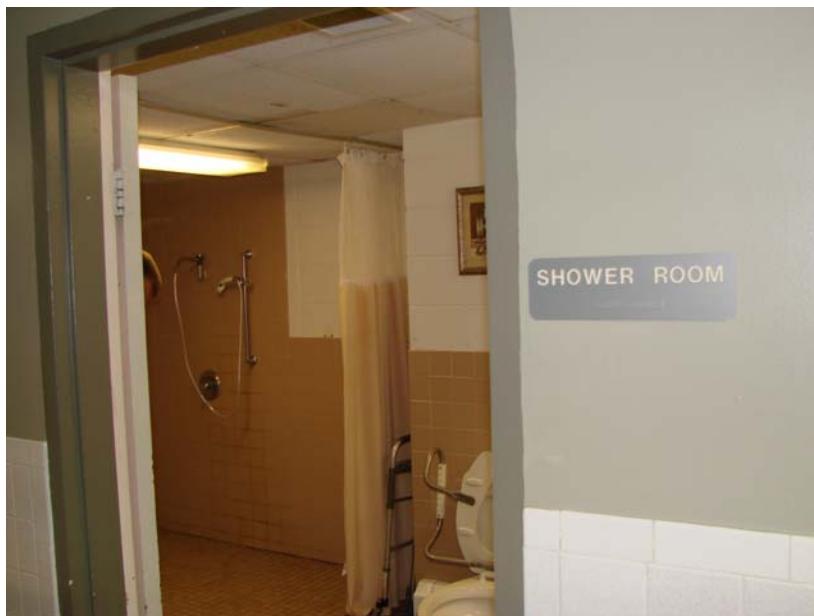
113_MI_1: South 2 shower room.

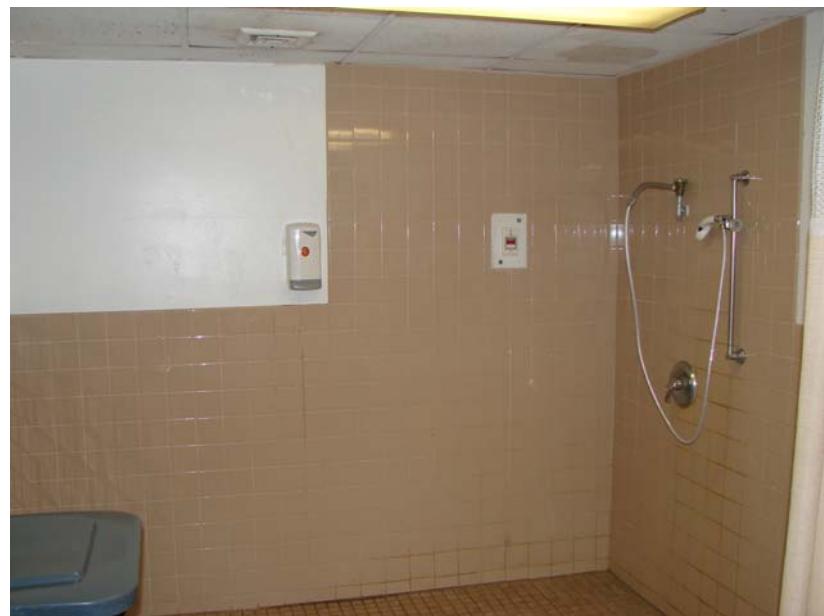
114_MI_1: South 2 shower room.

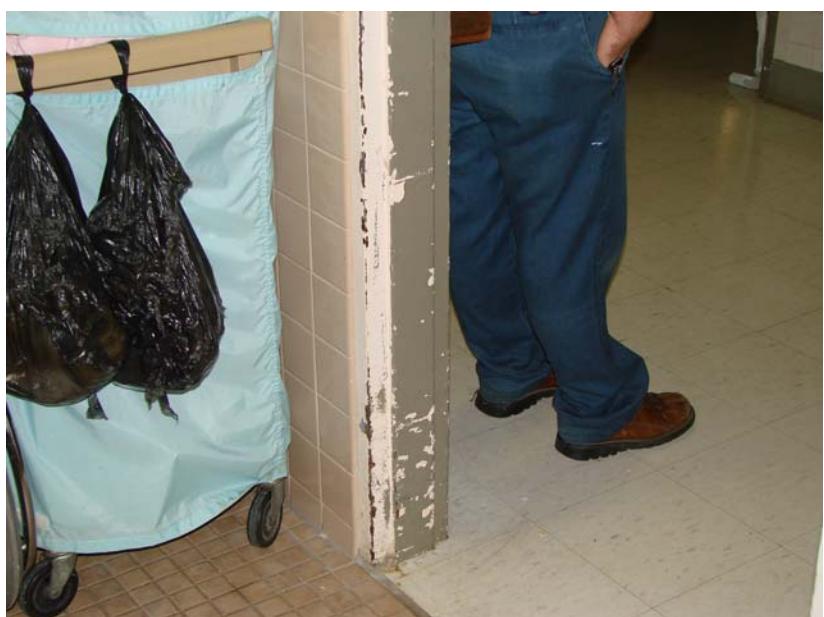
116_MI_1: Detail - paint scratched from shower room door frame.

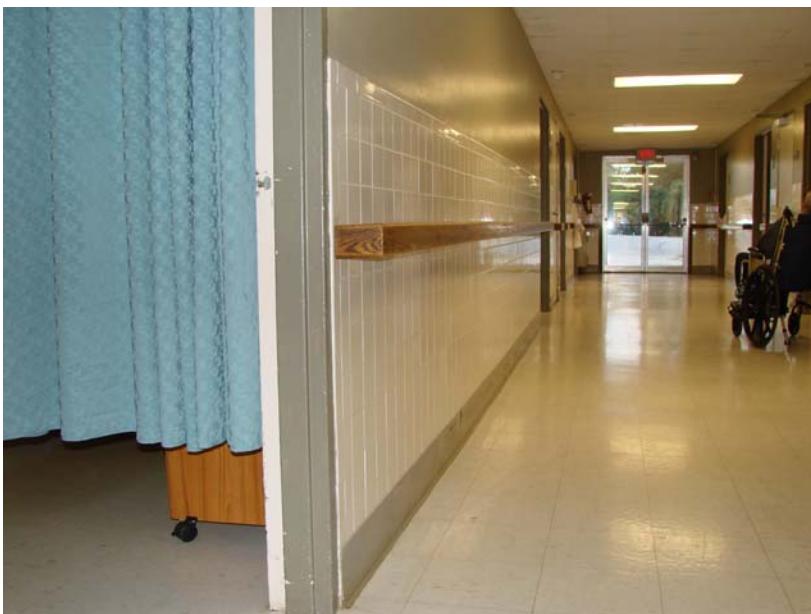
117_MI_1: South 2 Hall corridor detail - VCT floor, vinyl base, ceramic tile wainscot, wood handrail, painted wall (skim coat over CMU block wall), acoustic

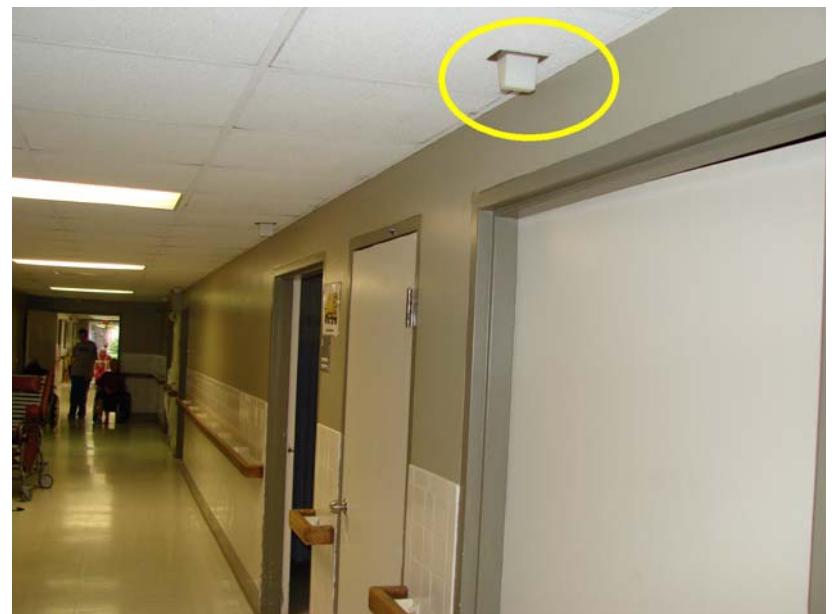
118_MI_1: South 2 corridor detail - nurse call lights in ceiling.

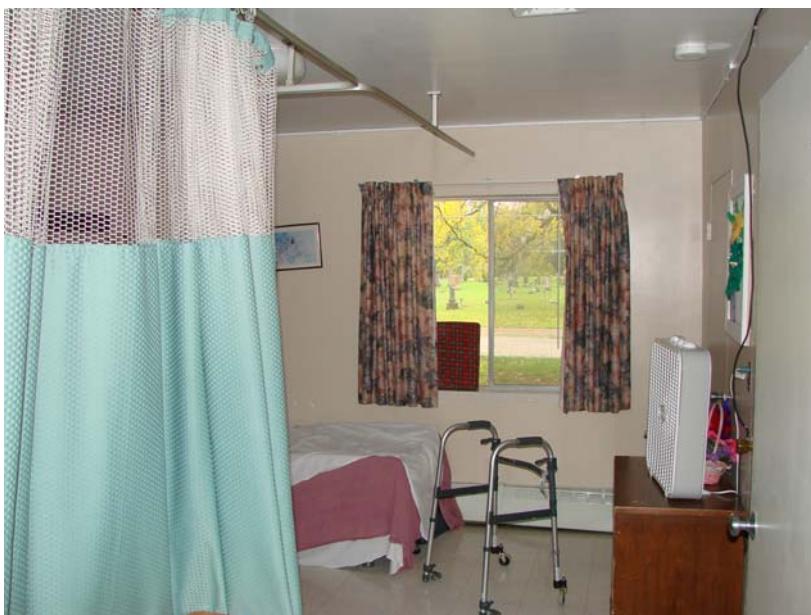
119_MI_1: South 2 Hall semi-private room.

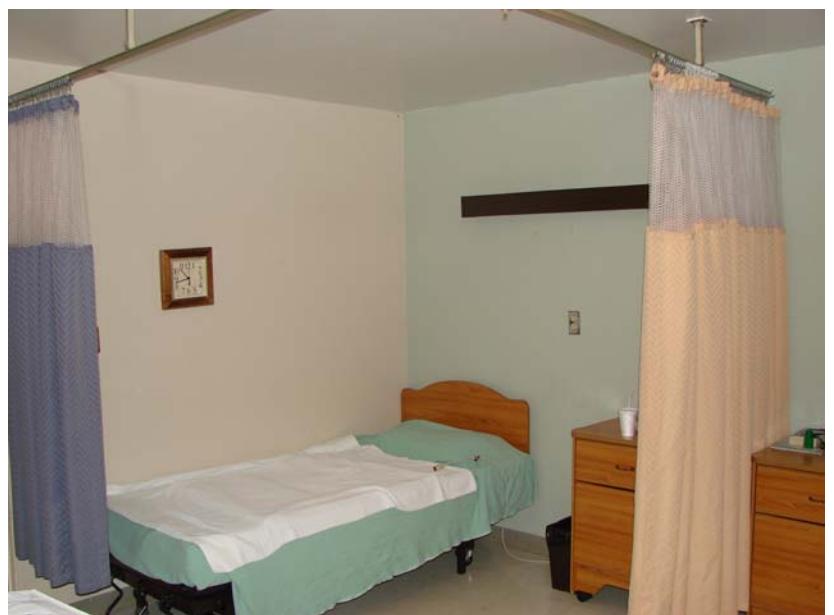
120_MI_1: South 2 semi-private resident room.

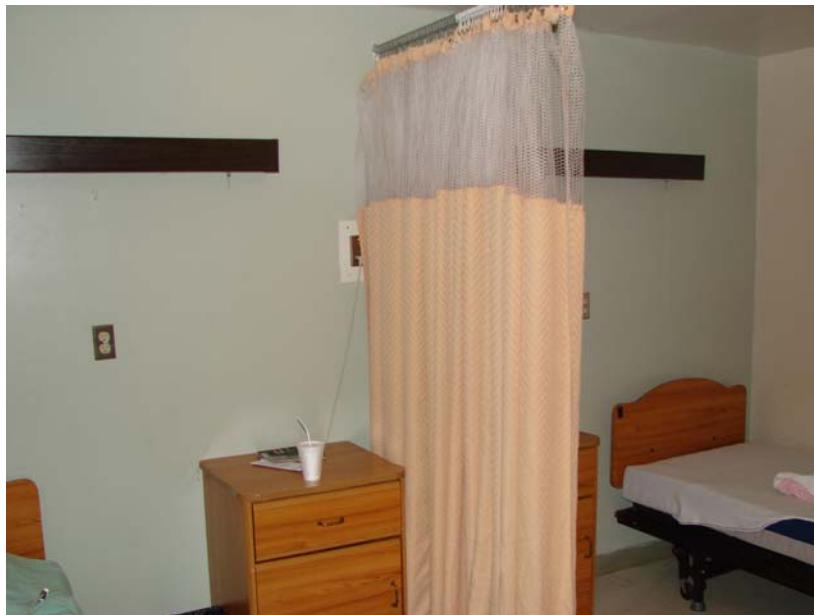
121_MI_1: South 2 semi-private resident room.

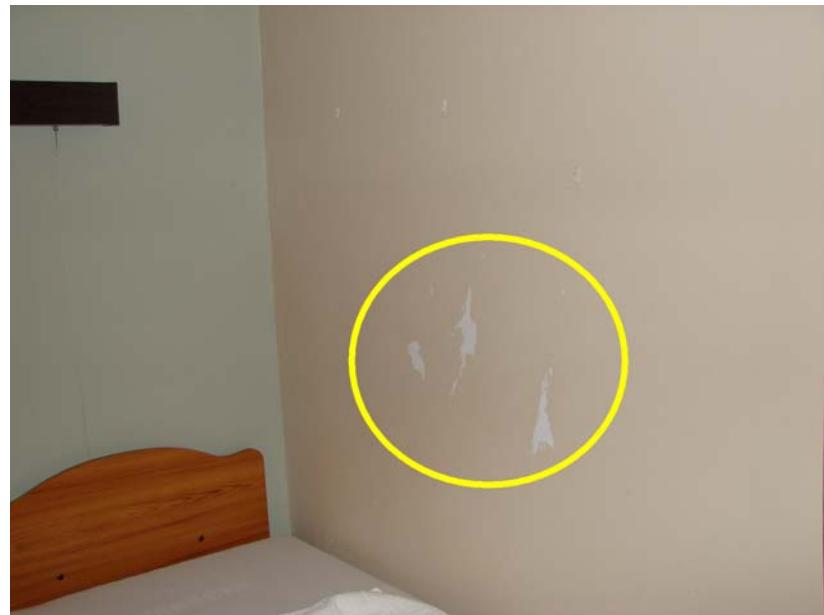
122_MI_1: Paint peeling off resident room wall.

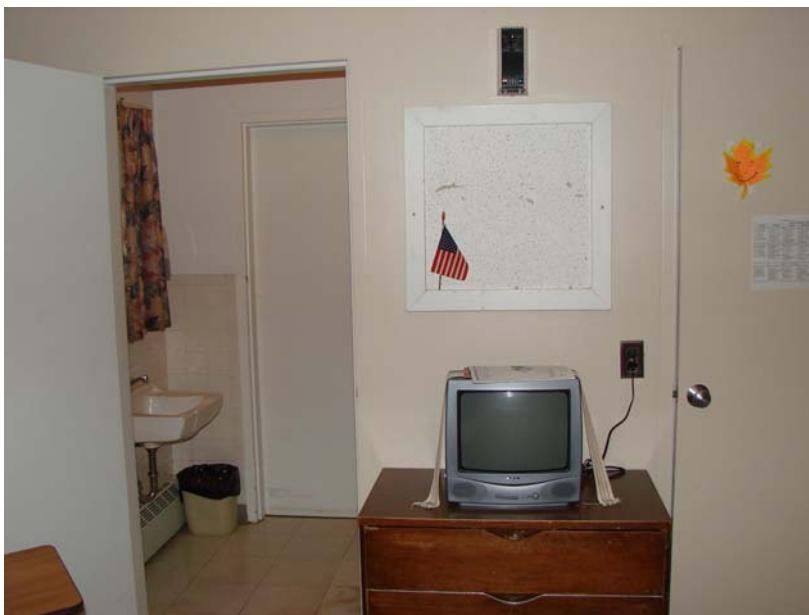
123_MI_1: Shared toilet & sink between resident rooms.

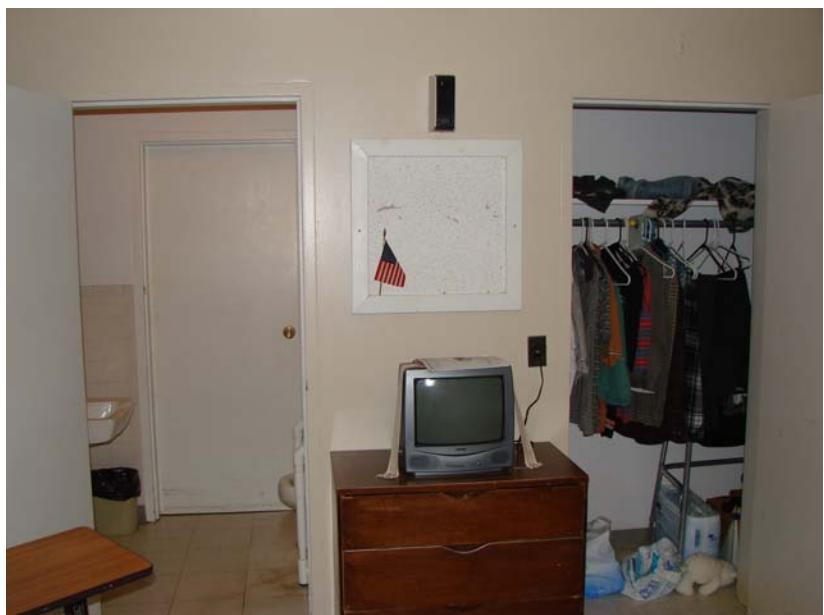
124_MI_1: South 2 semi-private resident room - shared toilet & sink; built in wardrobe closet.

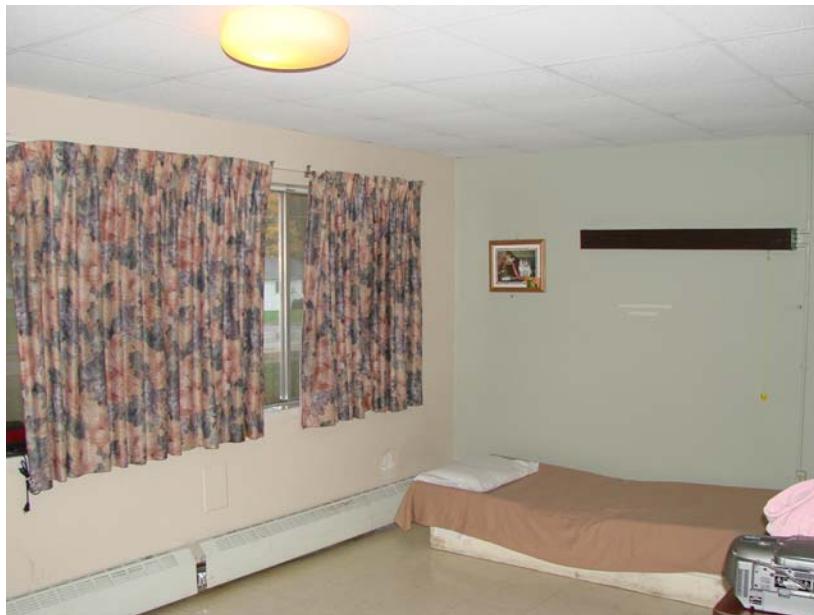
125_MI_1: South 2 private room (#10).

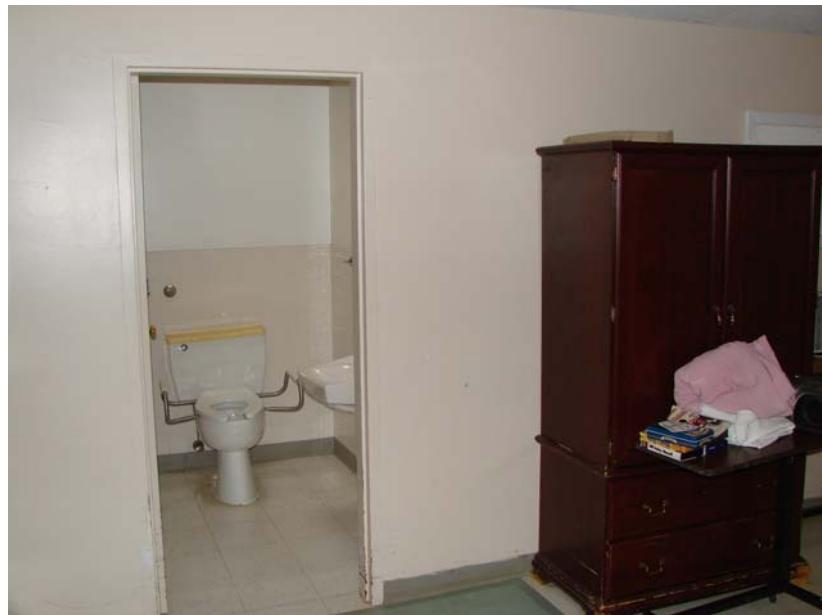
126_MI_1: Private toilet & sink in private room.

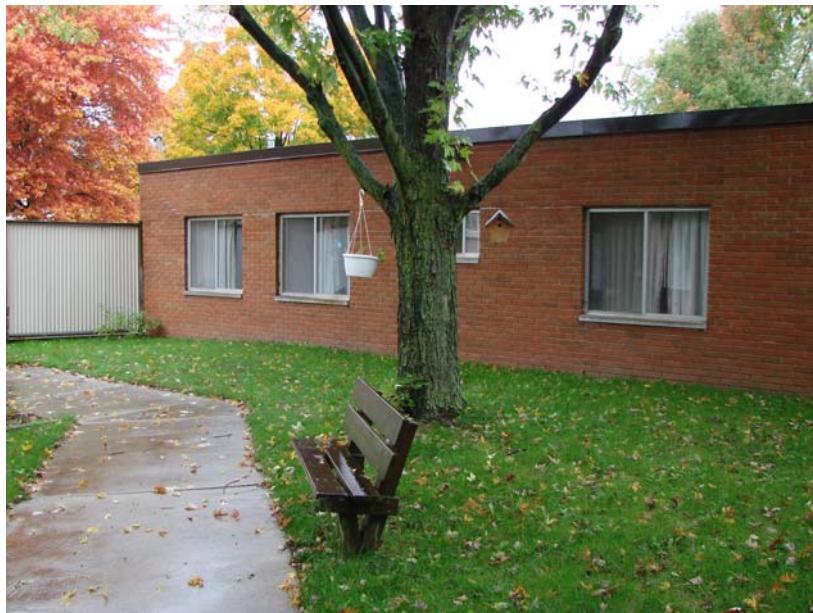
127_MI_1: Courtyard between west wings of South 1 and South 2 Halls.

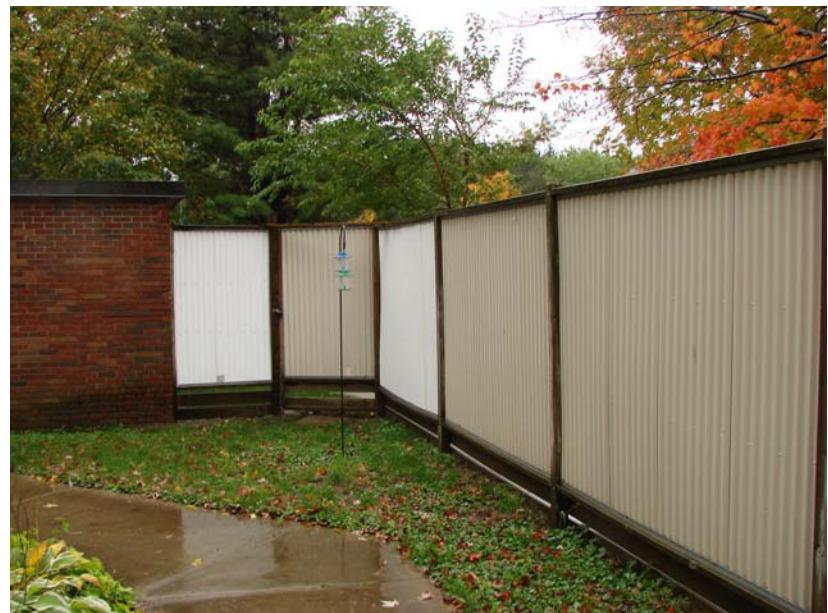
128_MI_1: Courtyard between west wings of South 1 and South 2 Halls.

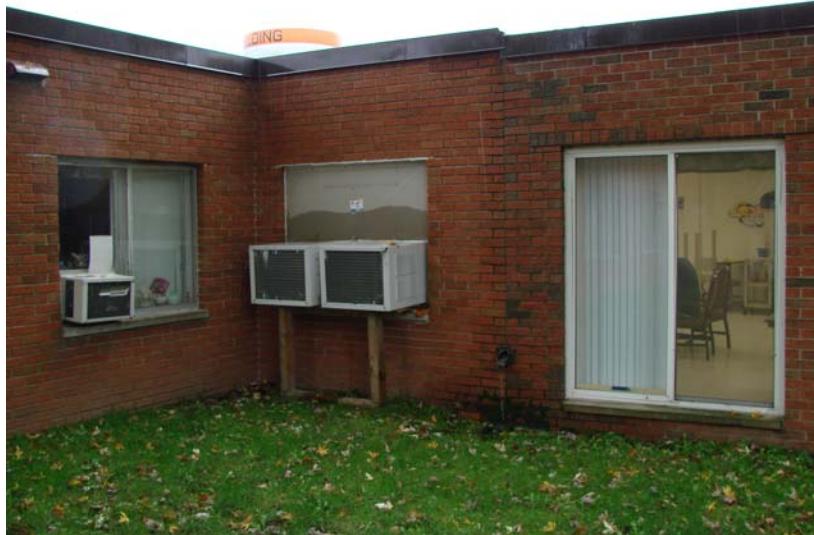
129_MI_1: Window unit air conditioners - dining room, staff office.

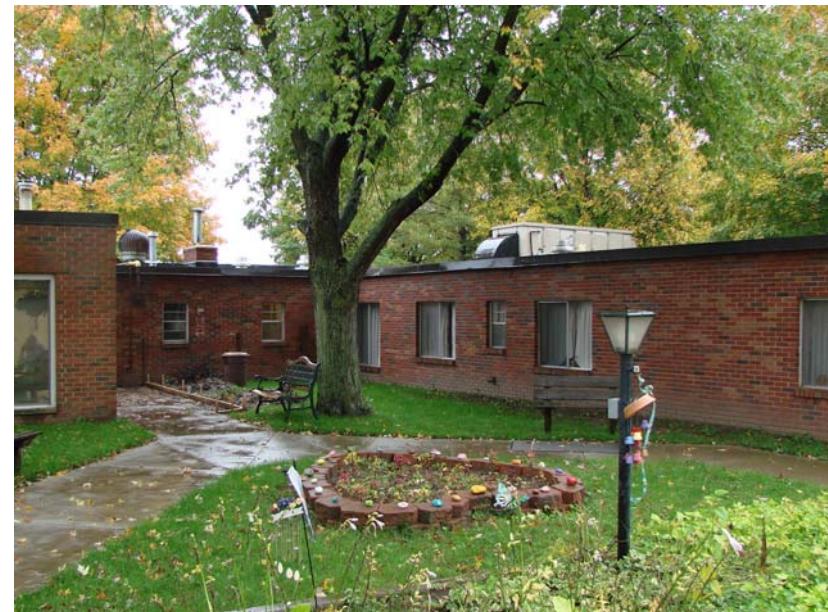
130_MI_1: Courtyard between west wings of South 1 and South 2 Halls.

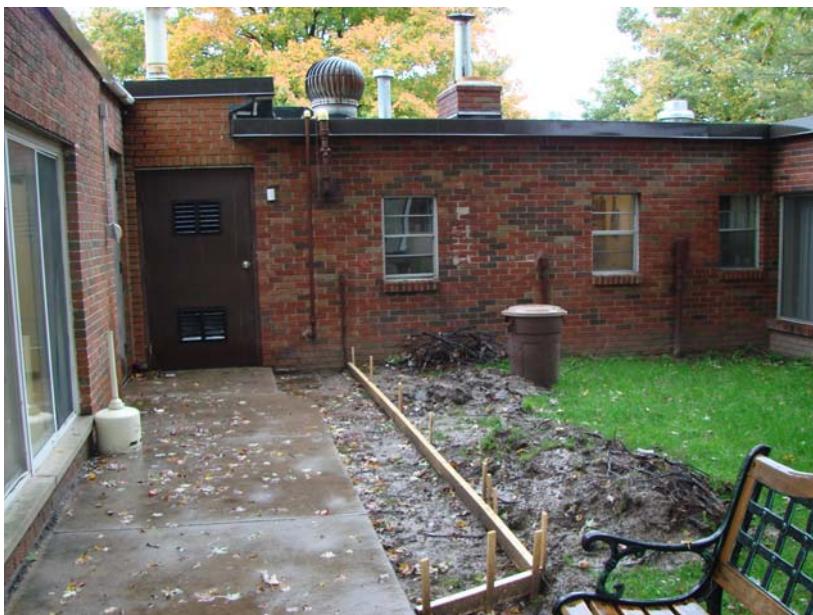
131_MI_1: Form boards - staff in widening sidewalk to boiler room.

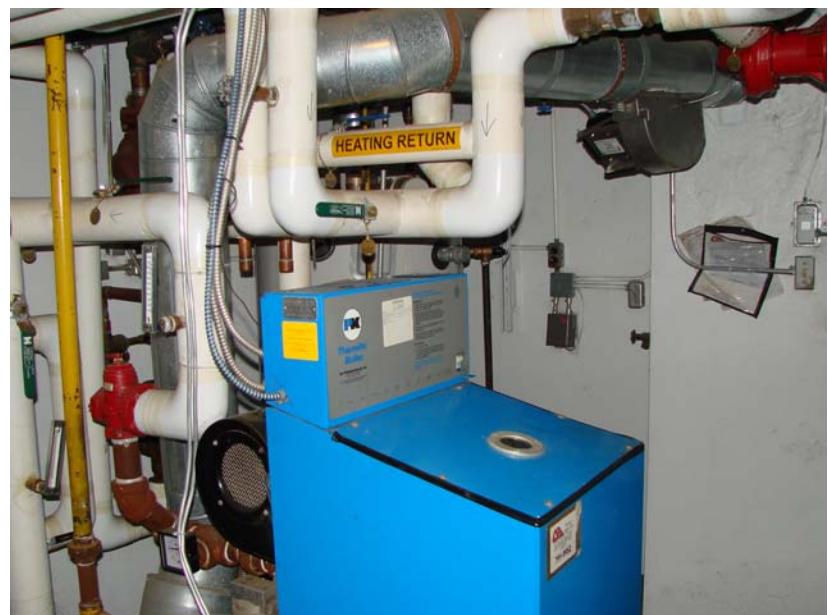
132_MI_1: South 2 Hall boiler room. Patterson-Kelly boiler, 700,000 BTUH (1998).

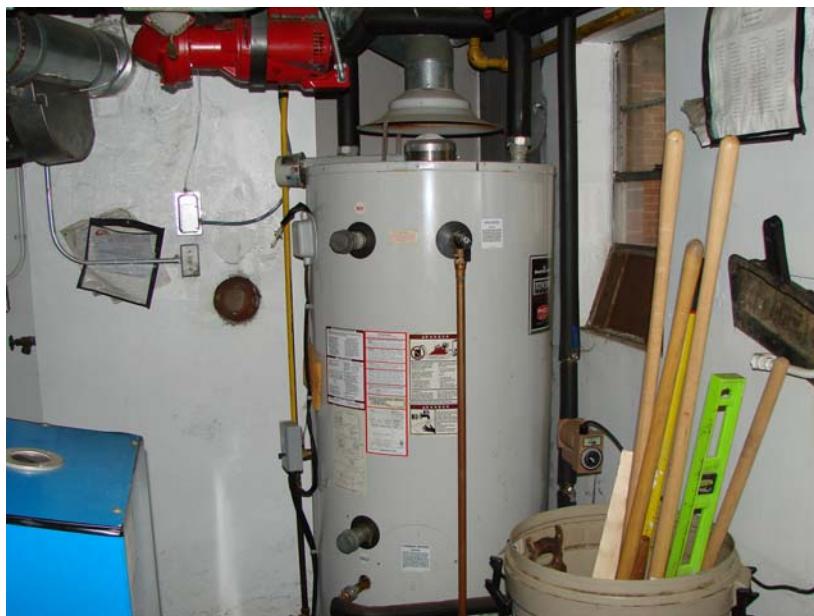
133_MI_1: Bradford White water heater, 199,999 BTUH, 100- gal.

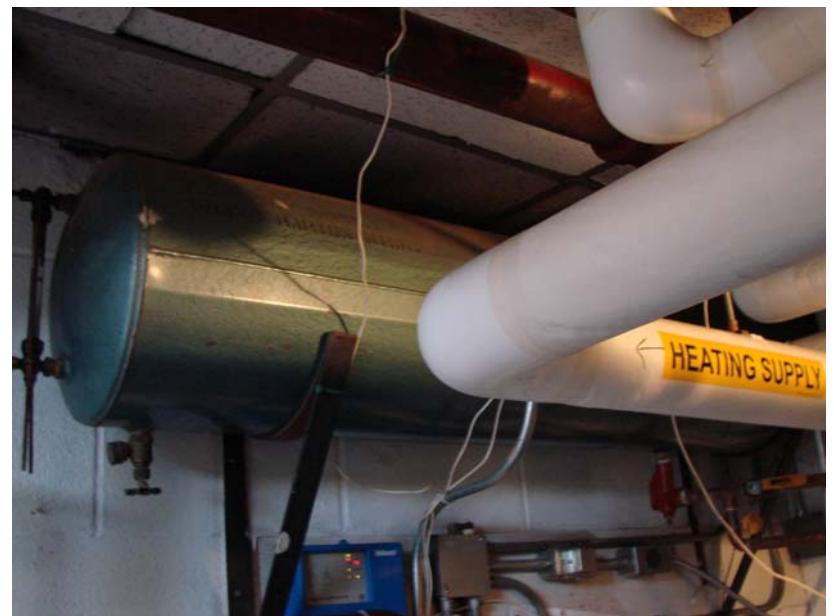
134_MI_1: Expansion tank (heating hot water).

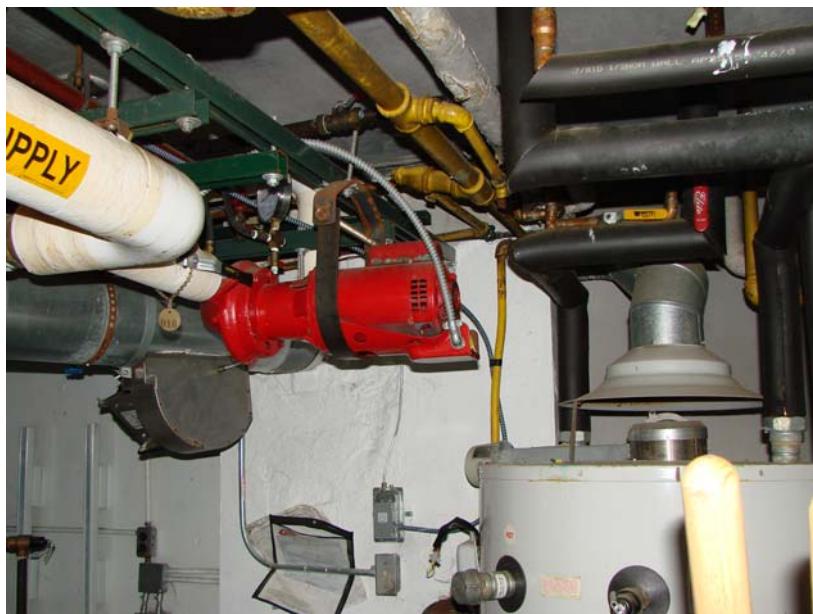
135_MI_1: Circulating pump.

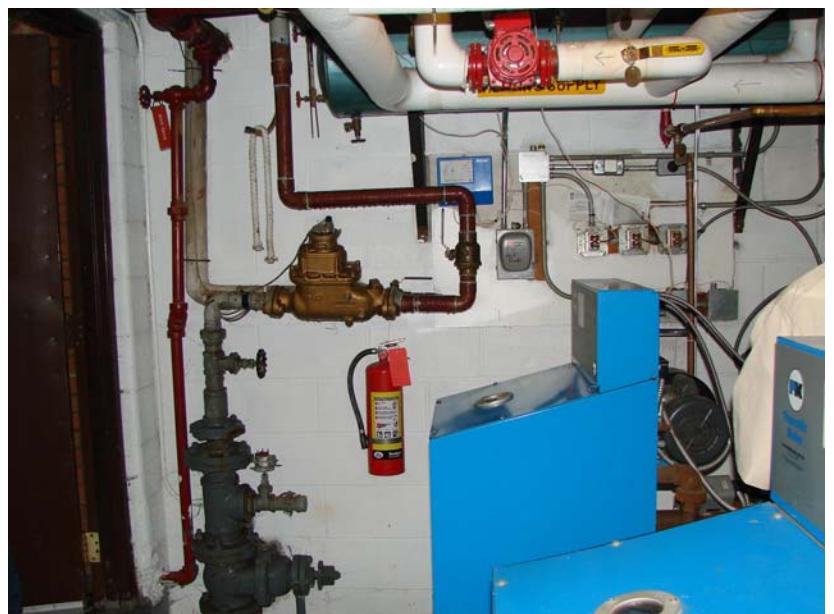
136_MI_1: Fire sprinkler riser (facility is only partially sprinkled).

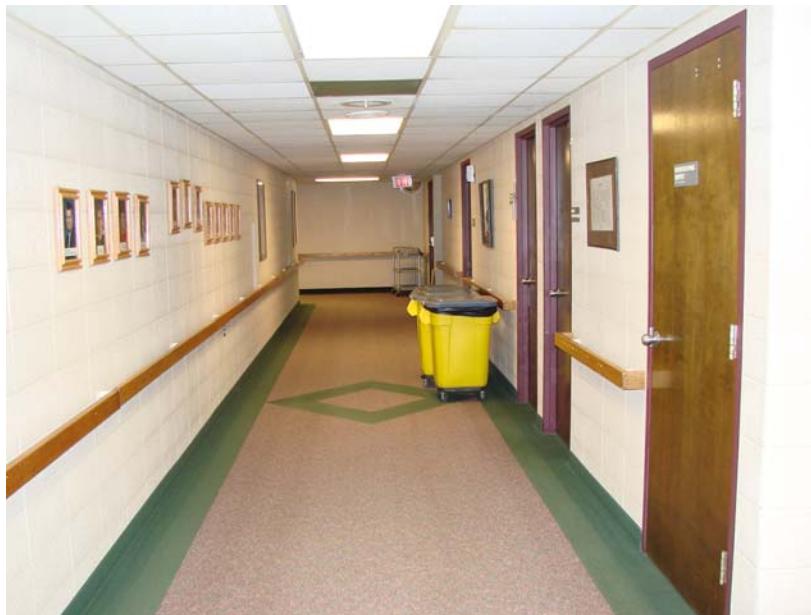
137_MI_1: Center corridor looking north to East Hall (newest addition - 1980's).

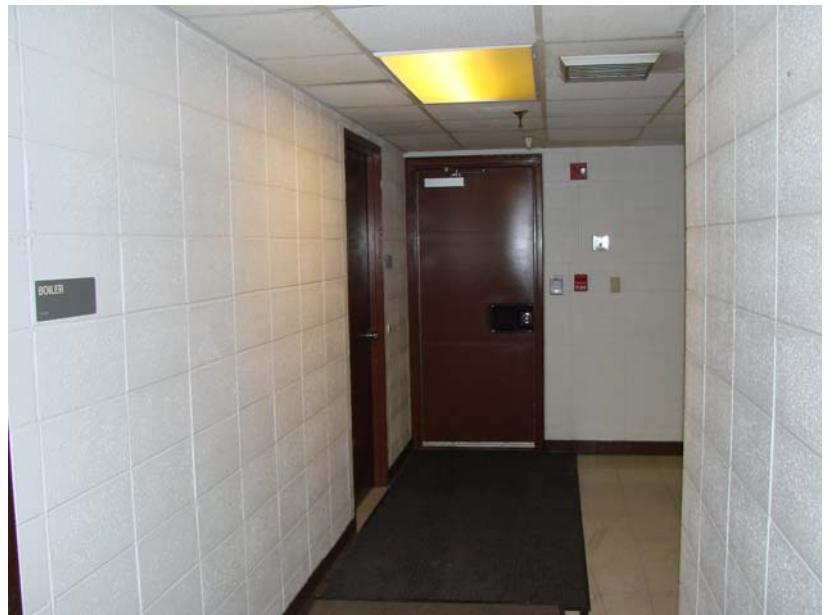
138_MI_1: Service corridor - central wing.

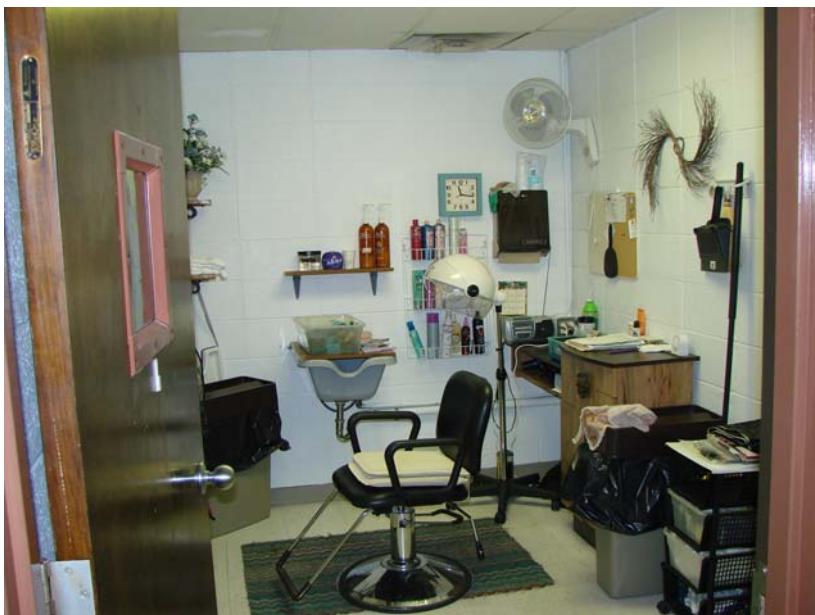
139_MI_1: Beauty shop.

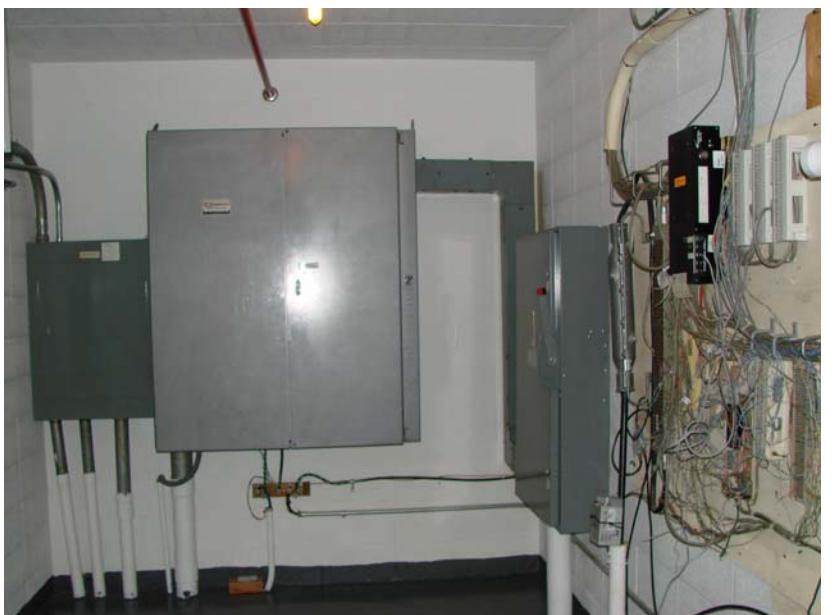
140_MI_1: Electrical room - 600 Amp main service, telephone patch panels.

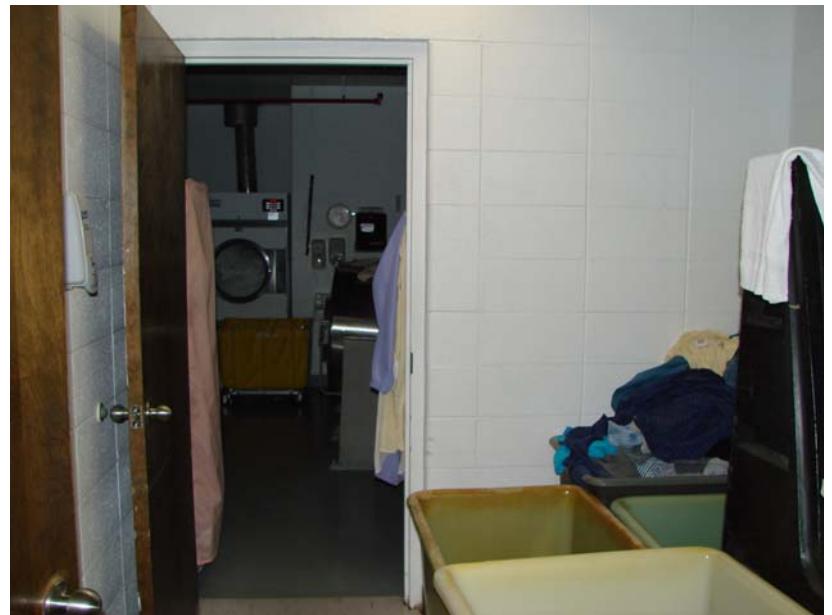
142_MI_1: Laundry - soiled linen room.

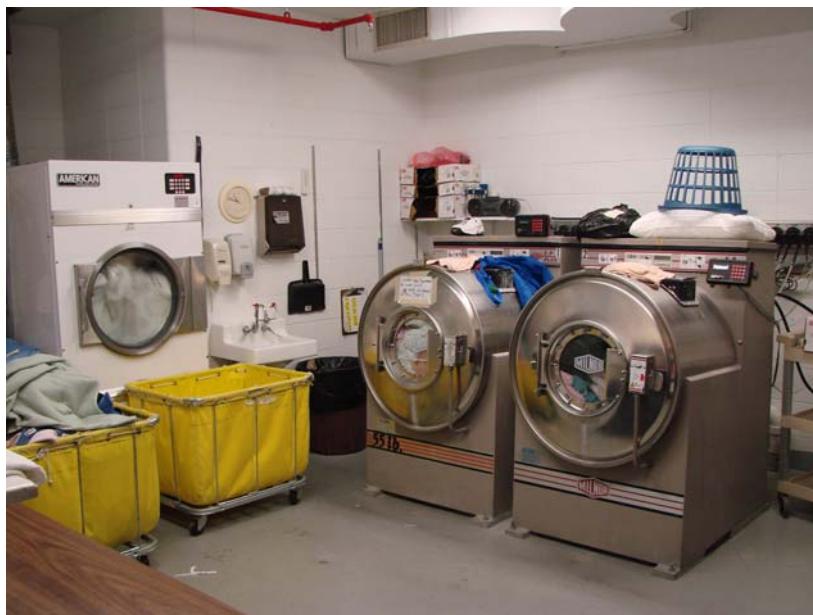
143_MI_1: Laundry - 55# Milnor washers (6-yrs); 55# American dryer (15+ yrs).

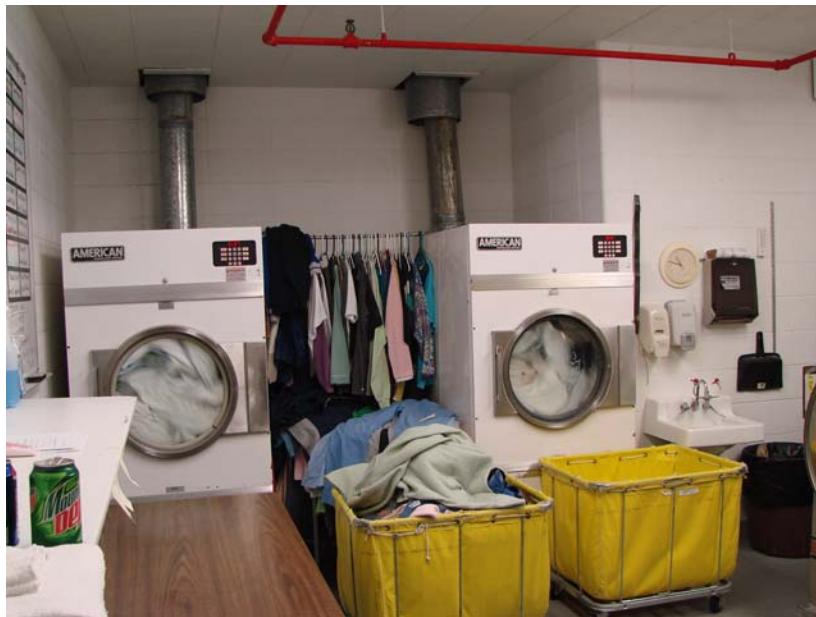
145_MI_1: Laundry - 55# American dryers (15+ yrs).

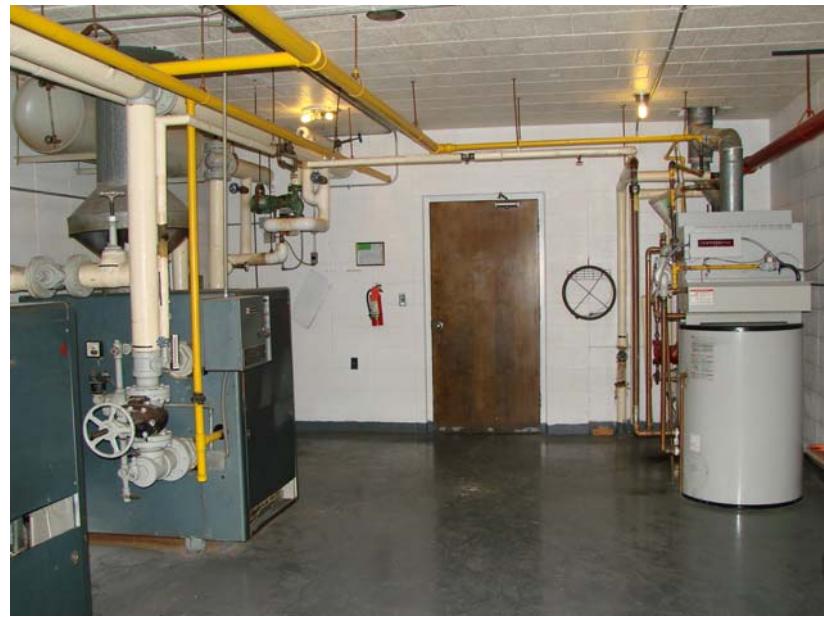
146_MI_1: Central corridor boiler room - Weil-McClain boilers, Lochinvar water heaters.

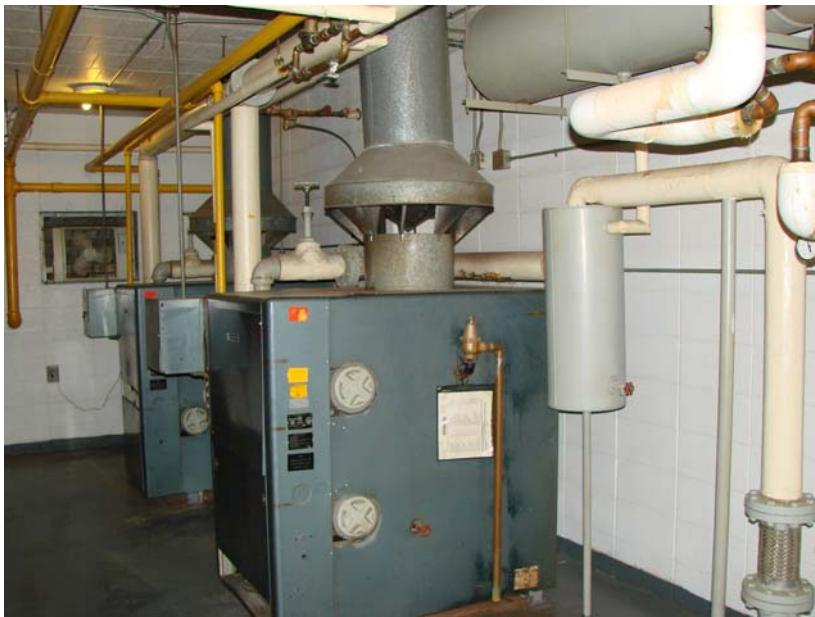
147_MI_1: Central wing boiler room - Weil-McClain boilers, 1,190,000 BTUH (20+ yrs).

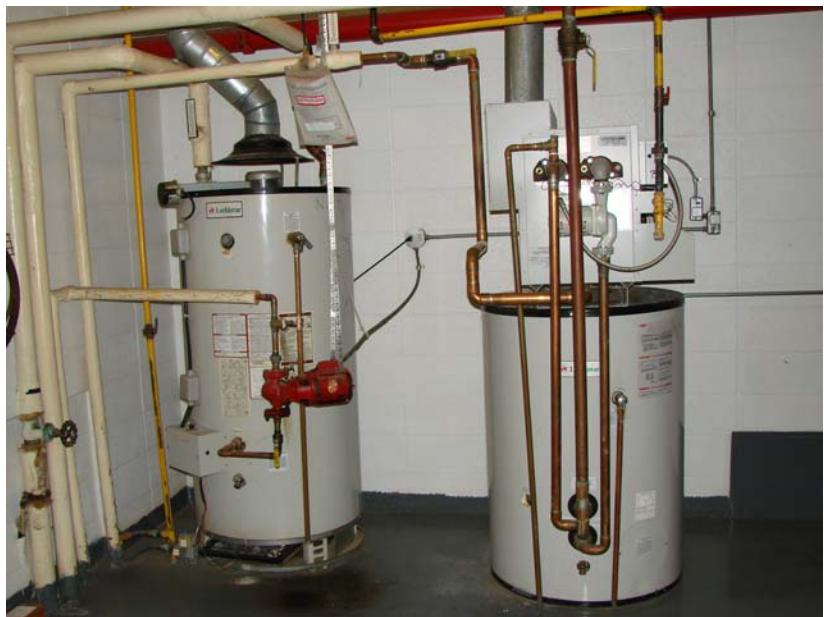
148_MI_1: Lochinvar water heaters, 100-gal, 199,900 BTUH (10-yrs).

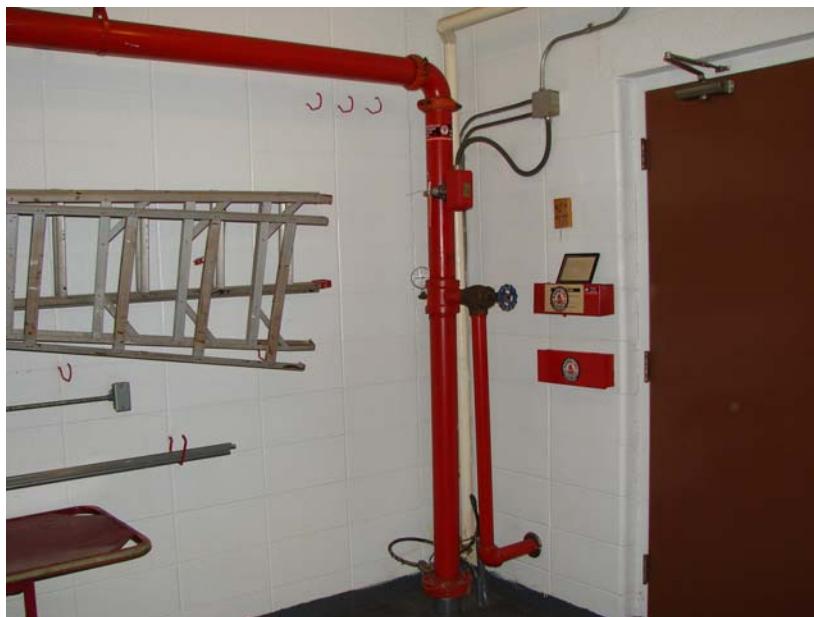
149_MI_1: Fire sprinkler riser for north wings (east & west) - note facility is not fully sprinkled.

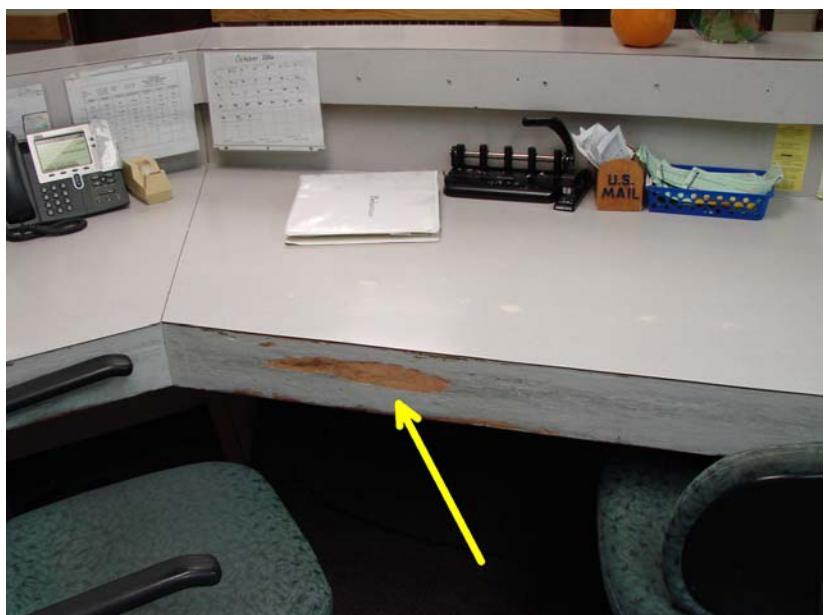
160_MI_1: Nurse station detail - counter top needs maintenance.

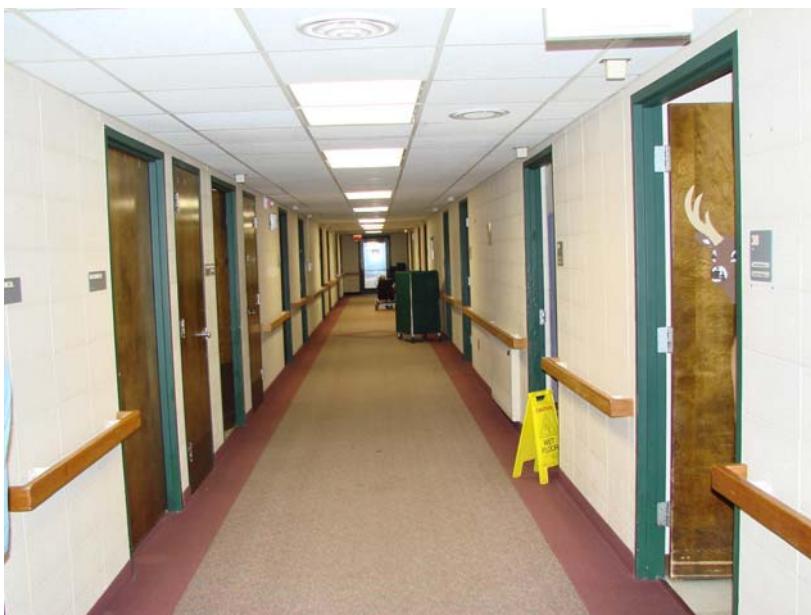
163_MI_1: West Hall looking south from nurse station - carpet, carpet base, painted CMU block walls, wood handrail, acoustical grid ceiling.

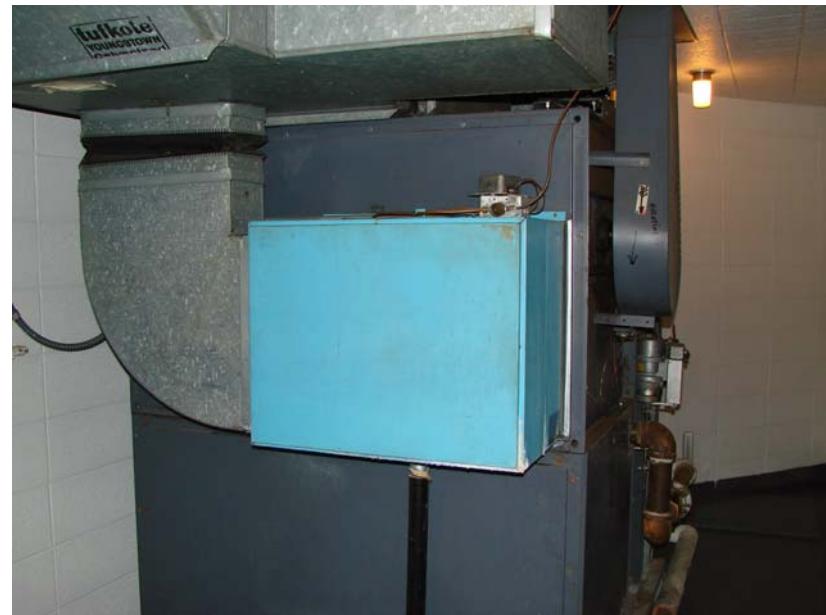
166_MI_1: Trane air handler in West Hall.

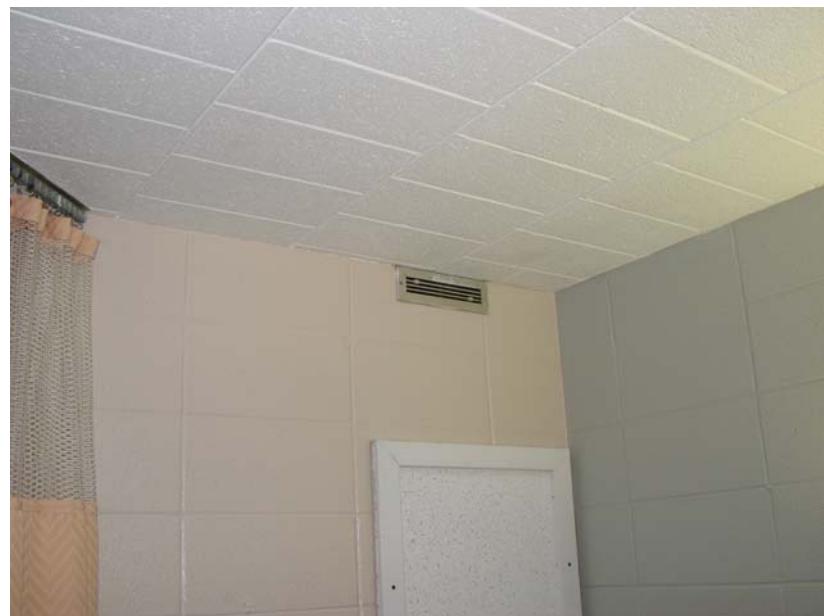
178_MI_1: Make up air in resident room.

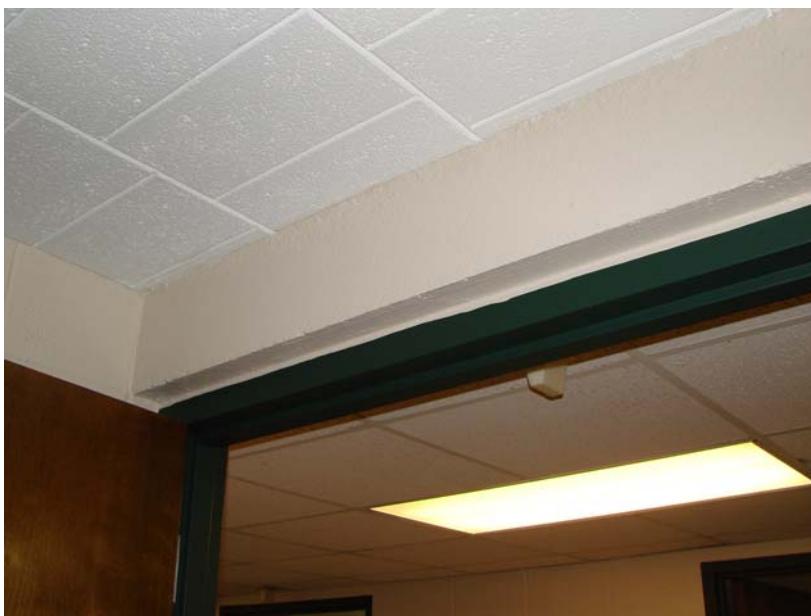
179_MI_1: Ceiling detail - exposed concrete plank ceiling in resident rooms, dropped acoustical grid ceiling in corridor.
