PROPERTY CONDITION REPORT

The Willows @ Anytown

414 East Street ♦ Anytown, USA 01995

Client: No.1 LTC Operator

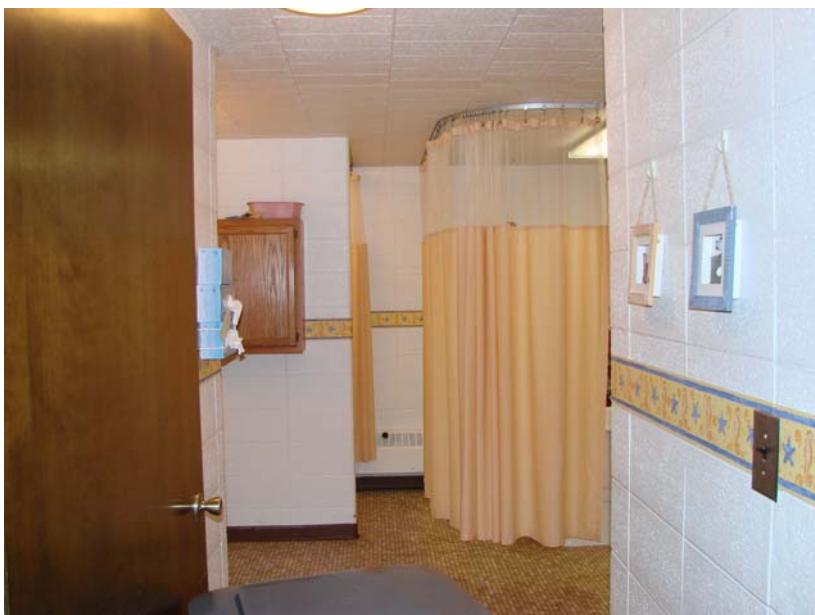
187_MI_1: East Hall tub-shower room.

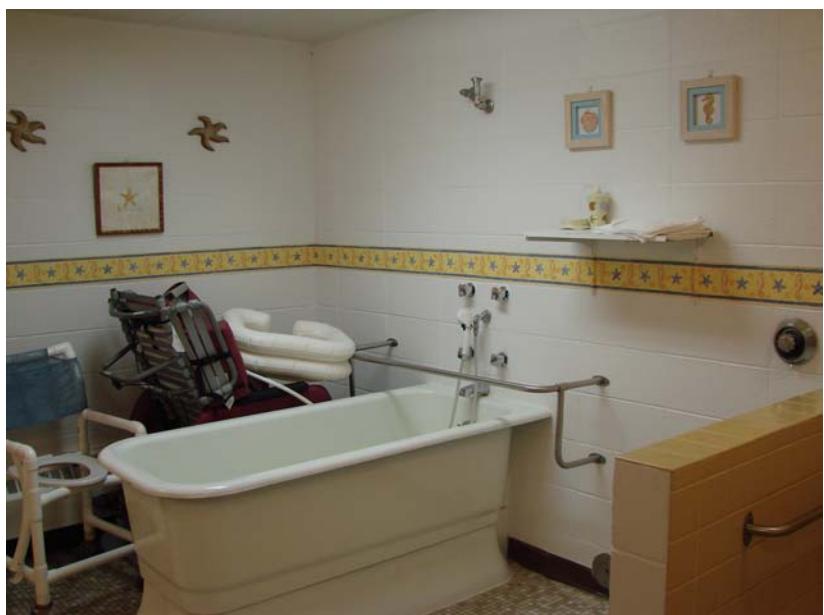
<u>Photo</u>	<u>Description</u>
188.	East Hall tub/shower room.
189.	East Hall tub/shower room.
190.	Shower floor detail - average condition.
191.	Control door to physical therapy/default facility entrance.

188_MI_1: East Hall tub-shower room.

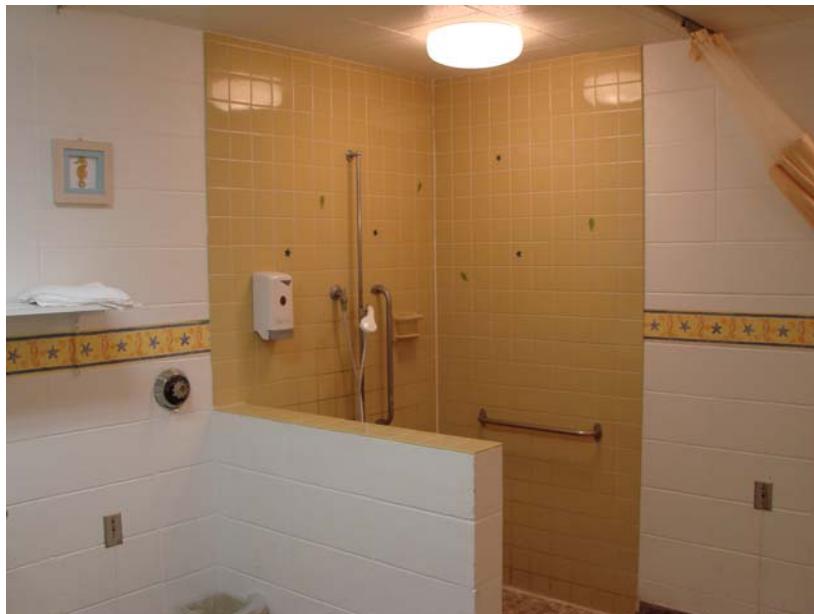
189_MI_1: East Hall tub-shower room.

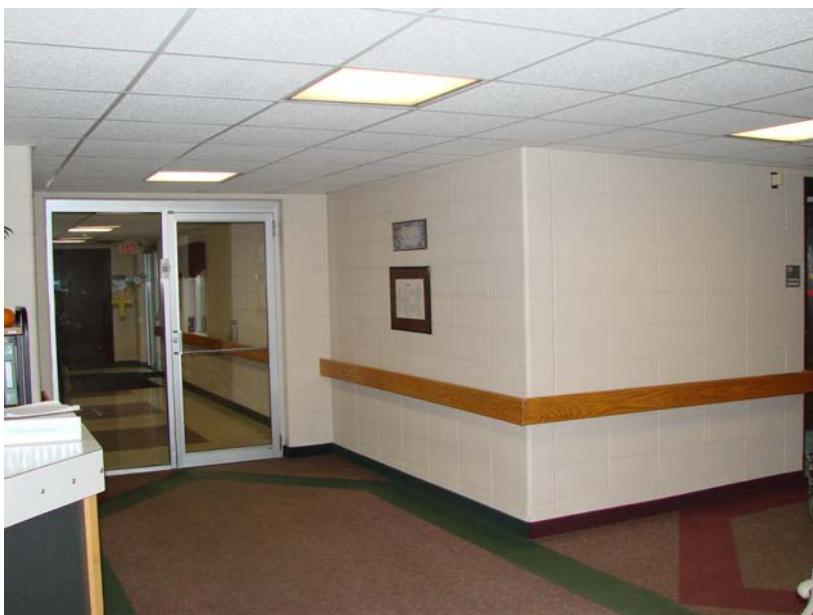
191_MI_1: Control door to physical therapy-default facility entrance.

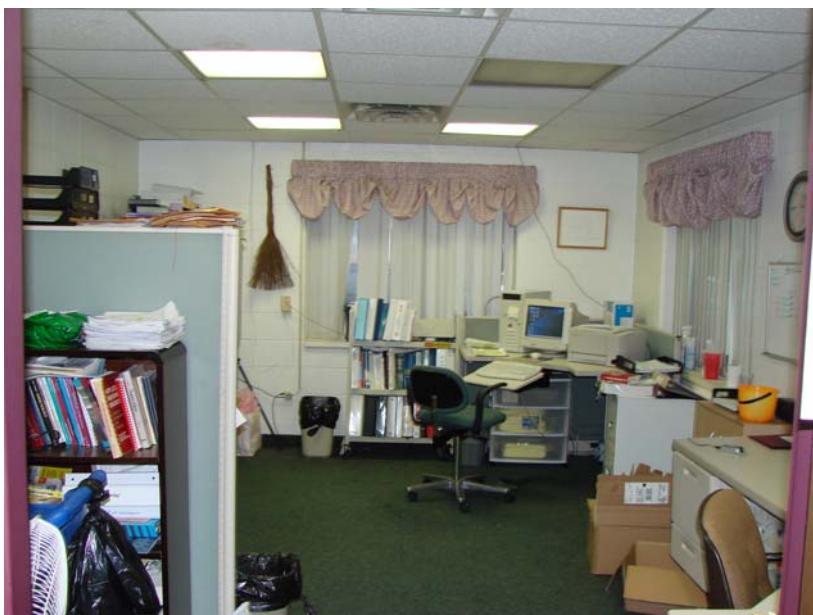
198.	Training bathroom in physical therapy.
199.	Physical therapy office.
200.	Water stains on ceiling tile in therapy office.
201.	Central Hall roof looking at porte-cochere.

199_MI_1: Physical therapy office.

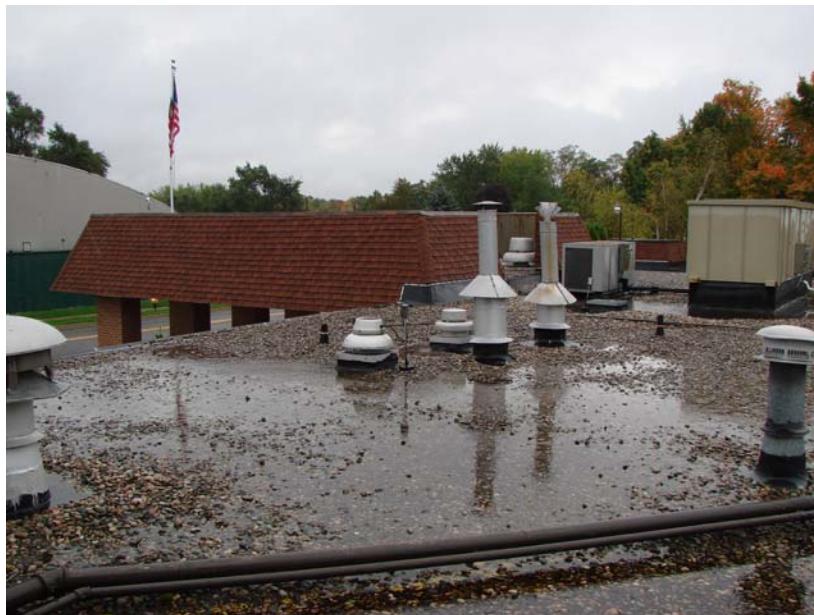
201_MI_1: Central Hall roof looking at porte-cochere.

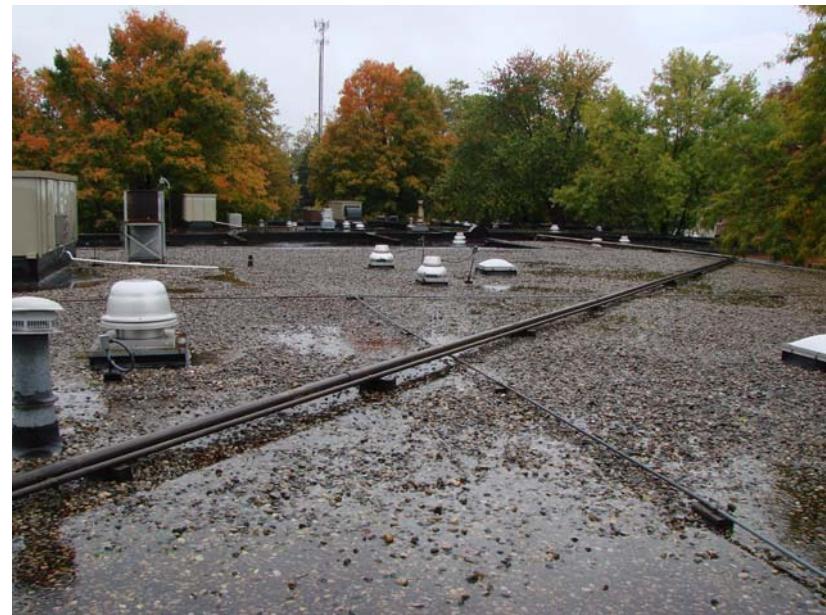
202.	Central Hall roof looking to South 1 Hall.
203.	Central Hall roof top air conditioner.
204.	Roof drain dislodged from its correct position.
205.	Parapet wall at Central Hall porte-cochere.

202_MI_1: Central Hall roof looking to South 1 Hall.

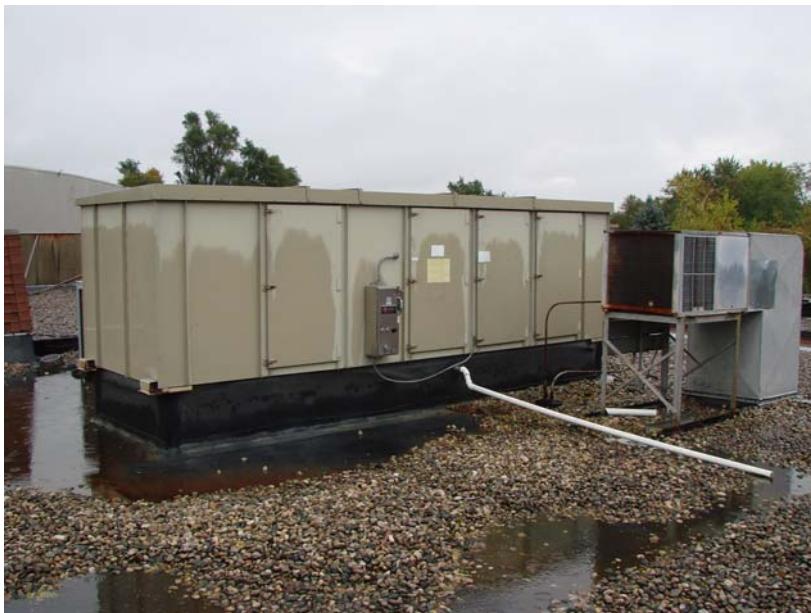
203_MI_1: Central Hall roof top air conditioner.

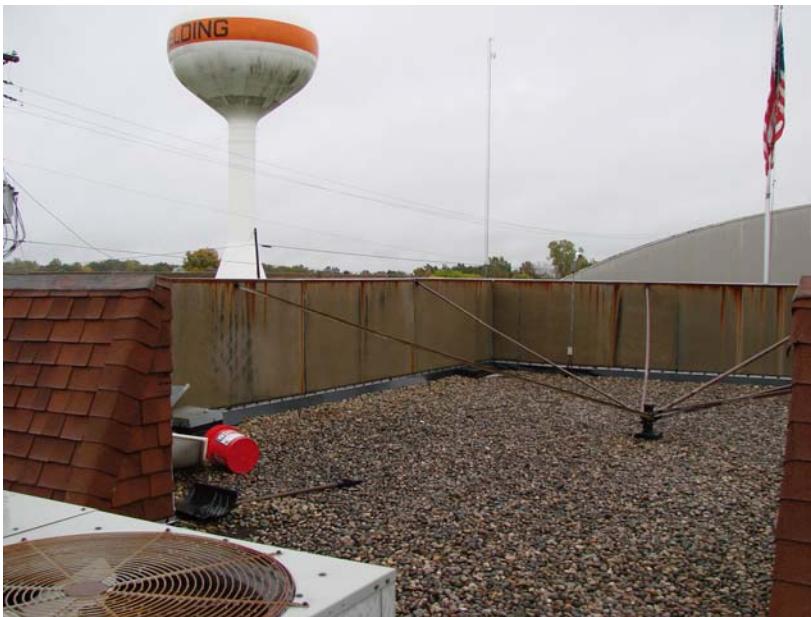
205_MI_1: Parapet wall at Central Hall porte-cochere.

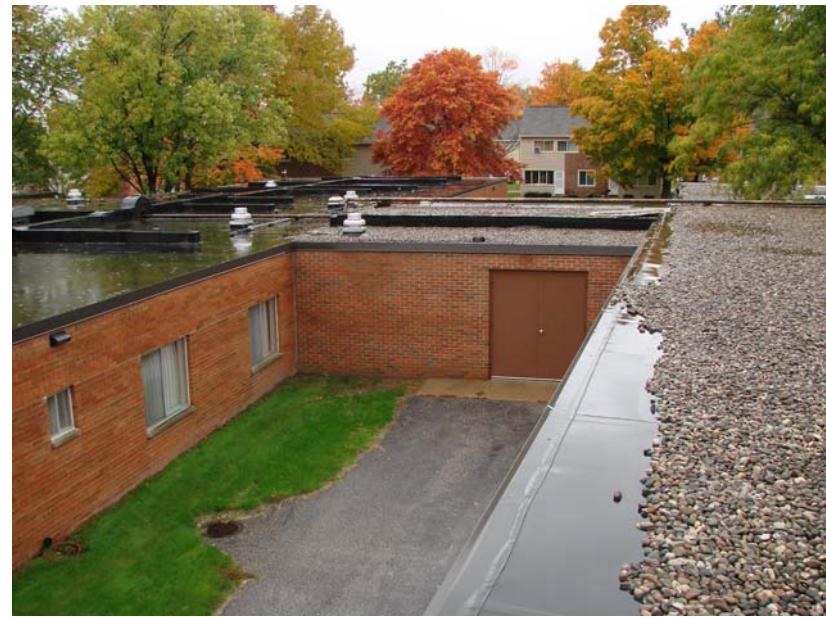
206.	Connection between South 1 and Center Hall building additions.
207.	South Hall 1 roof.
208.	Air conditioners on South 1 Hall roof.
209.	Water ponding on South Hall 1 roof - drainage obstructed by HVAC ducts.

206_MI_1: Connection between South 1 and Center Hall building additions.

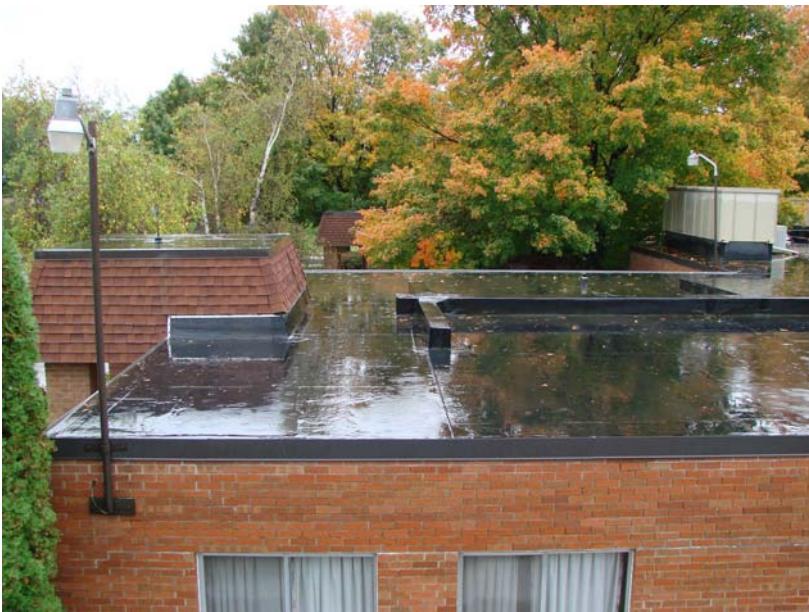
207_MI_1: South Hall 1 roof.

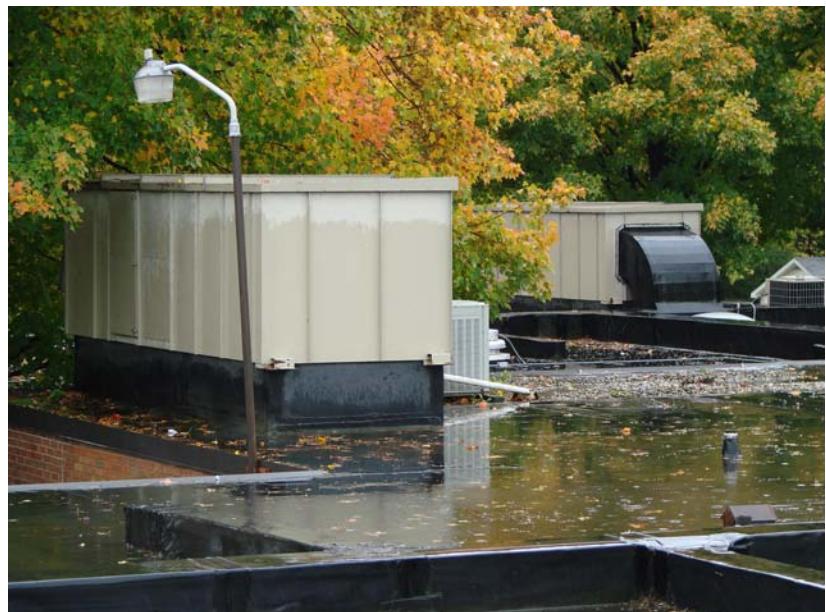
208_MI_1: Air conditioners on South 1 Hall roof.

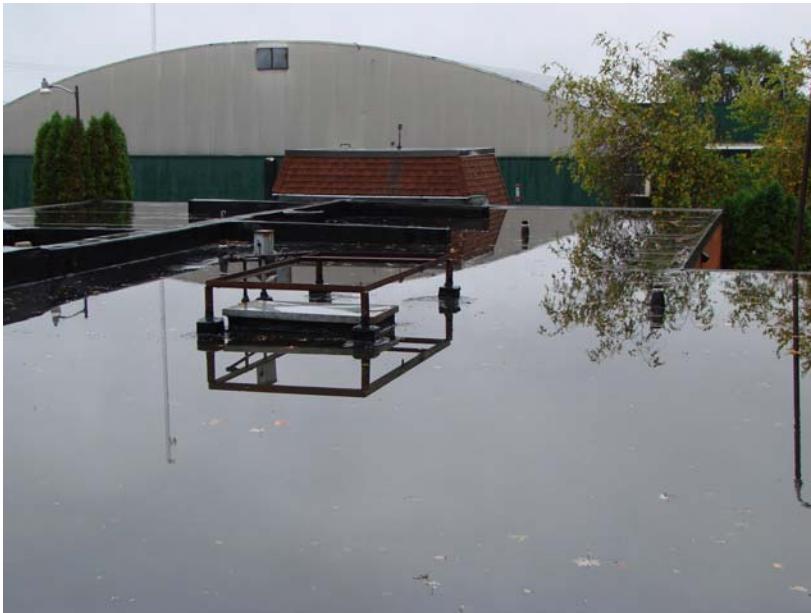
209_MI_1: Water ponding on South Hall 1 roof - drainage obstructed by HVAC ducts.

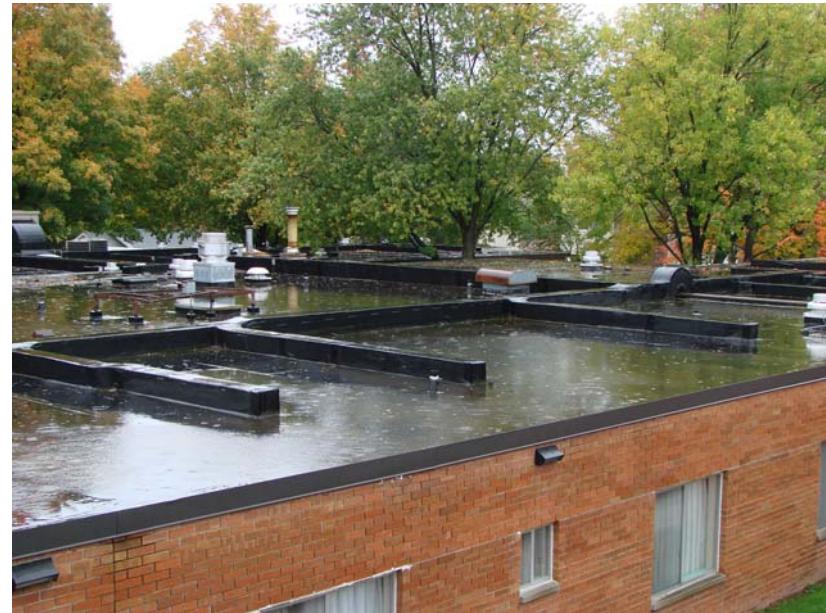
210_MI_1: South Hall 1 roof - note EPDM rubber roof membrane is applied over corridor HVAC ducts.

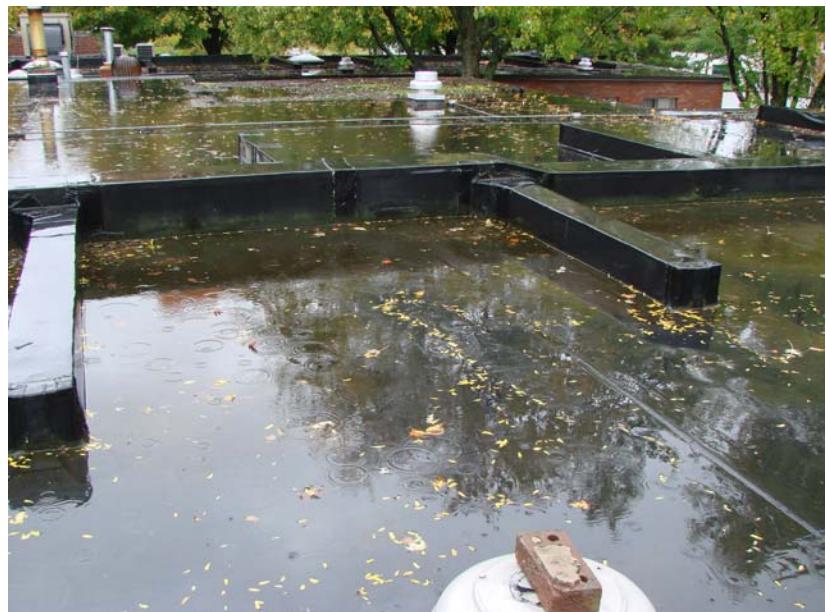
212_MI_1: Detail - HVAC ducts prevent proper roof drainage.

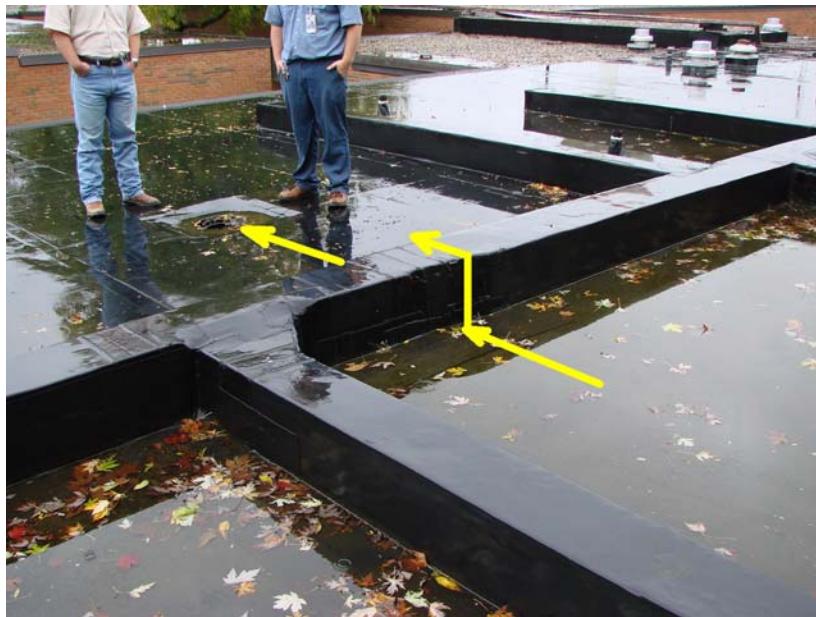
213.	Detail - HVAC ducts preventing proper drainage to roof drain.
214.	Water ponding detail - approx 3/4" deep.
215.	Tree growing between South 1 and South 2 Halls needs to be trimmed away from air conditioners.

213_MI_1: Detail - HVAC ducts preventing proper drainage to roof drain.

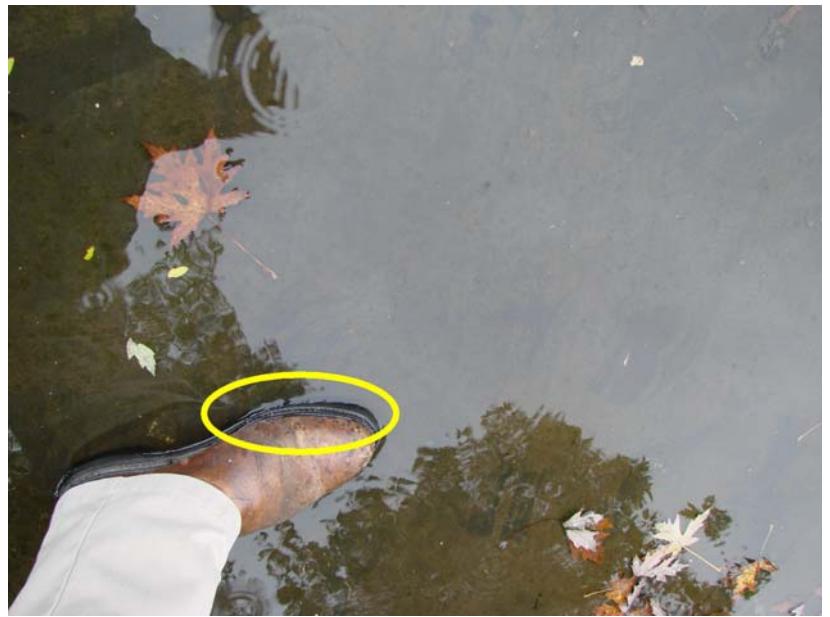
214_MI_1: Water ponding detail - approx 3-4- deep.

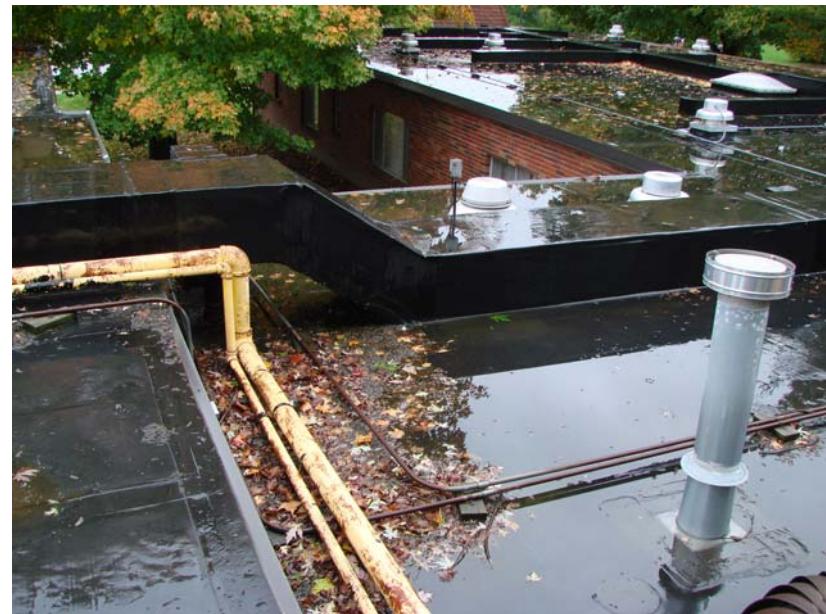
216.	Vegetation growing in roof ballast.
217.	Air conditioner on South 2 Hall roof.
218.	Transition between South 2 and South 1 Hall additions.
219.	South Hall 1 detail - HVAC duct arched over conduit pipe.

218_MI_1: Transition between South 2 and South 1 Hall additions.

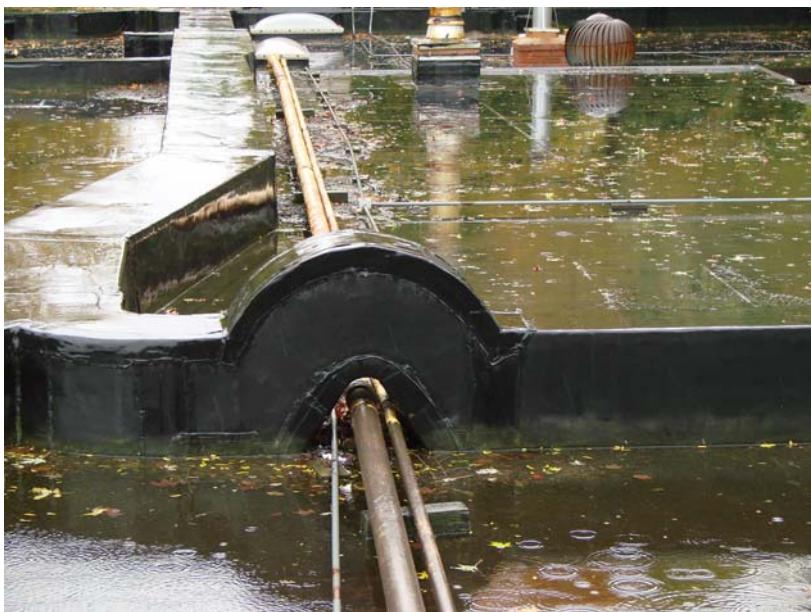
219_MI_1: South Hall 1 detail - HVAC duct arched over conduit pipe.

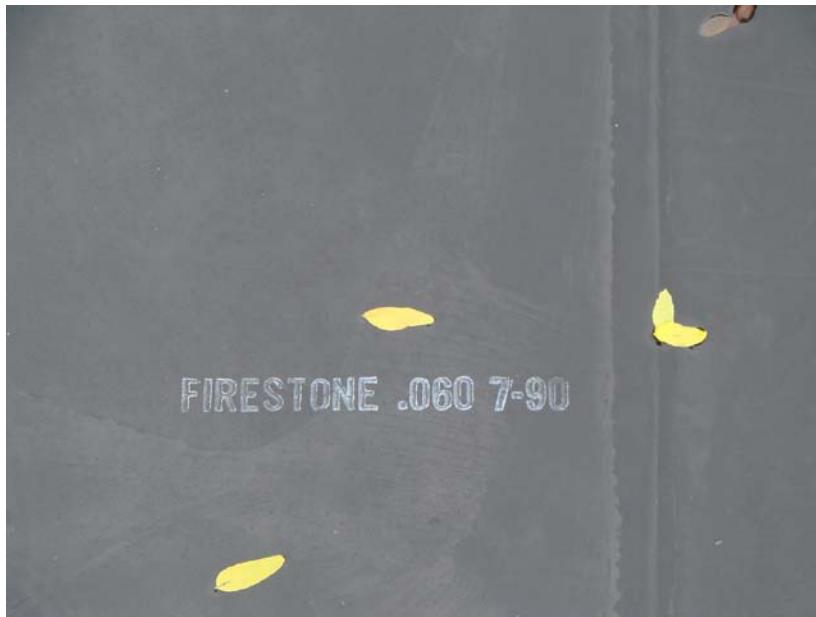
221_MI_1: South Halls roof detail - 60-mil EPDM rubber roof, installed 1990.

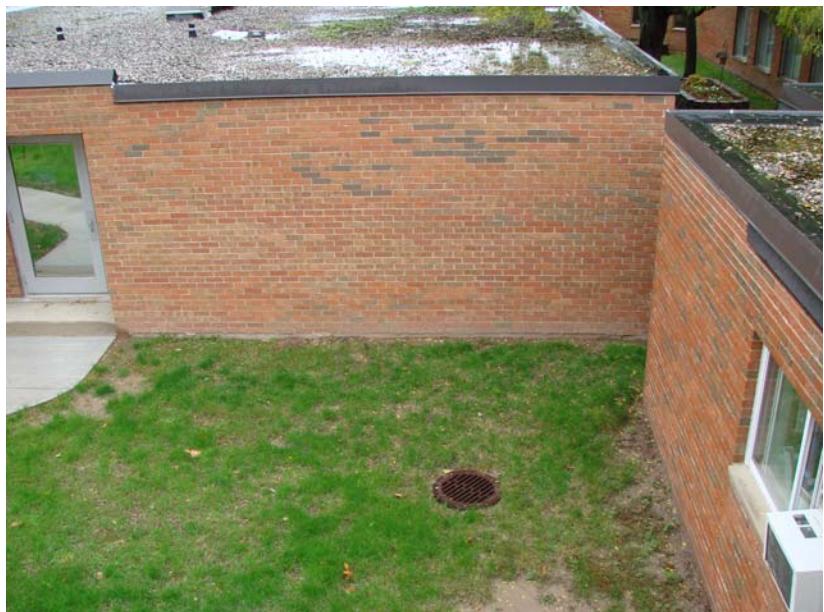
224_MI_1: Area drain at south end of West Hall.

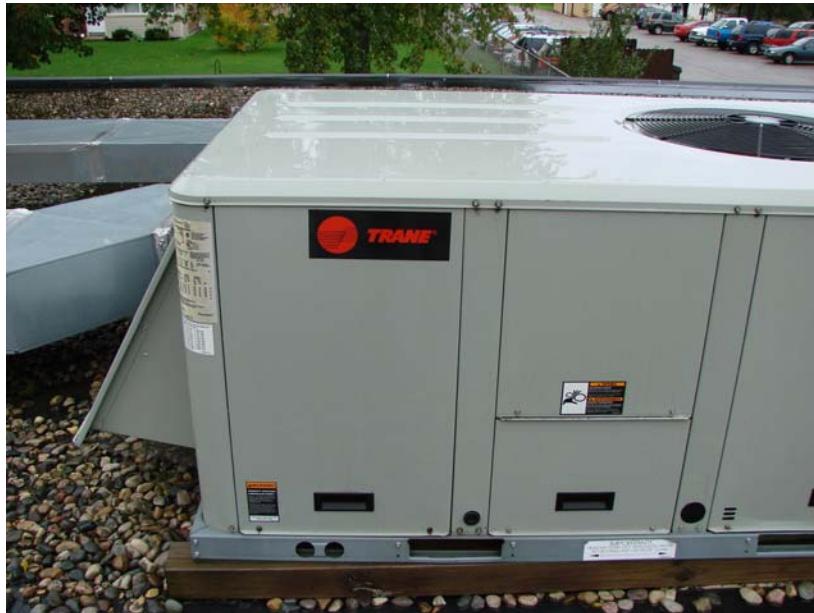
226.	West hall roof looking west to parking lot.
227.	East Hall roof.
228.	East Hall roof.
229.	Trane air conditioner on West Hall roof.
230.	Vegetation growing in roof ballast.
231.	Parking lot entrance from Hall Street.
232.	Service drive around East Hall to west parking lot.
233.	Gazebo between Central Hall and East Hall.
234.	Courtyard between East Hall and Central Hall.
235.	Privacy fence around main gas service.

229_MI_1: Trane air conditioner on West Hall roof.

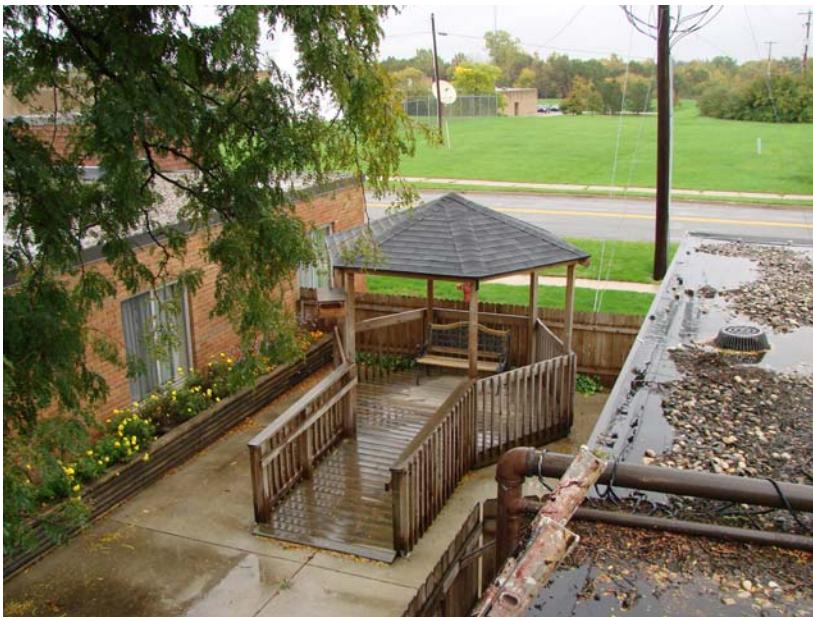
233_MI_1: Gazebo between Central Hall and East Hall.

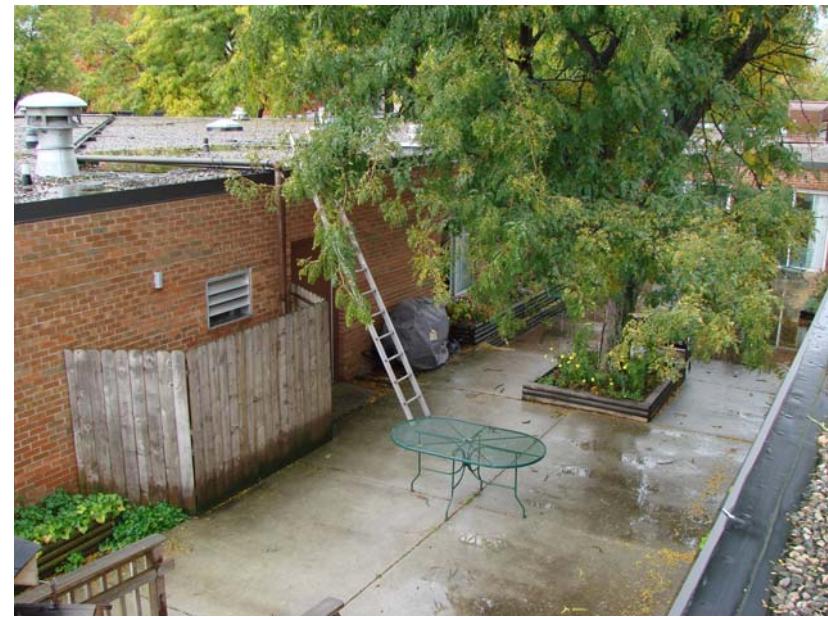
234_MI_1: Courtyard between East Hall and Central Hall.

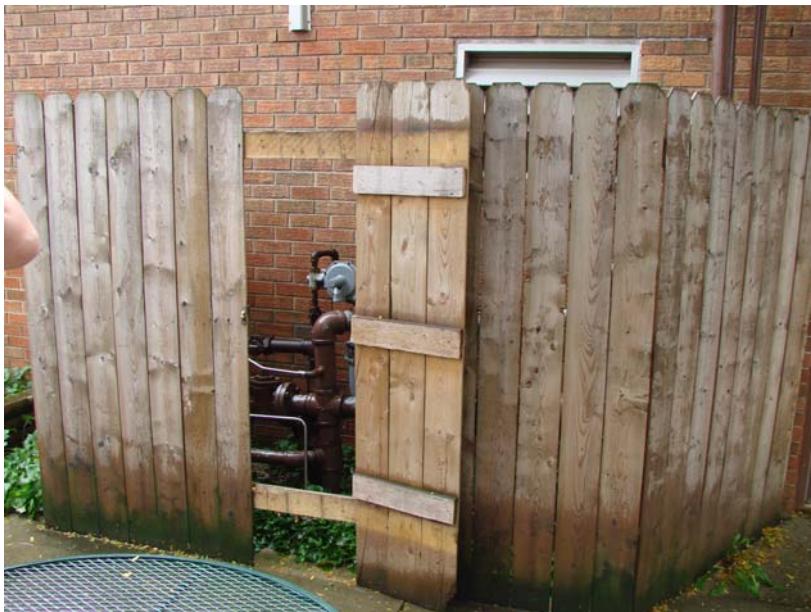
235_MI_1: Privacy fence around main gas service.
